SANDOWN PARK

Sandown Park Racecourse
Annual Structural Survey 2018

October 2018

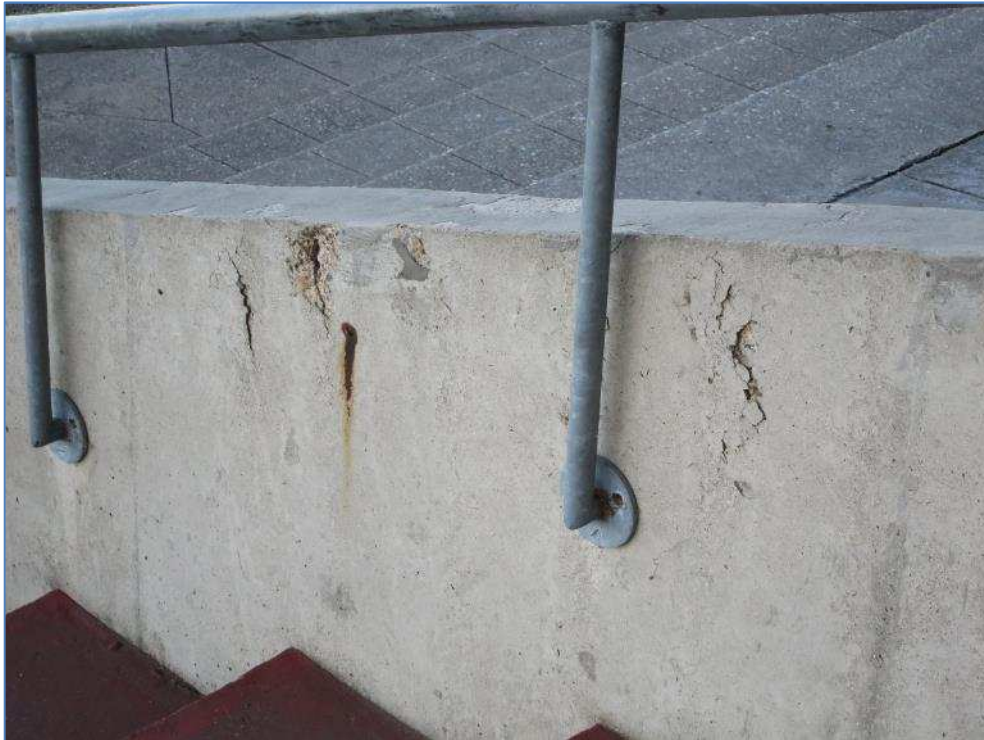
7-46 Concrete spalling on vomitory wall

The front terrace is in a poor state, with many areas of concrete spalling. The racecourse are at present looking to make good the terrace and prevent water ingress into the building. It is recommended that the crush barriers to the terrace be painted whilst carrying out these works.

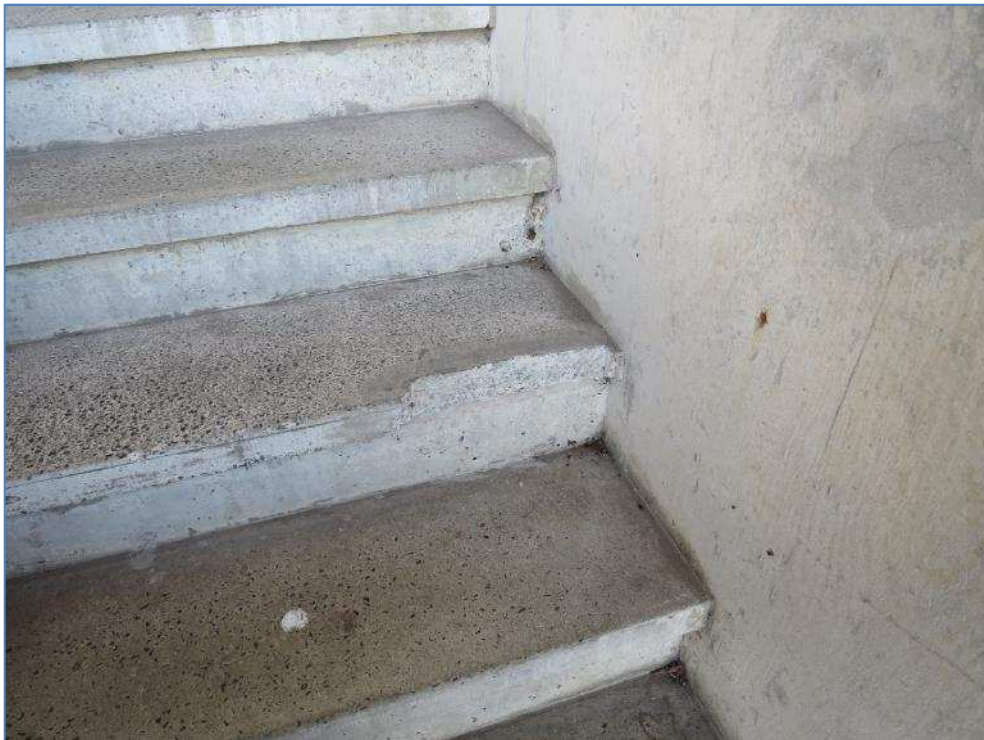
7-47 Section of concrete step spalled

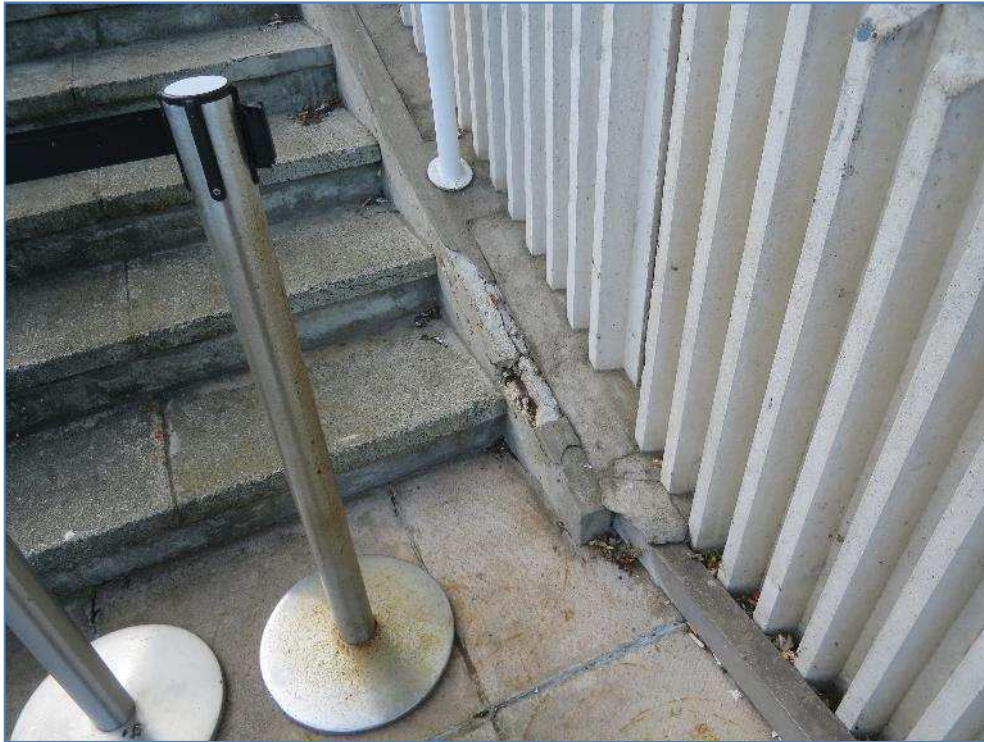
7-48 Concrete spalling on side wall to steps

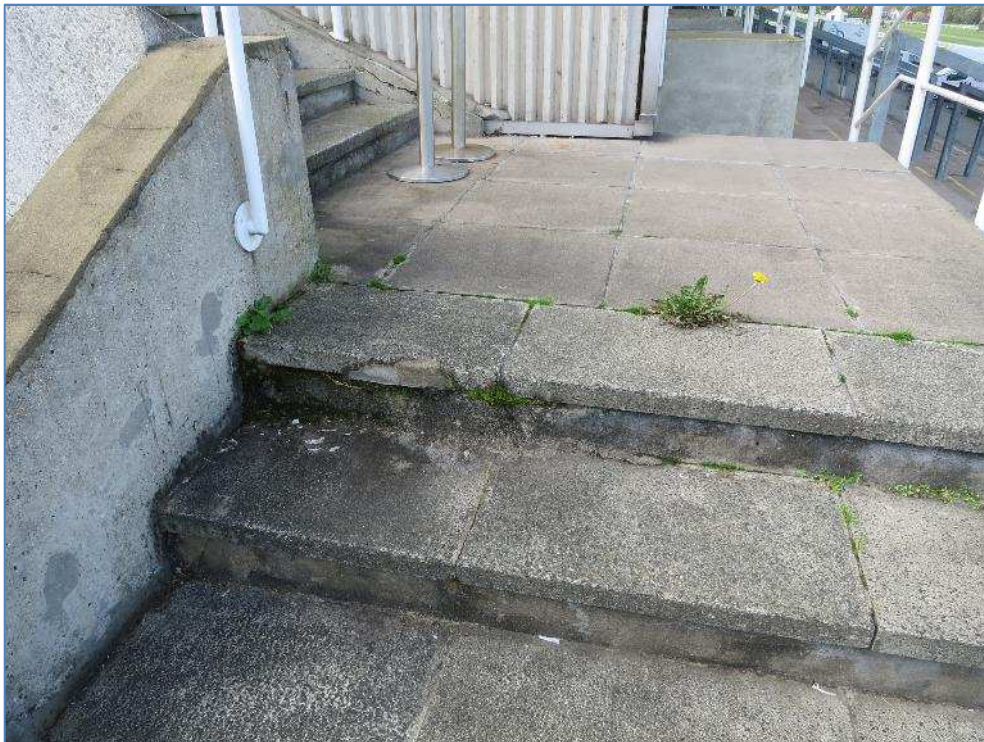
7-49 Plant growth on steps

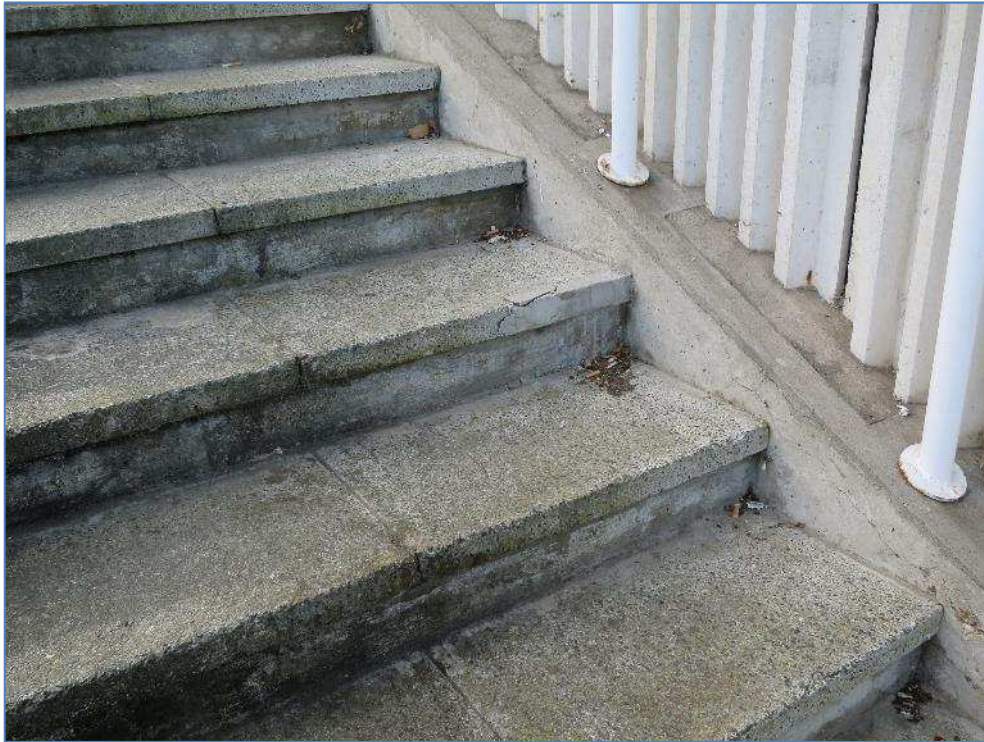
7-50 Concrete repair failing

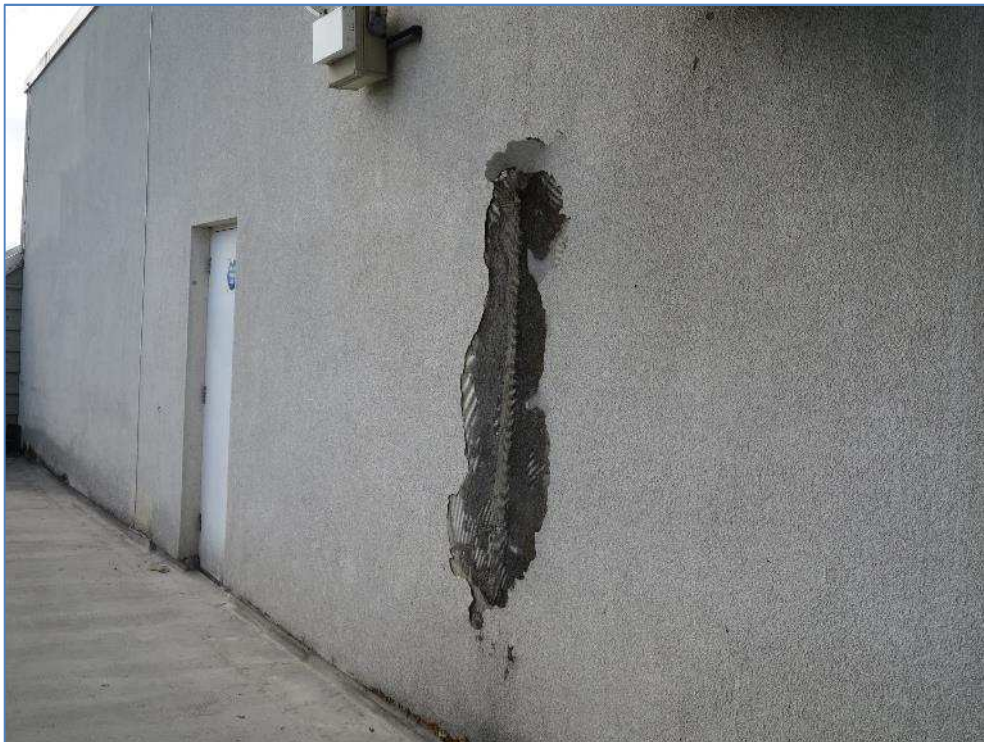
7-51 Render spalled on side wall to stand

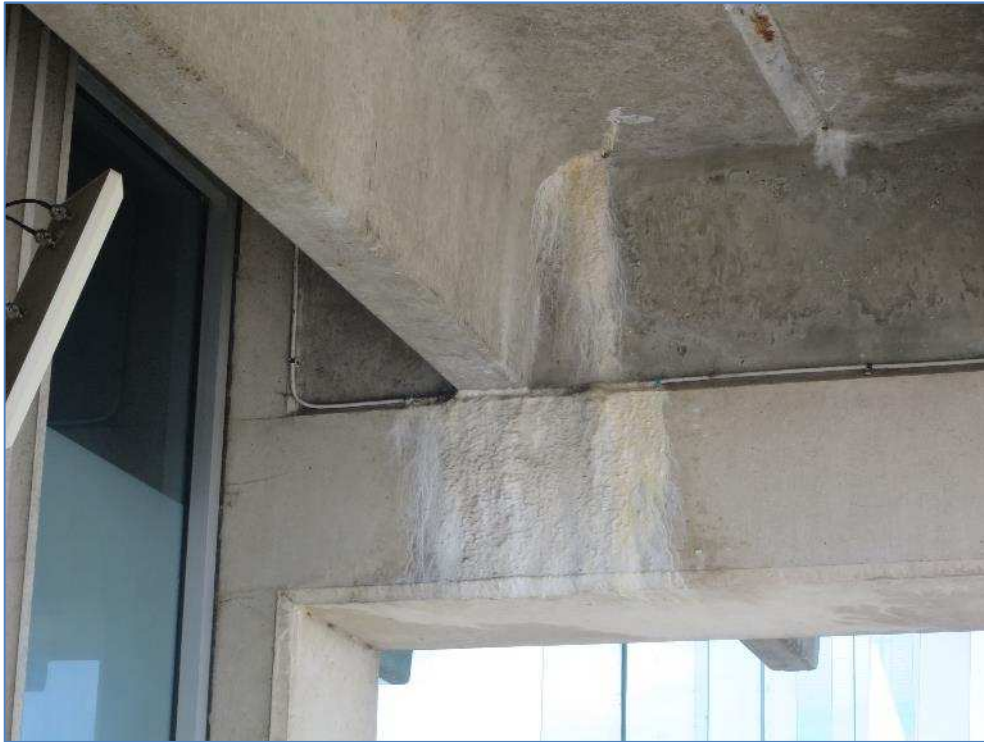
7-52 Leaching through concrete terrace

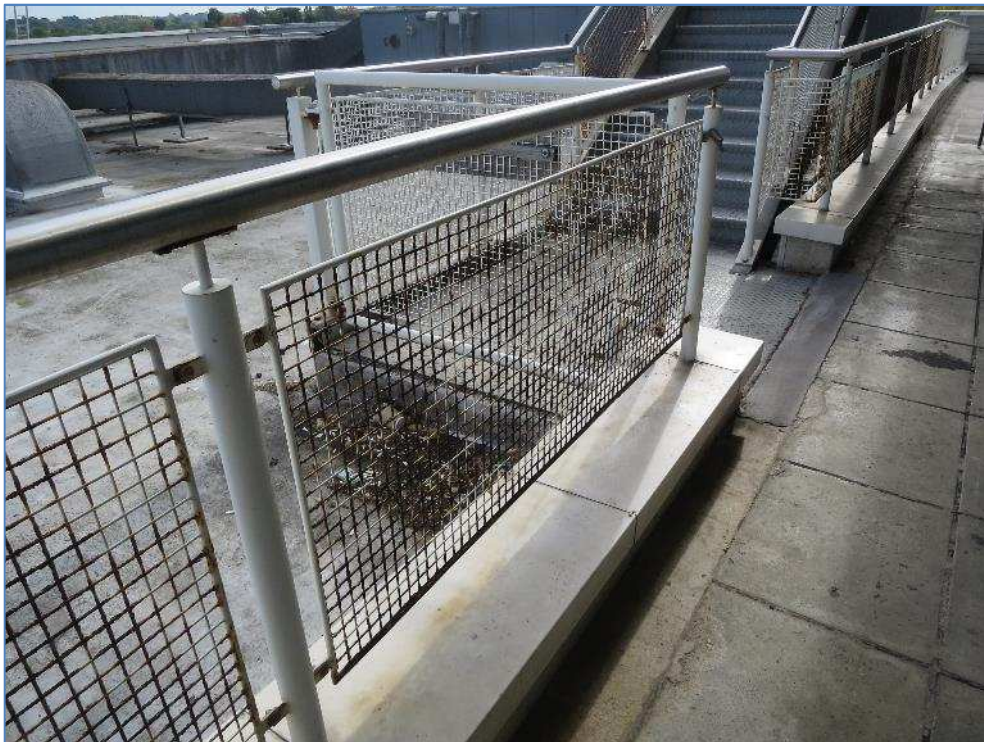
7-53 Surface rust to barriers

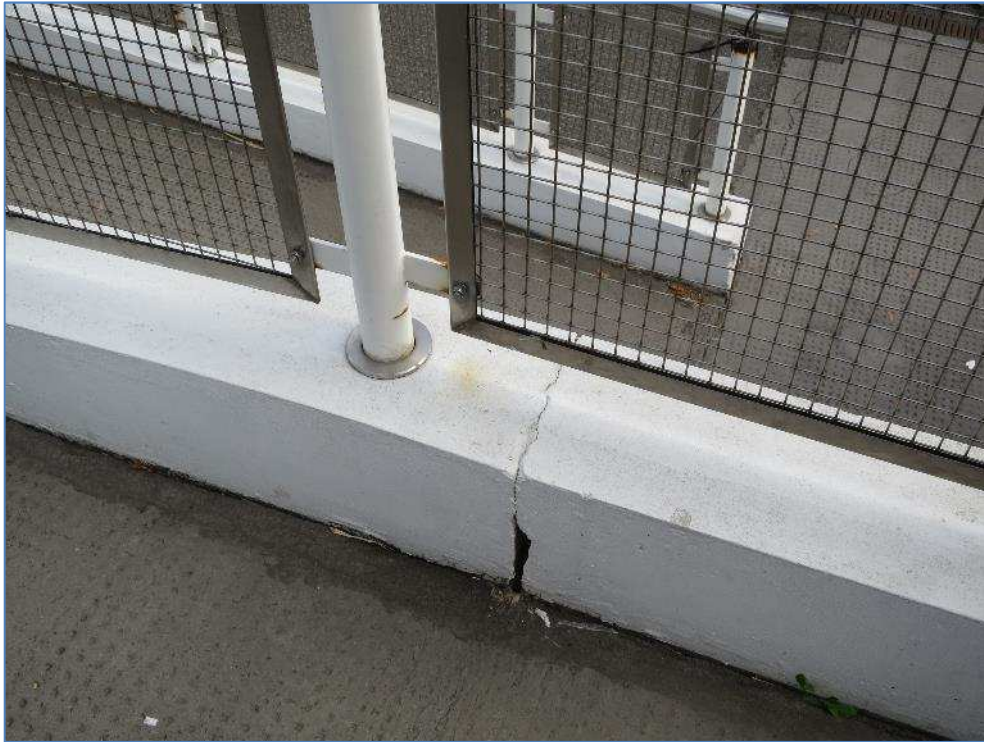
7-54 Cracks in concrete wall to ramp

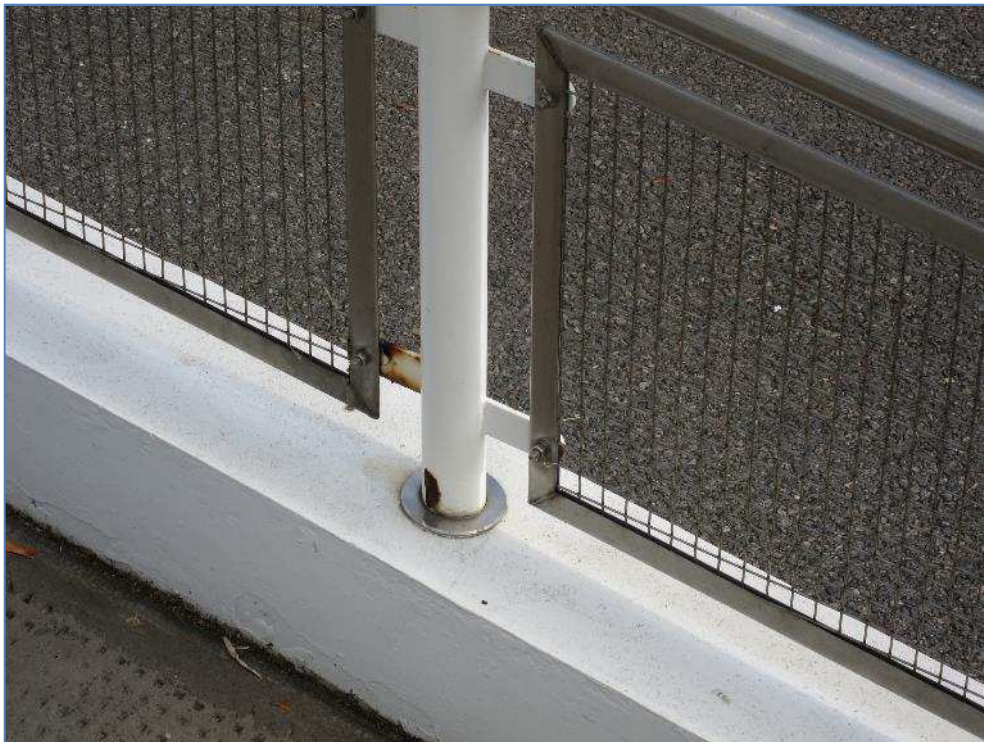
7-55 Surface rust to barrier where finishes have failed

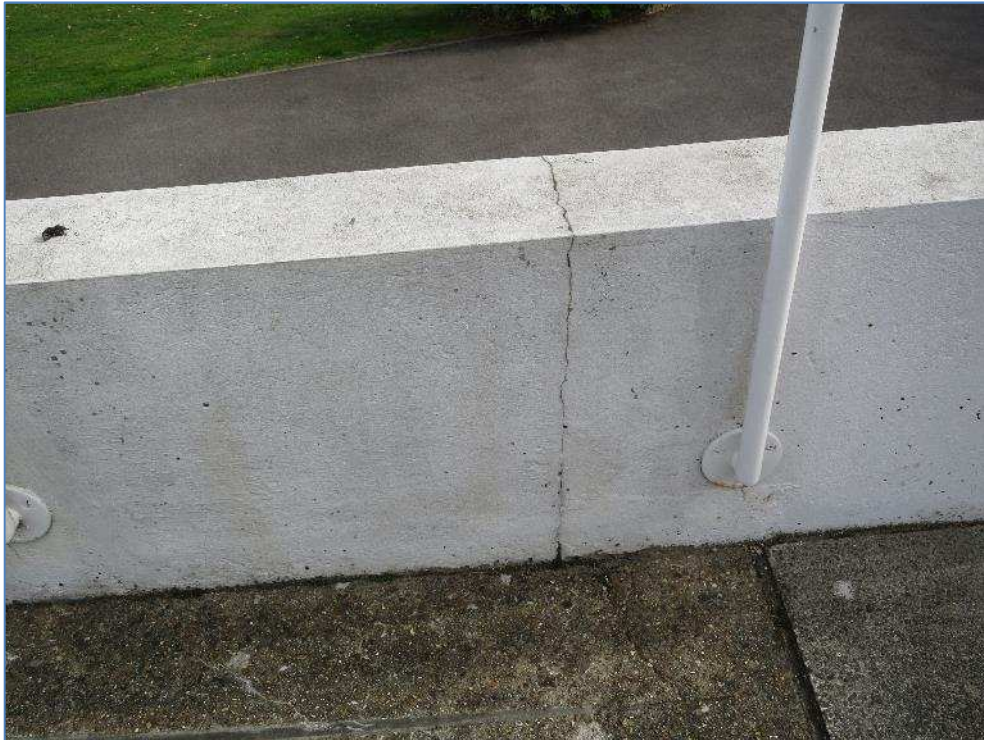
7-56 Crack in end wall of terrace adjacent ramp

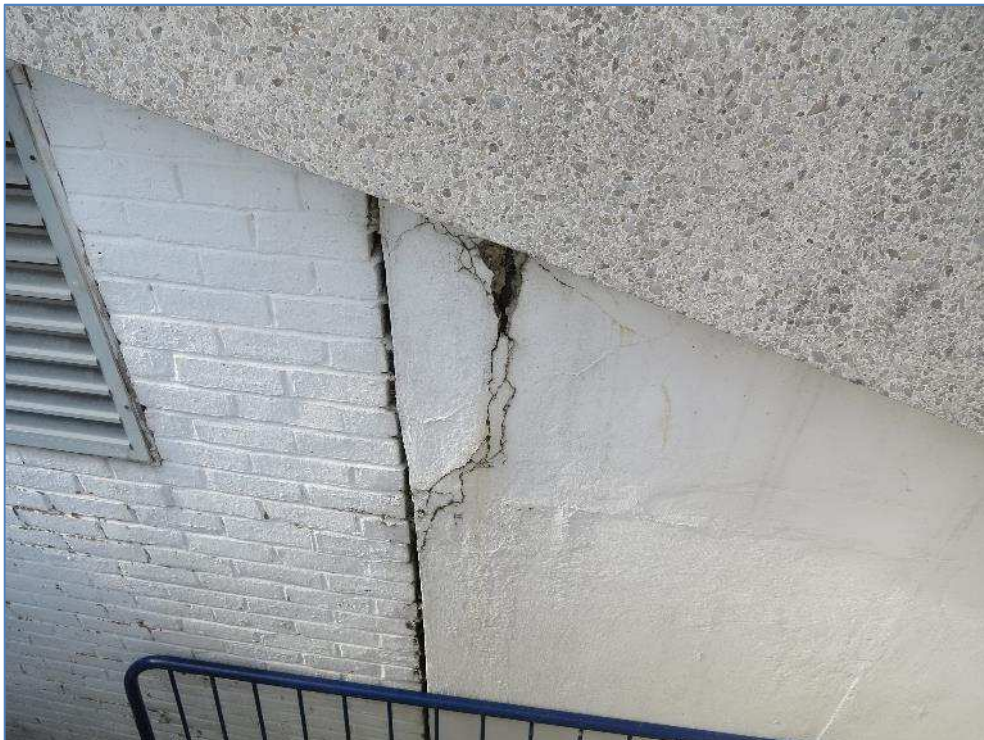
7-57 Cracks in render to end wall of stand

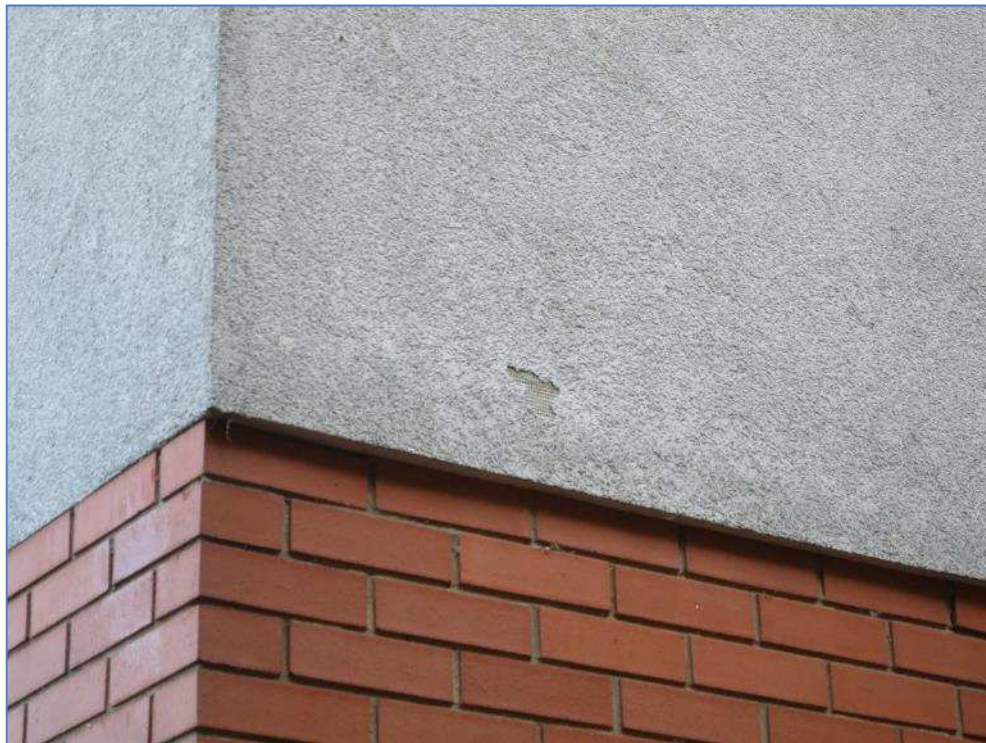
8-01 Minor area of render spalled new bin store

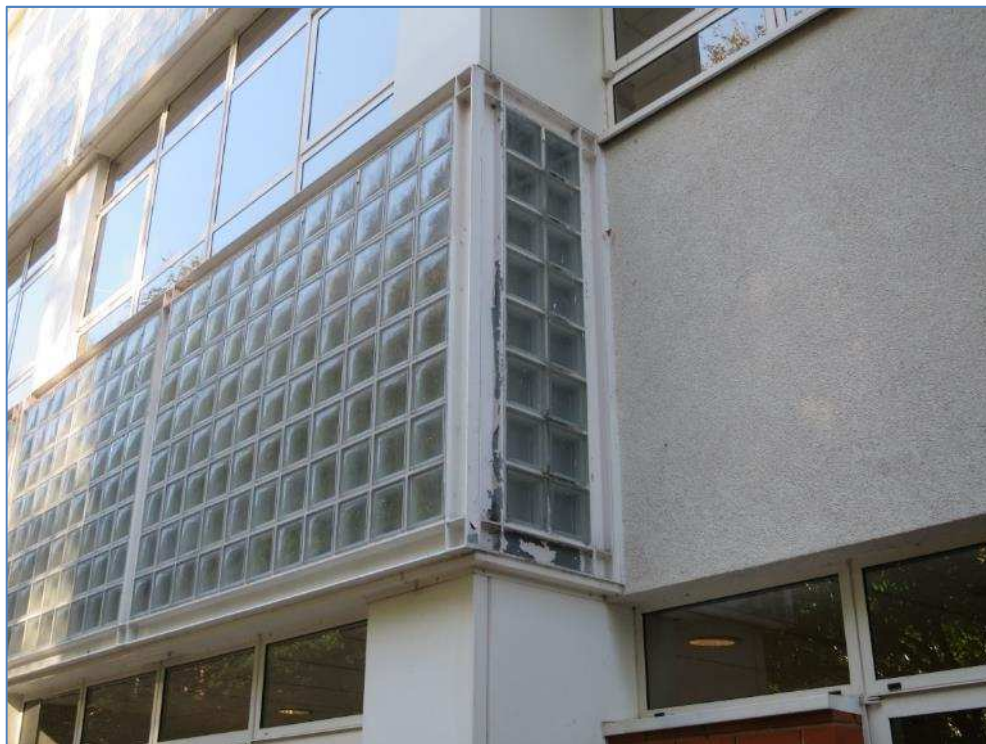
8-02 Paint peeling from steel around feature windows

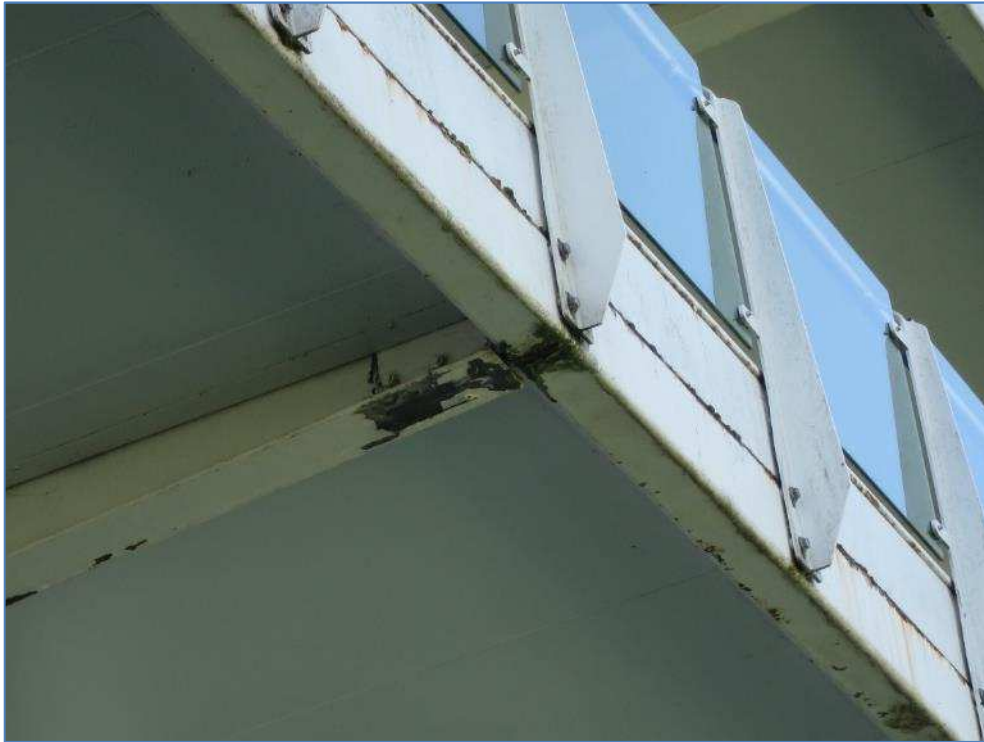
8-03 Surface rust to balcony support steelwork

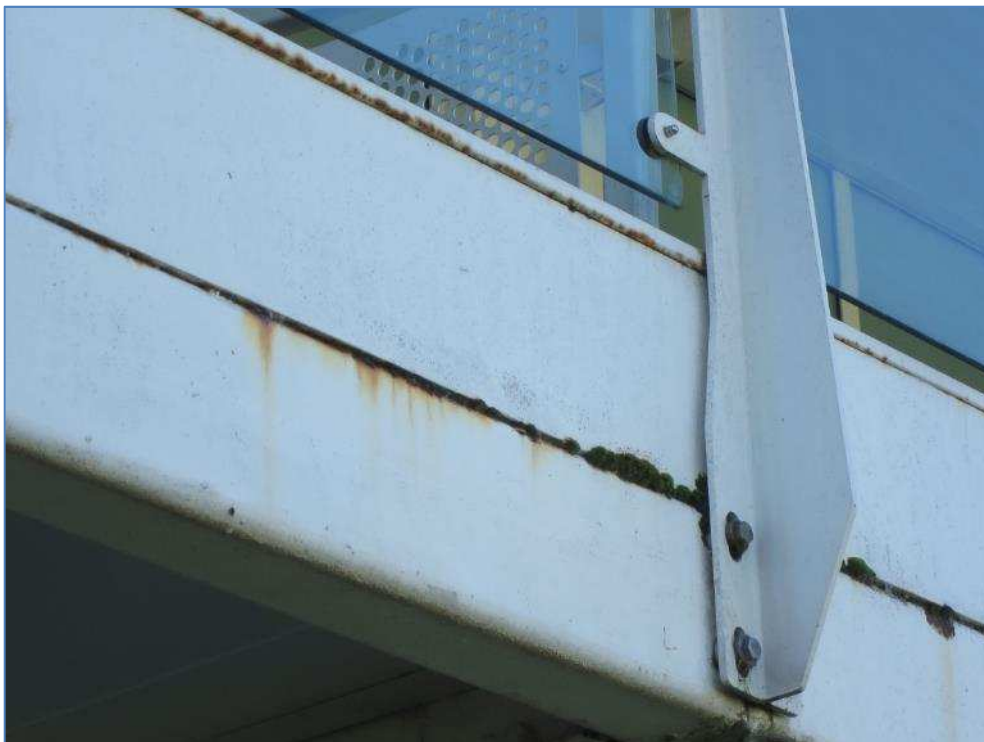
8-04 Moss growth in joints between steel members

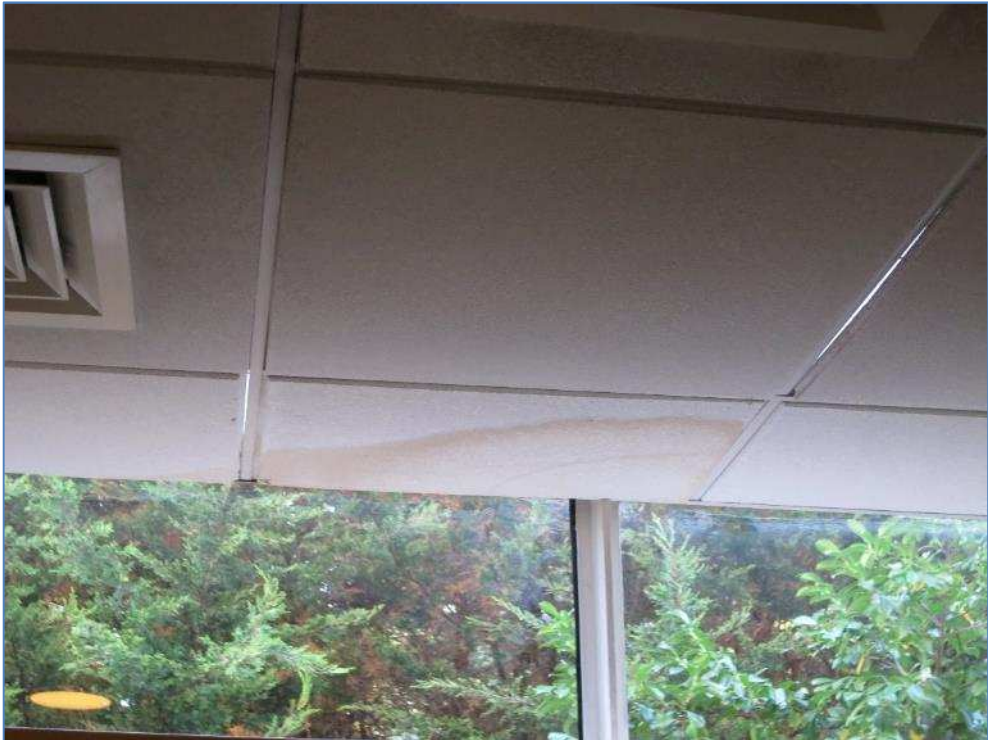
8-05 Water damage to ceiling in gent's toilet

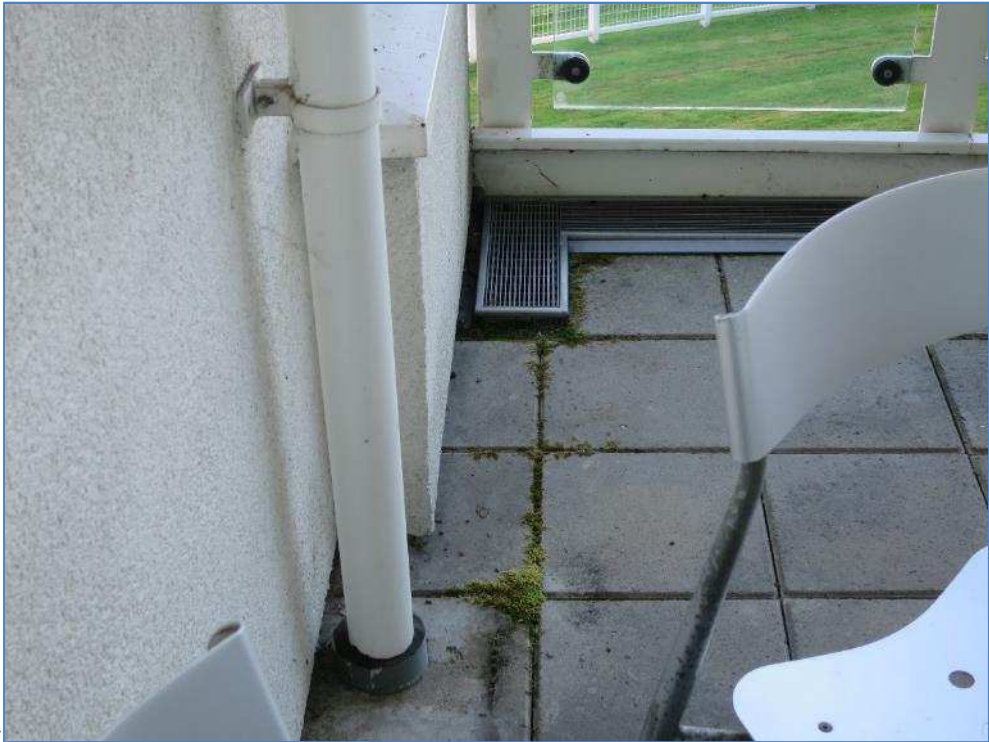
8-06 Plant growth on private box balcony

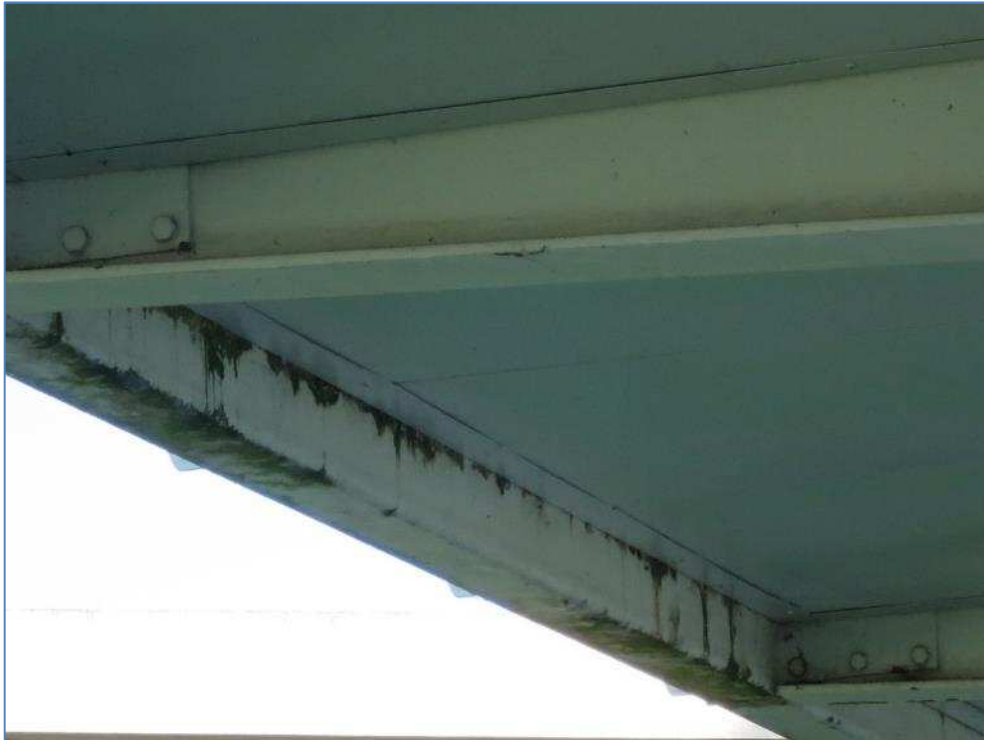
8-07 Surface rust to balcony support steelwork

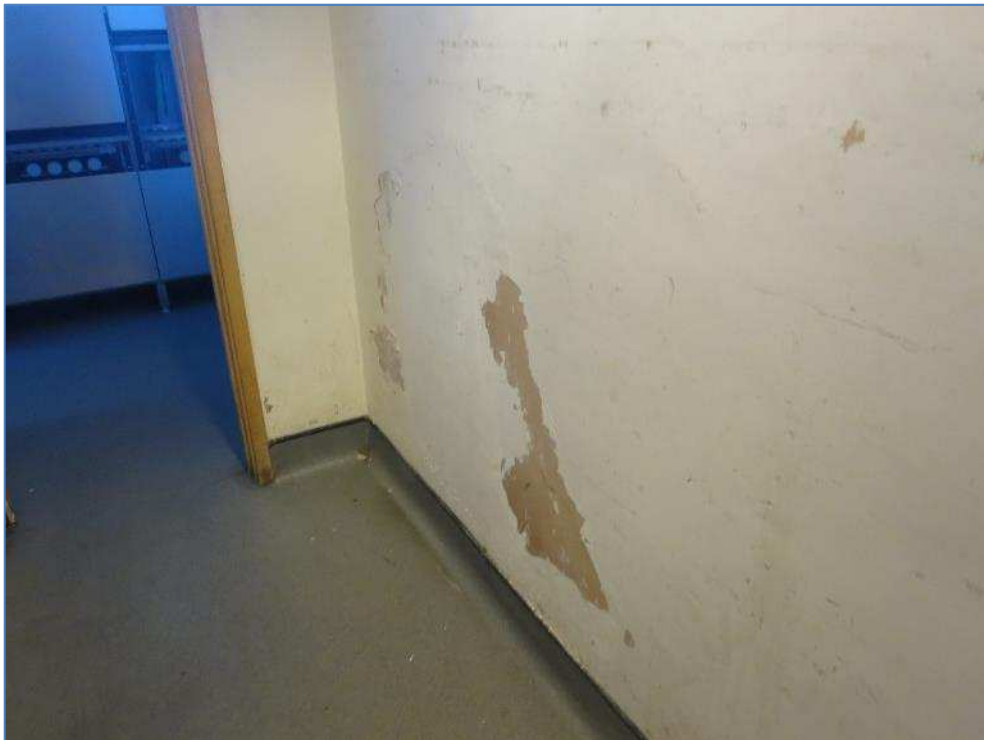
8-08 Water damage to wall in corridor to kitchen

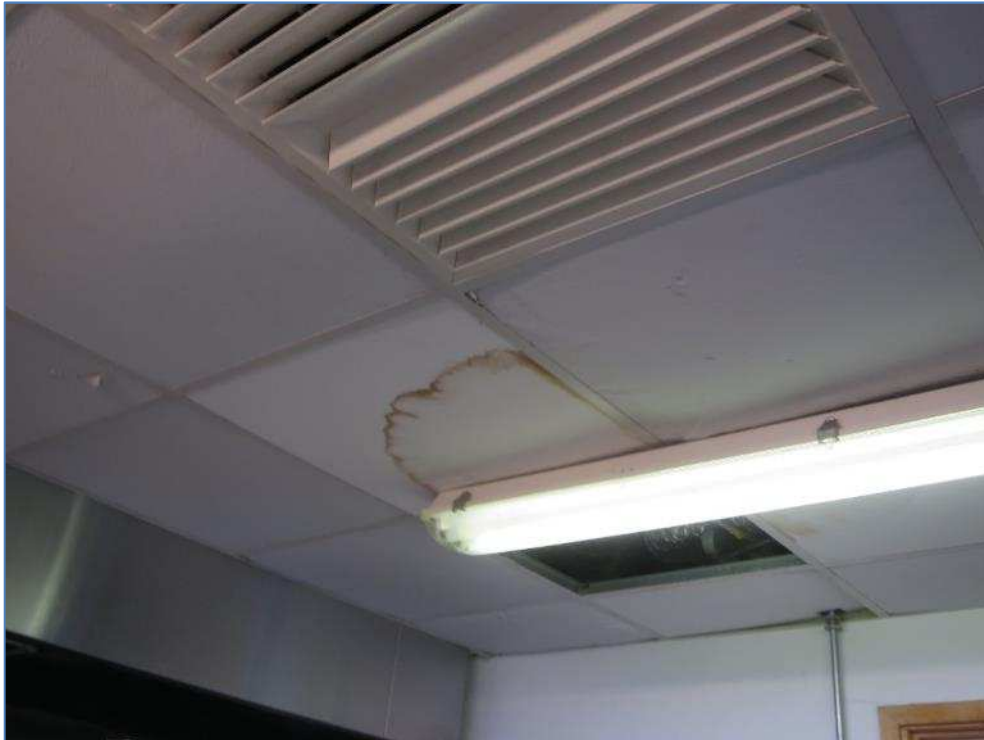
8-09 Water damage to ceiling in kitchen

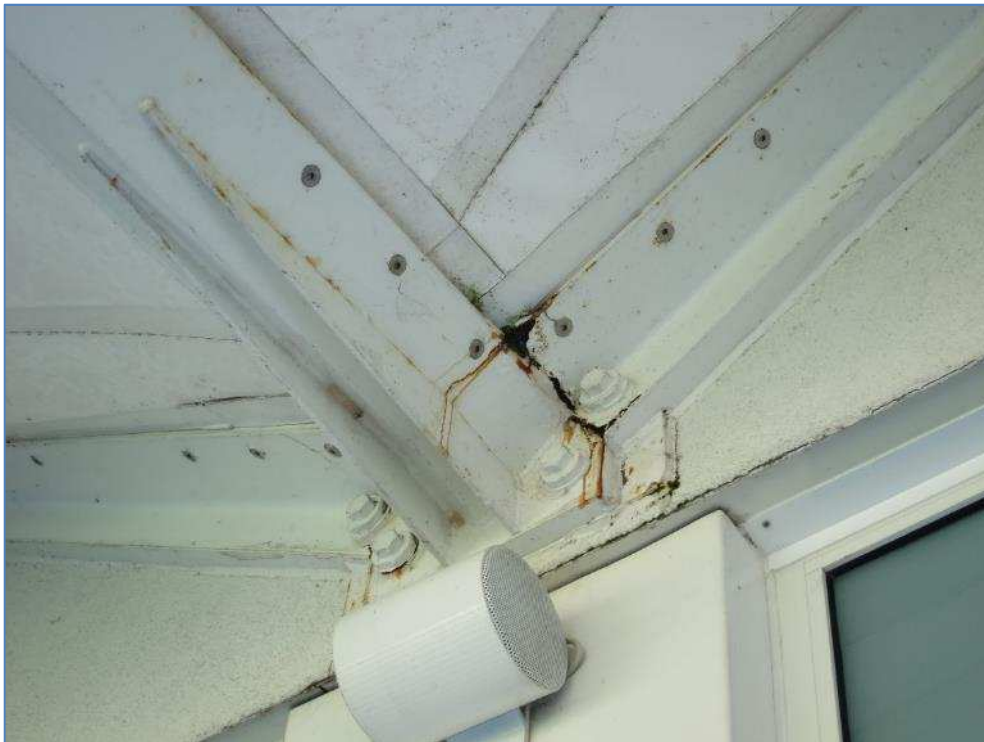
8-10 Minor surface rust to roof canopy support steelwork

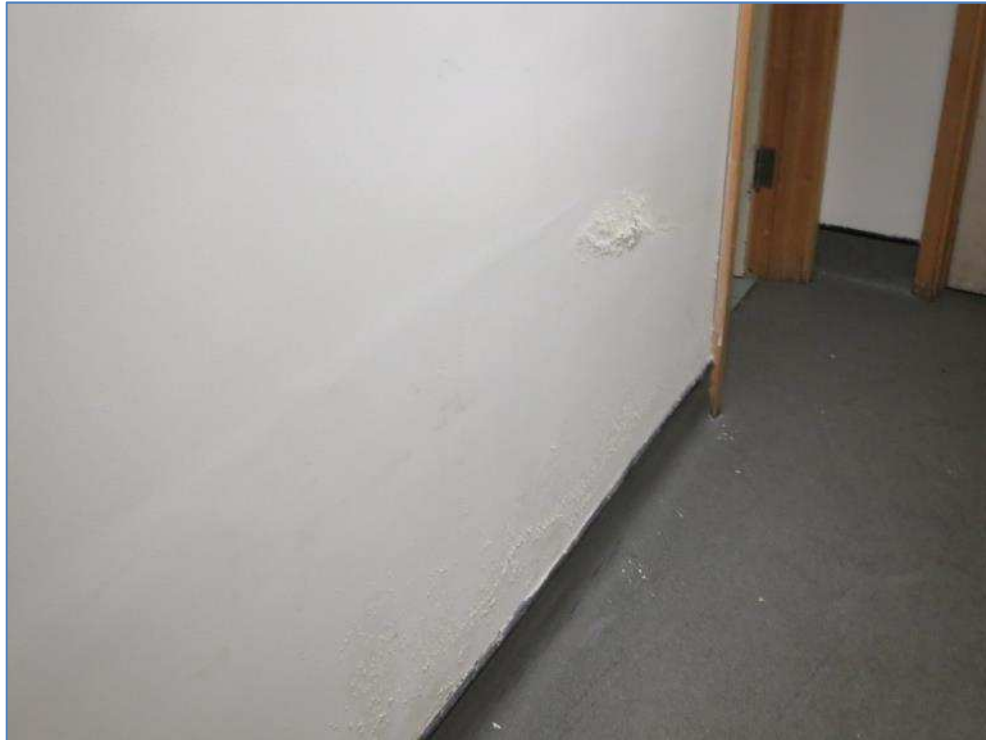
8-11 Water damage to wall in corridor to kitchen

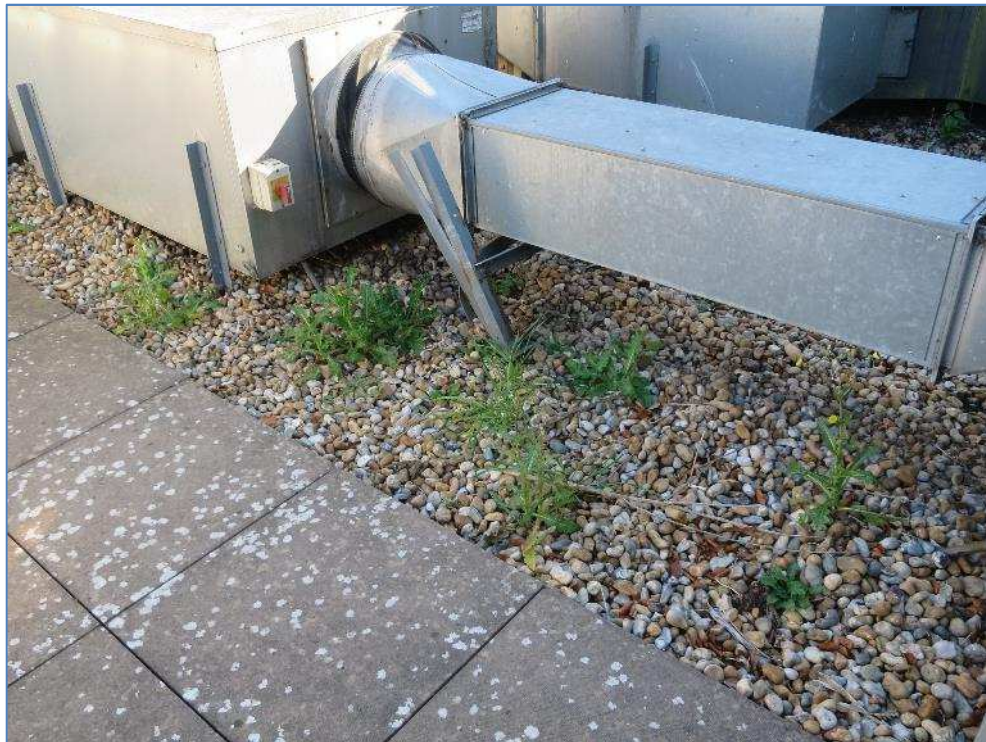
8-12 Plant growth on roof

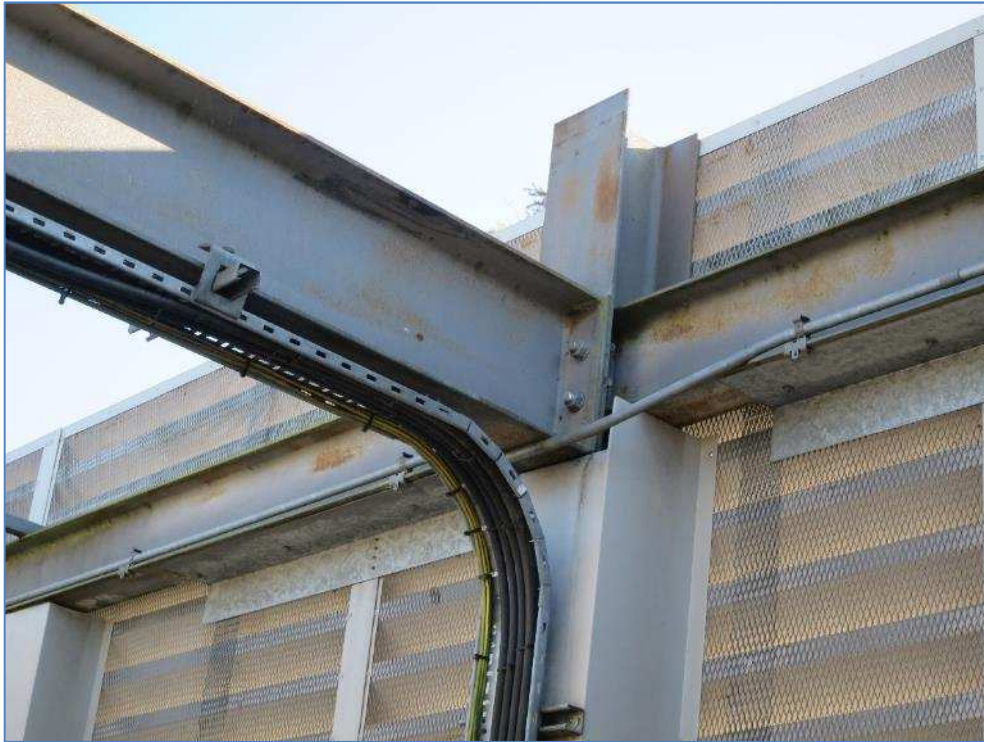
8-13 Minor surface rust to plant enclosure support steelwork

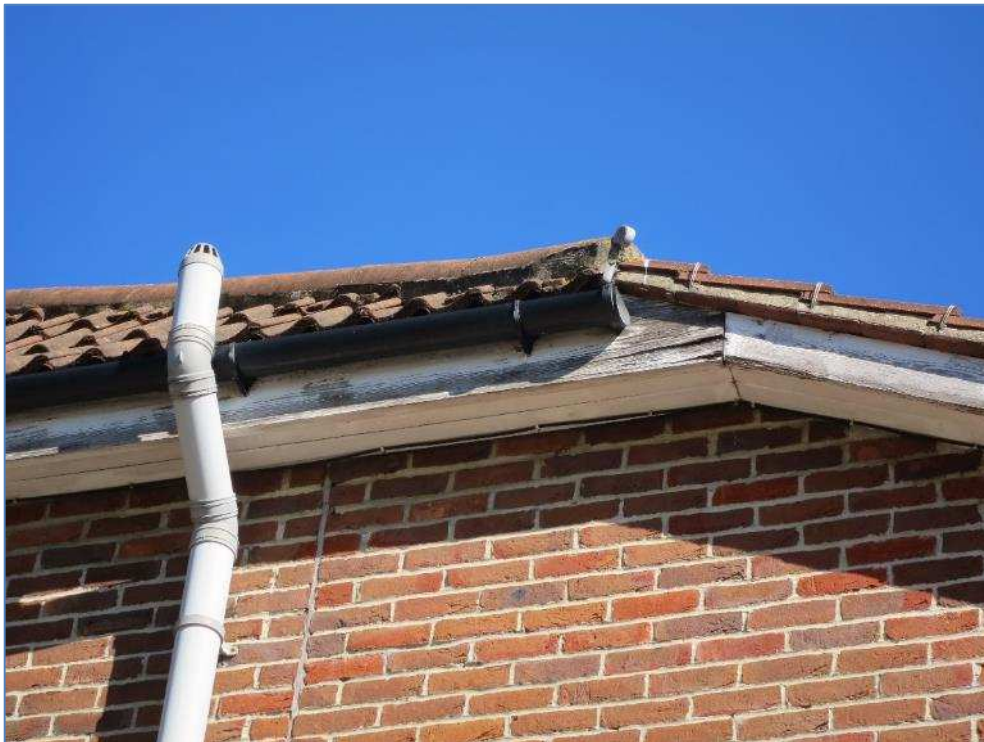
3-02 Timber eaves boarding rotting

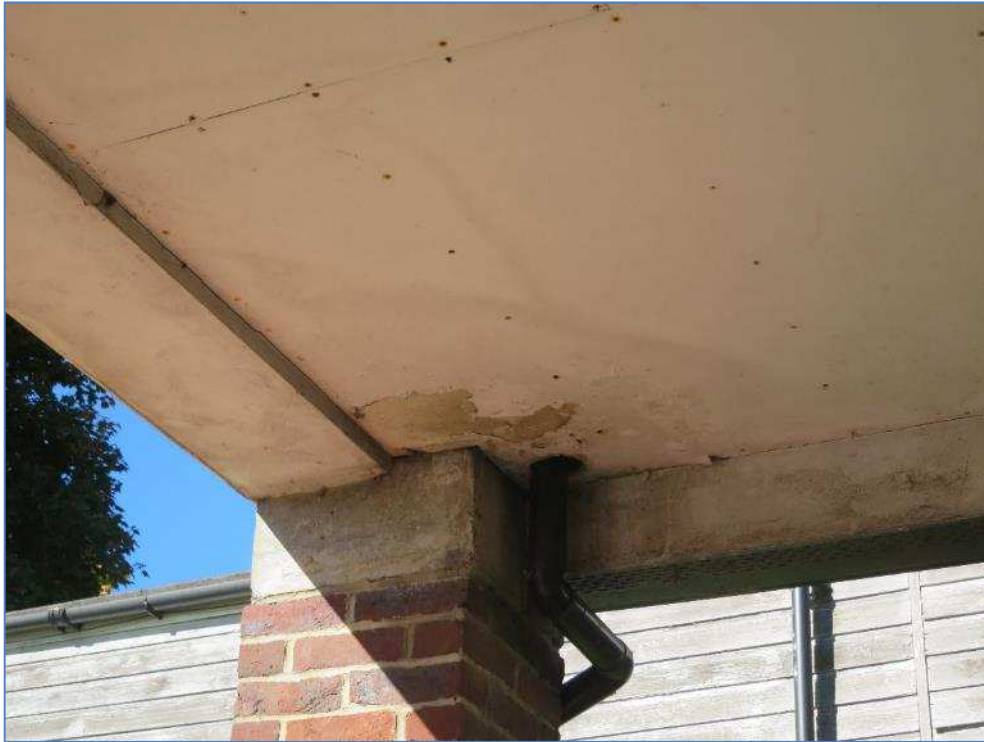
3-05 Water damage to soffit of carport

The loose roof tile over the main entrance to the lodge should be made good as a matter of urgency. The cause of the water damage to the carport soffit should be investigated and remedied prior to making good.

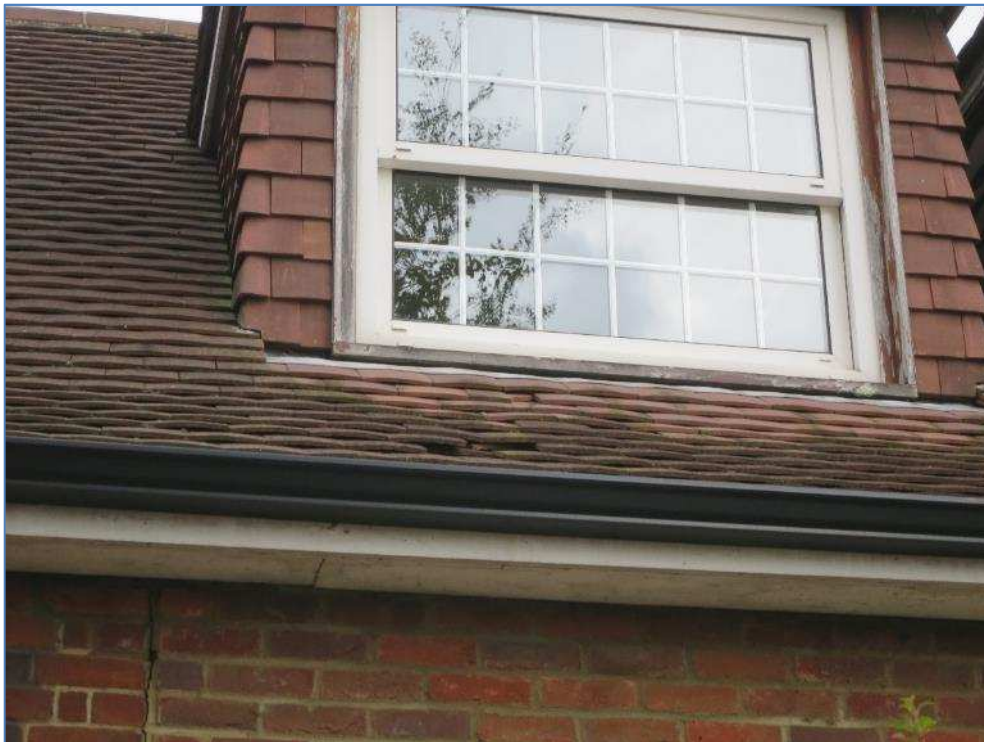
4-01 Missing and damaged roof tiles outside male jockeys

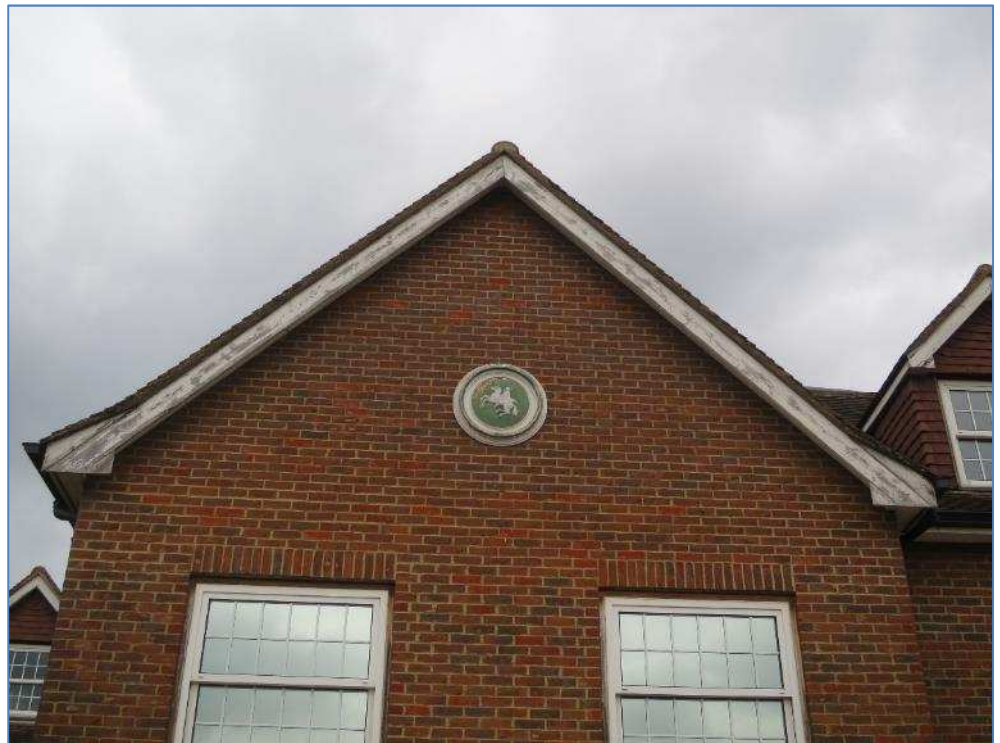
4-02 Paint peeling heavily from timber fascias

The external timber will need to be repainted fairly soon in order to prevent further deterioration. Rotten sections of the timber should be raked out and filled prior to repainting.

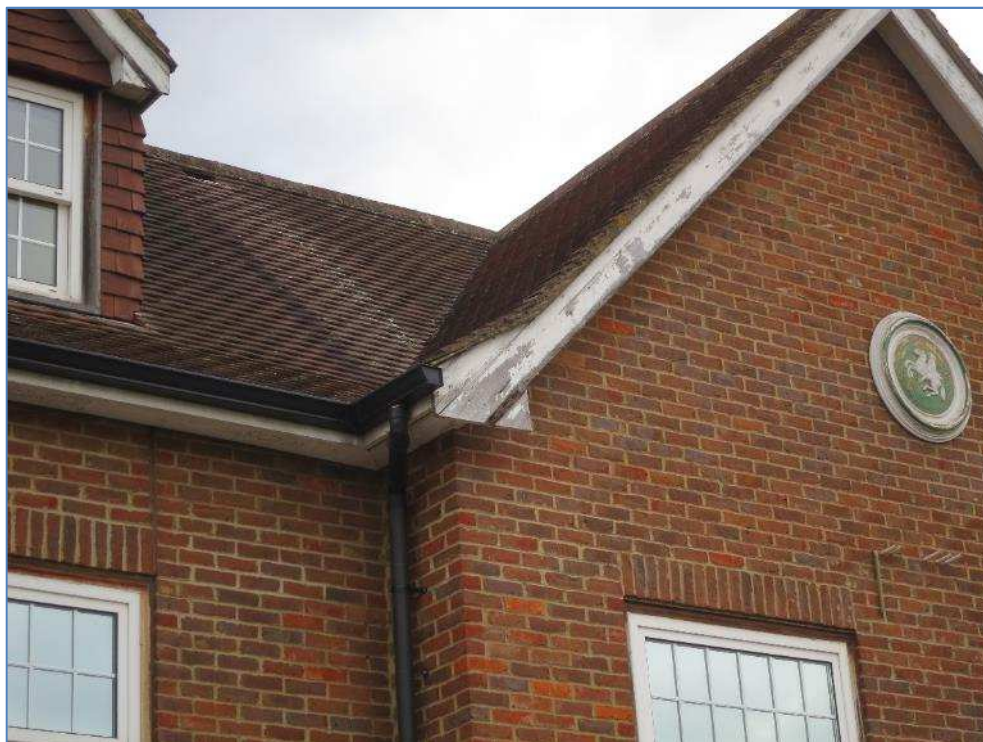
4-03 Heavy rot to timber fascia

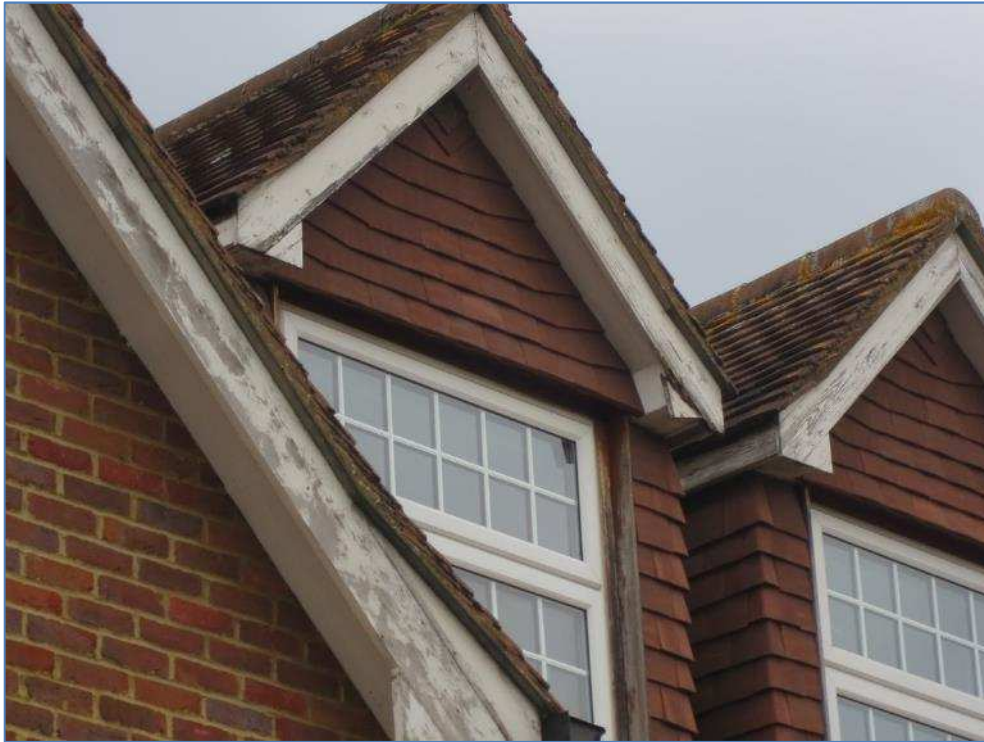
4-04 Heavy rot to timber fascias
