SANDOWN PARK

Sandown Park Racecourse
Annual Structural Survey 2018

October 2018

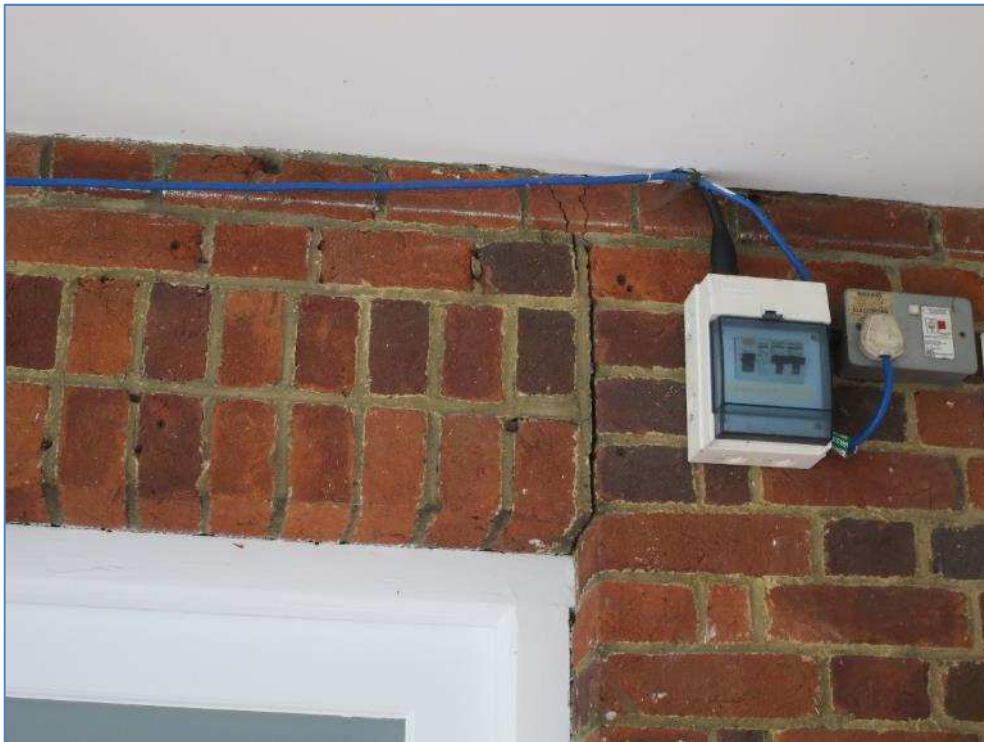
4-05 Crack in brickwork at end of lintel

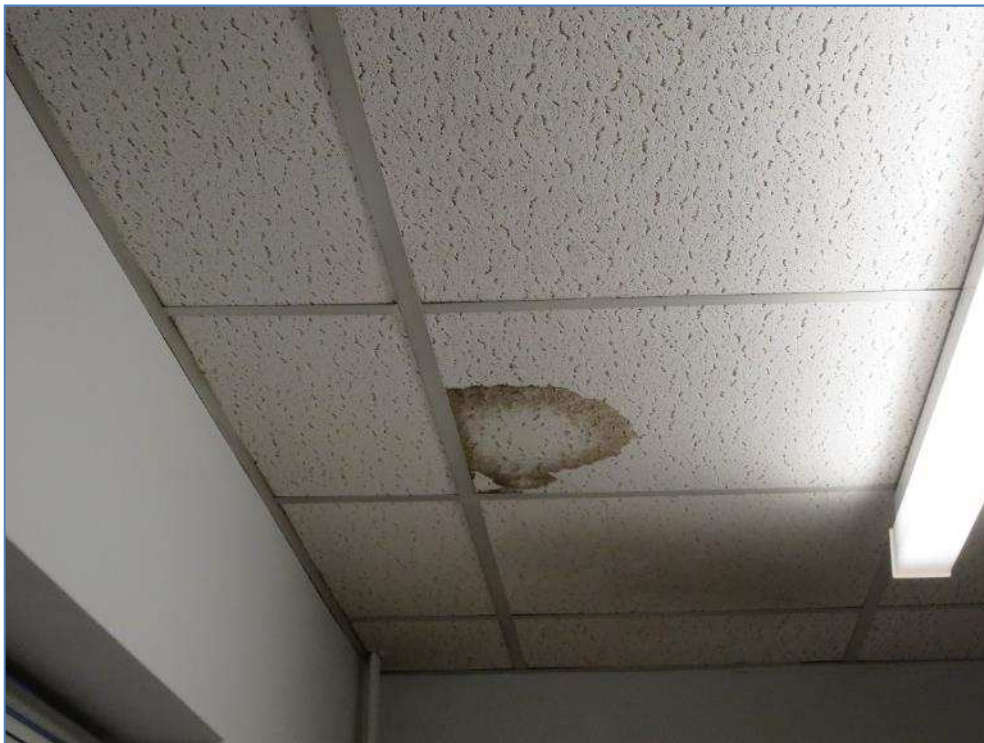
4-06 Damp damage to ceiling in lady jockeys toilet

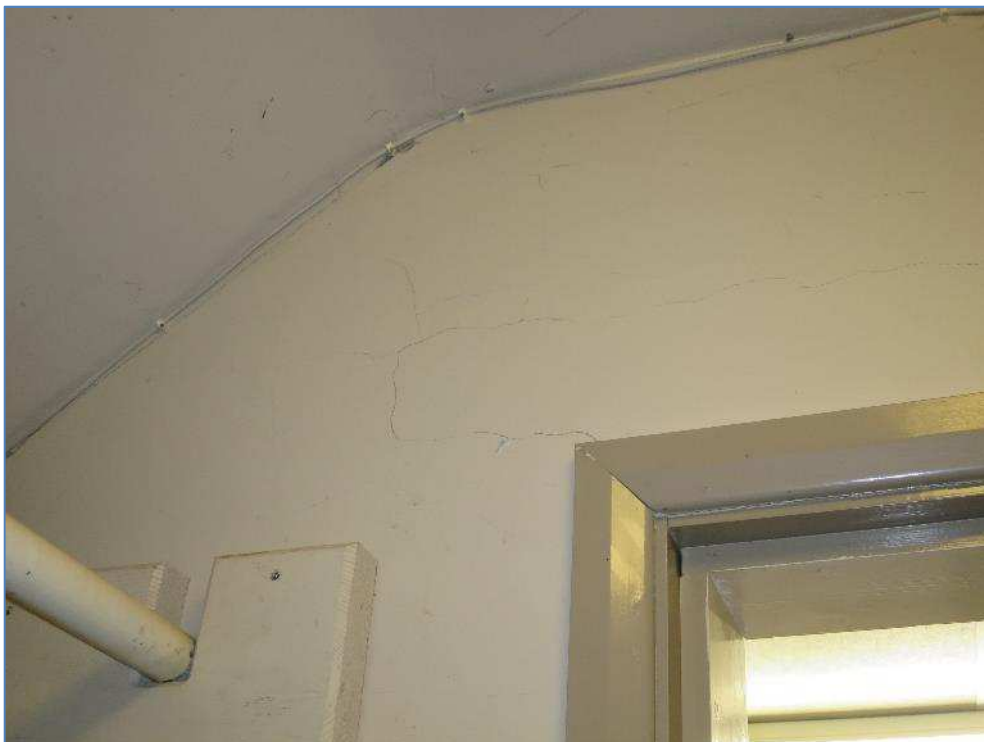
4-07 Minor cracks in wall in valets store room

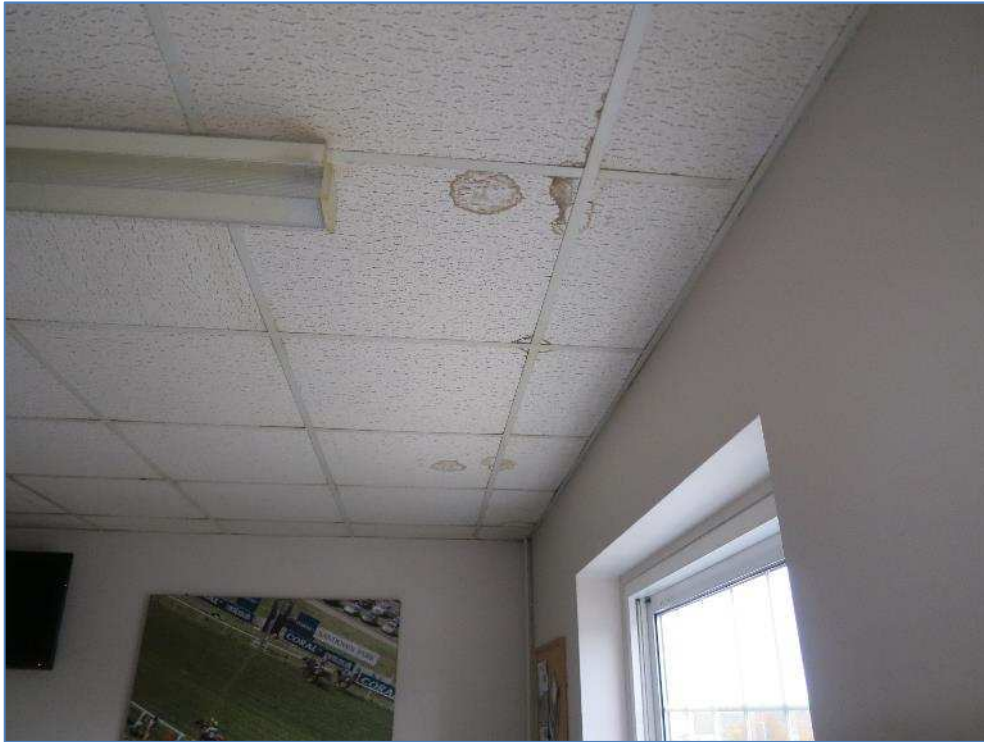
4-08 Damp damage to ceiling in jockeys rest room

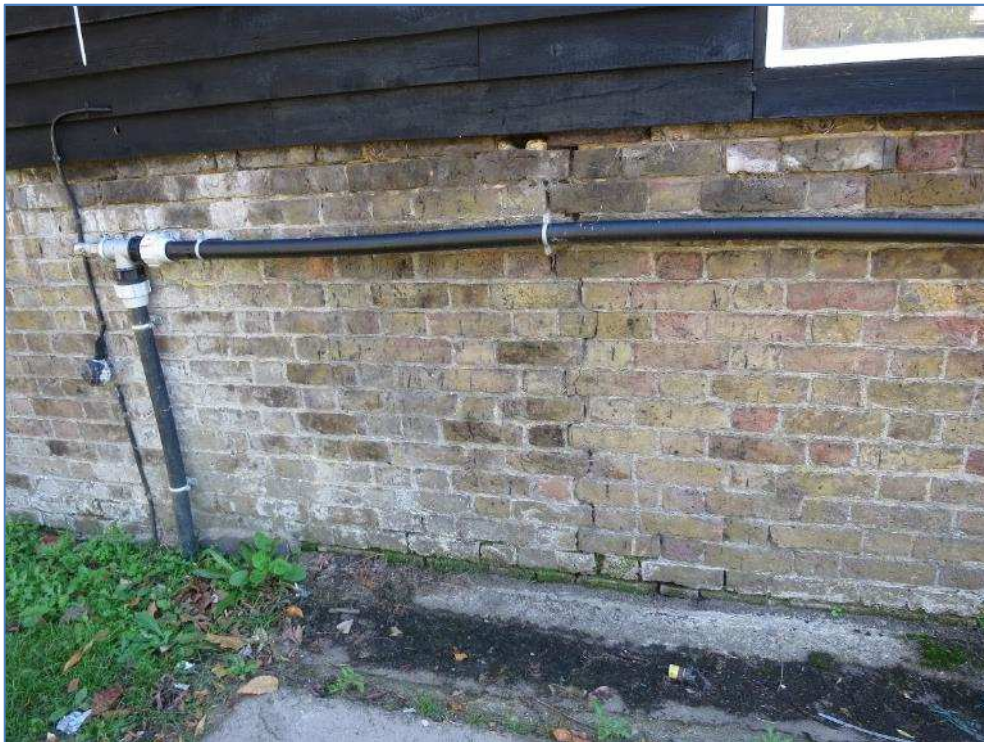
5-01 Cracks in brickwork to rear of veterinary unit

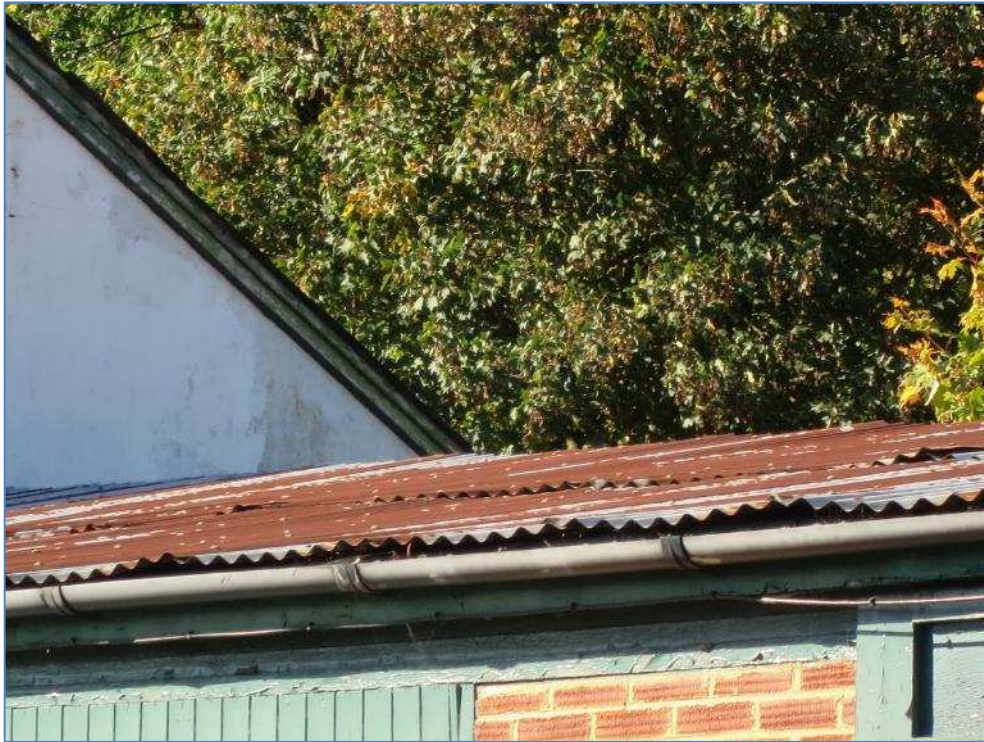
5-02 Corrugated roof sheeting rusting heavily

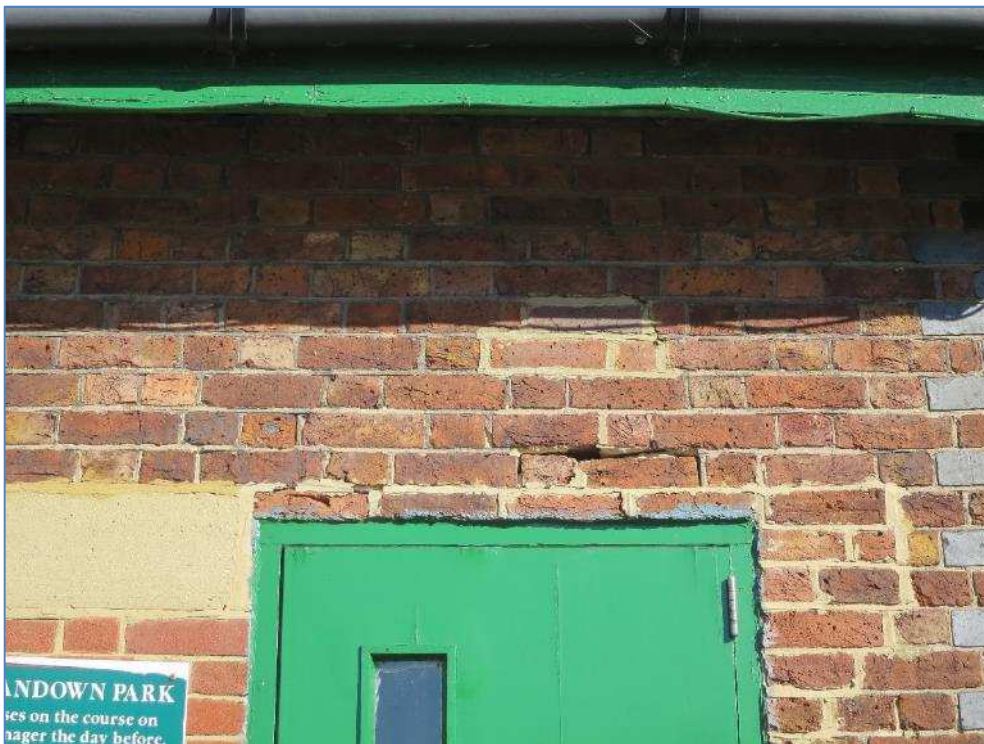
5-03 Loose brick over door to stable manager's office

The loose bricks over the entrance to the stable office need to be made good as soon as possible. The crack in tack boxes 13-18 should be filled due to its location and the apparently loose bricks

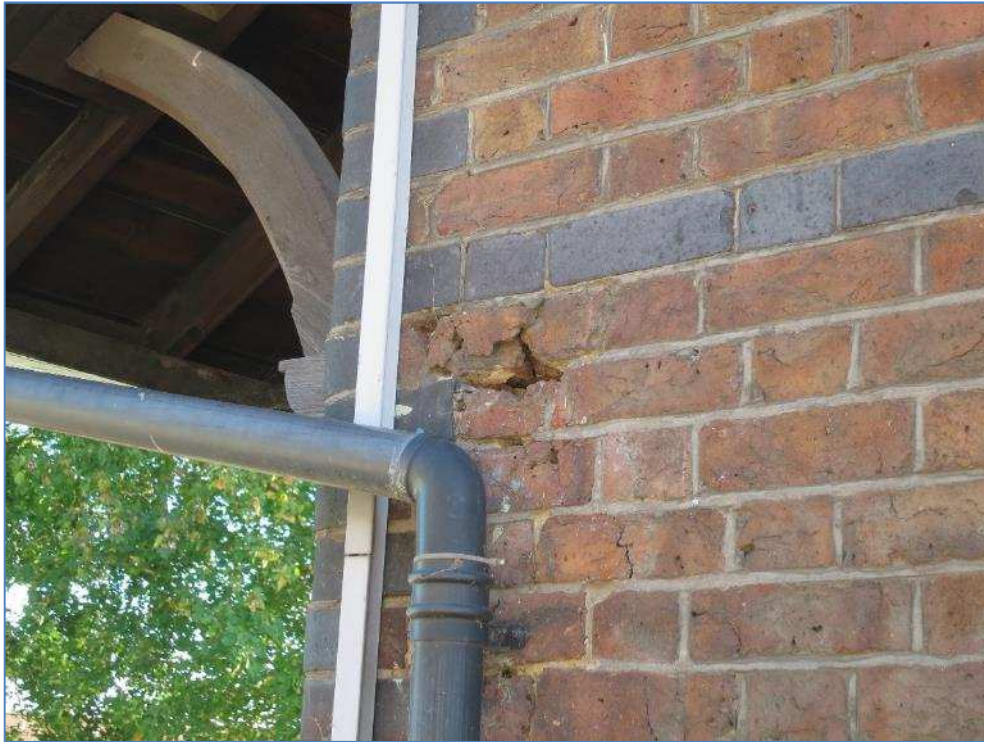
5-04 Bricks spalling on end wall of entrance building

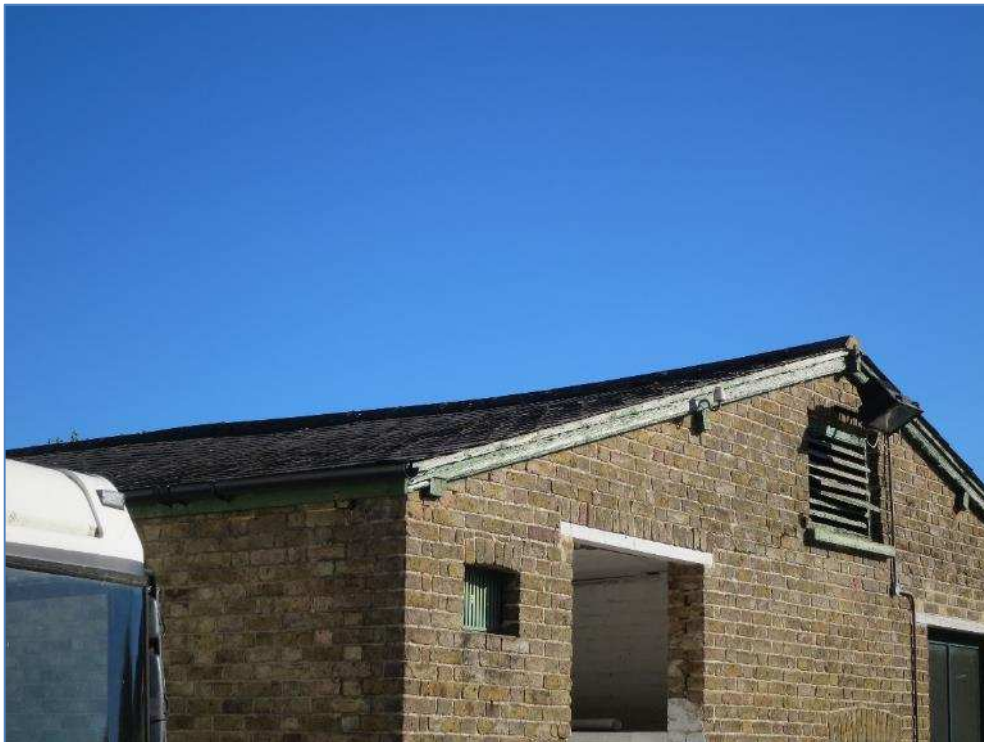
5-05 Roof ridge sagging over stables

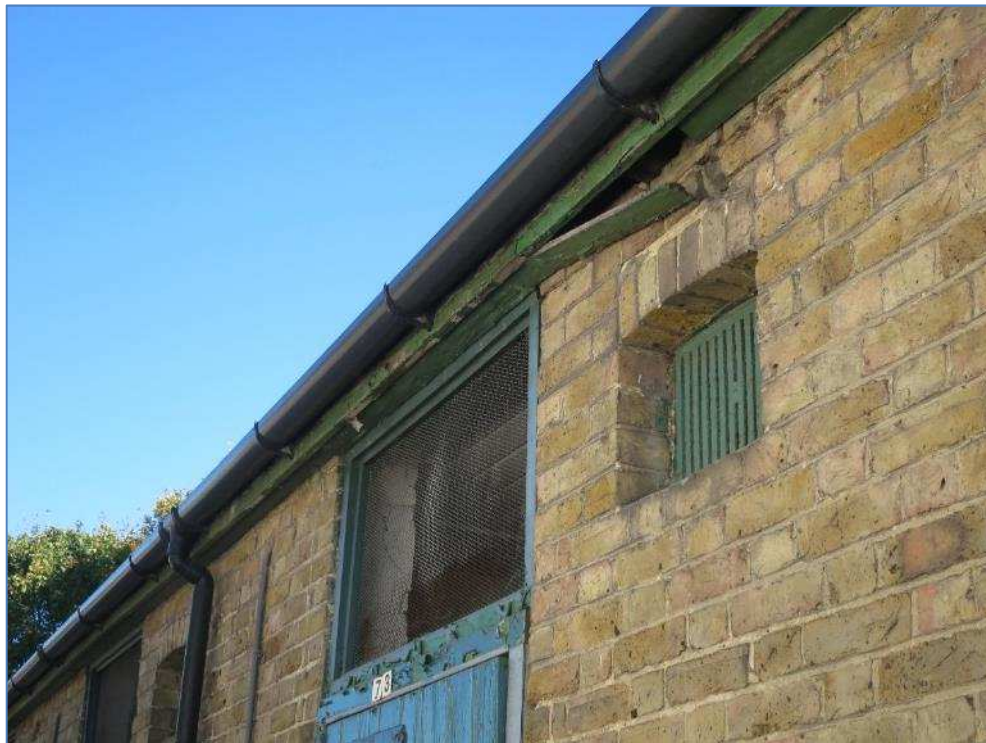
5-06 Eaves soffit board working loose

The stables are in a fairly run down state and in need of work in a number of areas. The timber is rotting in many places and generally in need of repainting to prevent further deterioration. The loose eaves boards should be re-fixed straight away.

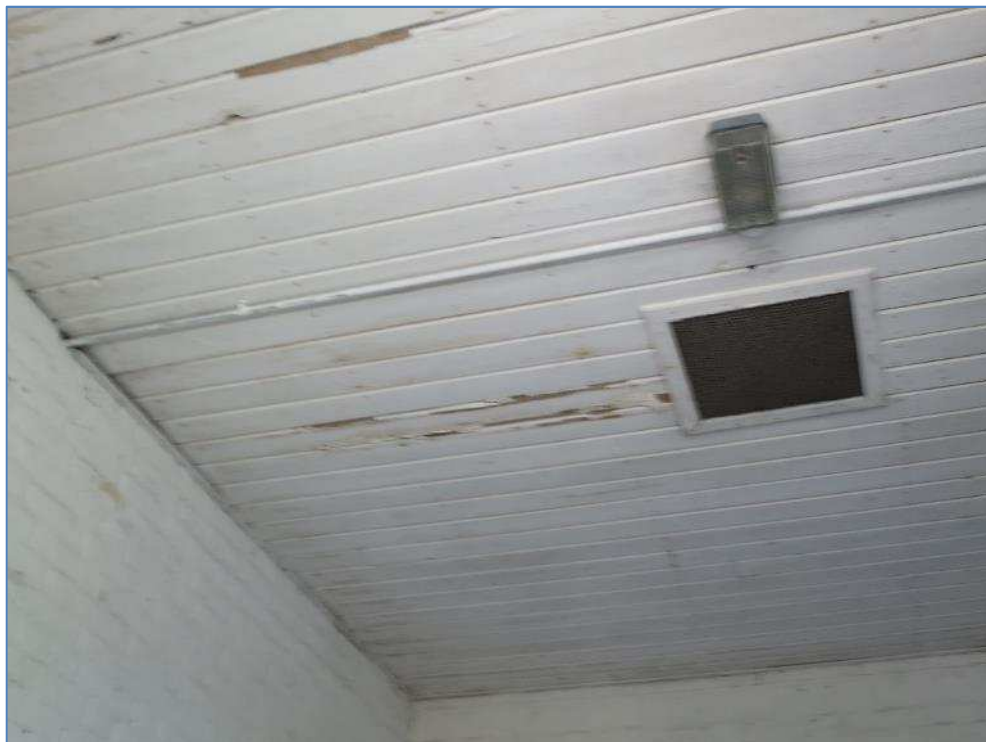
5-07 Timber soffit boarding rotting in stable 72

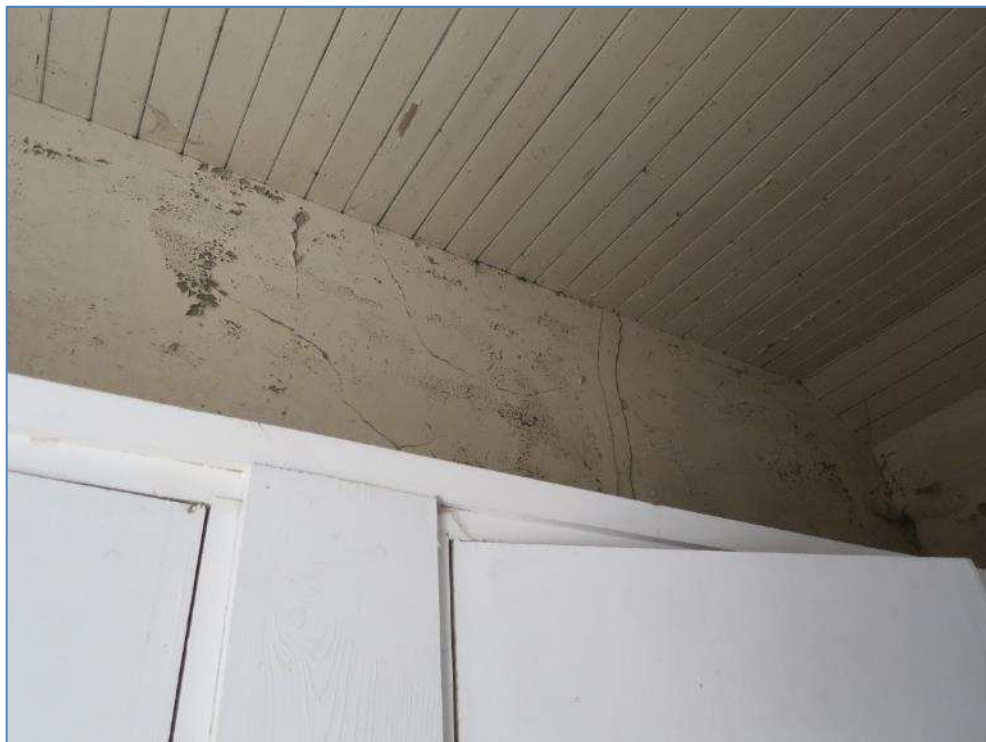
5-13 Cracks in end wall of tack boxes 7-12

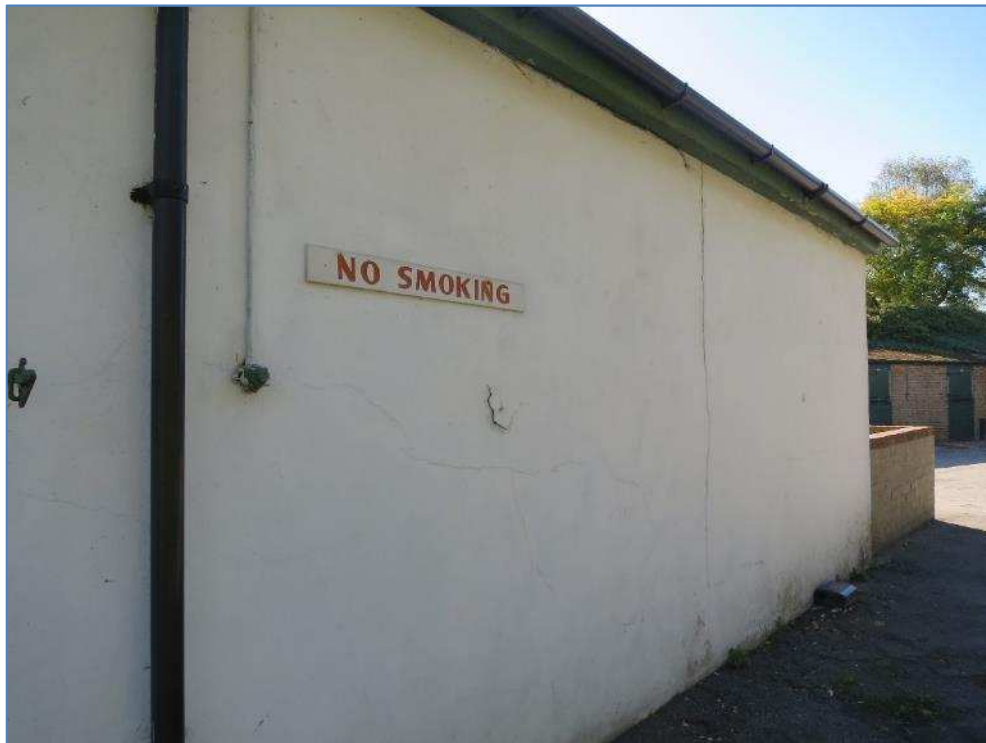
5-14 Cracks and loose render to external wall

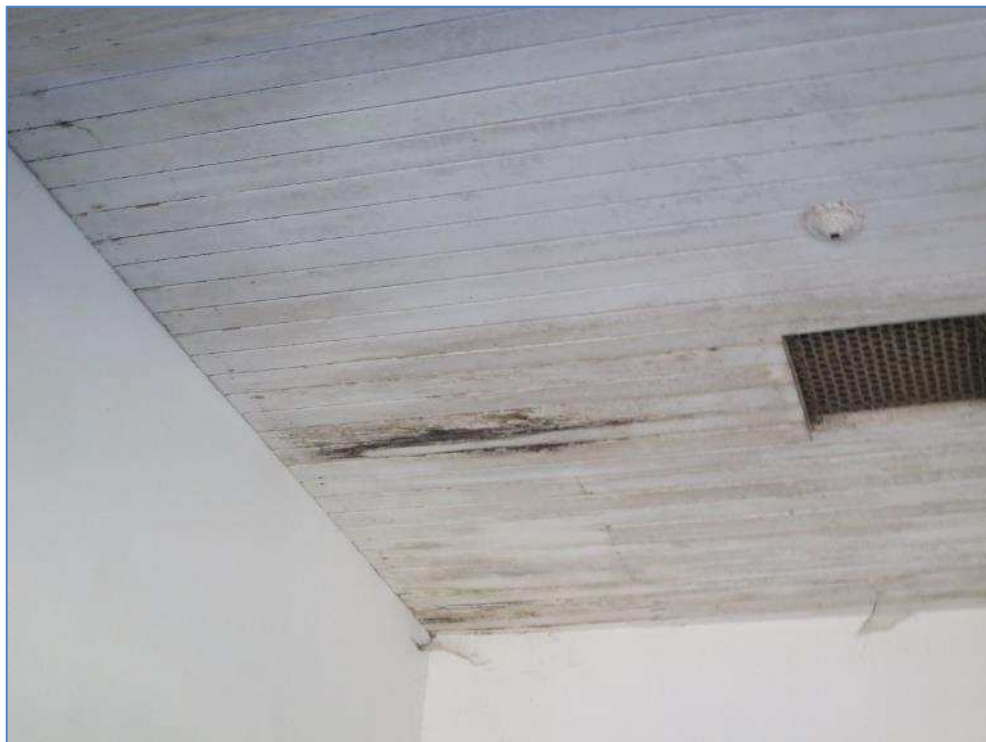
5-15 Timber soffit boards rotting in stable 96

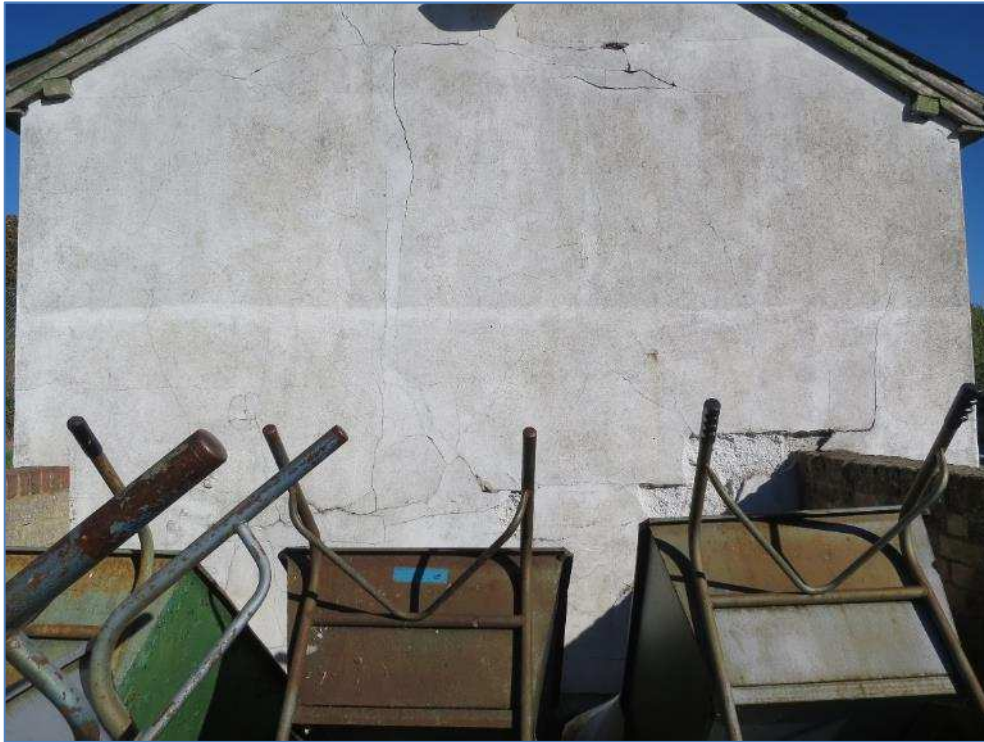
5-16 External render spalled and spalling to end wall

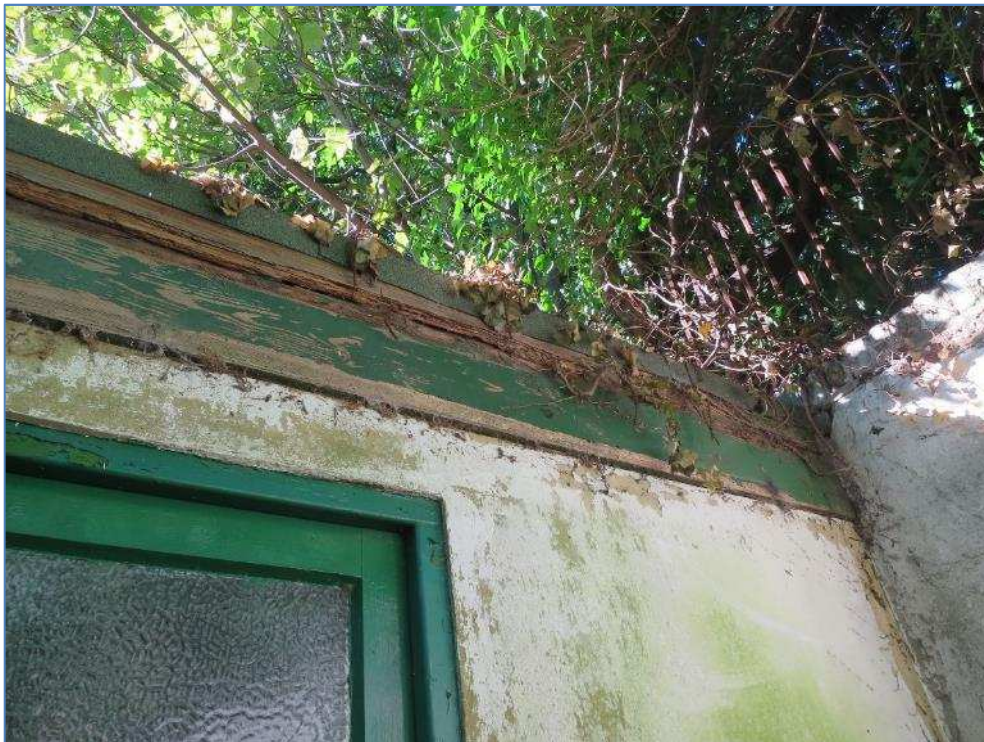
5-17 Timber eaves boards rotting heavily to toilet block

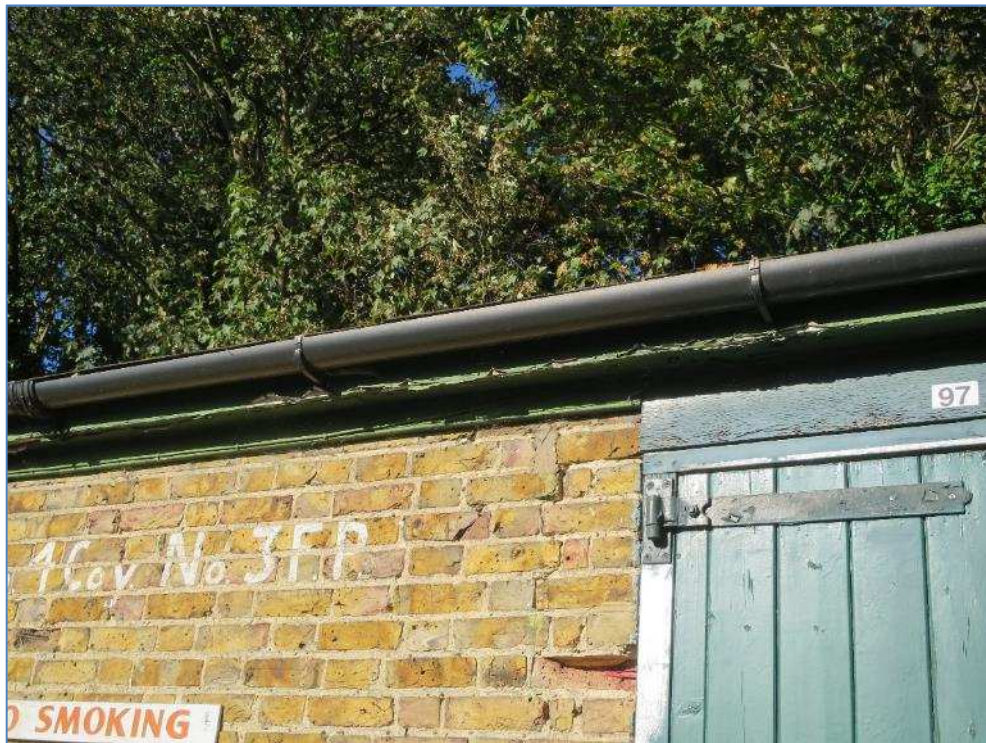
5-20 Paint peeling from timber eaves boards with minor rot

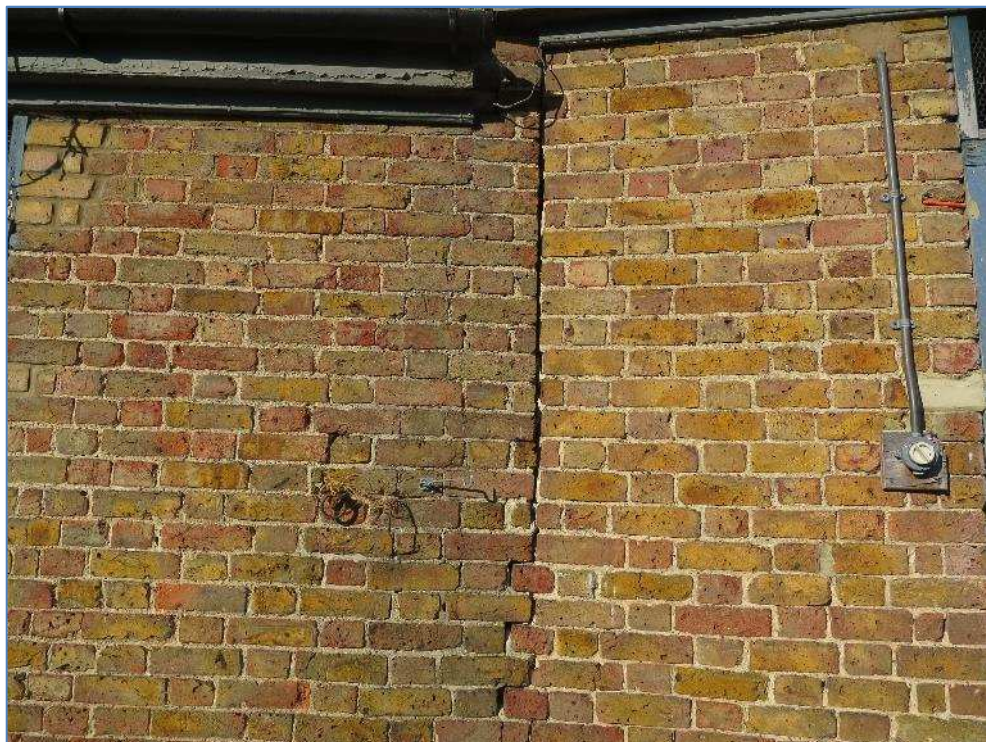
5-21 Crack in wall at step between stables 108 & 109

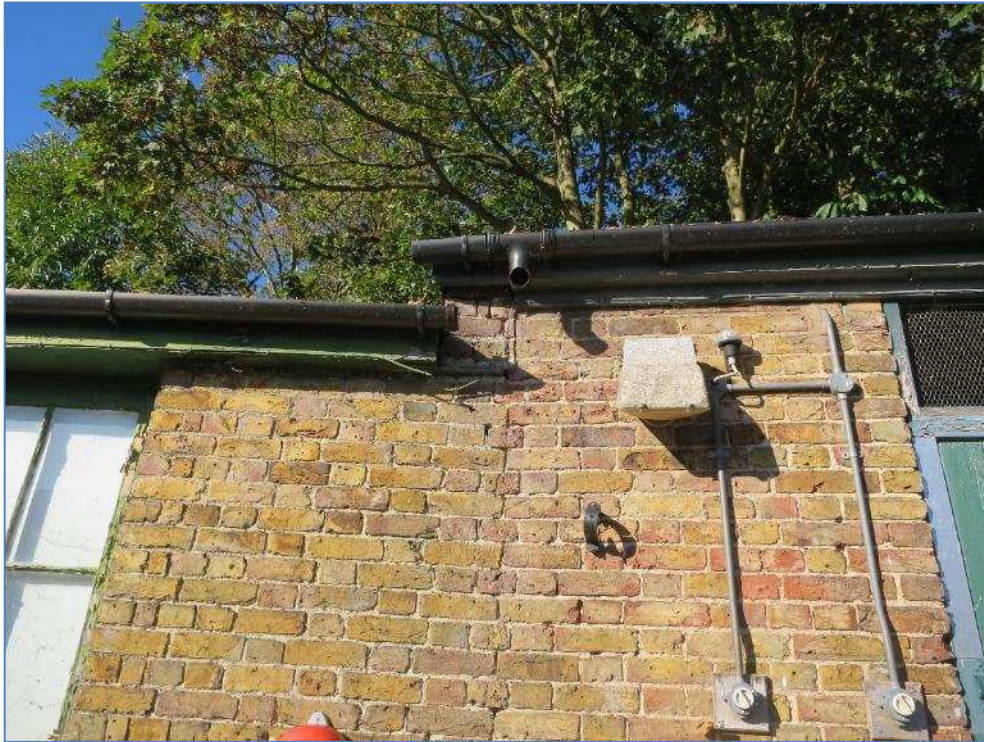
5-22 Gutter downpipe missing near stable 110

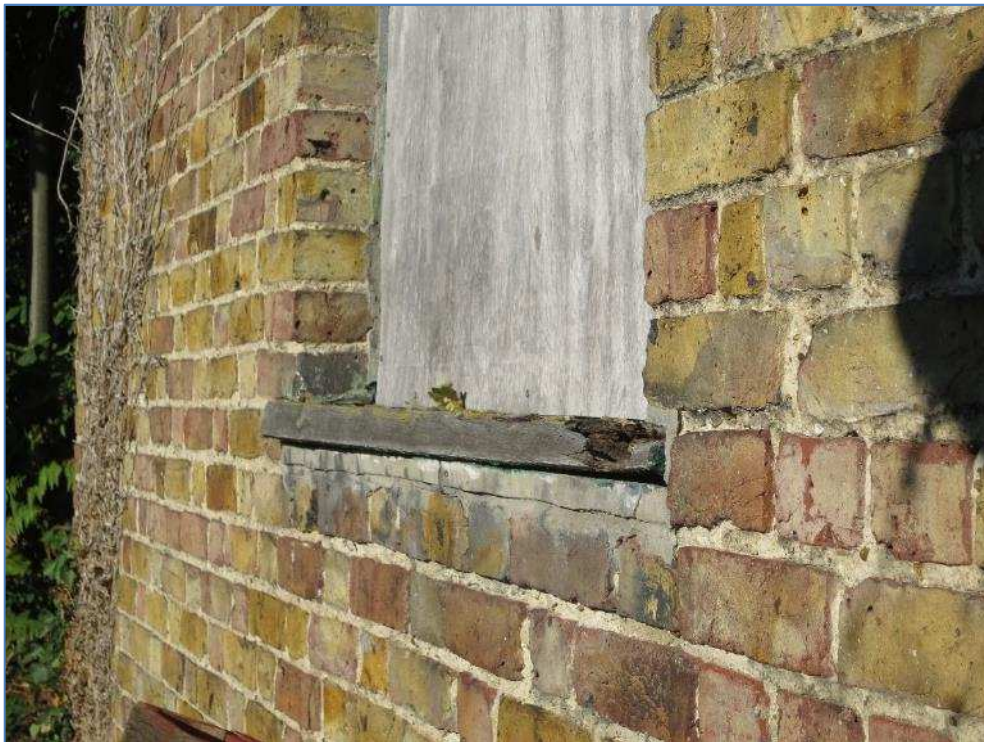
5-23 Timber window frame rotting heavily

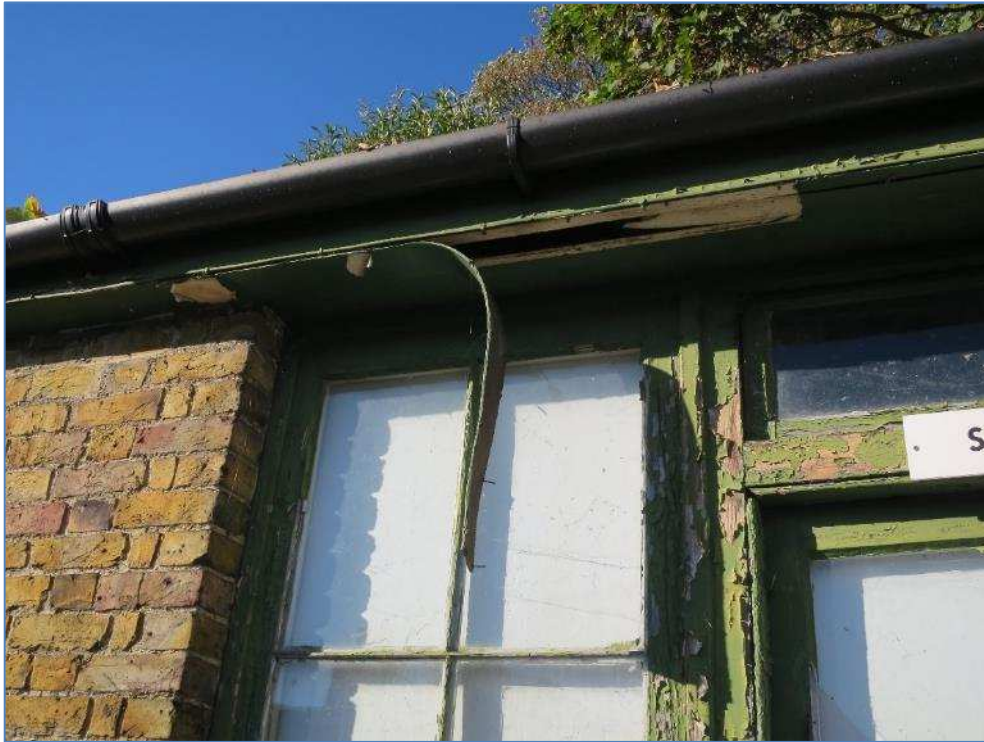
5-24 Timber eaves boarding working loose

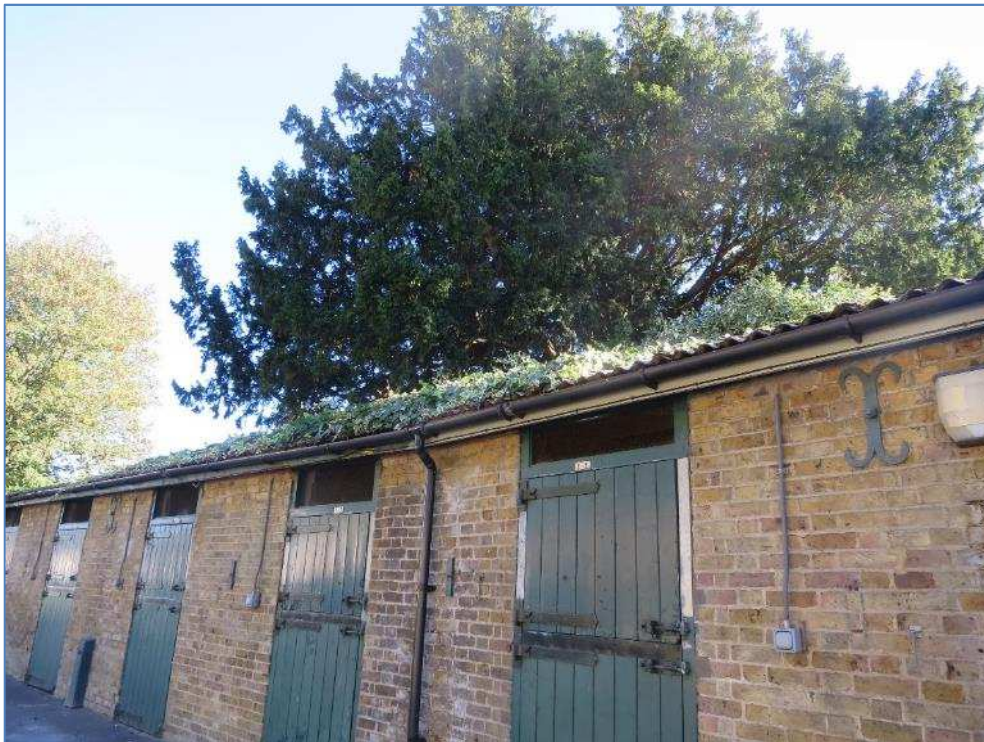
5-25 Plant growth on roof

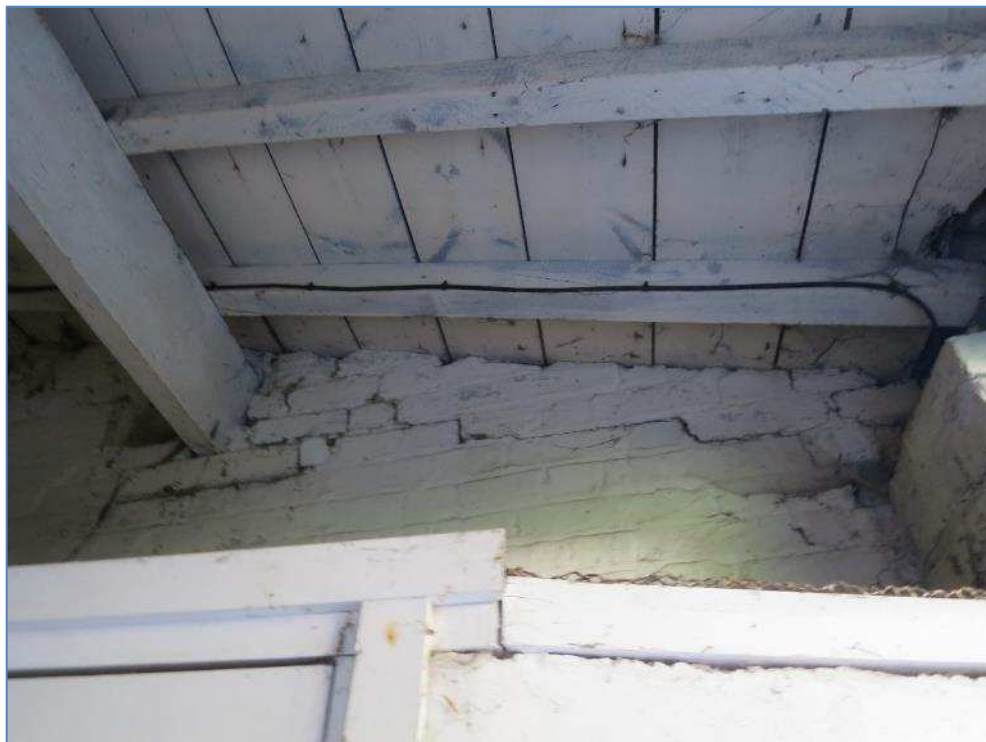
5-29 Cracks in wall to tack boxes 19-24 adjacent stable 17

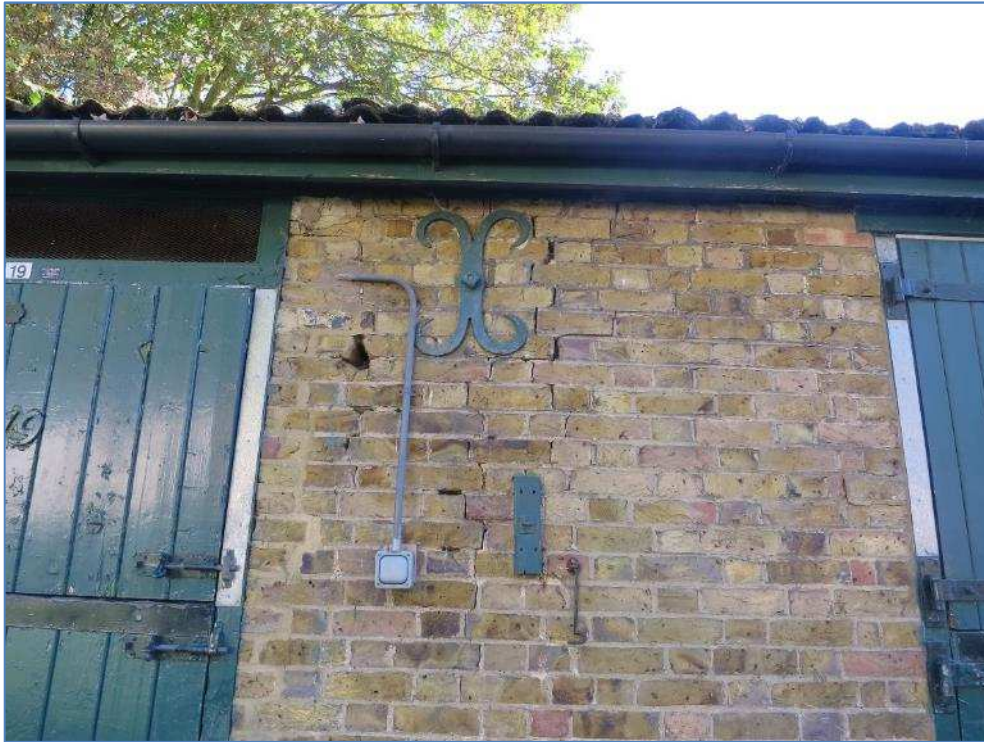
5-30 Crack in wall between stables 18 & 19

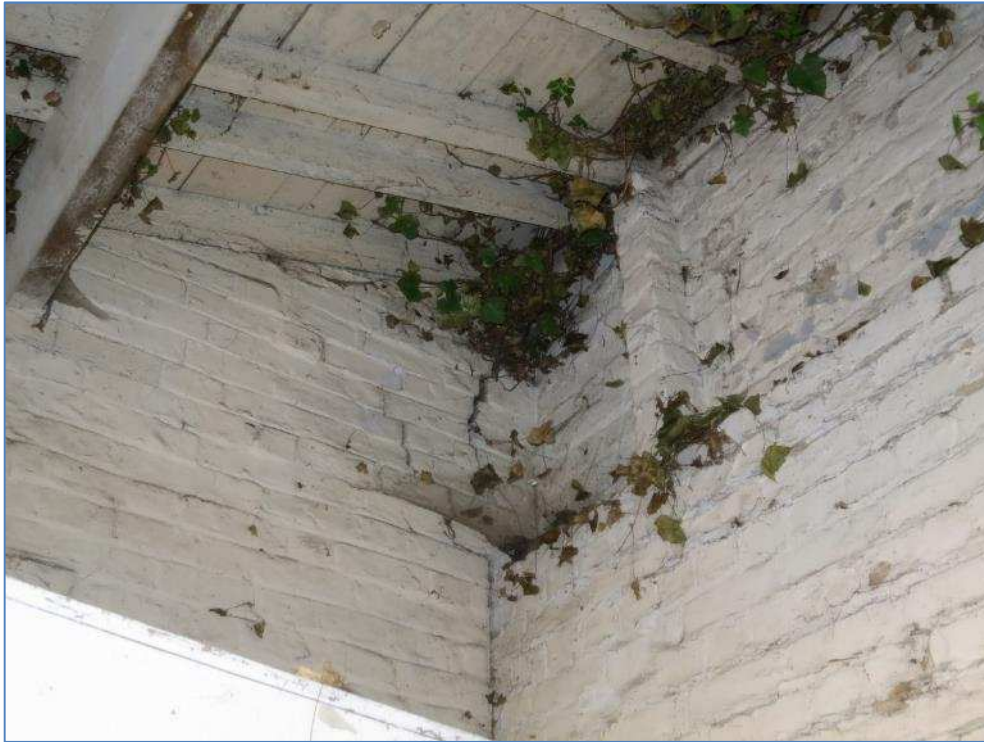
5-32 Crack in wall in tack boxes 13-19 adjacent stable 32

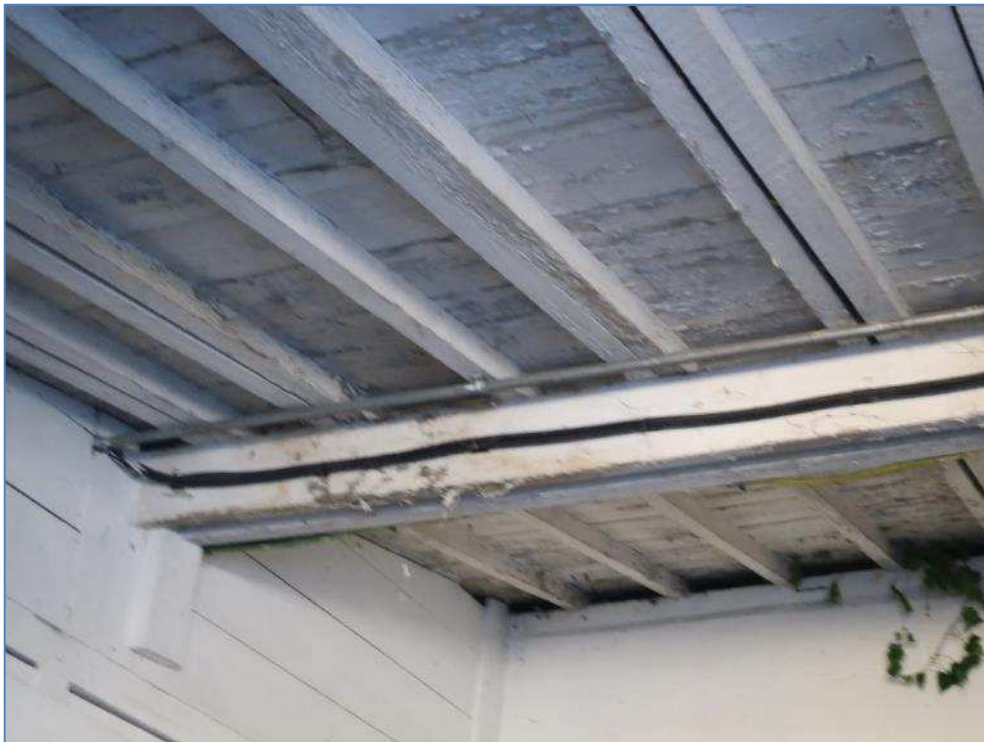
5-33 Timber soffit boarding rotting in stable 49

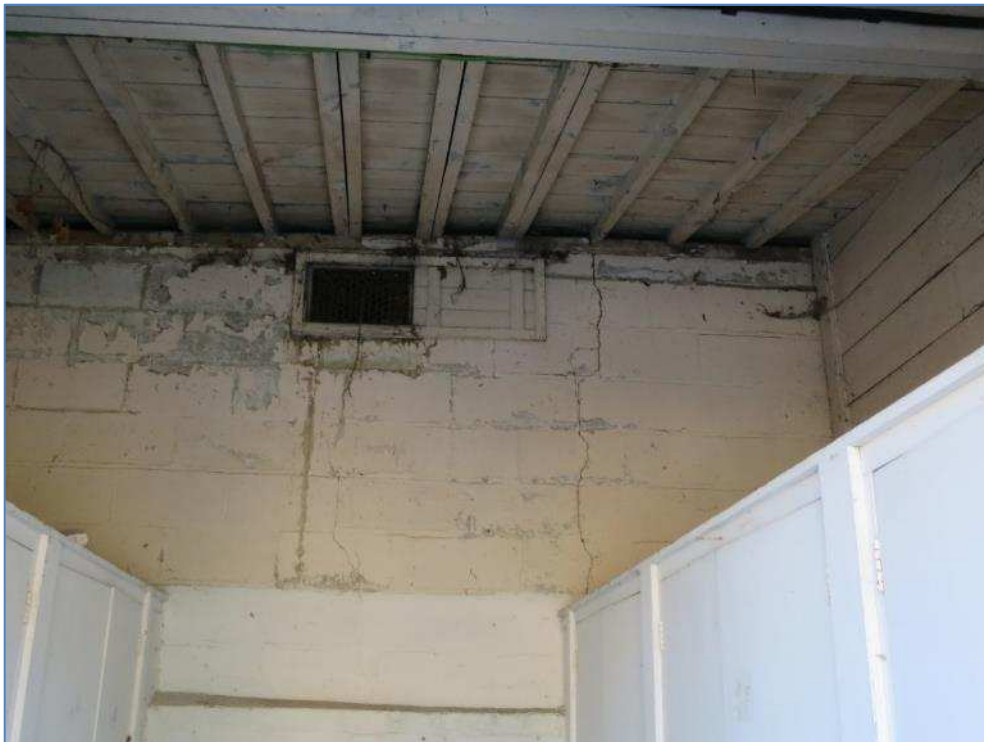
5-35 Cracks in rear wall of tack boxes 1-6

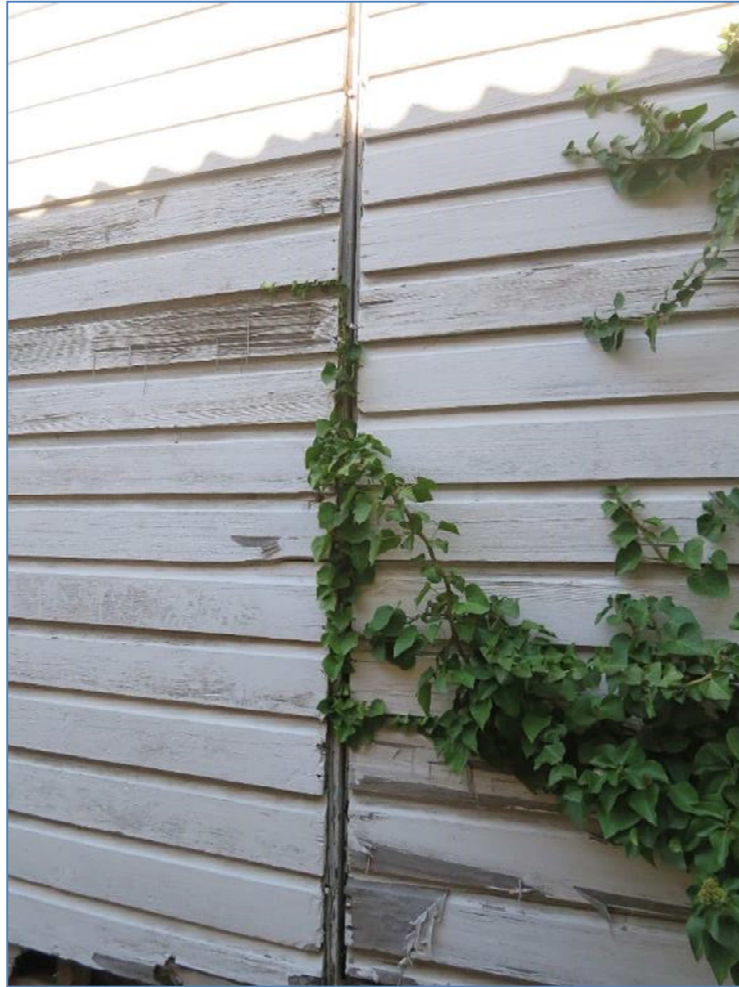
6-02 Timber infill between panels missing

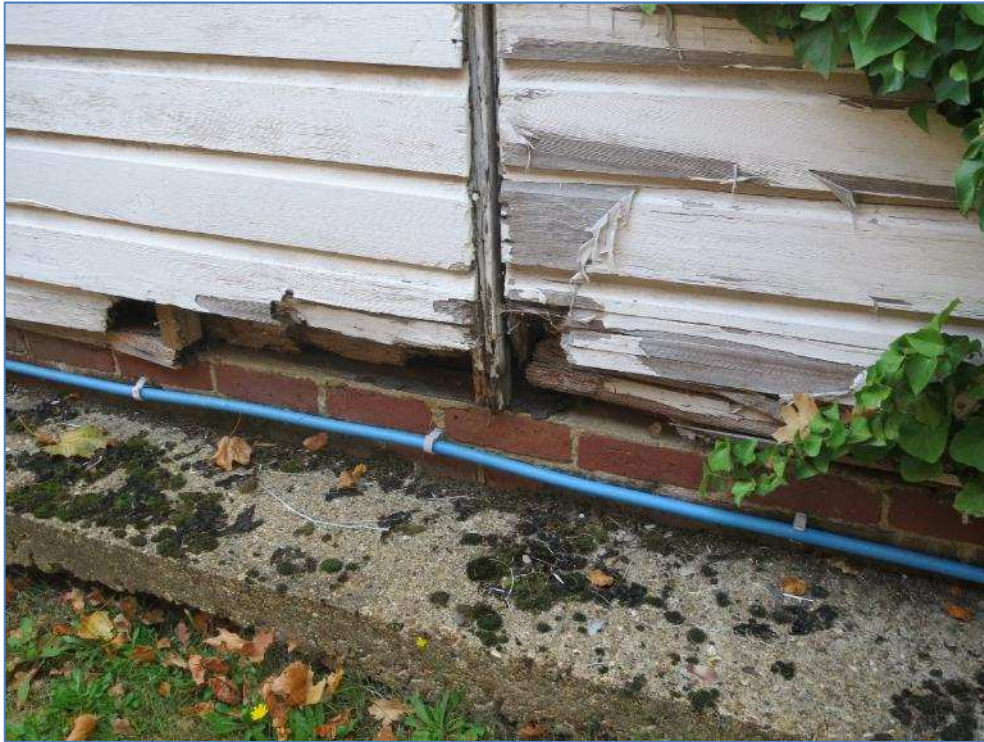
6-03 Timber cladding rotting heavily

The damaged timber on the rear elevation should be made good to prevent further deterioration. At the same time the timber should be repainted.

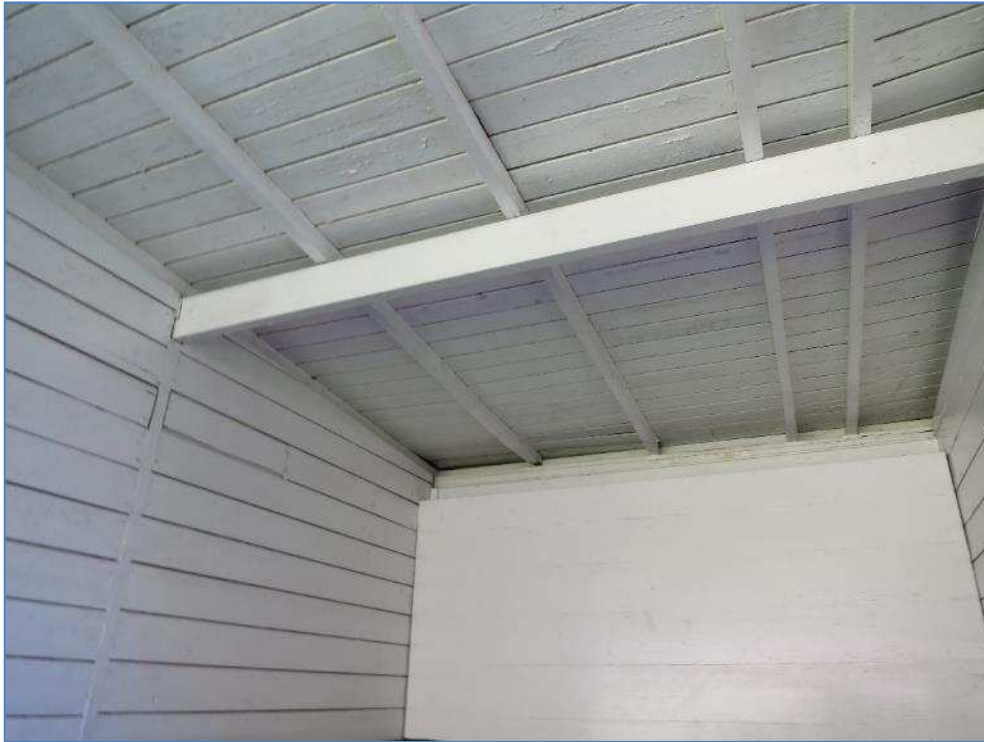
6-05 Timber soffit boarding warping

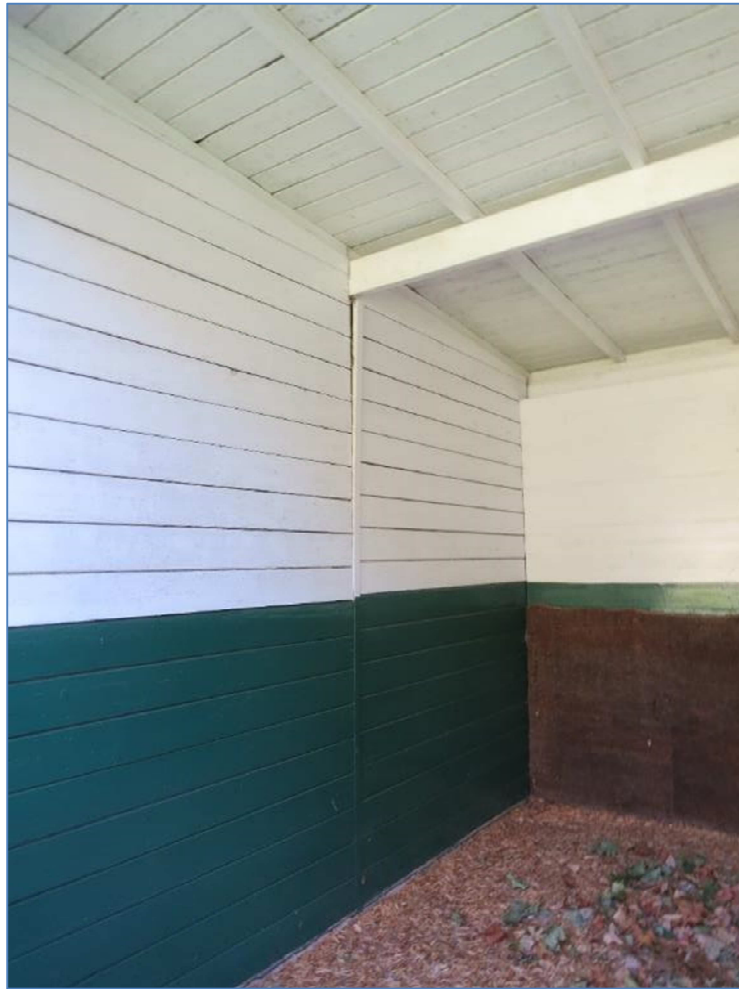
6-06 Timber infill between panels working loose
