SANDOWN PARK

Sandown Park Racecourse
Annual Structural Survey 2018

October 2018

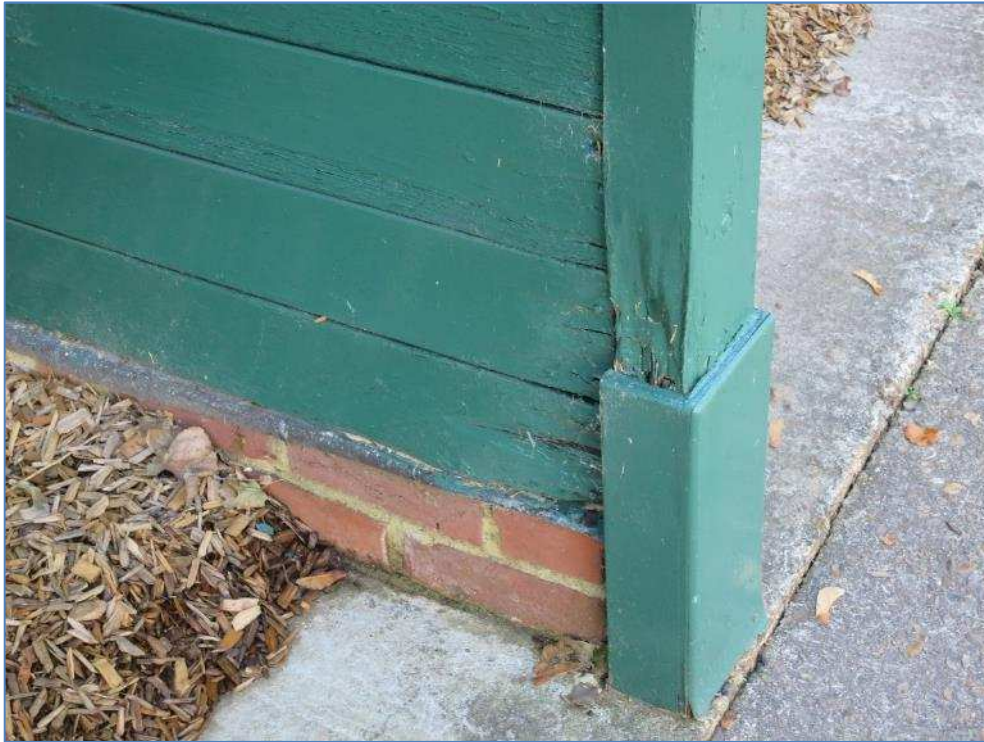
6-06 Timber to saddling box rotting

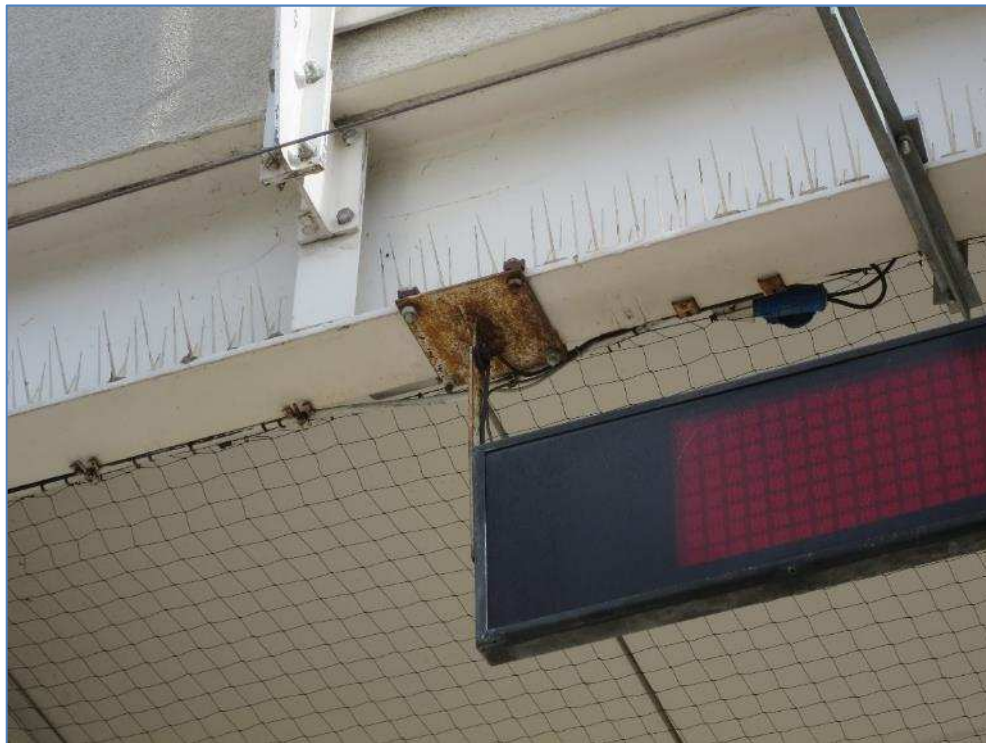
7-02 Illuminated sign support bracket rusting

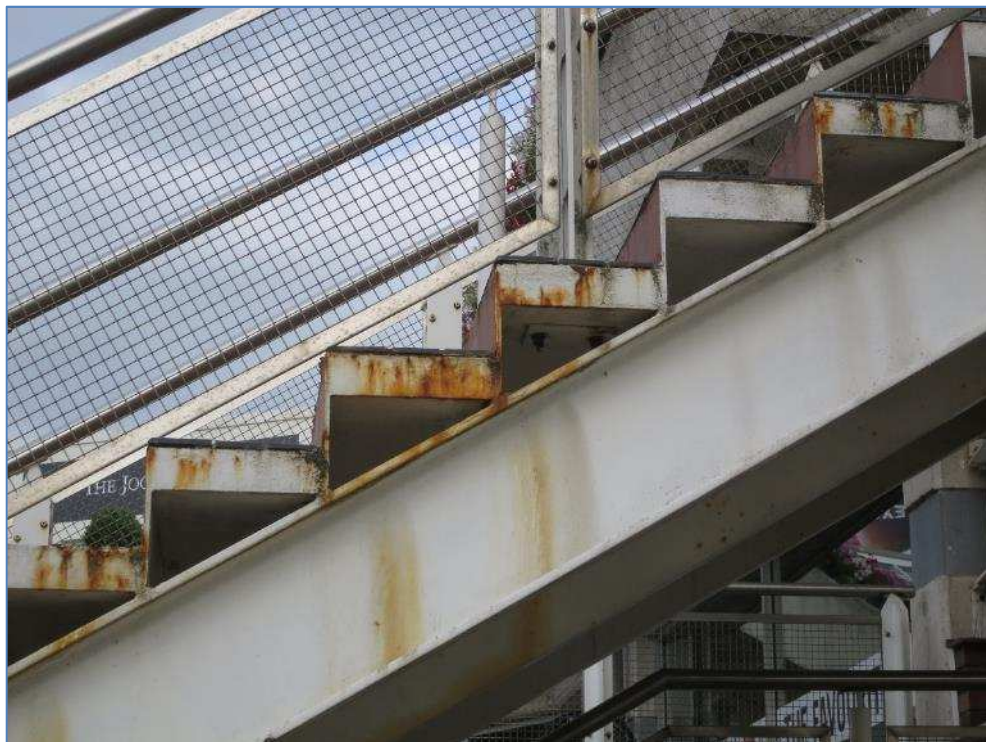
7-03 Surface rust to steelwork to staircase

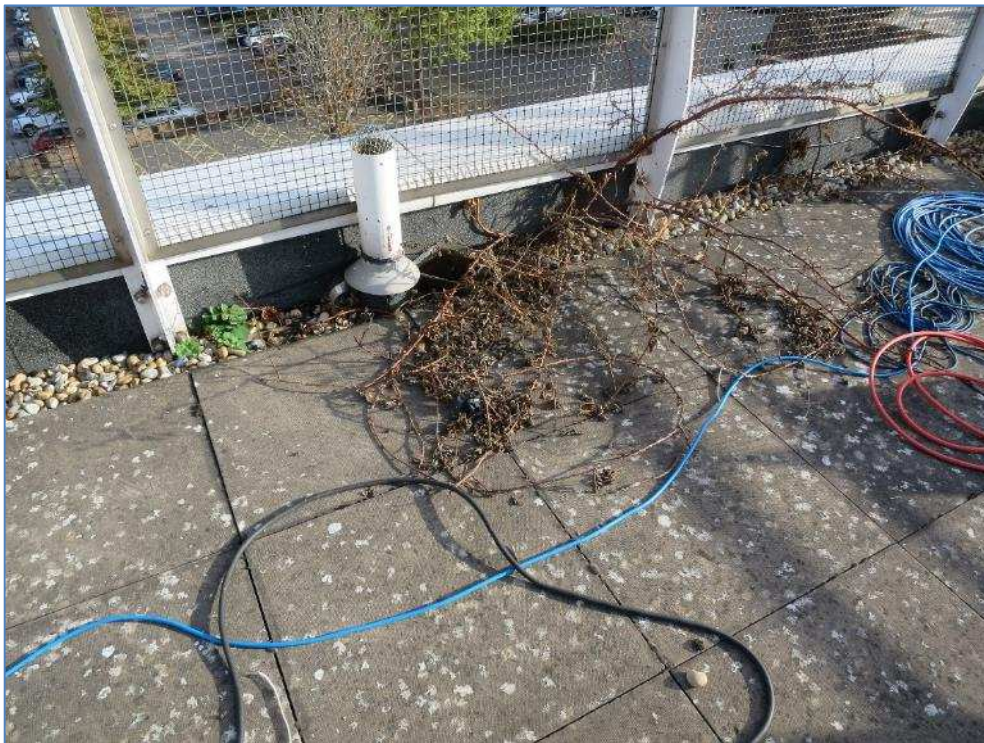
7-04 Plant growth on roof of media centre

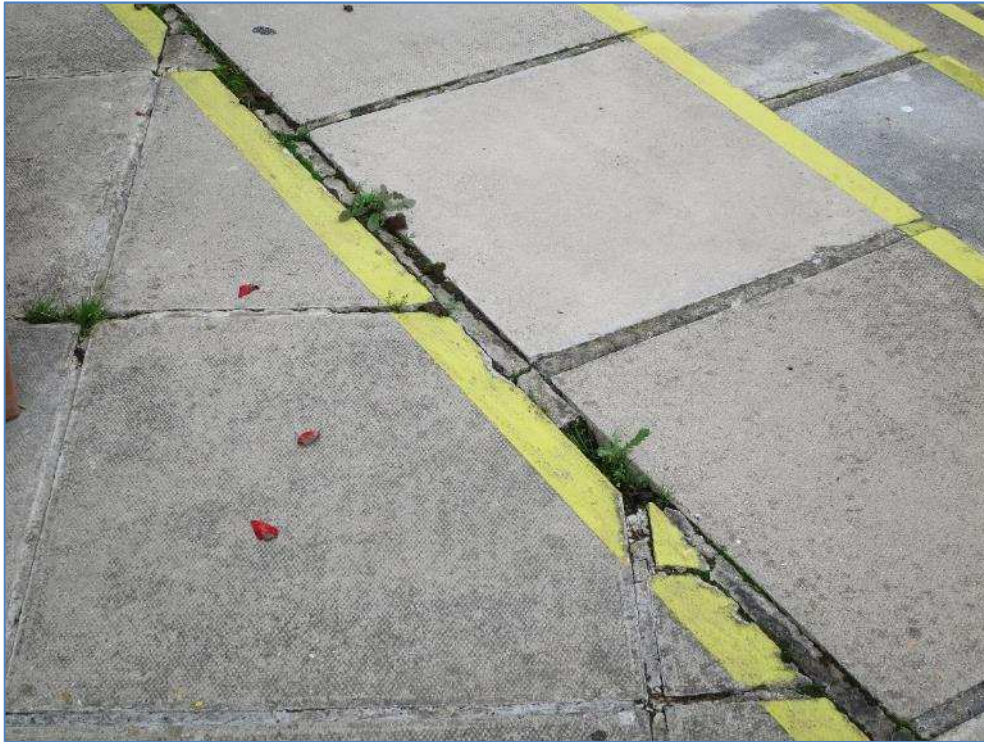
7-06 Plant growth on parade ring viewing terrace

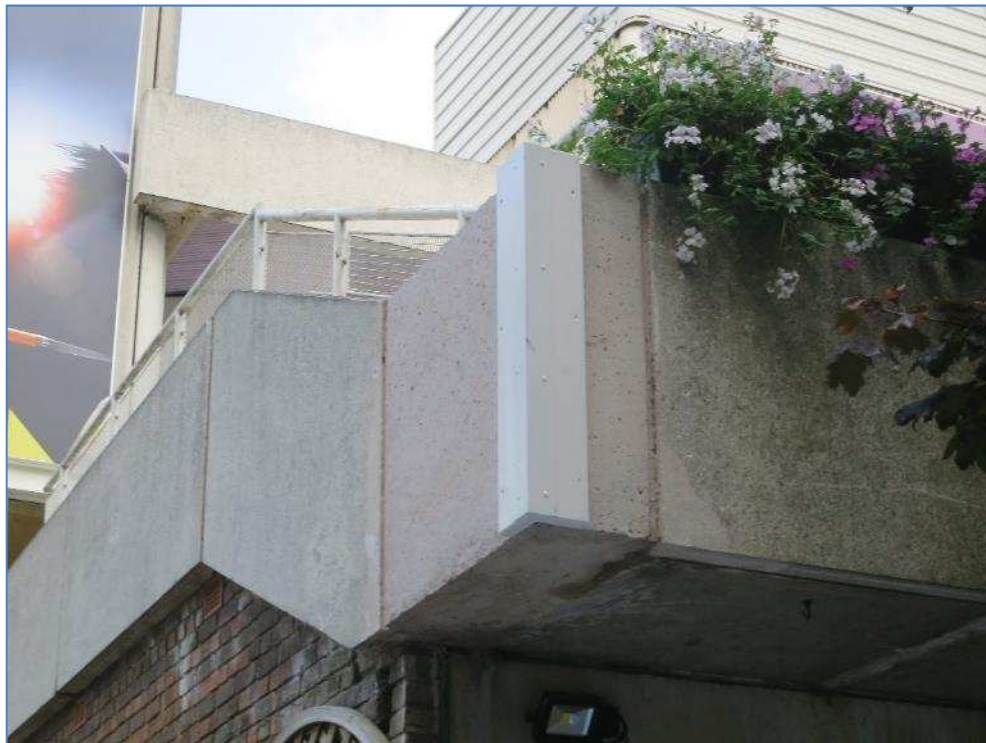
7-10 Impact damaged precast unit replaced with insitu concrete

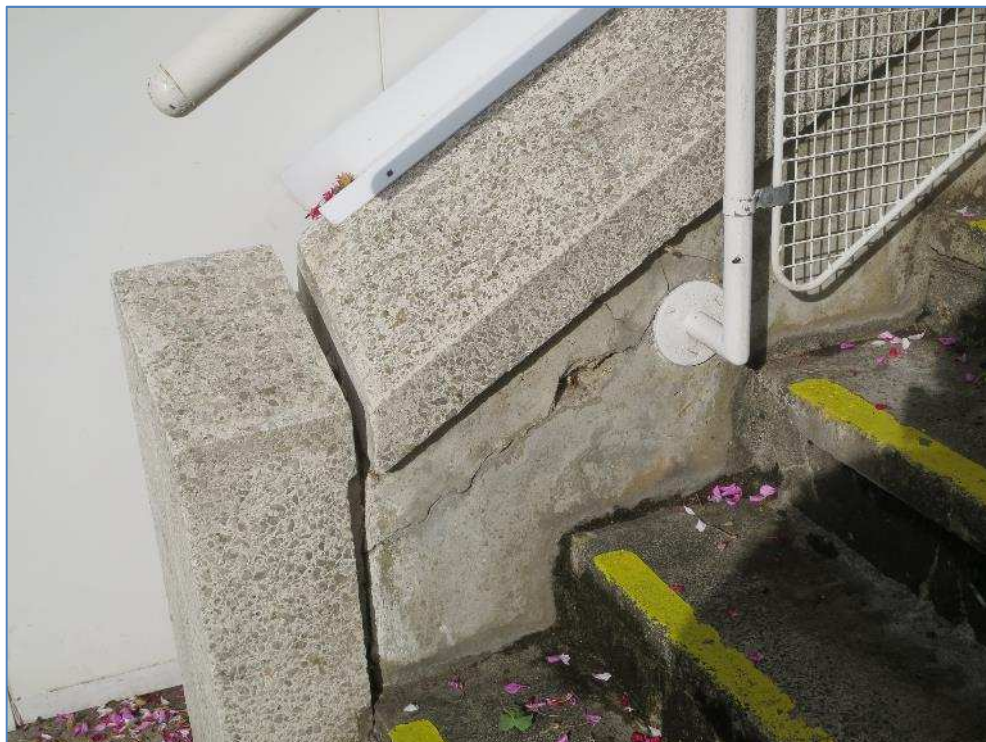
7-11 Cracks in concrete to central staircase
