BUILDING CONDITION REPORT 2020, INCLUDING M&E CONDITION SURVEY

Summary Building Condition Report for
Jockey Club Racecourses Limited

SANDOWN PARK RACECOURSE
PORTSMOUTH ROAD
ESHER
SURREY
KT10 9AJ

March 2020

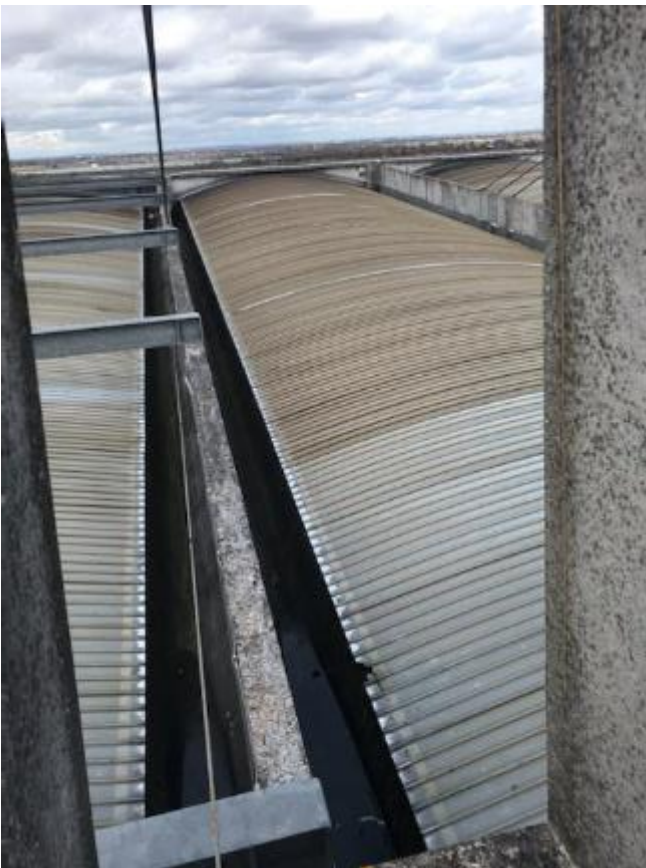
4. Typical discolouration and deterioration of brittle barrel vault canopy sections of roof.

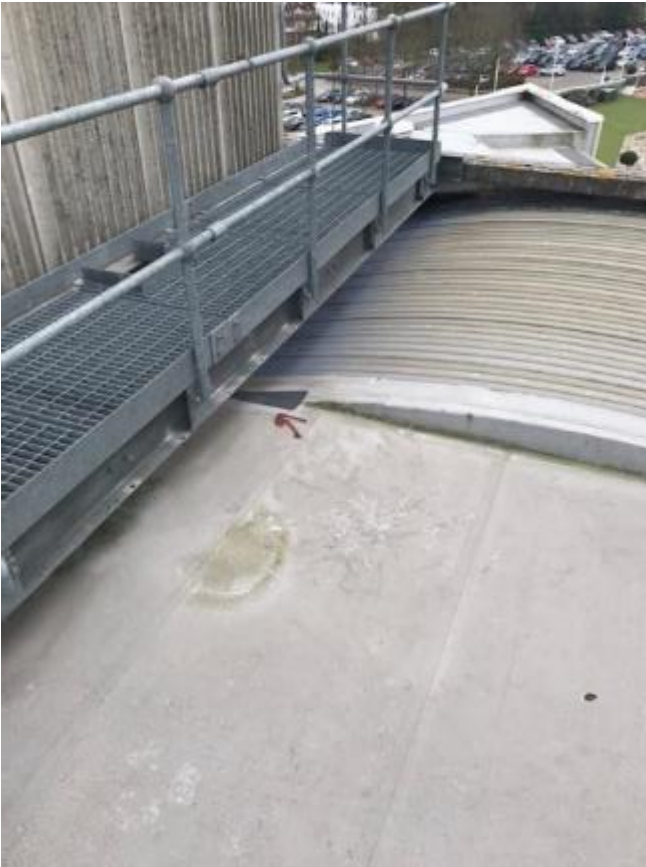
7. Typical example of patch repairs to abutment of flat roof sections and barrel vault canopy sections.

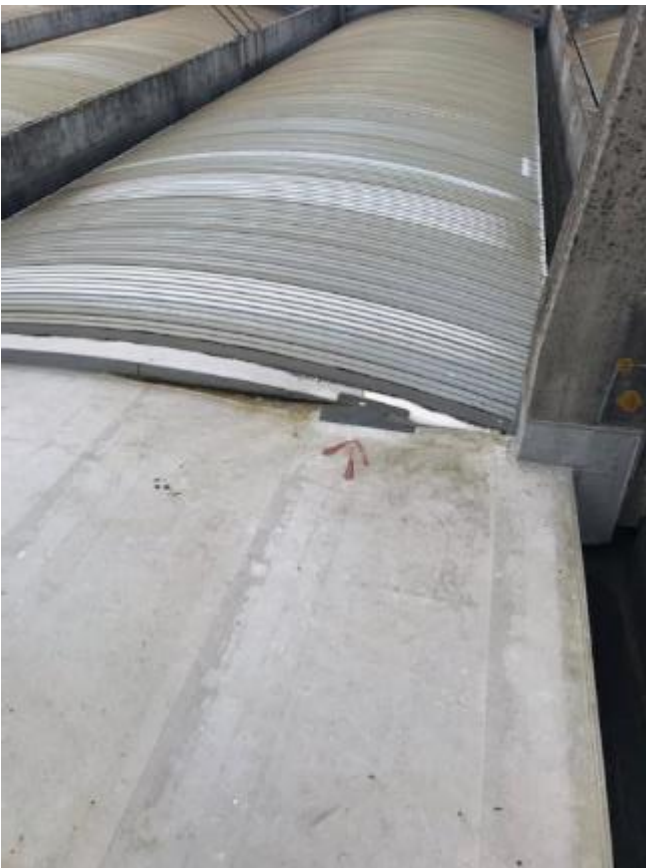
- 3.4 Various flashband patch repairs have been undertaken at the abutment of the flat roof sections and the barrel vault canopy sections of the roof. Whilst it seems that these temporary repairs have addressed some leaks, other persistent leaks remain and are causing damage to the Conference Rooms below. Ongoing repairs will be necessary.

8. Typical example of patch repairs to abutment of flat roof sections and barrel vault canopy sections.

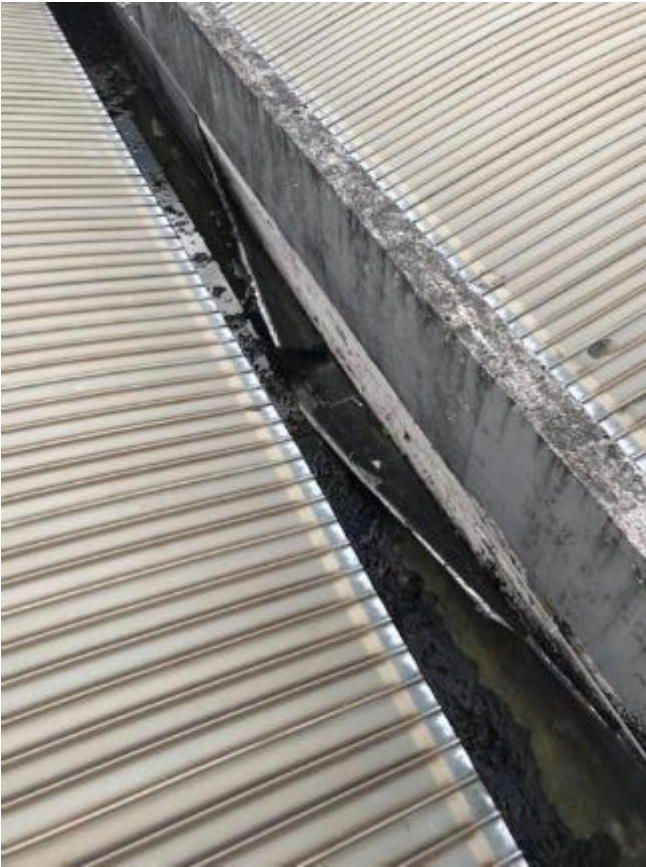
- 3.1 The Grandstand roof is in a dilapidated condition with many instances of water ingress to the Conference Rooms and Executive Boxes below.
- 3.2 The key area of concern is the concrete gutters extending between the barrel vault canopy roof sections which have previously been lined but the lining has since failed and is now delaminating in several instances.

9. Close up of typical failed/delaminating gutter linings.

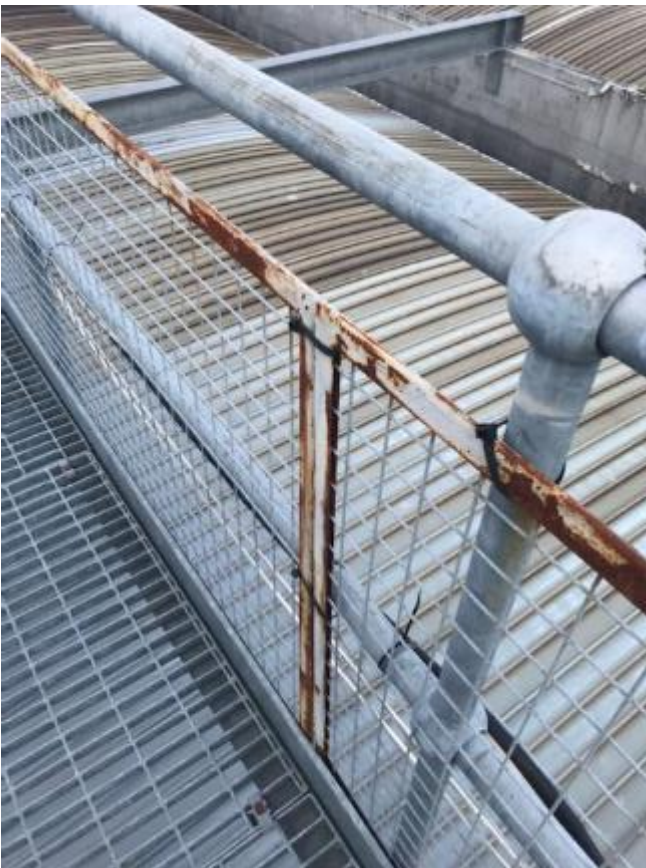
- 3.5 External joinery and metalwork at roof level are in need of redecoration with instances of wet rot noted to the base of the painted timber plant room doors and corrosion to metal handrails and balustrading.

10. Example of typical corrosion to external metalwork/handrails.

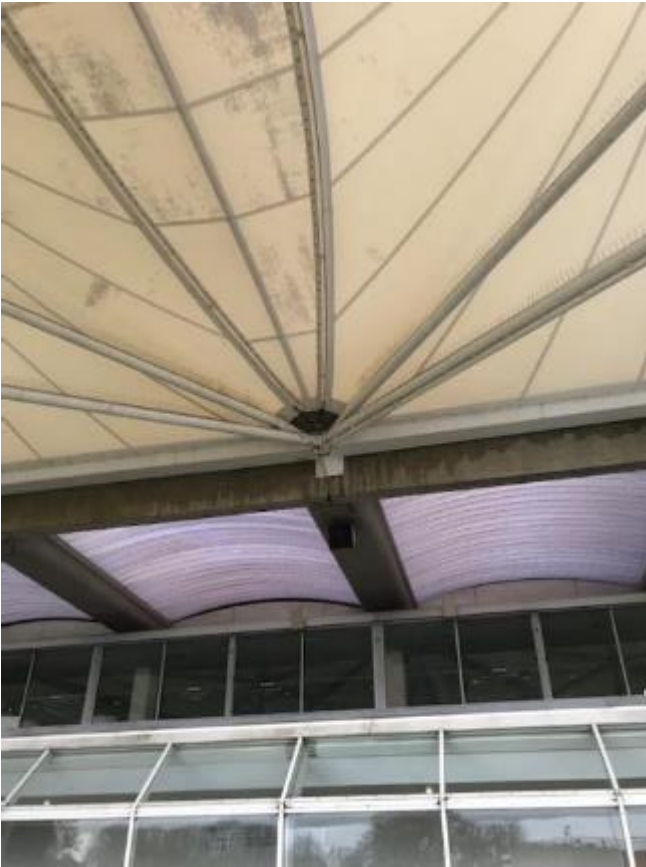
- 3.11 The problem of water ingress is exacerbated by significant leaks from the rainwater hoppers and pipework to the fabric roof canopy structure above. The ongoing leaks to the rainwater goods from these canopies can not easily be resolved without significant remedial works or ideally a redesign of the rainwater collection and disposal. In the meantime, the rainwater cascades from the hoppers and pipework over the roof and glazing onto the terrace. During our inspection of the site, we witnessed a short rain shower and substantial leaks were noted from the terrace canopy rainwater hoppers and downpipes,

19. Soiled and degraded fabric canopy structure over terrace with leaking rainwater hoppers and pipework.

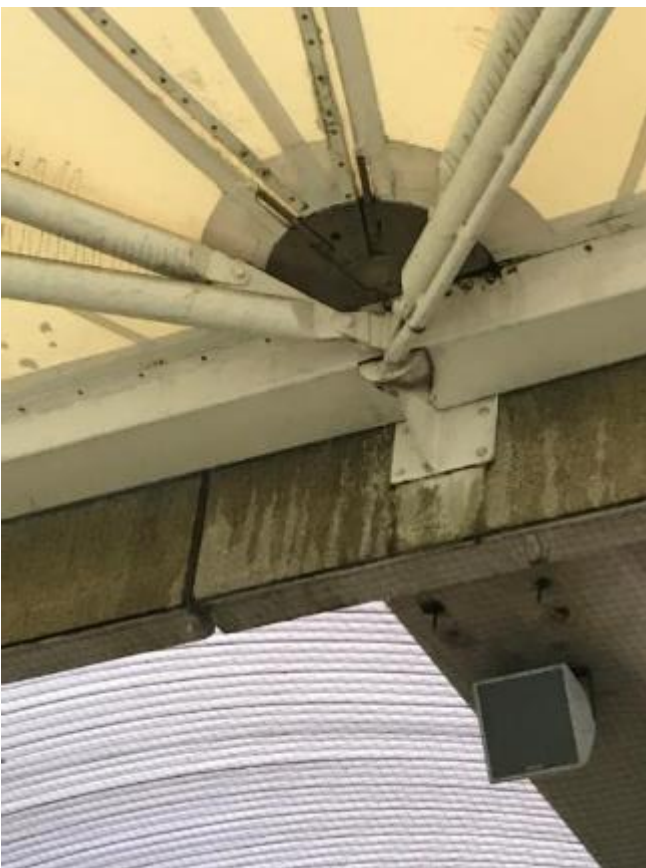
20. Close up of leaking fabric canopy and hopper / gutter detail.

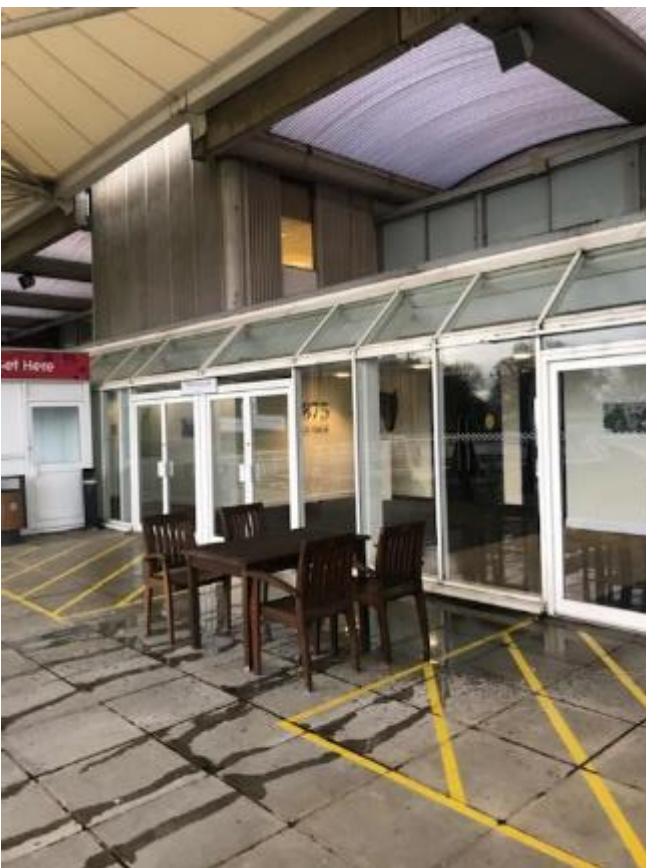
22. View of leaks from fabric canopy cascading down the terrace glazing and across the terrace pavings.

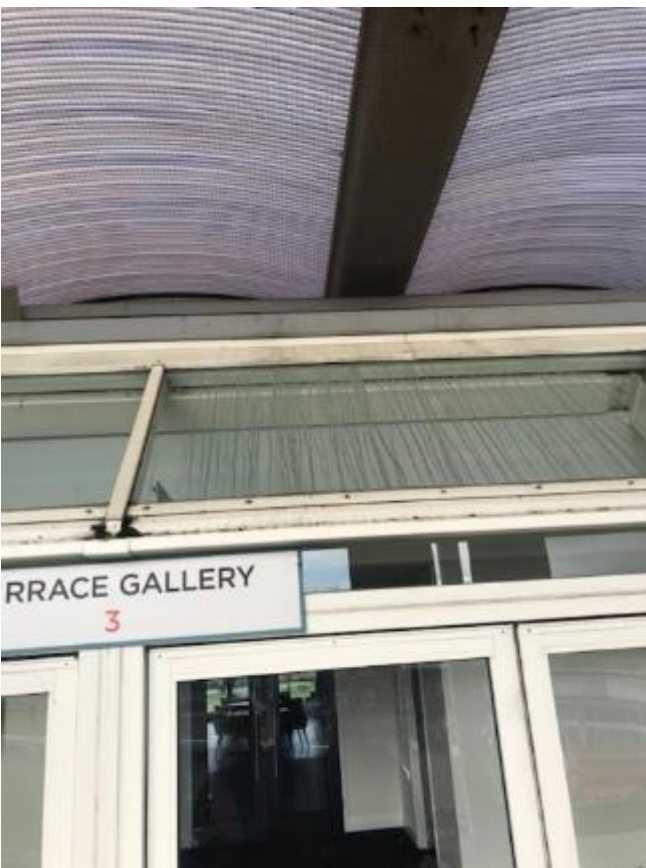
24. Water staining to corridor glazing from leaks from fabric canopy over the terrace.

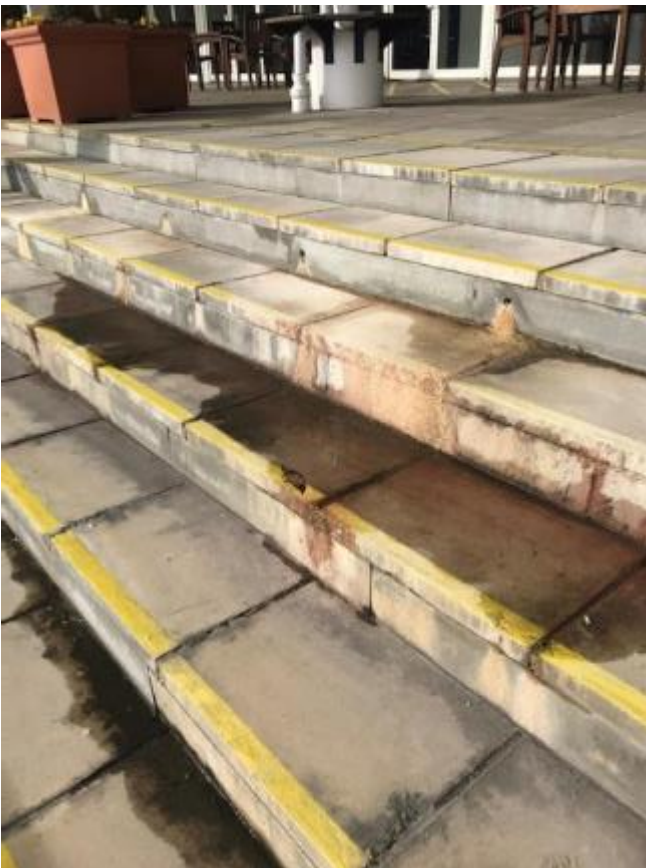
- 3.9 The Terrace overlooking the Parade Ring to the rear of the Grandstand is also a source of many ongoing leaks into the Function Rooms below.
- 3.10 Similar to the concrete steppings, thermal movement in the underlying structure appears to be the main issue. As can be seen from the photographs, the joints in the concrete pavings have opened up significantly in part and the underlying water-proofing layer/deck has clearly failed, as indicated by the many instances of internal water ingress. We consider it will prove very difficult to provide a long term solution without removing the concrete pavings and addressing the underlying water-proofing layer/deck which will incur significant expense. In the meantime, attempts have been made to seal the joints between the pavings with limited success, due to the ongoing thermal movement in the structure.

26. Rainwater leaking through the terrace pavings and steppings causing water ingress below.

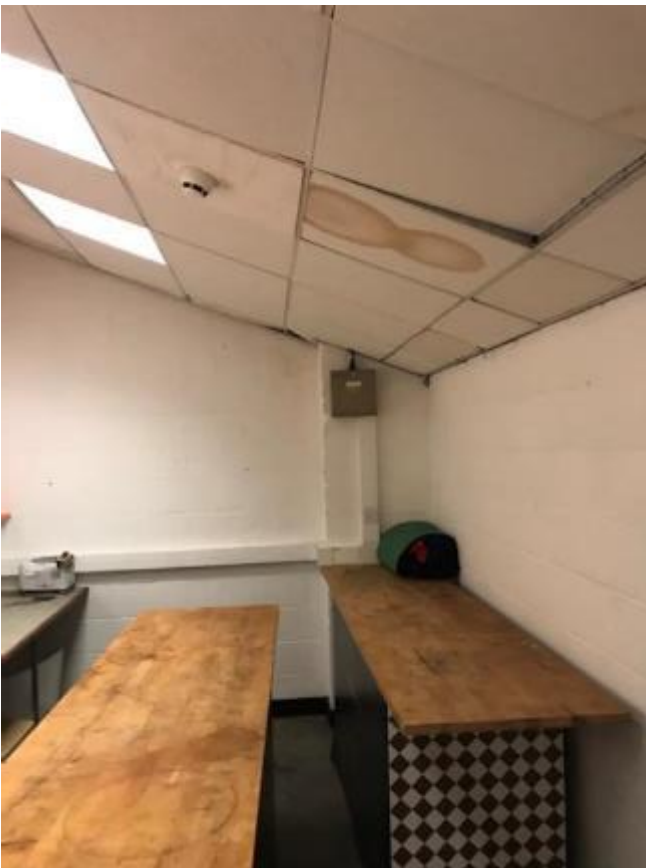
- 3.13 Despite a network of internal gutters, linings and individual buckets placed above the suspended ceilings there are many ongoing leaks into Esher Hall. The Maintenance Team have also hung buckets below the open ceiling soffit in clear view of customers, in an attempt to alleviate the effects of the worst leaks. We understand buckets are regularly emptied.

34. Leaks to ceiling tiles.

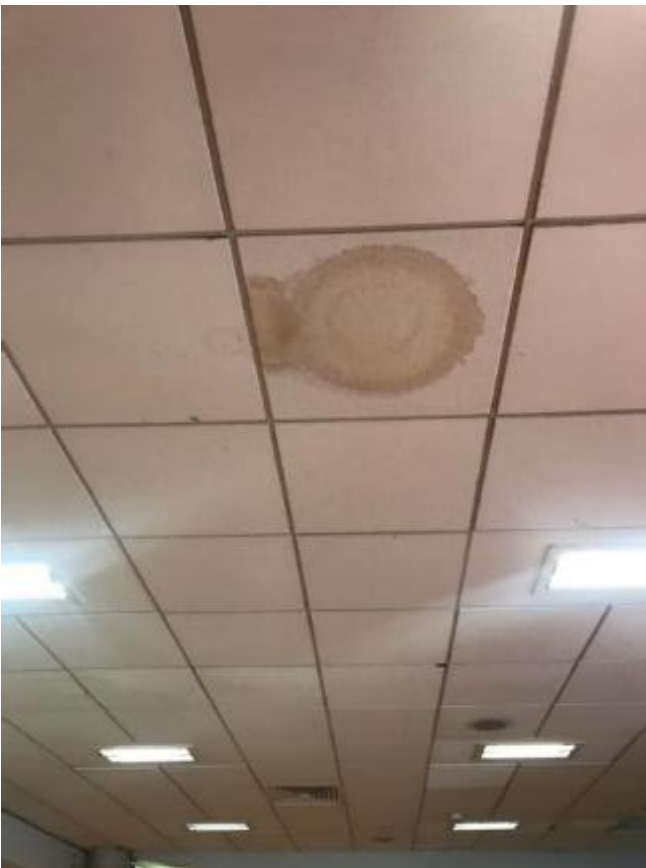
36. Leaks to ceiling tiles.

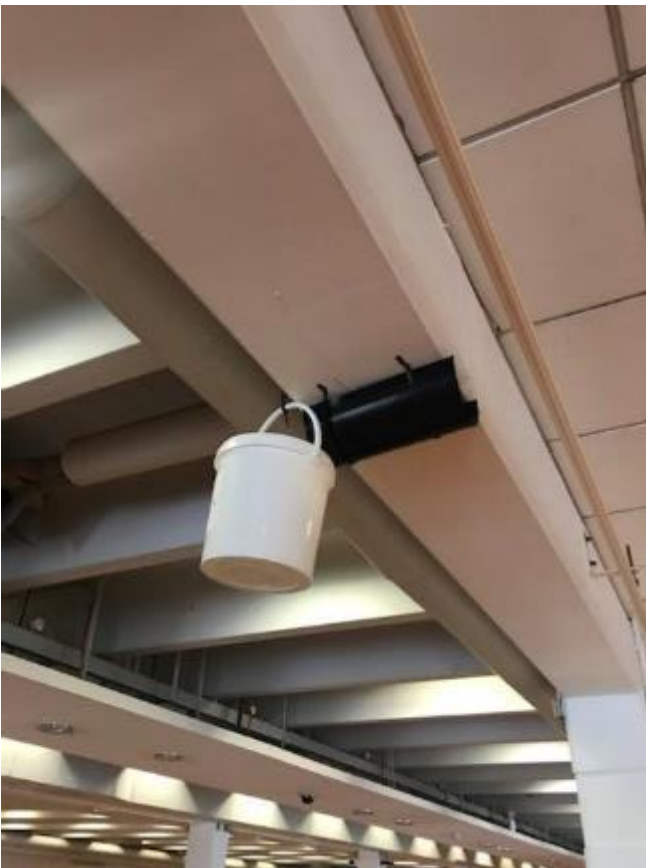
38. Example of bucket placed at ceiling level to deal with persistent leaks.

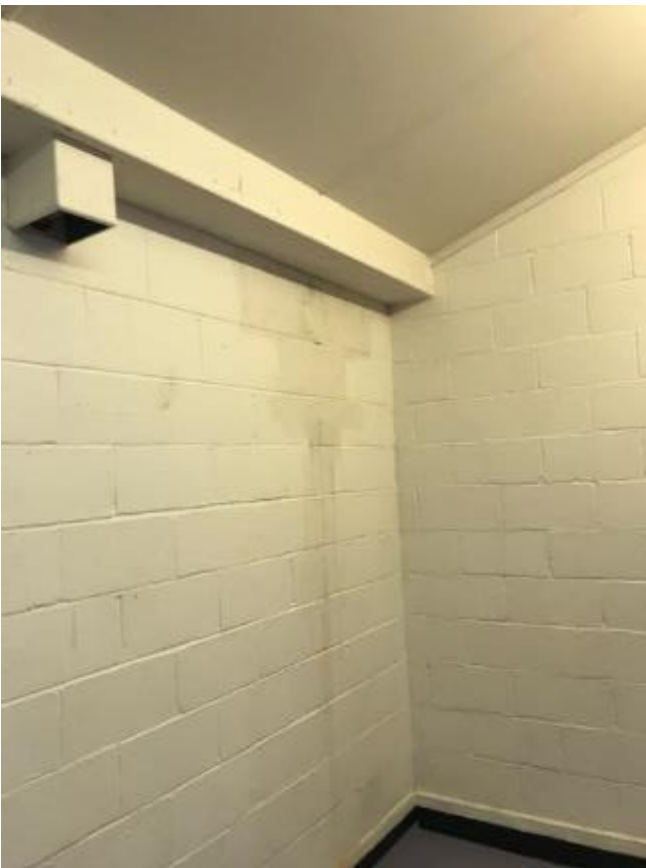
- 3.14 Water ingress has caused significant damp staining to the ceilings and walls. Furthermore, the vinyl floor covering has been damaged by instances of prolonged water ingress such that sections have had to be replaced. Unfortunately, the original colour of the vinyl floor covering is no longer available and hence patch repairs have been undertaken in non-matching colours. Elsewhere the vinyl floor covering is consistently worn and scuffed and customer standards dictate that replacement is required as soon as possible.

40. Damp staining to wall grinning through the painted finish.

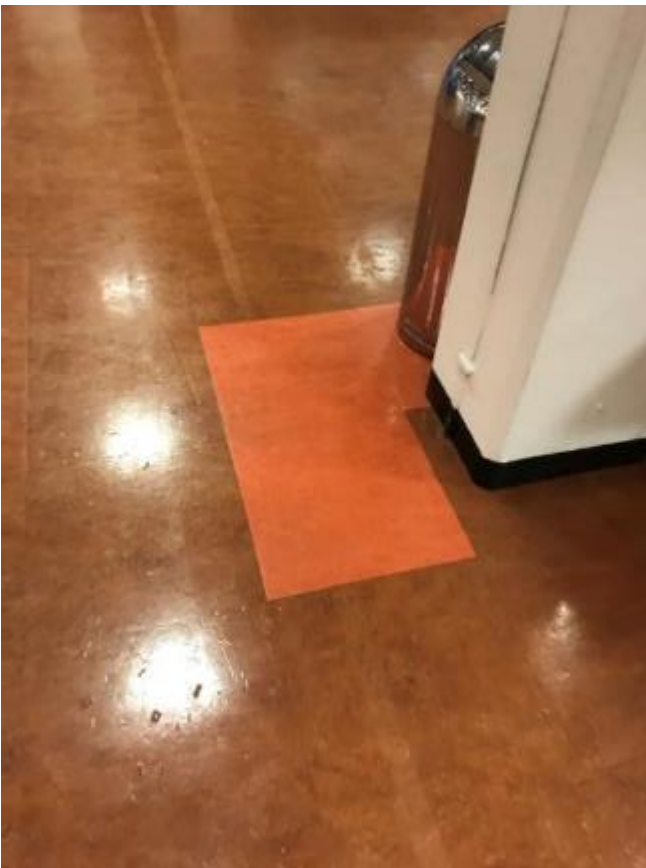
46. Floor covering patch repaired in non-matching colours, as original colour is no longer available.

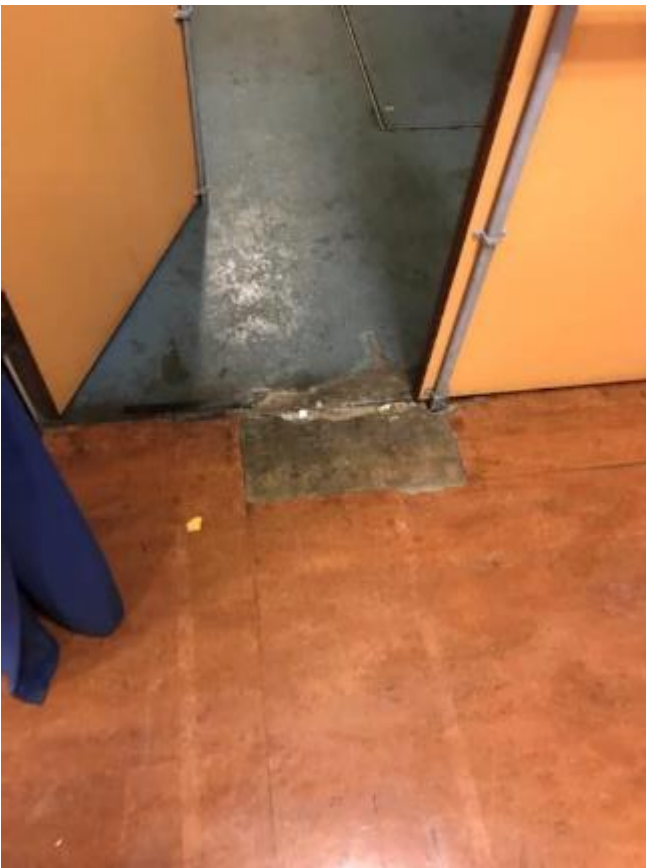
48. Example of damaged flooring adjacent to back of house/fire exit doors.

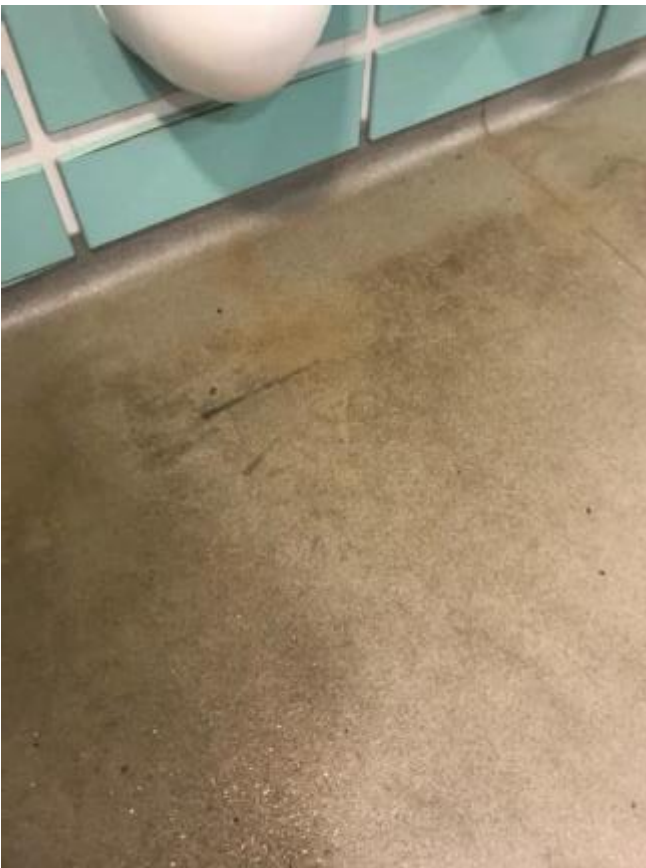
54. Heavy marking/staining to sheet vinyl around urinals in Gents Toilets.

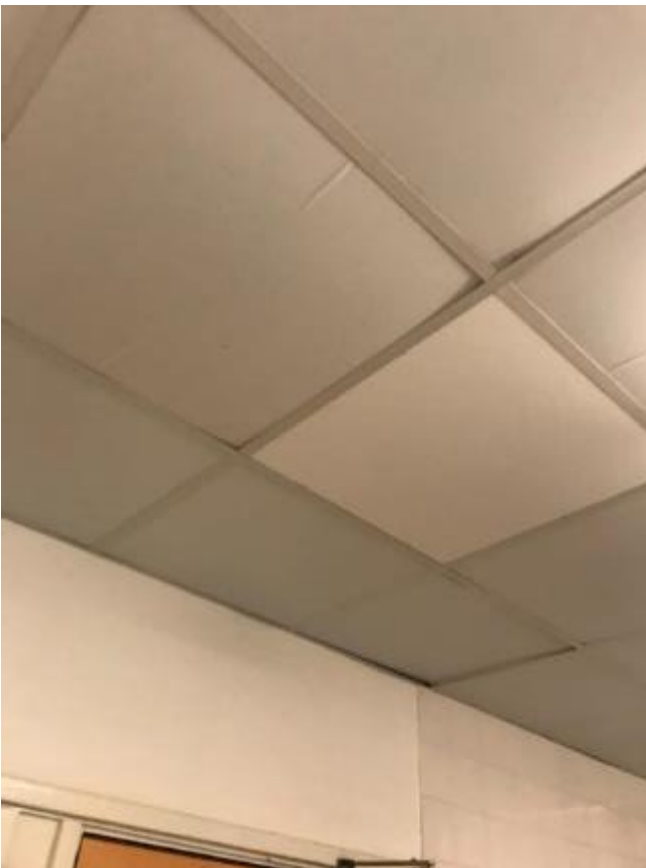
58. Kitchen ceiling tiles replaced following leaks.

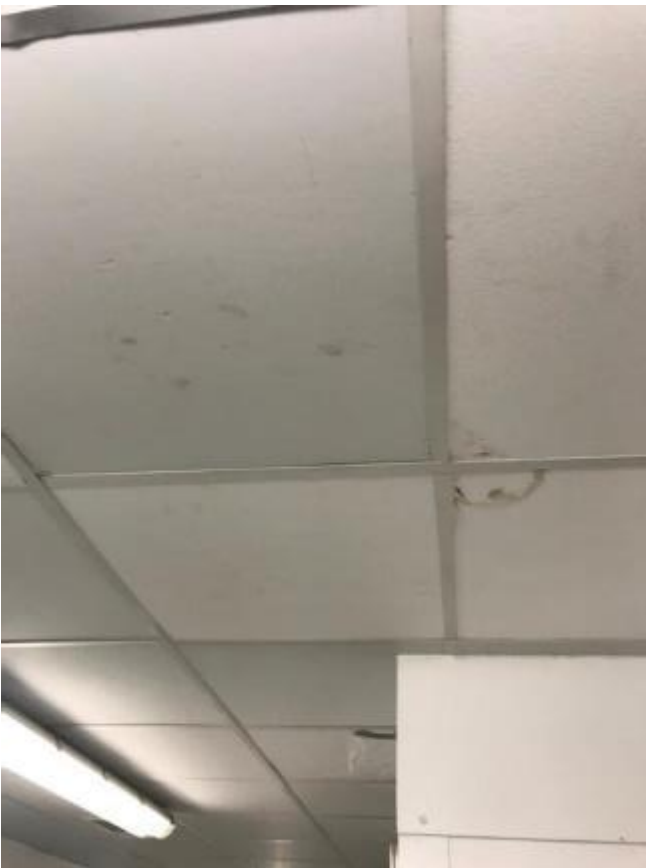
60. Example of damaged ceiling tiles.

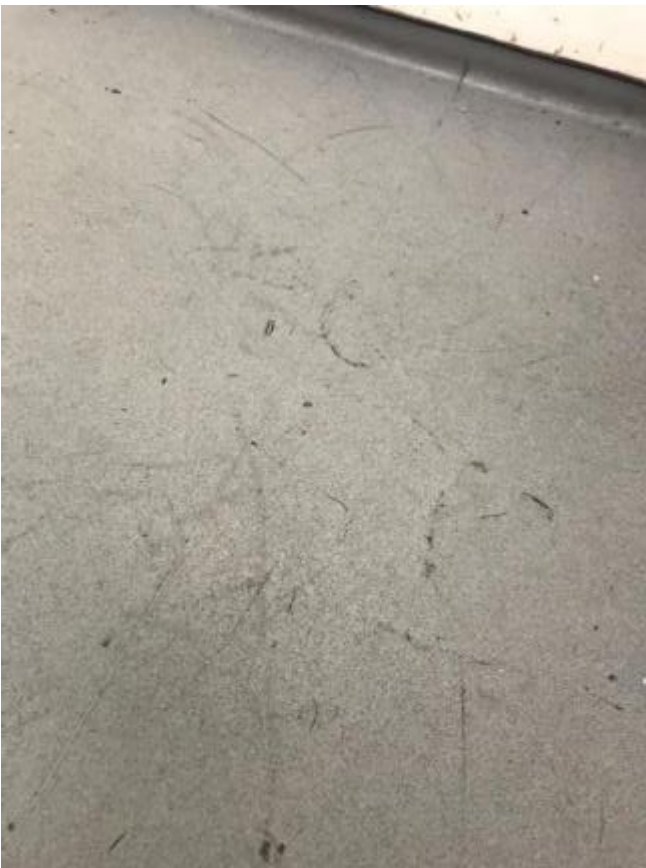
62. Close up of heavy scuffing to the sheet vinyl floor finish in the kitchen.

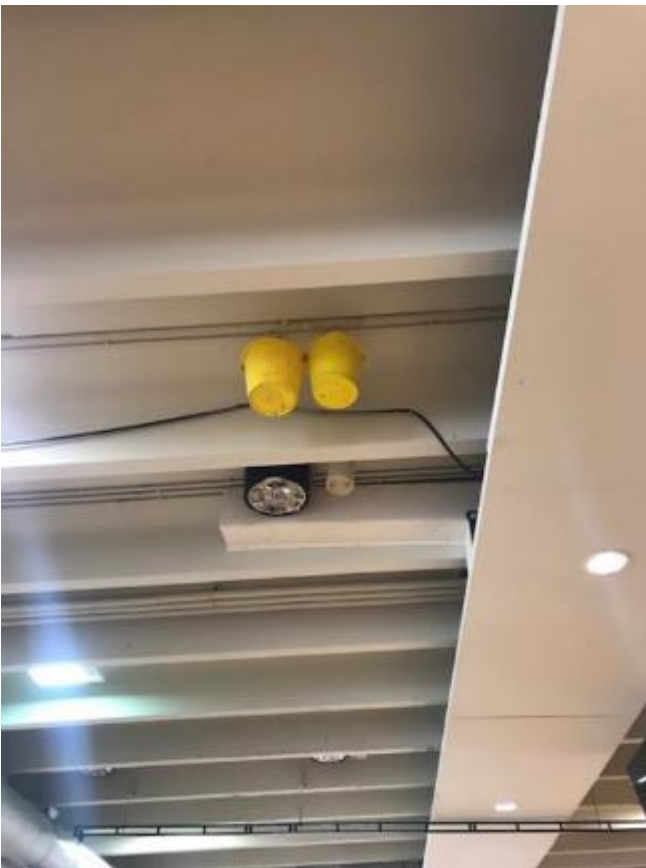
68. Buckets suspended from ceiling soffit to deal with persistent leaks.

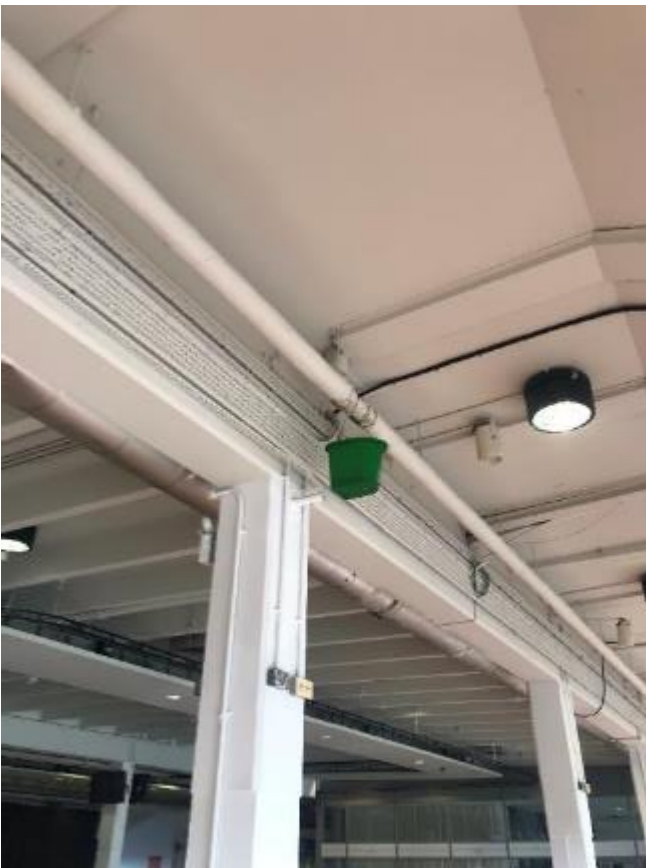
70. Buckets suspended from ceiling soffit to deal with persistent leaks.

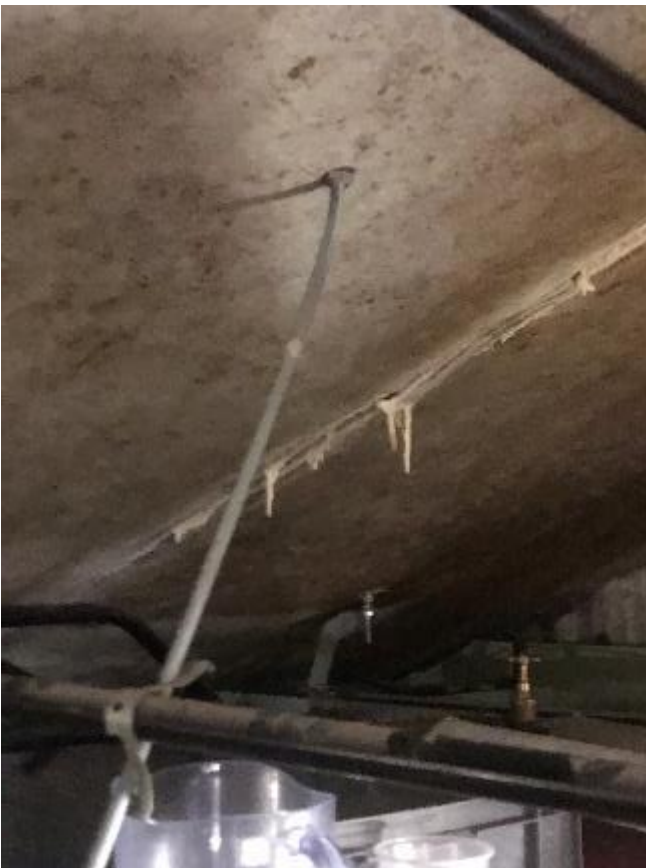
72. Example of buckets strategically placed above ceilings to Champagne Bar to catch leaks.

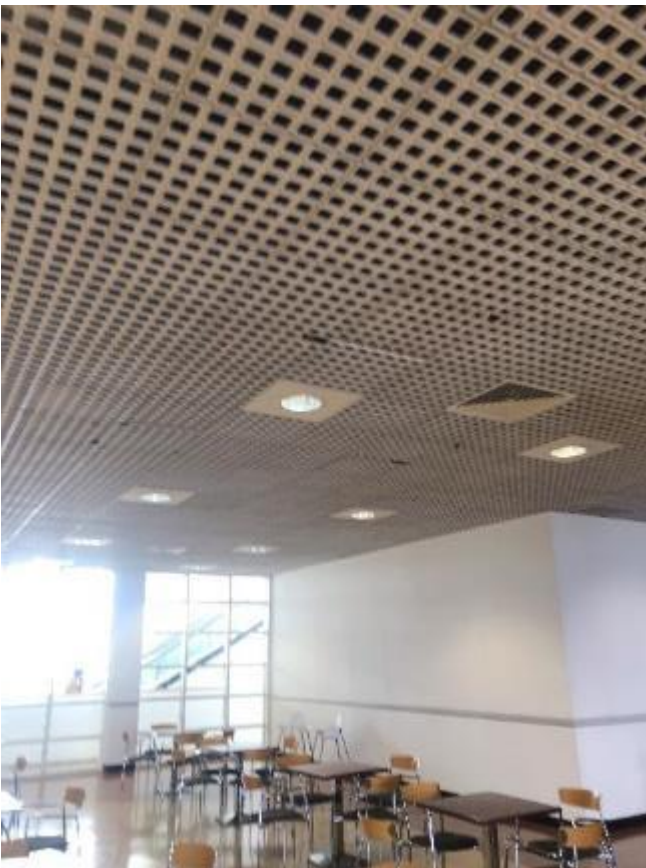
78. Dated stained and damaged ceiling to Food Court Area.

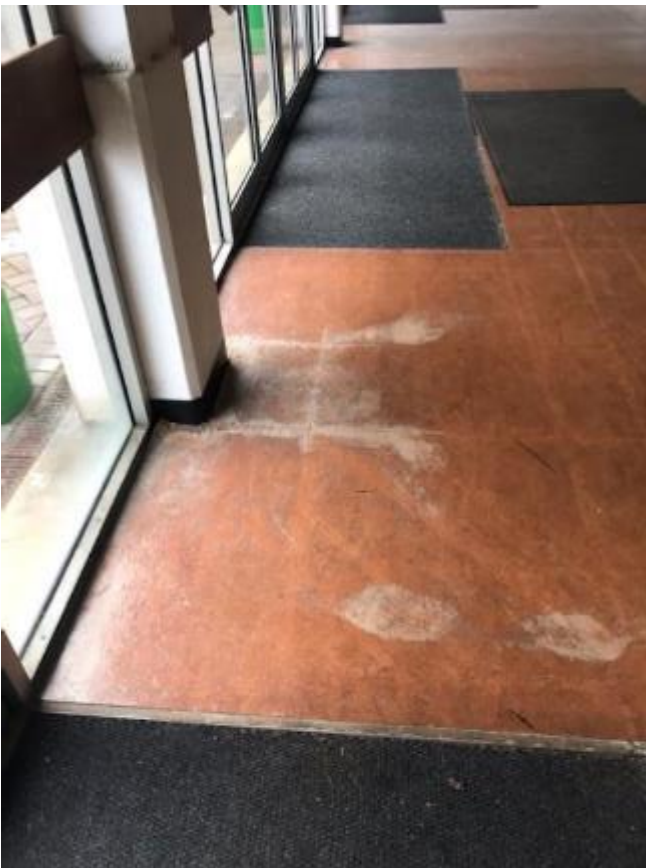
80. Example of heavily stained floor vinyl due to persistent leaks from Parade Ring Terrace.

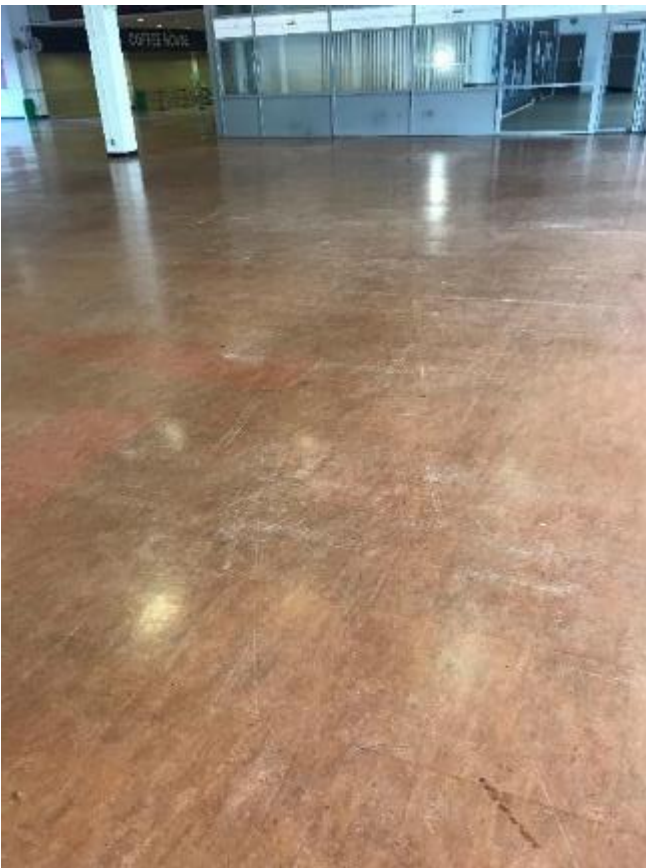
84. Consistently worn and discoloured vinyl floor in need of replacement.

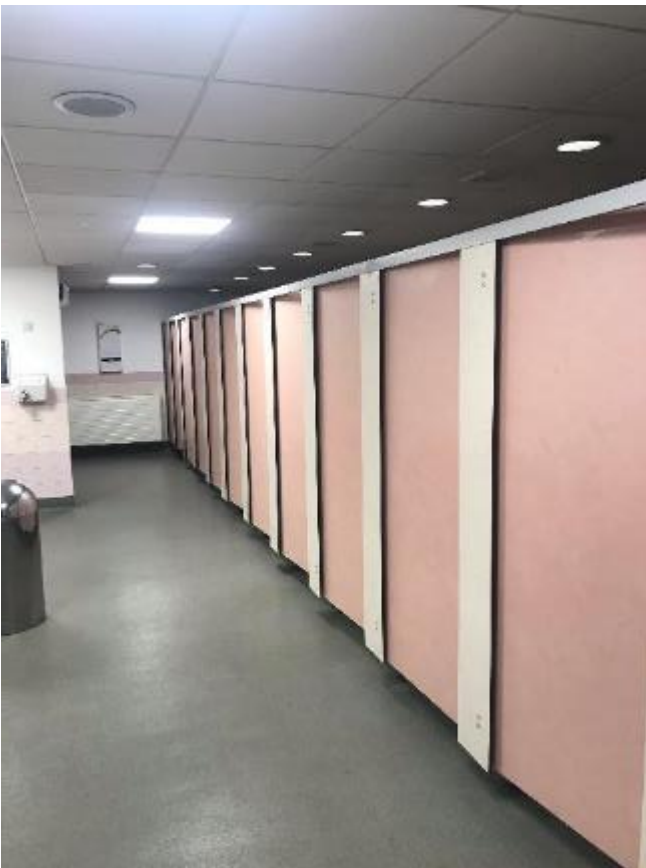
86. Dated Ladies Toilets in need of upgrade by Customer Standards.

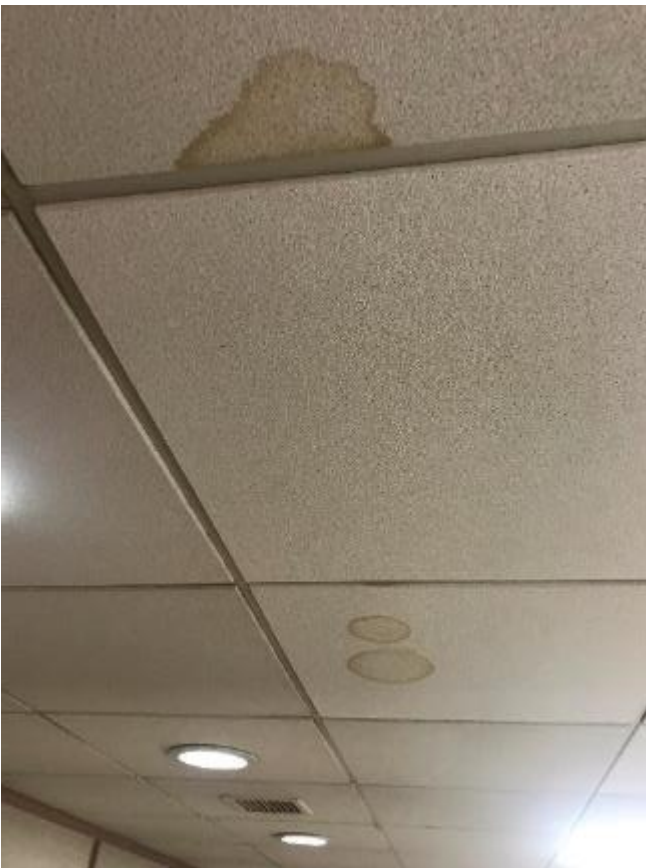
88. Example of water stained ceiling tiles in Ladies Toilets.

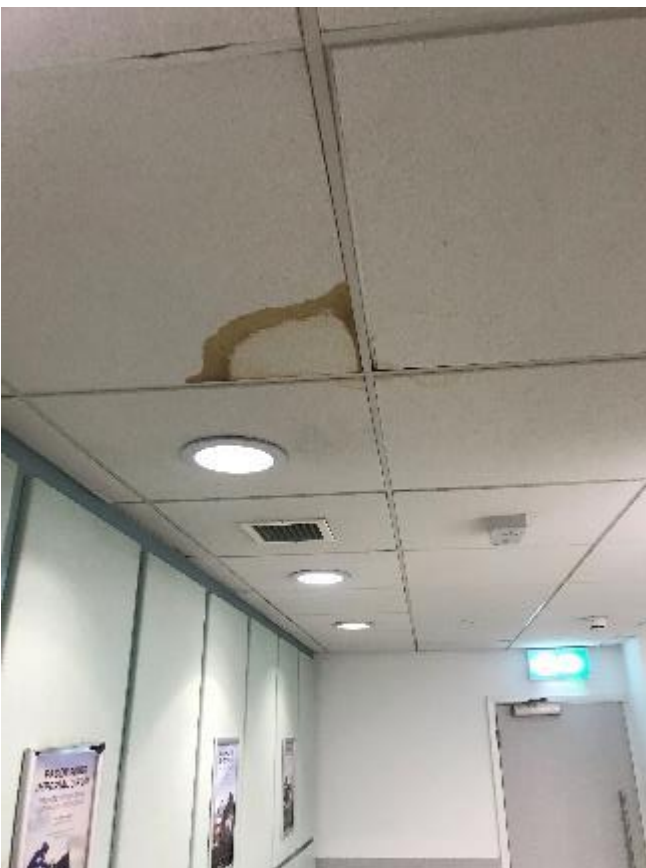
94. Example of water stained ceiling tiles in Gents Toilets.

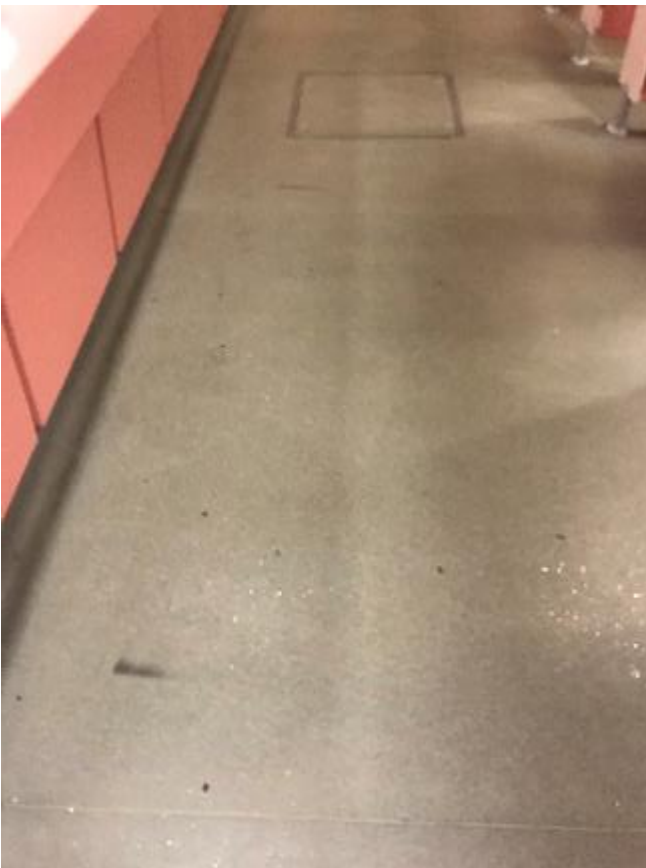
100. Vinyl floor to lower floor Ladies Toilets is heavily worn and soiled.

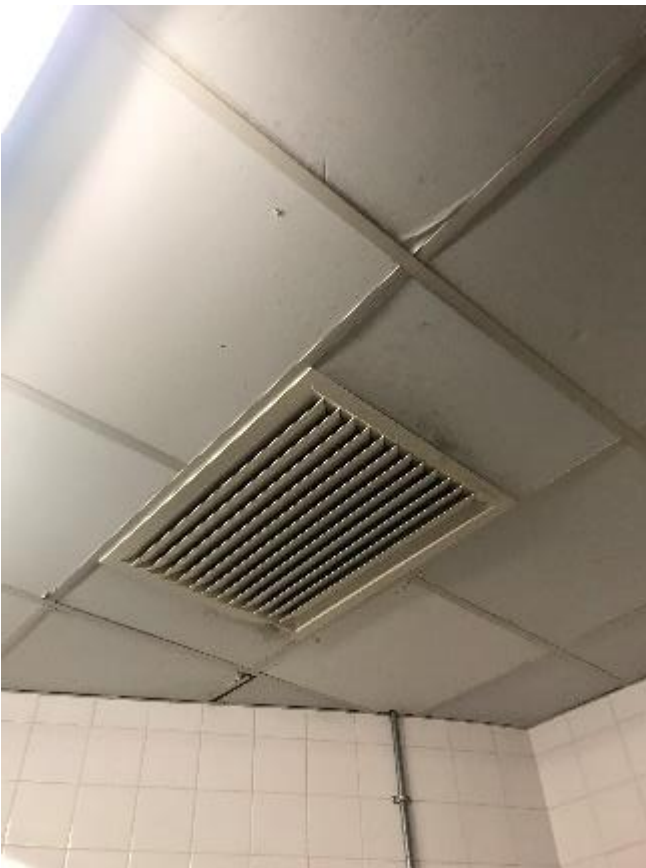
106. Example of ceiling tiles replaced following water ingress.

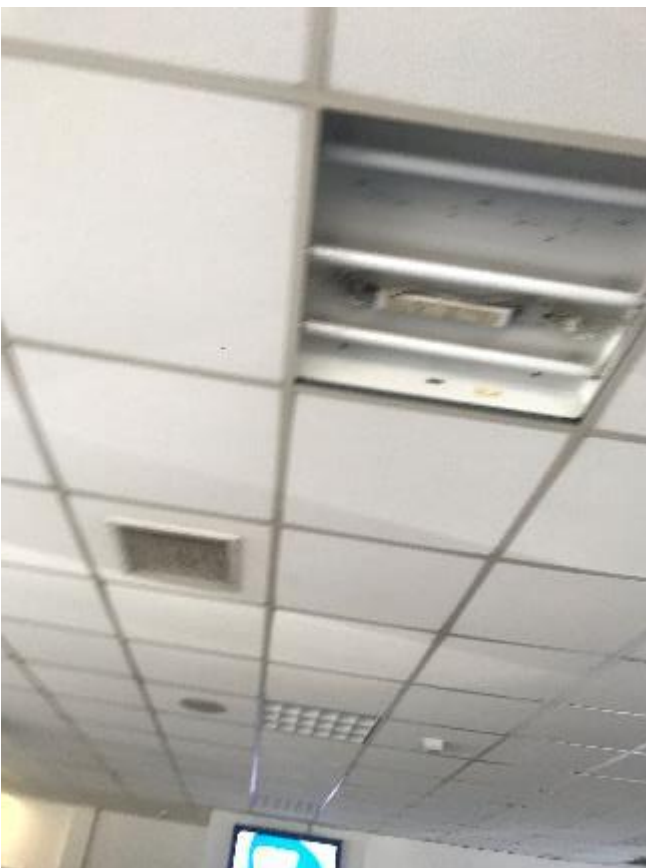
110. Example of faulty light fitting.

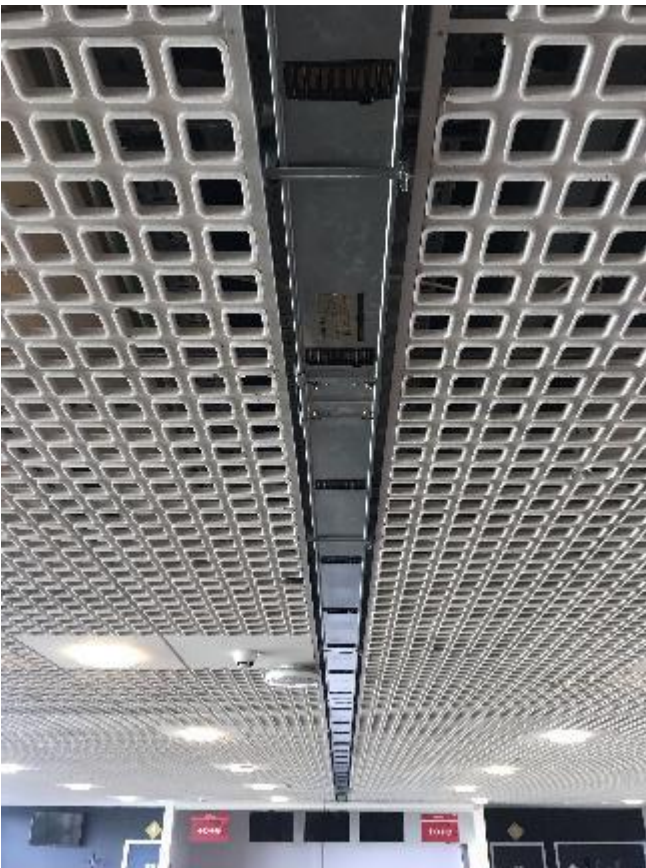
118. Close up of dated and damaged ceiling.

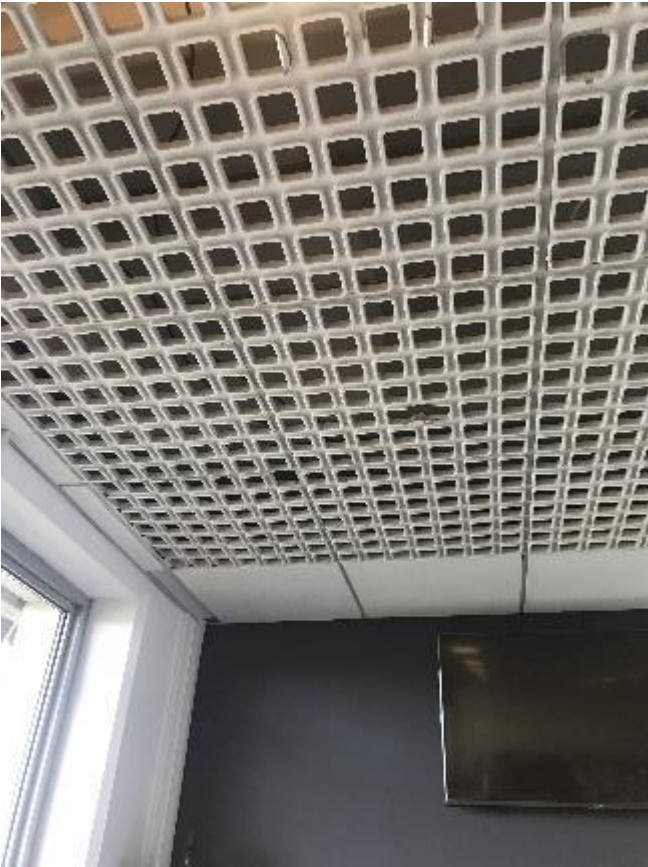
119. Close up of dated and damaged ceiling.

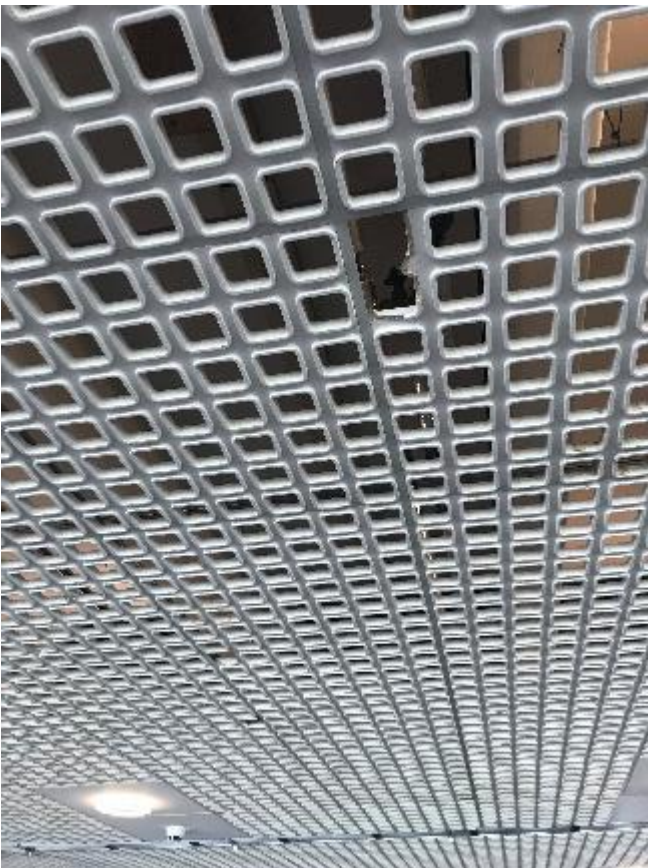
120. Close up of dated and damaged ceiling.

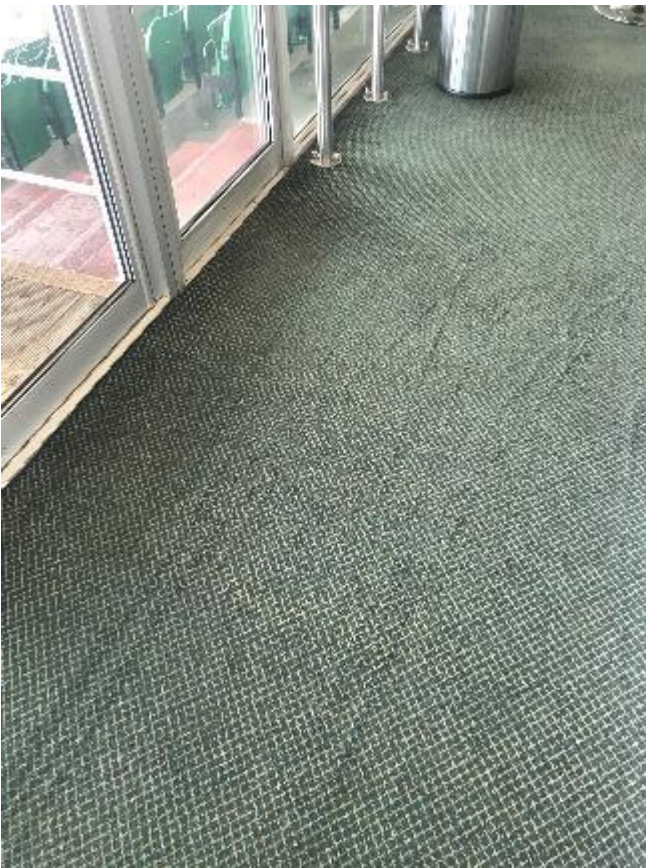
122. Close up of worn and tracked carpet.

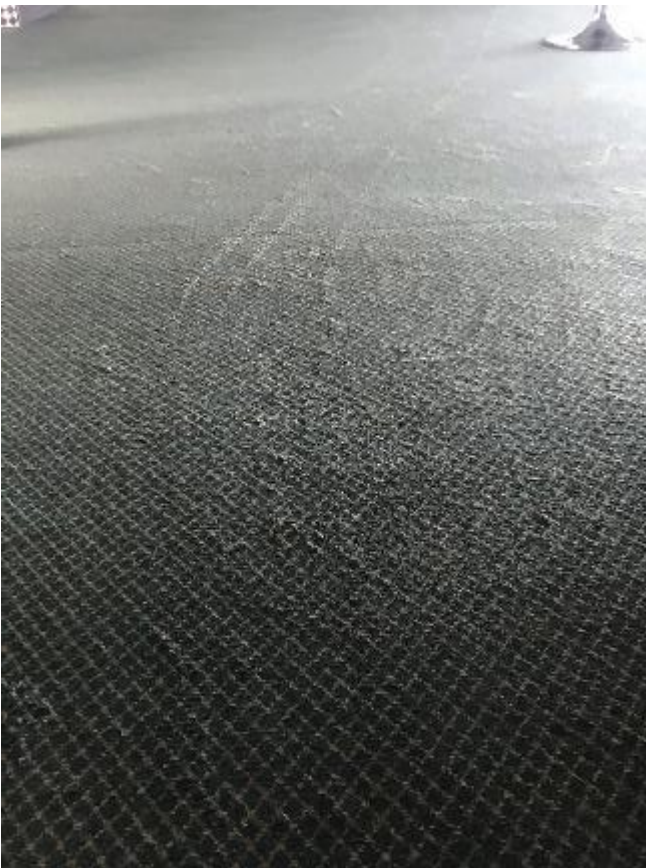
124. Close up of worn and tracked carpet.

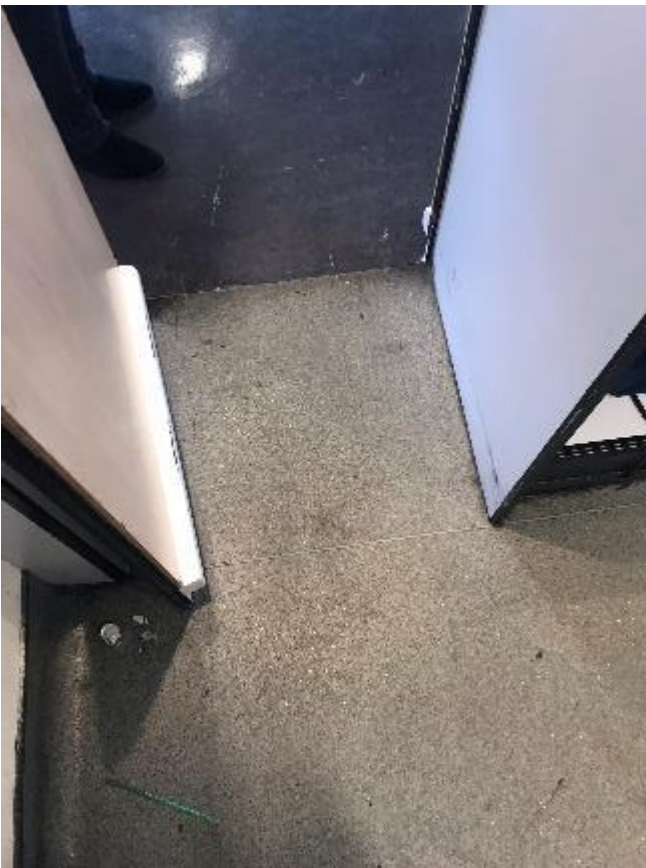
126. Close up of heavily soiled and worn vinyl floor finish to servery/bar area.
