BUILDING CONDITION REPORT 2020, INCLUDING M&E CONDITION SURVEY

Summary Building Condition Report for
Jockey Club Racecourses Limited

SANDOWN PARK RACECOURSE
PORTSMOUTH ROAD
ESHER
SURREY
KT10 9AJ

March 2020

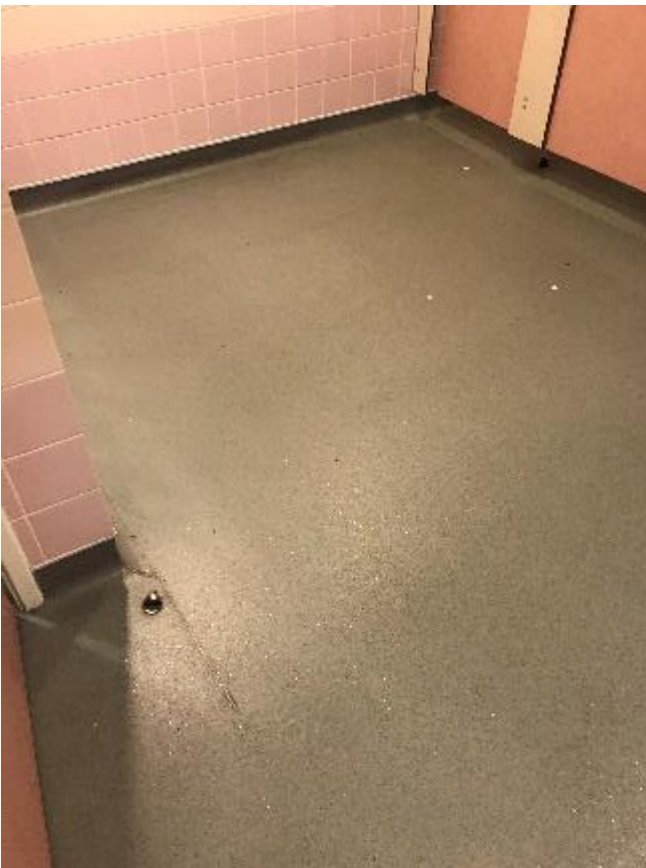
130. Worn and soiled vinyl floor covering in Ladies Toilets.

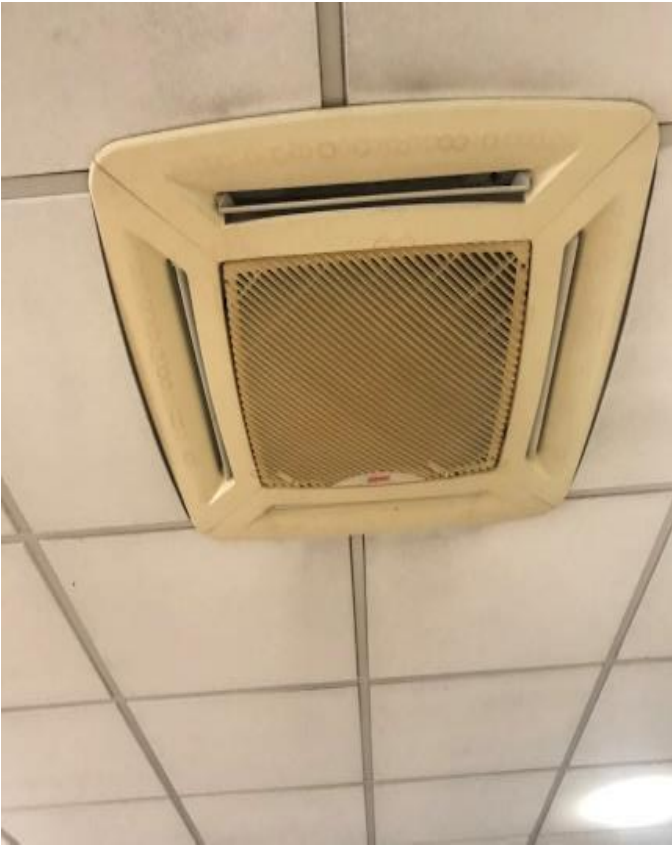
137. Close up of heavy soiling to ceiling in lobby area.

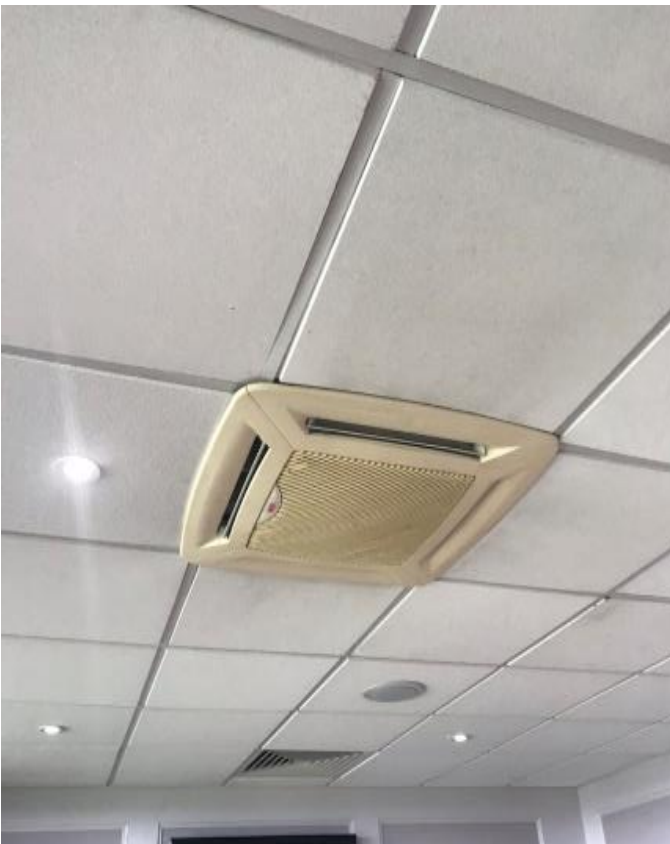
142. Typical staining to ceilings.

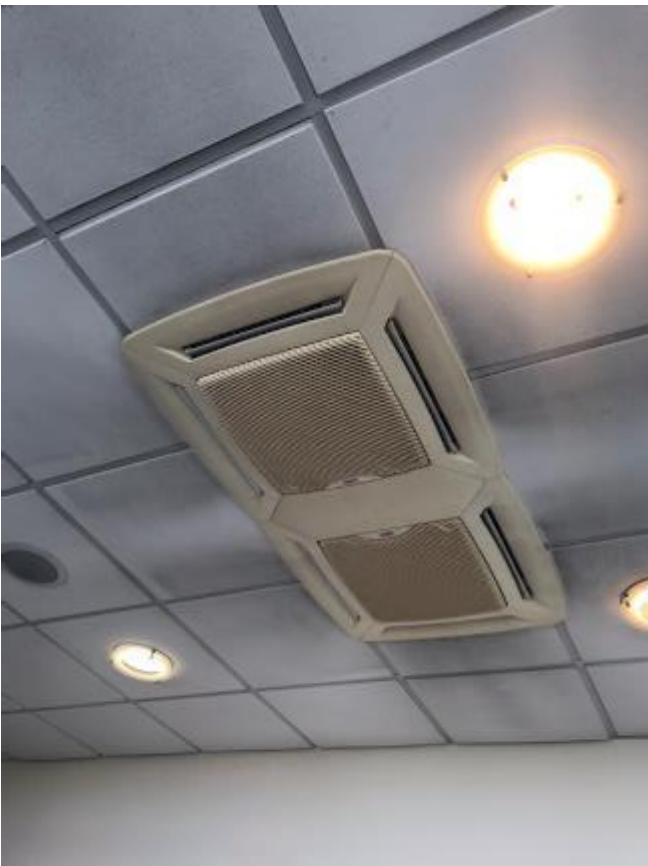
144. Typical staining to ceilings.

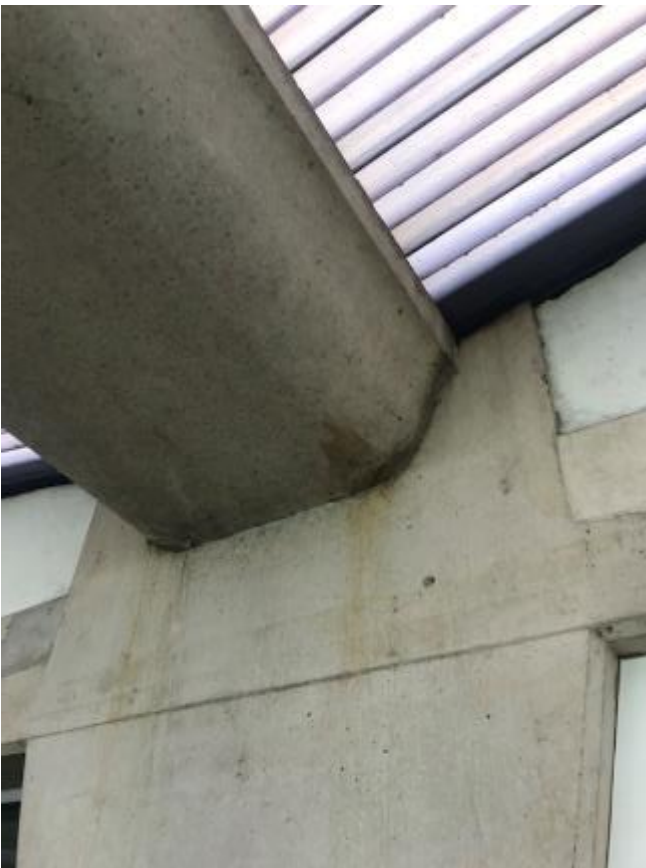
- 3.25 Leaks are apparent to the concrete gutters from the main roof canopy and do not generate the premium brand when viewed from the balconies of the second floor boxes.

146. Close up example of leaks from Grandstand gutter above balconies to Second Floor Boxes.

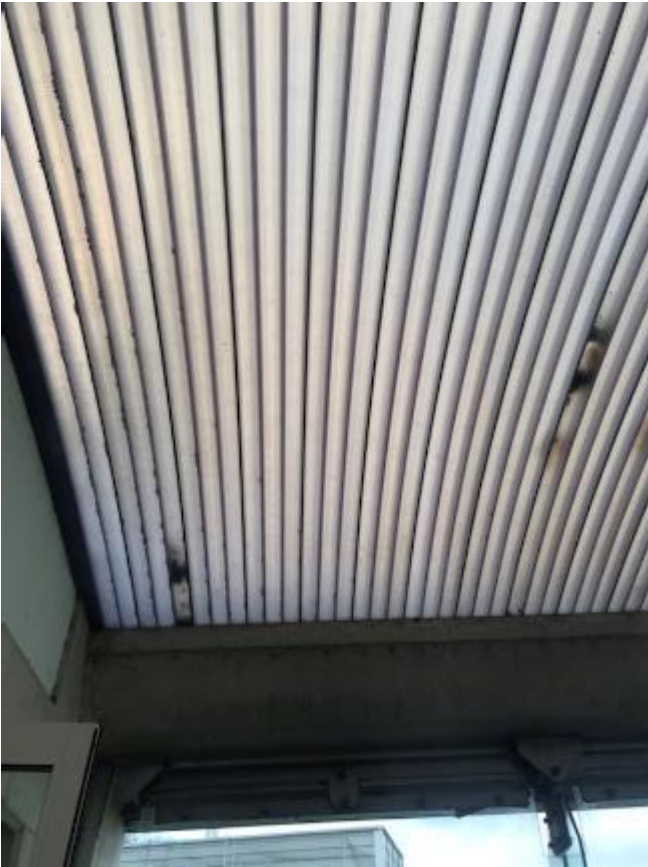
147. Close up of soiled and holed Grandstand barrel vaulted canopy over balconies to Second Floor Boxes.

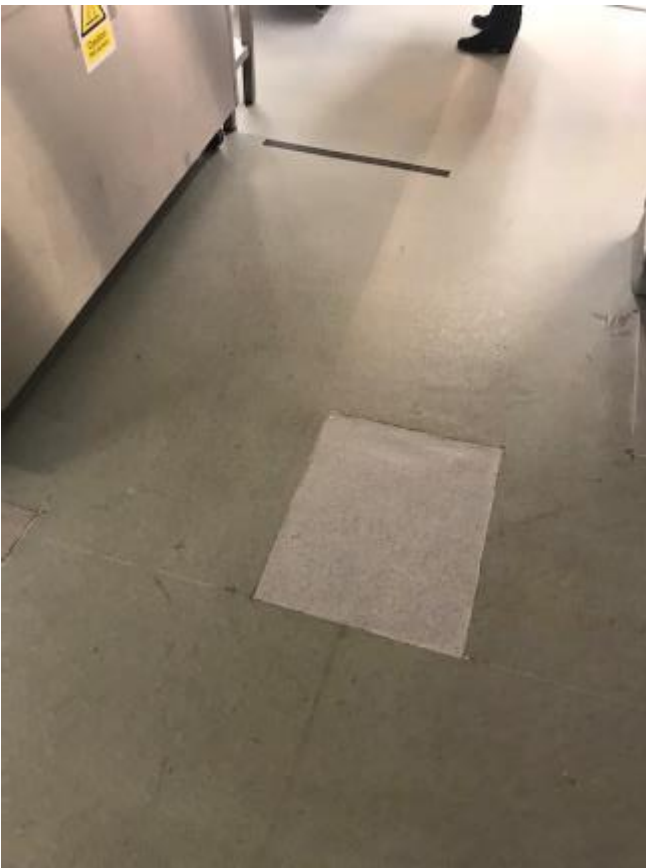
152. Example of soiled and patch repaired vinyl floor covering to second floor kitchen.

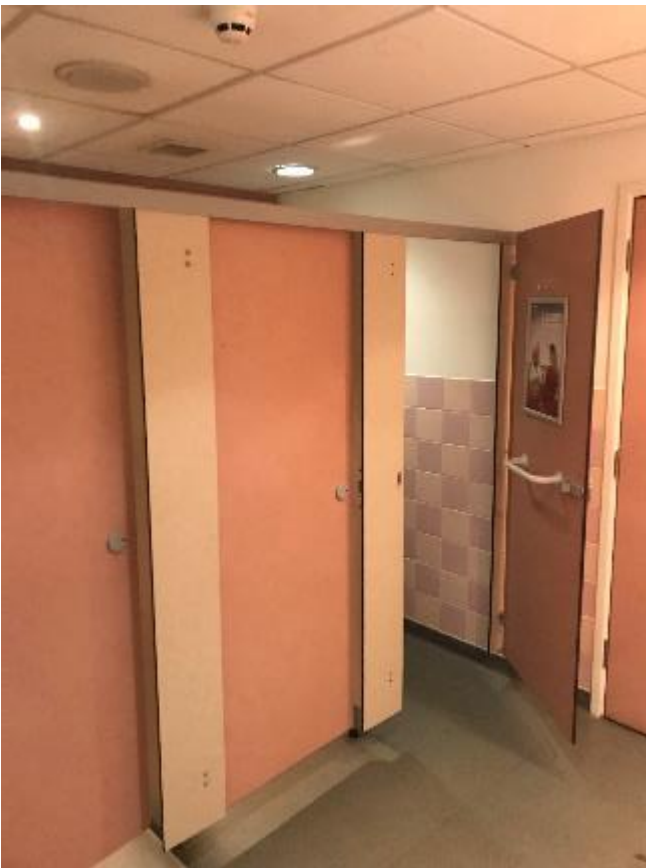
160. General view of second floor Ladies Toilets – dated by Customer Standards.

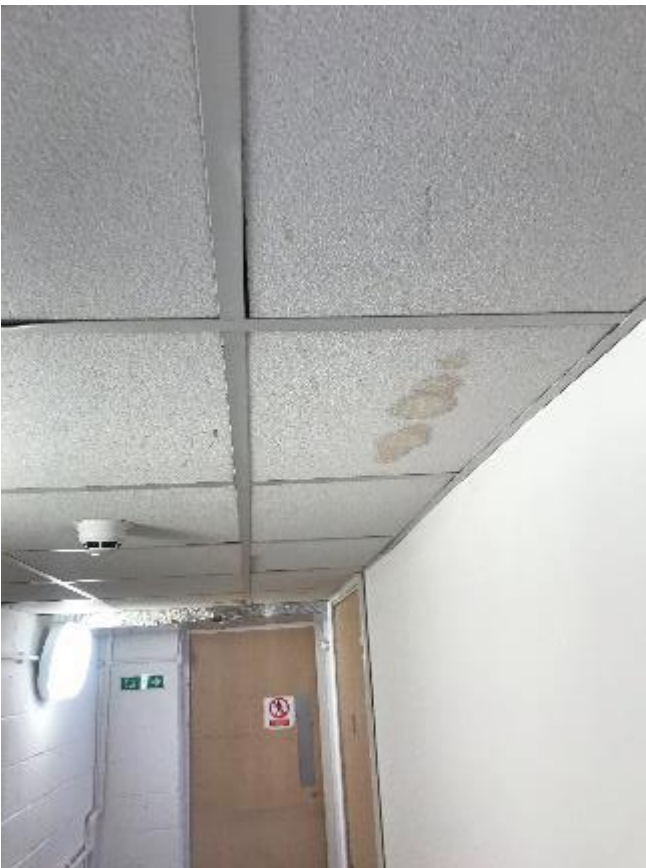
170. Example of stained ceiling tiles in second floor escape corridor.

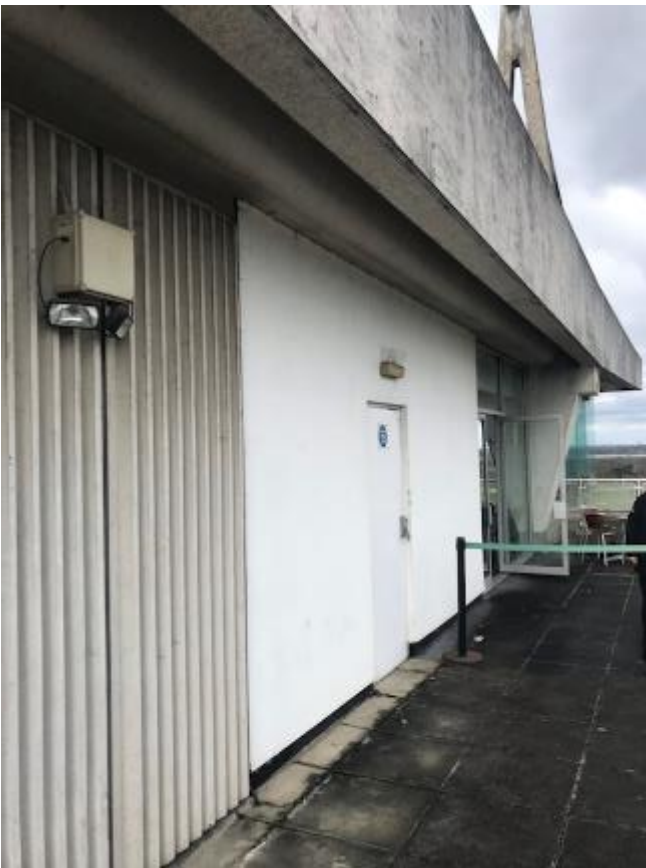
172. Leaks from roof/parapet onto second floor and terrace next to second floor boxes.

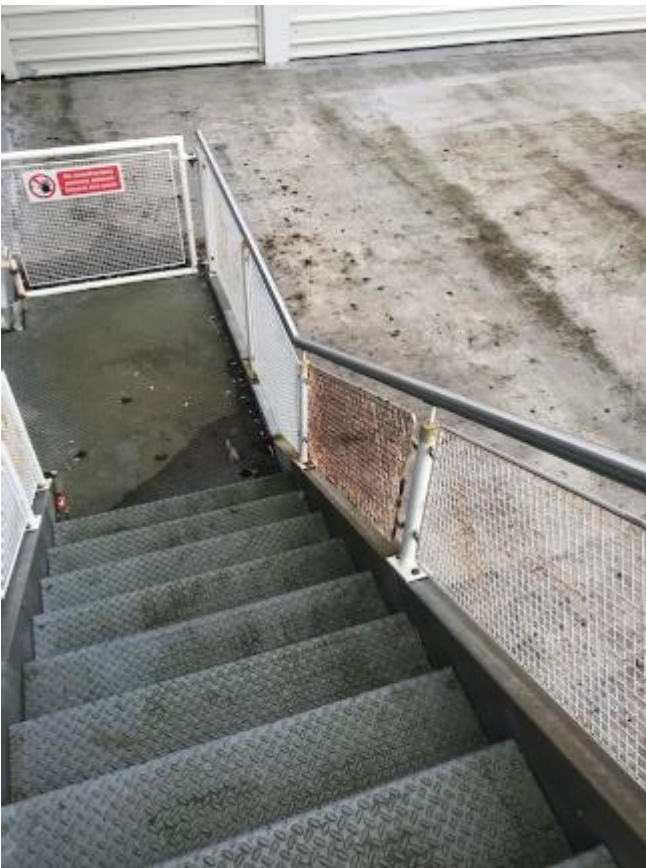
174. External escape stairwell from second floor terrace. Note: corrosion to balustrades.

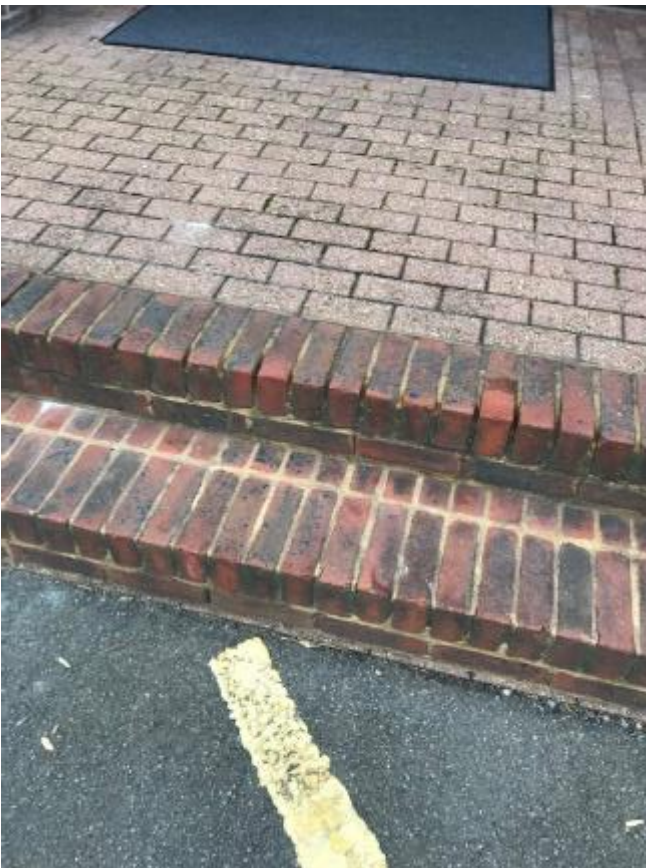
- 4.1** The external fabric to the Lodge is deteriorating. In particular, the paint finishes to the roof level fascias and soffits are peeling and appear unsightly
- 4.2** Brickwork to the entrance steps is spalling in part with some perished mortar joints
- 4.3** The bitumen macadam car park surface in the vicinity of the Lodge is breaking up and pot holed and does not provide a good first impression for the customer.
- 4.4** The metal fire escape staircase is also in need of redecoration.

184. Bricks to entrance steps are spalling in part with some perished mortar pointing.

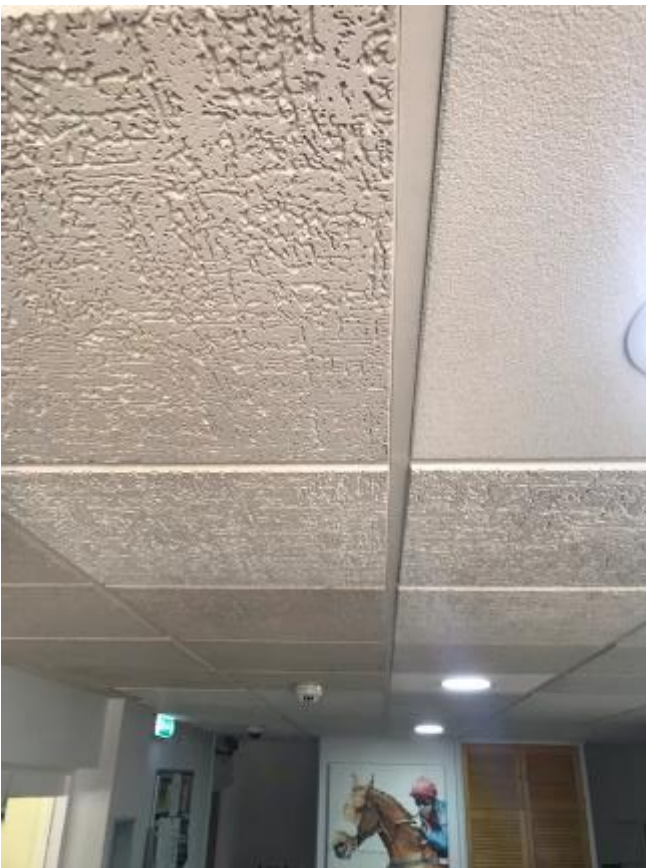
190. Close up example of non-matching ceiling tiles.

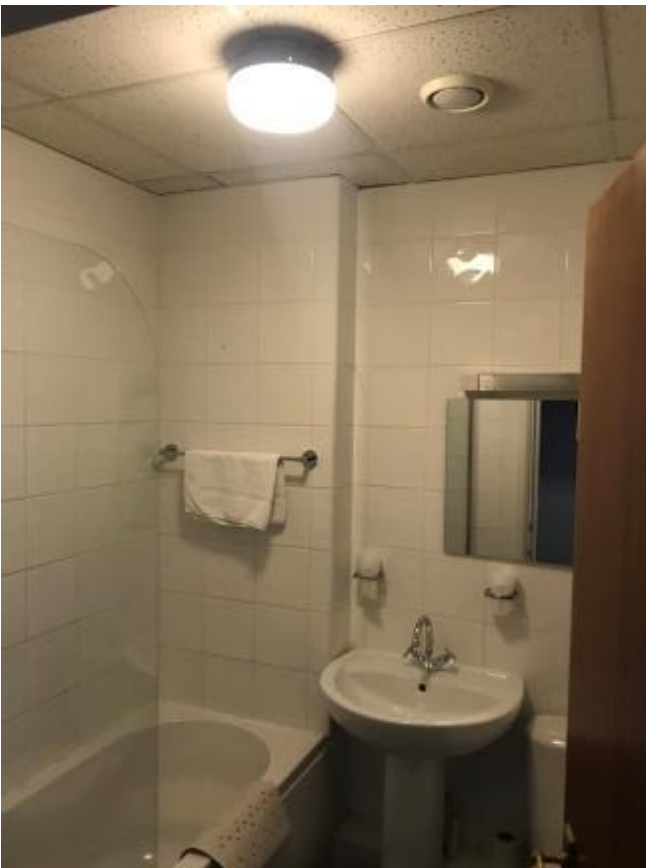
202. En-suite bathroom in need of modernisation by Customer Standards.

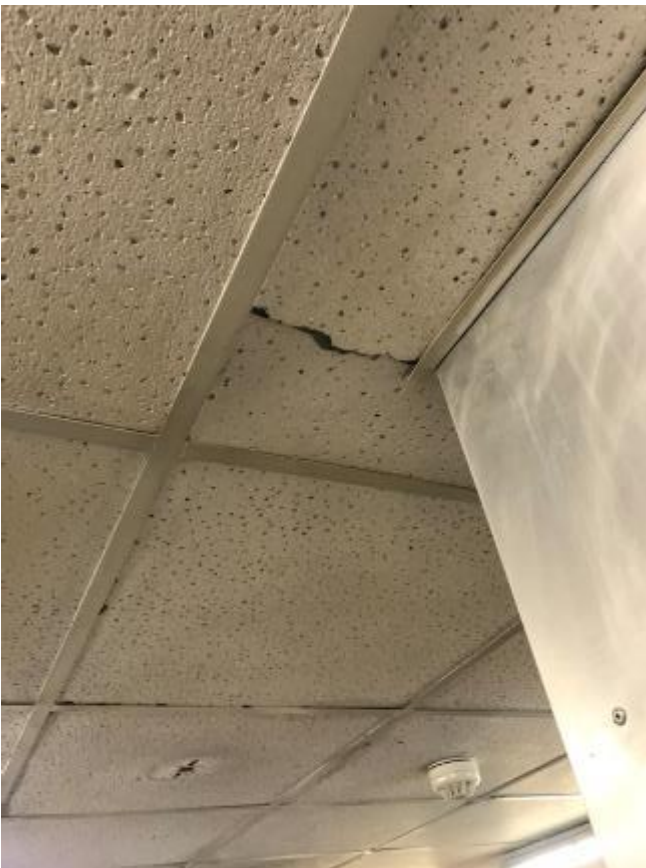
208. Close up of soiled and damaged ceiling tiles to kitchen.

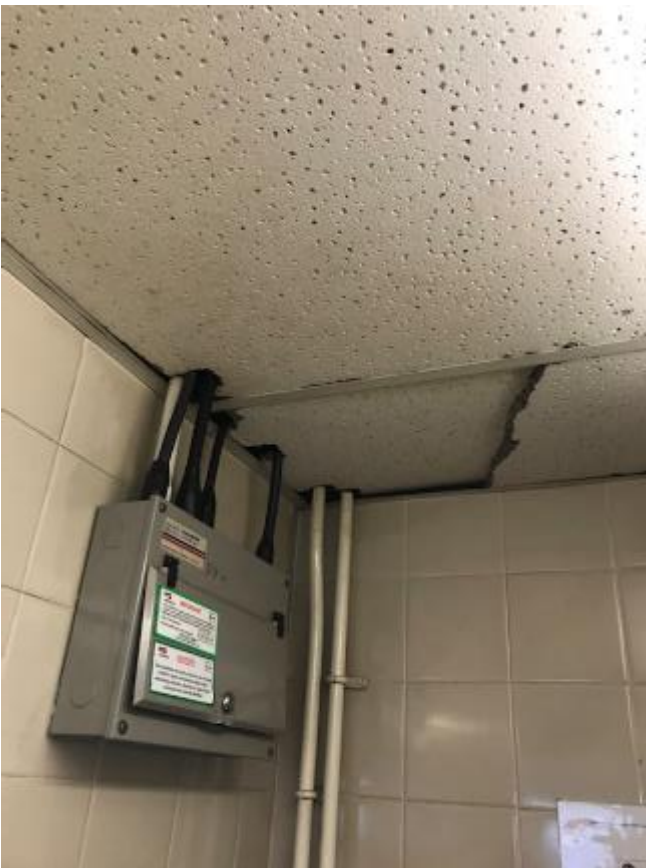
210. Close up of soiled and damaged ceiling tiles to kitchen.

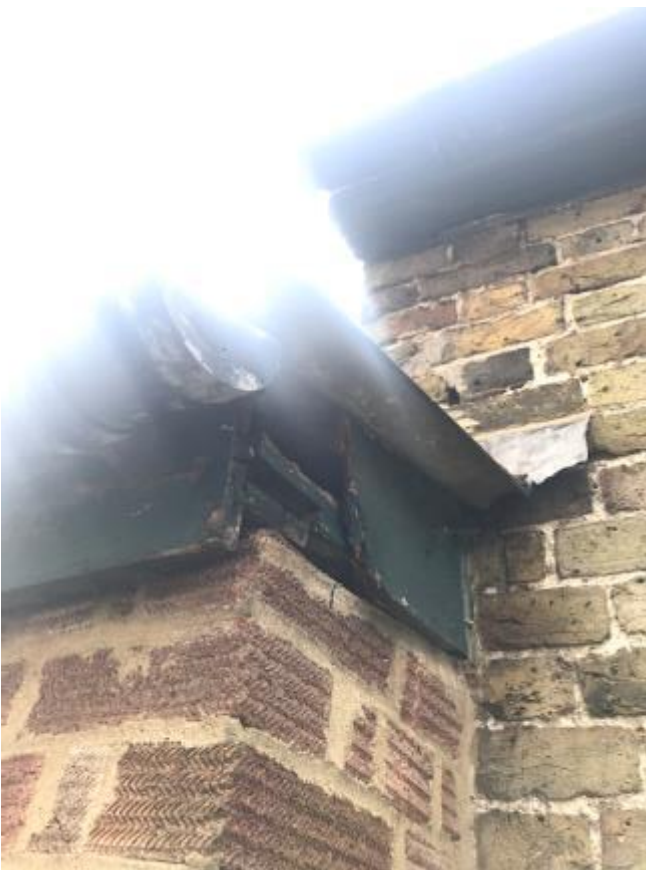
216. Barge boards and fascias are in poor decorative order with some wet rot/missing sections of timber.

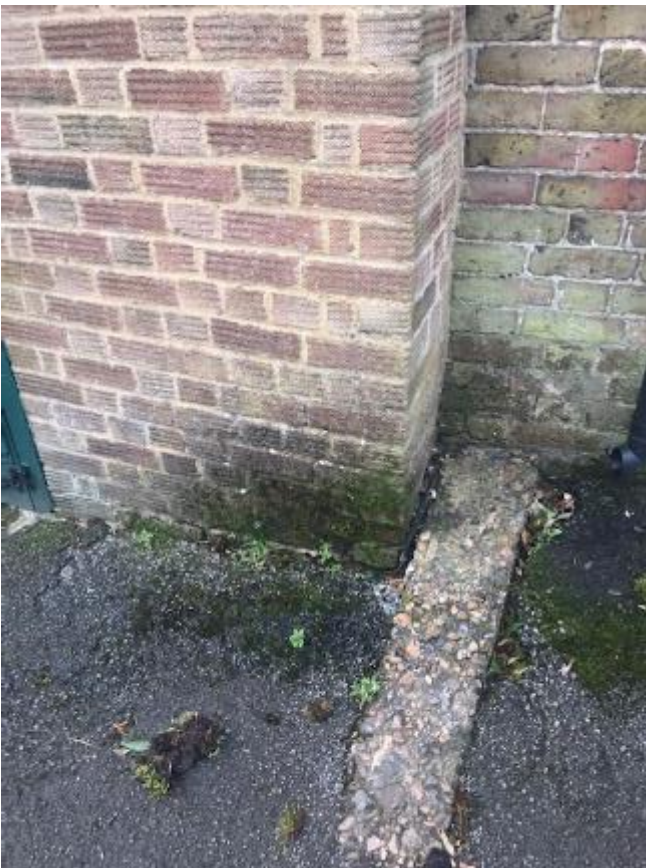
218. Defective rainwater goods are leaking and causing damp staining to the brickwork below.

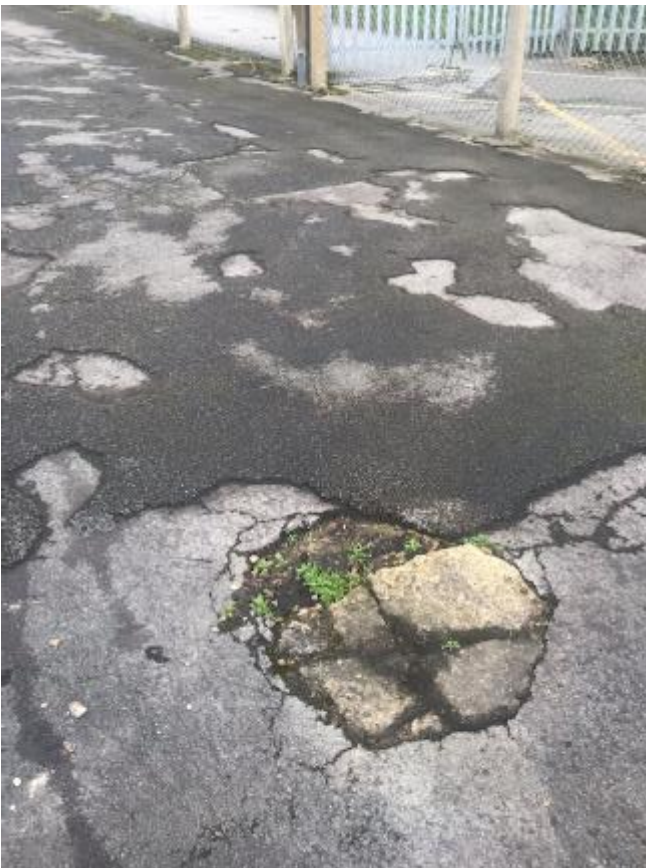
- 5.9 Whilst some patch repairs have been undertaken to bitumen macadam yard surfaces, large areas remain in poor condition and uneven with many potential trip hazards for stable personnel and horses.

222. The yard surface is breaking up alongside stable block 56 – 69 and a trip hazard for horses and personnel alike.

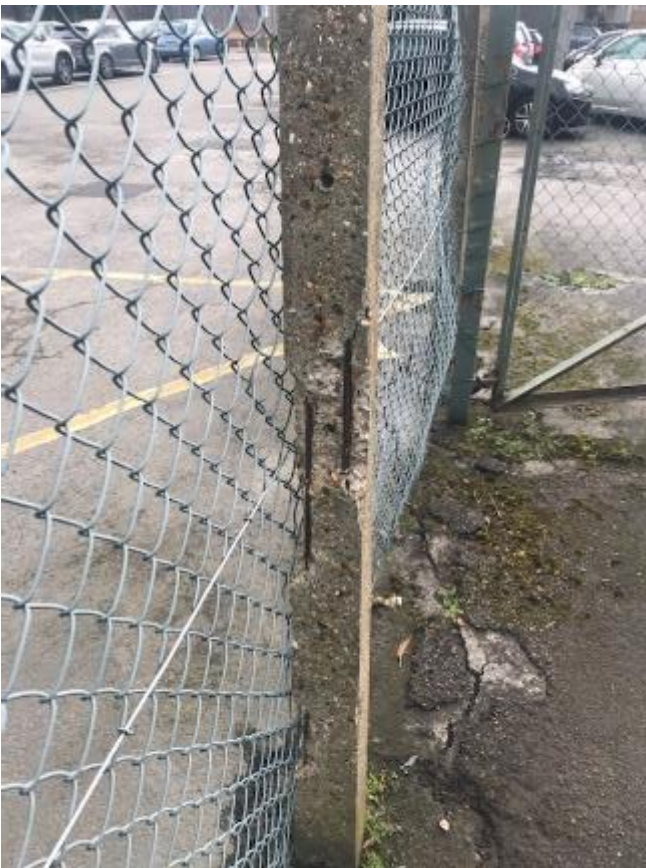
224. The perimeter concrete fence posts are spalling in part exposing the corroded reinforcement.

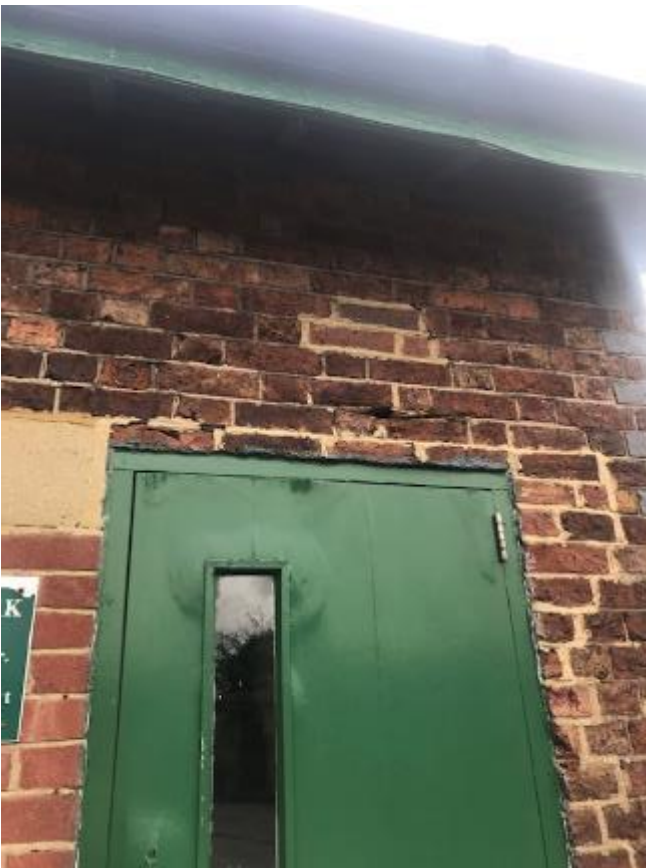
226. Patch repaired and cracked brickwork to Stable Managers Office.

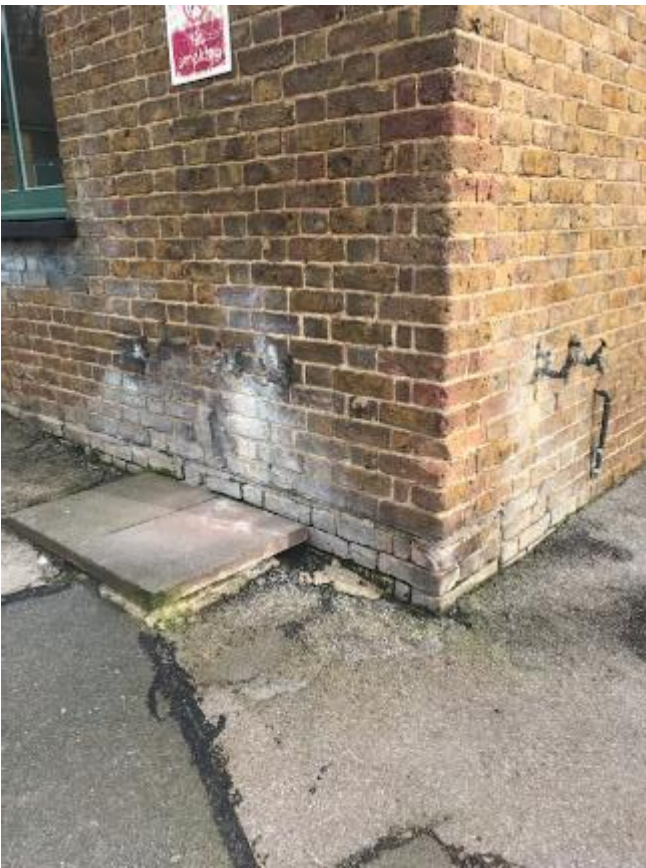
230. Decorations and brickwork to the gable elevation of stable 72 are in poor condition.

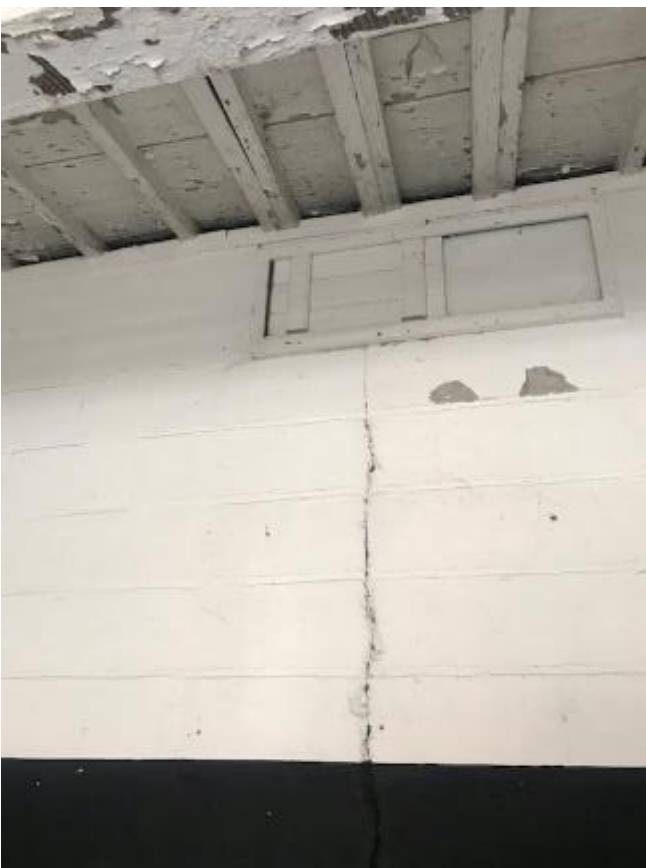
234. Leaking roof, rotten timber soffit and peeling decorations to stable 46.

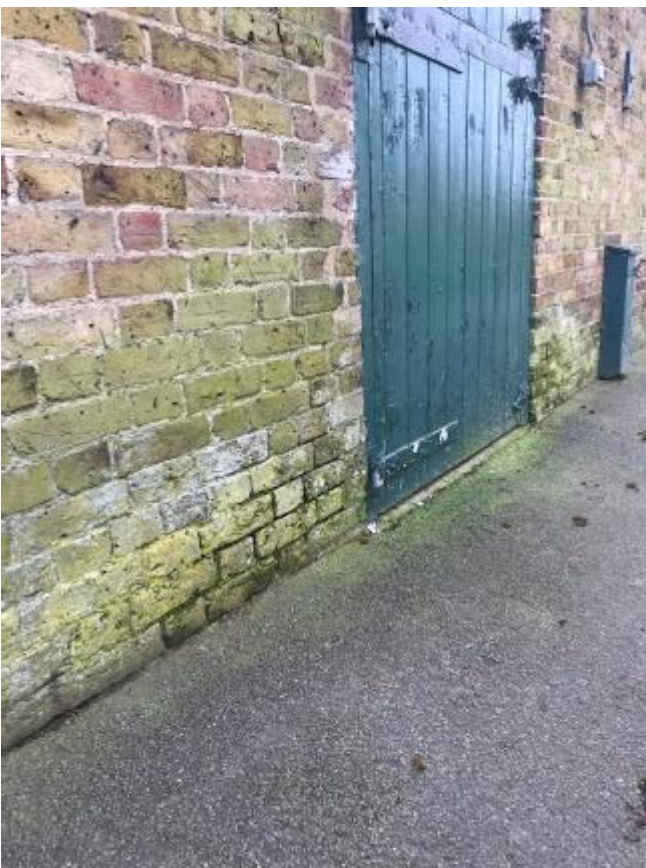
242. Close up of typical example of perished mortar to low level brickwork.

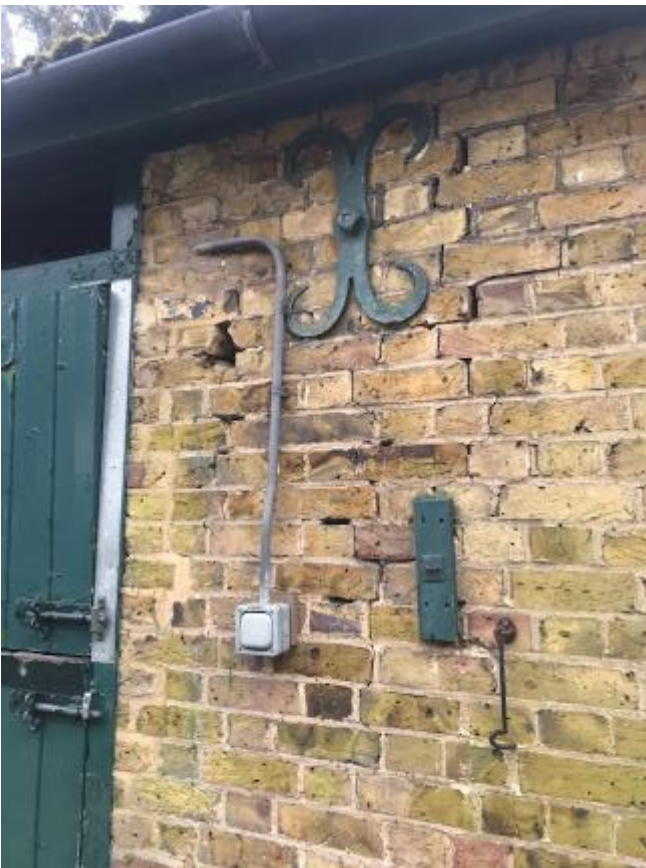
244. Cracked and damaged brickwork to front wall of stable 19.

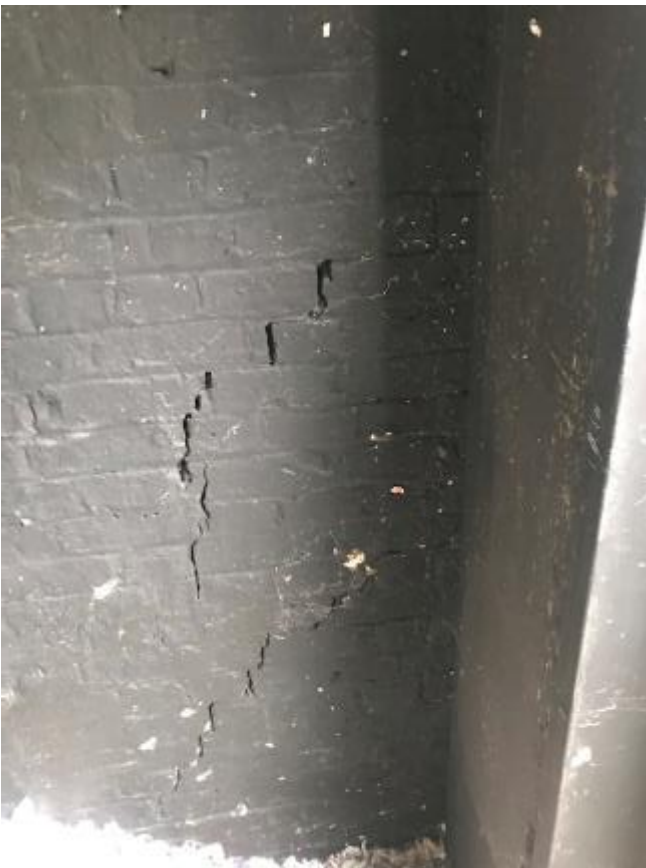
246. Cracked wall between stable 19 and stable 18.

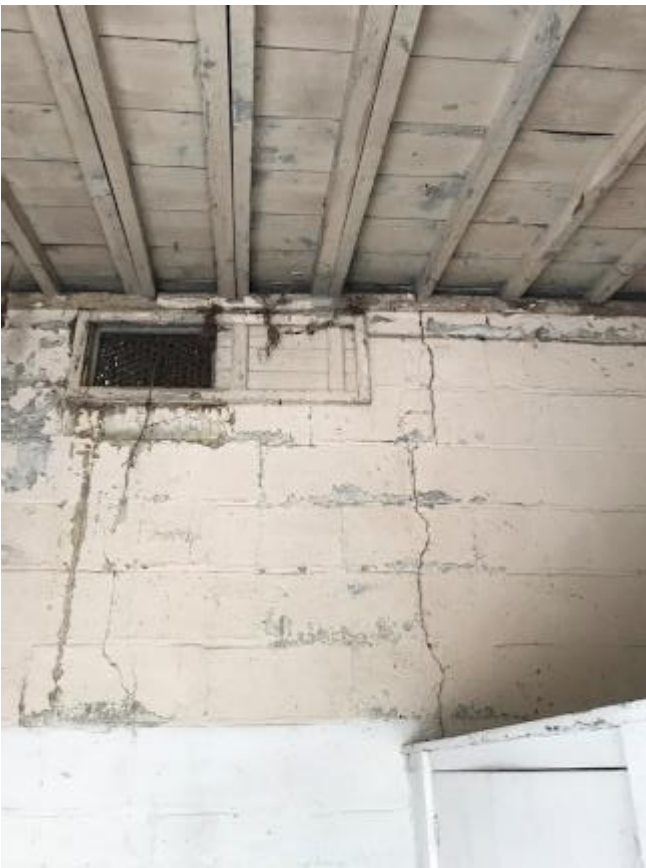
250. Cracked rear wall to Tack Boxes 1-6 together with peeling paintwork to timber soffit and blockwork wall.

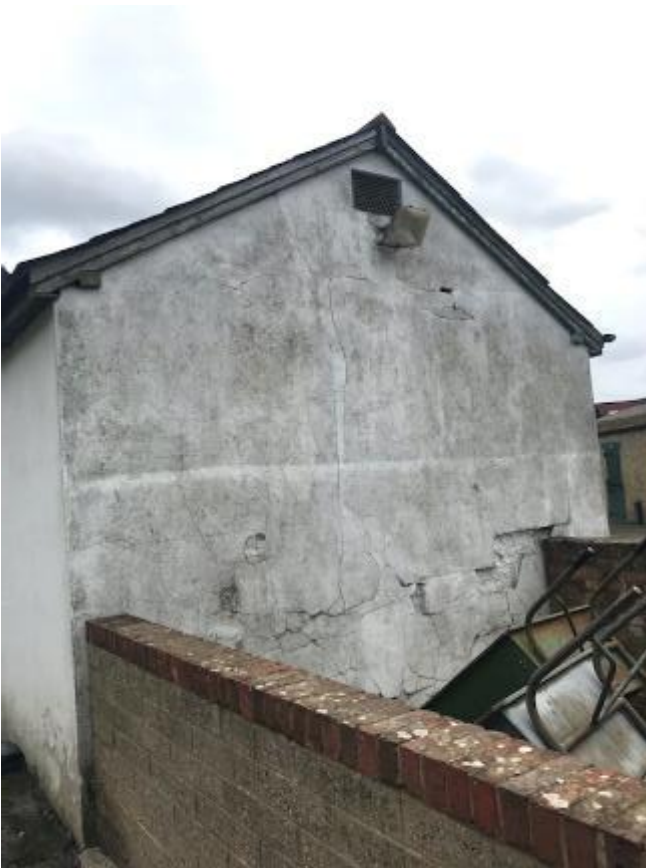
- 5.6 The rendered finish to the gable elevation of the Tack Boxes 7-12 is extensively cracked and blown.
- 5.7 External joinery is consistently in poor decorative order with some wet rot noted to fascias. Wet rot timber decay was also noted to the windows and doors to the gable elevation of Stable 72 and the Stable Stores to the far end of the Stables from the Stable Entrance.

260. Cracked and blown render to gable elevation of Tack Boxes 7-12.

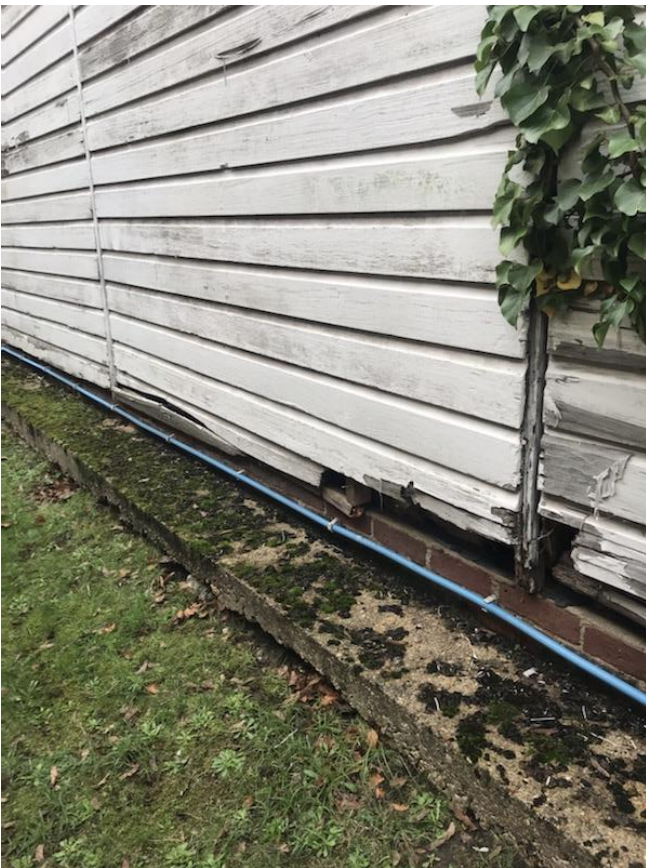
264. Rear elevation of saddling boxes in poor decorative order with some wet rot to the timber cladding.

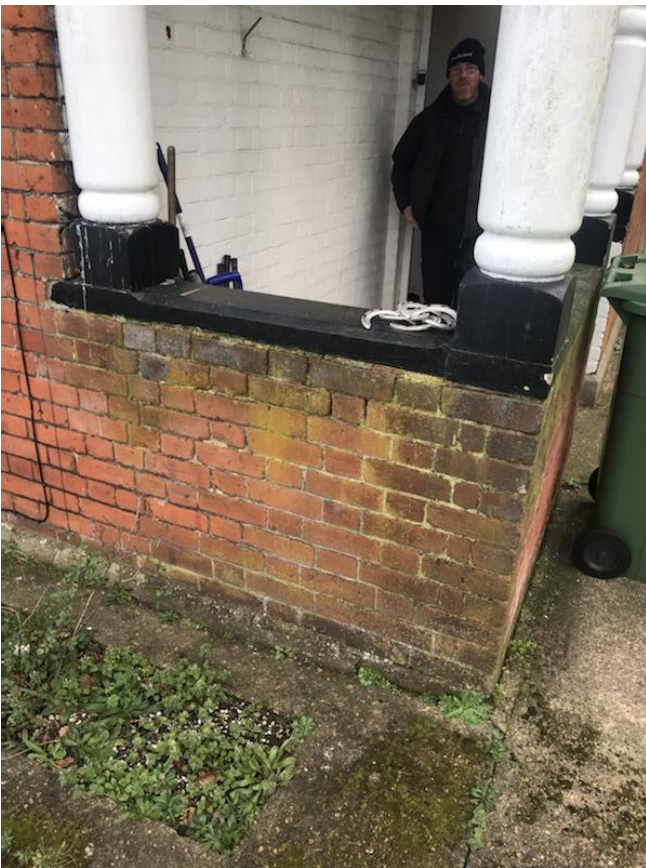
268. Damp stained and patch repointed external brickwork.

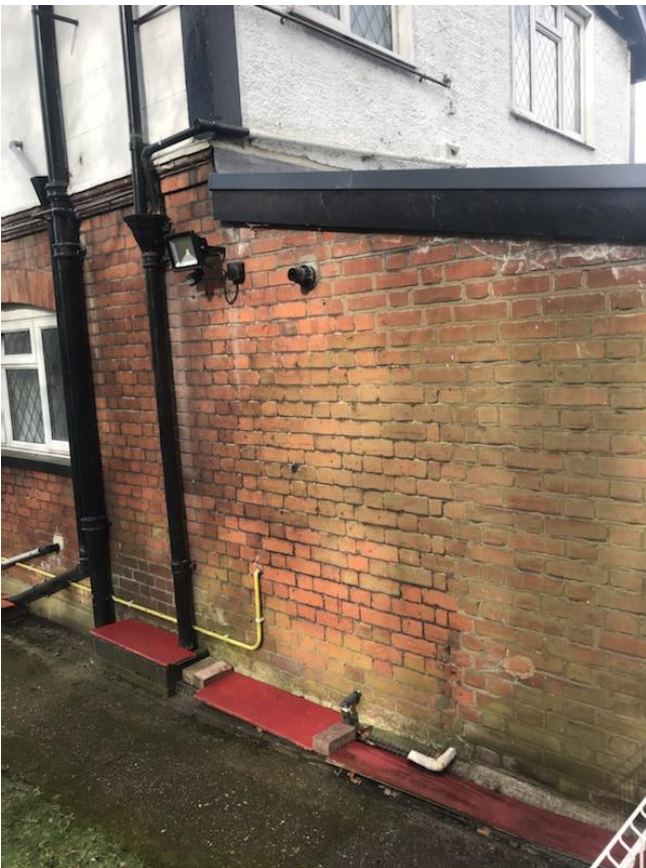
274. Damp stained and patch repaired brickwork to side elevation of lean-to extension.
