**LAND OFF PUMP LANE  
RAINHAM  
KENT  
ME8 7TJ**

**INQUIRY DOCUMENT: Mott Macdonald Road Safety Audit**

# **Pump Lane, Lower Rainham**

Road Safety Audit  
Stage 1

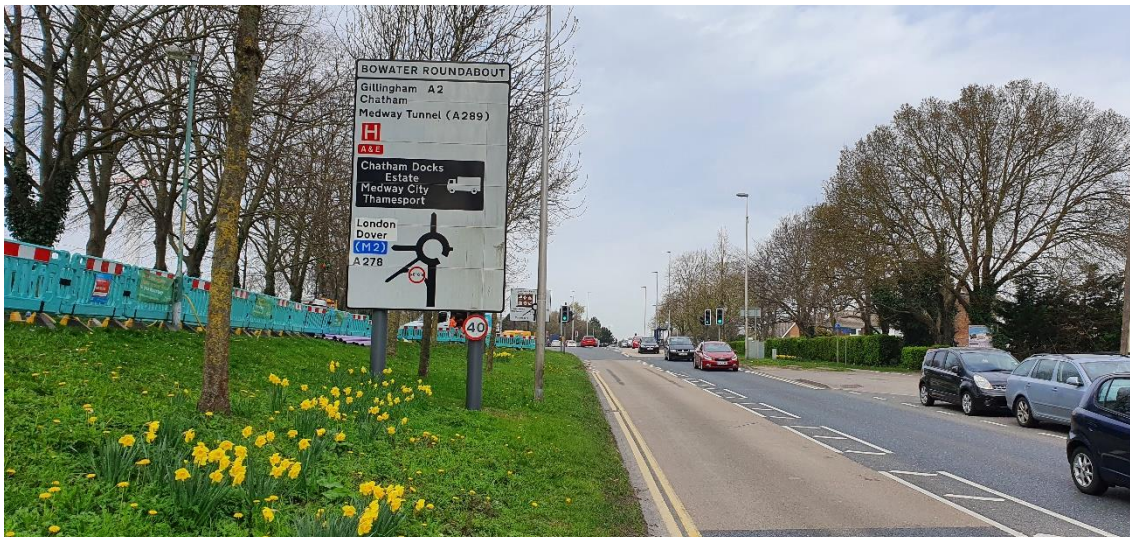
*Summary: Existing ADS may restrict forward visibility to nearside traffic signals.*

Two existing ADS are present on the north-westbound approach to the new crossing location. One of these will need to be relocated to accommodate the additional traffic lane, but it is unclear if the south-eastern most sign will be repositioned. The presence of these signs within the verge may restrict forward visibility to the nearside traffic signals increasing the risk of inappropriate approach speeds and possible crossing overshoot related collisions.

**Figure 1: Existing ADS in advance of proposed crossing point.**

It is recommended that both ADS are appropriately positioned so that they do not impede forward visibility to the nearside traffic signals whilst being suitably located to provide lane choice guidance for motorists approaching the roundabout.

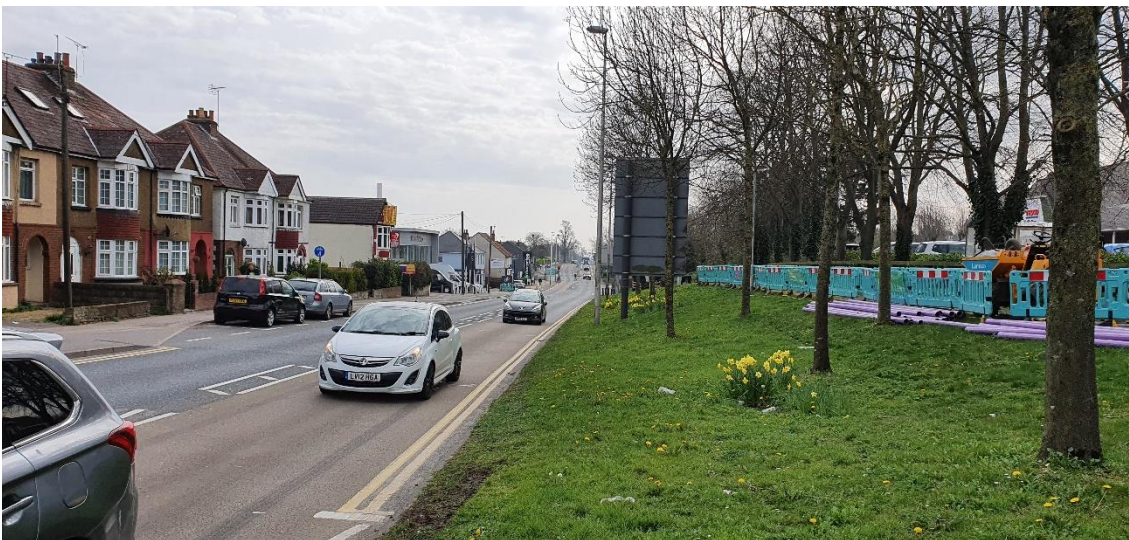
*Summary: Close proximity of vegetation and street furniture may lead to conflicts.*

The southern kerb of the A2 London Road is to be realigned to accommodate an additional lane of traffic in the north-westbound direction. A number of trees together with street lighting columns and other infrastructure are present within the verge. It is unclear what vegetation clearance and street furniture relocation is to be undertaken in association with the kerb realignment works.

The Audit Team is concerned that failure to remove vegetation and relocate street furniture to an appropriate offset from the realigned kerblines will create insufficient clearance from the edge of the carriageway, increasing the likelihood of items being struck by passing vehicles.

**Figure 2: Existing trees and street furniture.**

It is recommended that vegetation and street furniture items are offset a minimum of 450mm from the realigned kerblines.

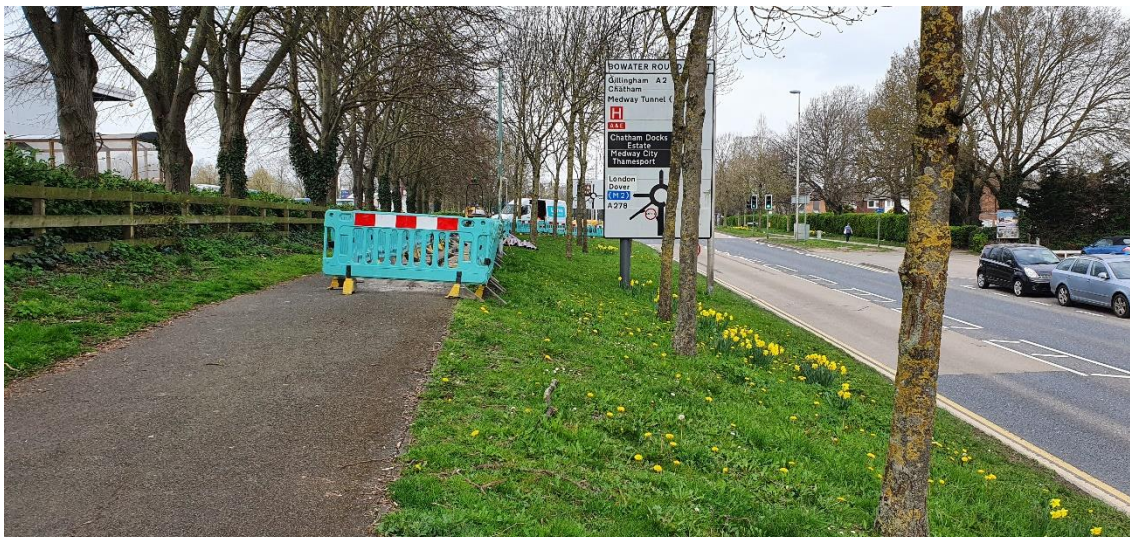
*Summary: Unclear construction method may result in inappropriate drop from footway / cycleway.*

An additional lane of traffic is to be provided in the north-westbound direction utilising the existing verge area on the southern side of the A2 London Road. A footway / cycleway runs parallel to the A2 at this location but at a notably higher level. The ground between the footway / cycleway and the new carriageway will require some form of retention or re-grading and it is unclear what construction method and new gradient will be used.

The Audit team are concerned that a steeper gradient or retaining structure may present a hazard to pedestrians or cyclists should they leave the paved surface and increase the risk of slips, trips and falls resulting in personal injury or increase the risk of falls into the carriageway.

**Figure 3: Existing traffic signals ahead sign at proposed access.**

It is recommended that a review of the gradient of the embankment provided between the widened carriageway and existing footway is undertaken with the view to introducing measures such as a level margin and suitably graded slope or, if this cannot be provided, segregation such as pedestrian guardrail to prevent falls into the carriageway.

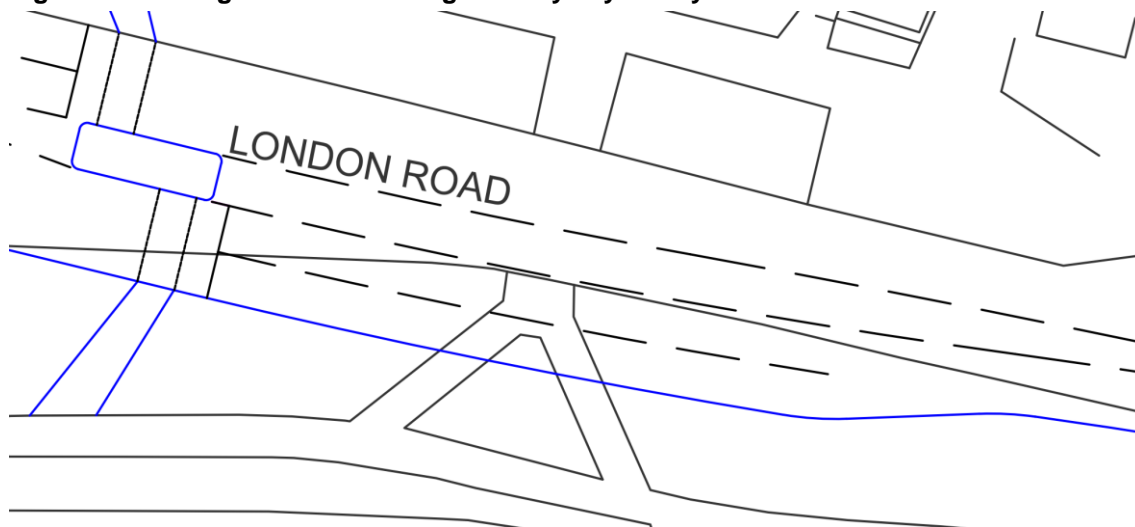
*Summary: Existing footway / cycleway associated with current crossing position should be removed.*

There is no indication if the existing footway / cycleway leading to the current crossing point are to be removed. Failure to remove the links may lead to pedestrians or cyclists attempting to cross at the existing crossing away from the relocated Toucan Crossing, increasing their vulnerability to being struck by passing vehicles.

**Figure 4: Existing Toucan Crossing footway / cycleways.**

It is recommended that the existing footway / cycleway links leading to the current Toucan Crossing are removed.

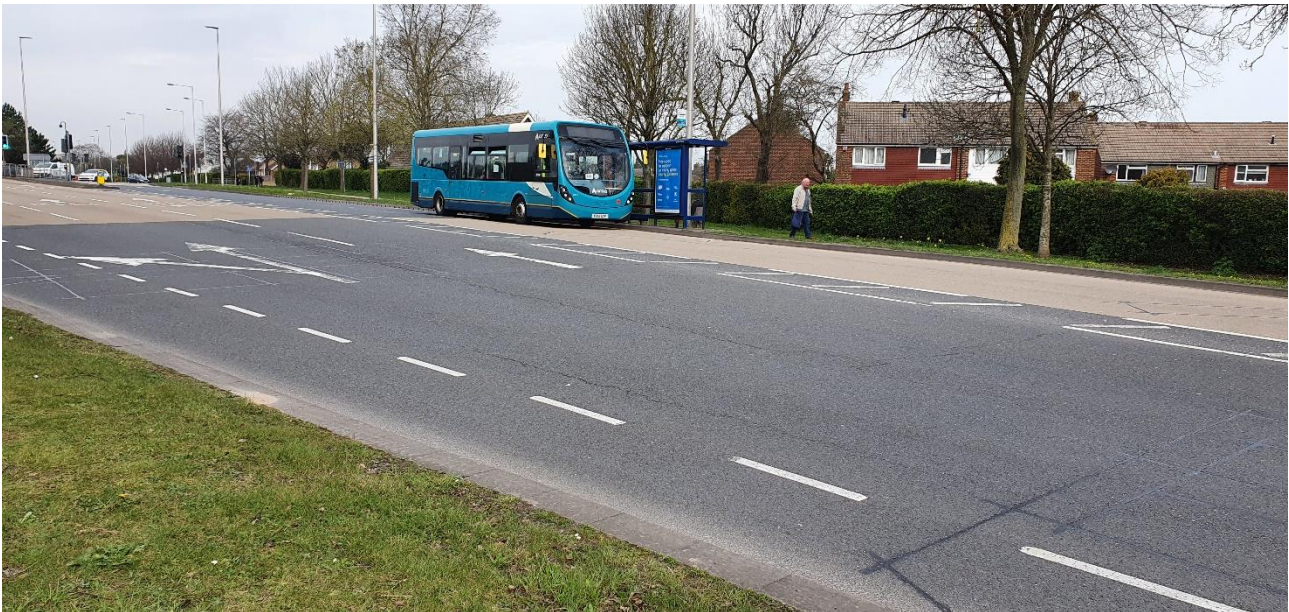
*Summary: Traffic signal loops associated with Bowater Roundabout located at proposed crossing position.*

Existing traffic signal carriageway loops for the Bowater Roundabout are located at the proposed position of the new Toucan Crossing. It is unclear if the loops will be relocated / modified and what impact this will have on the operation of the roundabout signals.

The presence of a Toucan Crossing at this location may have a detrimental impact on the operation of the existing signals increasing the risk of inappropriate traffic queues and, as a result, the risk of rear end shunt related collisions.

Furthermore, queuing back and across the crossing may increase the risk of pedestrians and cyclists crossing through stationary traffic without waiting for a green pedestrian signal. This increases the risk of collisions with traffic passing through the crossing which may not be anticipating the need to stop.

**Figure 5: Existing traffic signal loops at propose crossing location.**

It is recommended that the impact the proposed crossing location has on the Bowater Roundabout signals is assessed and the design modified if necessary.

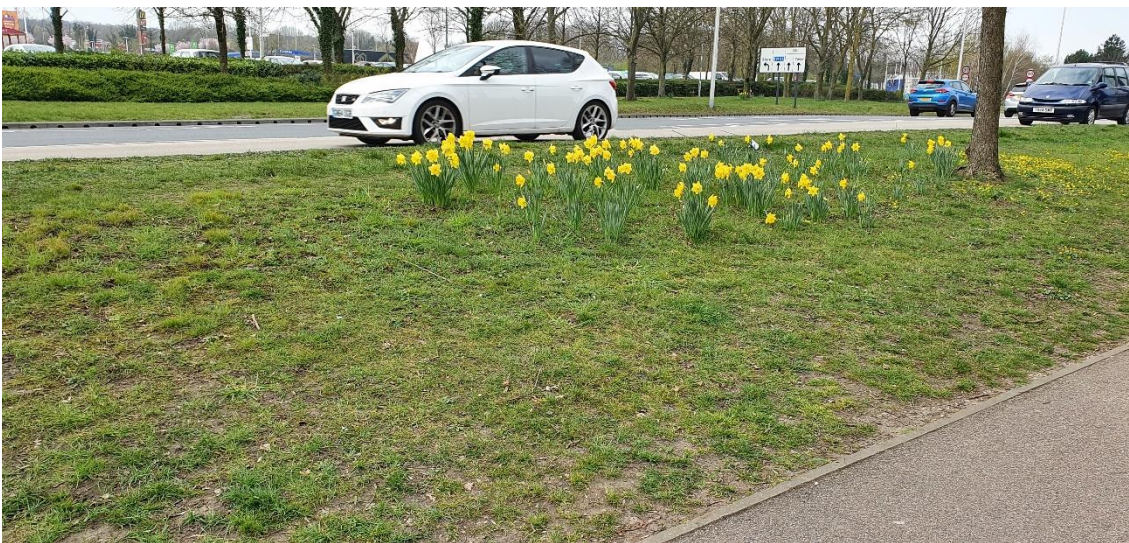
*Summary: Level difference between carriageway and adjacent footways / cycleways.*

On both sides of the A2 London Road the carriageway is notably lower / higher than the adjacent footways / cycleways. This requires 'ramps' leading from the footway / cycleways to the Toucan Crossing. It was noted that the gradient leading to the existing Toucan Crossing appeared inappropriate and a person using a mobility scooter was observed having difficulty crossing in a north-south direction. Failure to provide suitably graded approaches to the crossing point may hinder its safe use leading to collisions or trips / falls.

**Figure 6: Proposed location of Toucan Crossing.**

It is recommended that the gradient of the footway / cycleway links is no greater than 1 in 12 and that level landings are provided either side of the proposed crossing.

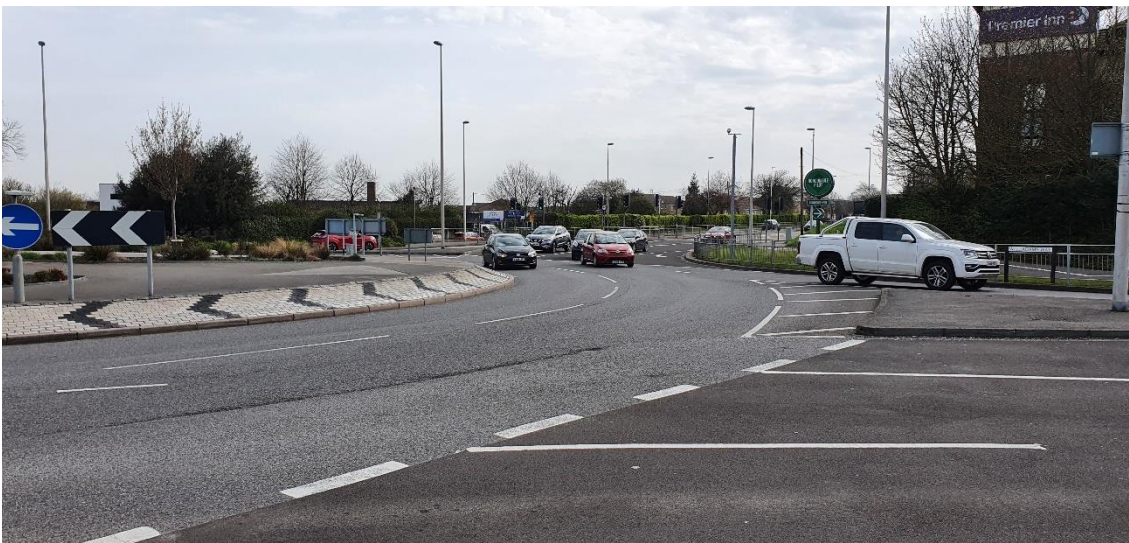
*Summary: Lack of 'confirmation' carriageway arrow markings may lead to collisions.*

Faded 'confirmation' carriageway arrows are present on all entries to the roundabout and on all sides of the circulatory carriageway except on the southern circulatory carriageway. The proposed modifications will result in an additional carriageway lane at this location and the lack of 'confirmation' arrows may lead to driver hesitation or late lane changes increasing the risk of collisions.

**Figure 7: Lack of confirmation arrows on southern circulatory carriageway.**

It is recommended that 'confirmation' carriageway markings are provided on the southern circulatory carriageway. It would also be beneficial to refresh all existing markings.

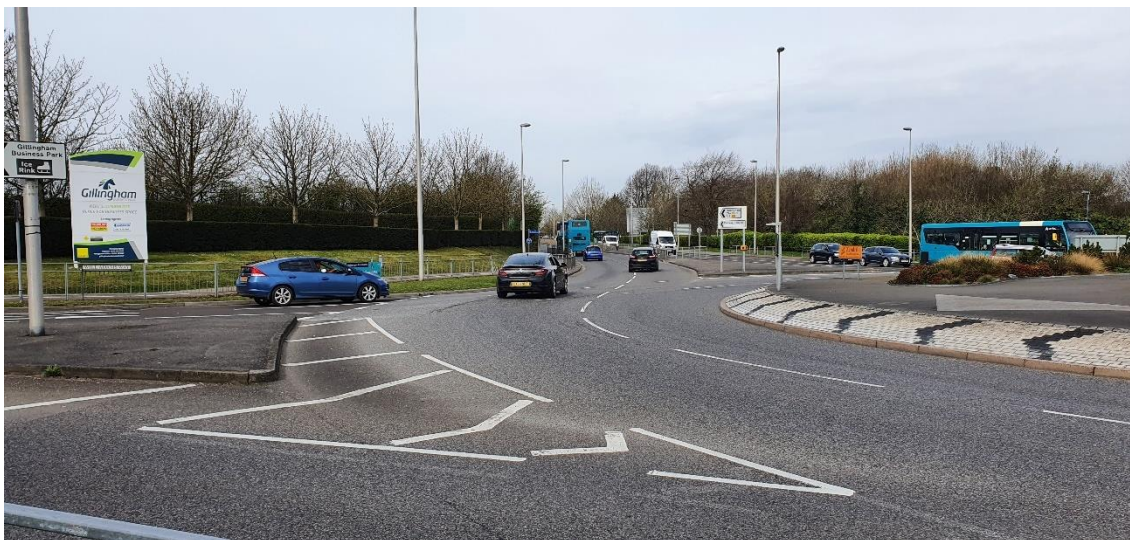
*Summary: Proposed lane arrangement on widened circulatory carriageway may result in inappropriate swept path movements at the roundabout.*

Three carriageway lanes are to be provided on a widened southern circulatory carriageway with two ahead lanes for the A2 and a right turn lane to continue around the roundabout. To accommodate the additional lane, the splitter island on the southern arm of the roundabout is to be modified but no other kerb realignment is proposed.

The Audit Team is concerned that the provision of an additional lane and the horizontal alignment of the southern circulatory carriageway is such that large vehicles continuing onto the westbound A2 may straddle two lanes of traffic increasing the risk of side swipe type collisions.

Furthermore, the audit team are concerned that vehicles in lane 1 of the widened roundabout circulatory carriageway may not anticipate the changes in direction required when navigating the roundabout to make the ahead movement. The audit team are concerned that, if travelling at higher than assessed speeds, there is an increased risk of vehicles colliding with the kerb or the verge / street furniture.

**Figure 8: Southern circulatory carriageway of roundabout.**

It is recommended that swept path analysis is undertaken for this junction to demonstrate that the proposed arrangements can accommodate anticipated vehicle types. If this is not possible, the geometry of the southern side of the roundabout should be modified accordingly.

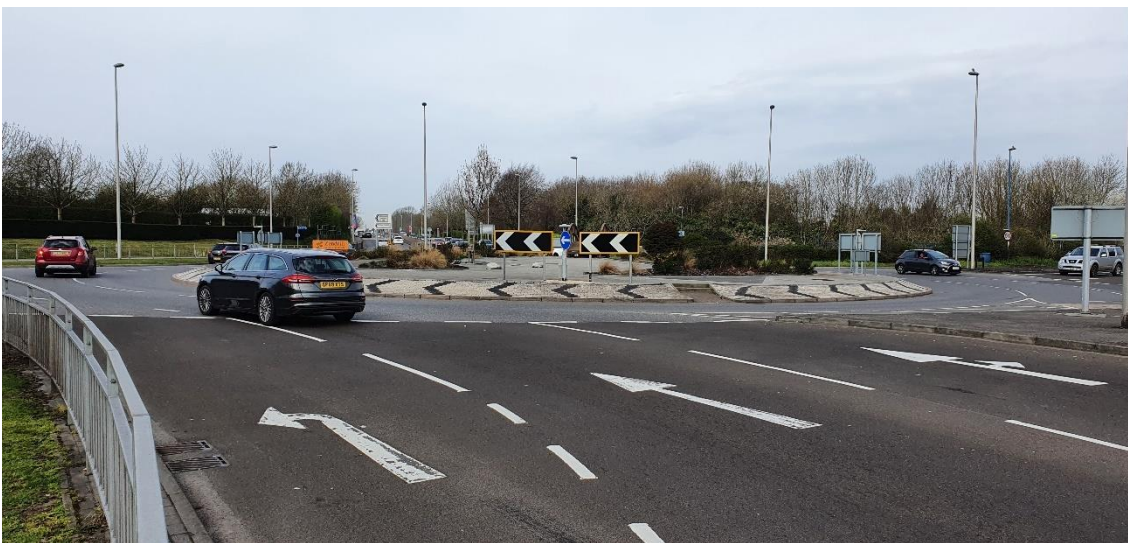
*Summary: Existing carriageway arrow markings require amendment.*

Three lanes of traffic are present on the A2 London Road westbound entry to the roundabout; these are designated as Lane 1 - 'Left turn only', Lane 2 - 'Ahead only', and Lane 3 - 'Ahead and right'. The proposed modifications to the roundabout will result in the lanes becoming Lane 1 - 'Ahead and Left', Lane 2 - 'Ahead only', and Lane 3 - 'Right turn only'. The design drawings do not indicate that these markings will be modified; failure to do so will result in incorrect lane choice and driver confusion increasing the risk of collisions.

**Figure 9: Existing carriageway arrow markings on westbound entry to roundabout.**

It is recommended that the carriageway arrow markings on the A2 London Road Westbound entry are appropriately modified to provide consistency with the other proposed changes.
