Appendix 10 – Physical Condition Survey

PHYSICAL CONDITION SURVEY

OLDFIELD HOUSE
JOHN LYON SCHOOL
 MIDDLE ROAD, HARROW-ON-THE-HILL
 HA2 0HN

The overall grade for this block has been considered to be: **Grade D; Bad. Life expired and/or at serious risk of imminent failure.**

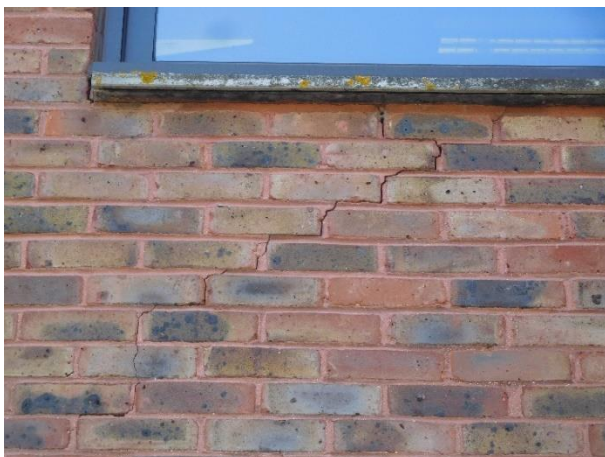
The building is clad with cavity brickwork and while the majority of the brickwork is considered to be in reasonable condition there are at least 3 No diagonal cracks along the Front Elevation located below the windows at First Floor level. The cracks get progressively wider from left to right with the widest crack approximately 2-4mm in width. The cracking is known to site staff and while a date of its first appearance is unknown it could be related to the recent extremes of weather experienced during the last winter and the present summer. It is also of note that the building is situated within the zone of influence of a willow tree that is located off the North corner of the building however it is beyond the scope of this survey to associate any direct link between the tree and the cracking. It is therefore recommended that a full structural survey be undertaken to determine the cause of the cracking and identify possible remedial works moving forward.

Photo showing the largest crack, located to the RHS of the Front Elevation.

01 - Masonry	D	£1,500	0	1				2018	Brickwork (cavity): Diagonal cracking noted to 3No. locations at First Floor level to Front Elevation. While cracking is all below 5mm in width it could be on-going with it recommended a structural survey be carried out.	Cost allows for structural survey to be carried out. Please note that possible remedial works could vary significantly in cost. Please see 'Summary of Works' section for further details.

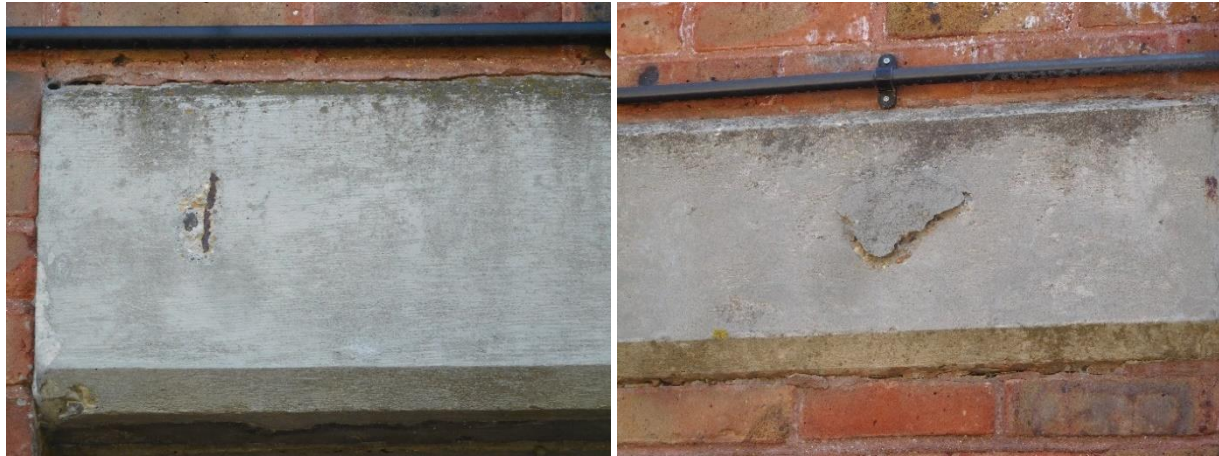
The reinforced concrete floor slab is exposed at First Floor level, with staining and delamination visible to localised areas on all elevations as a likely result of water ingress, a cost to inspect the slab with a contingency for repairs has been included.

Photos show a delaminated section of the slab with the rusted re-bar clearly visible and a section of the slab that is in the process of delaminating with a section of concrete about to fall away.

01 - Masonry	D	£5,000	0	1				2018	Exposed concrete floor slab: Minor delamination and rust staining from re-bars visible to localised areas on all elevations.	Cost allows to carry out specialist repairs as required.

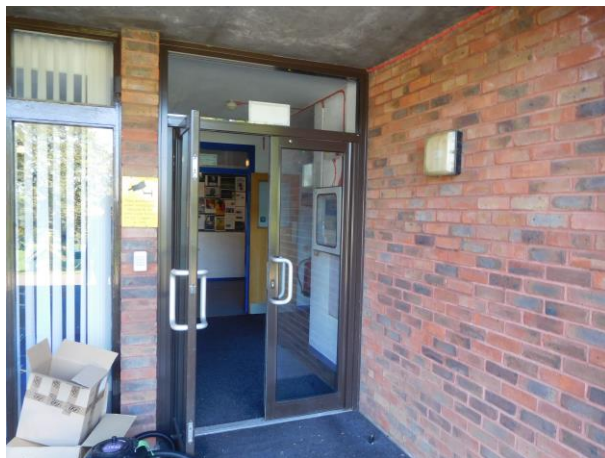
The block is accessed by a single set of aluminium double doors and as a result are subject to a heavy workload with signs of general wear visible, as a result their complete replacement is likely to be required within the maintenance period. Minor repair works are also required to the steel plant room doors that are showing signs of weathering and general deterioration.

Photo shows the set of double aluminium doors that operate as the main (and only) entrance and exit into the building.

B(C)	£2,000	5	4				2023	Main Entrance - Aluminium doors: Are showing minor signs of deterioration with lifecycle replacement likely to be required within the maintenance schedule.	Cost allows for replacement.
B2 - Building - External Fabric

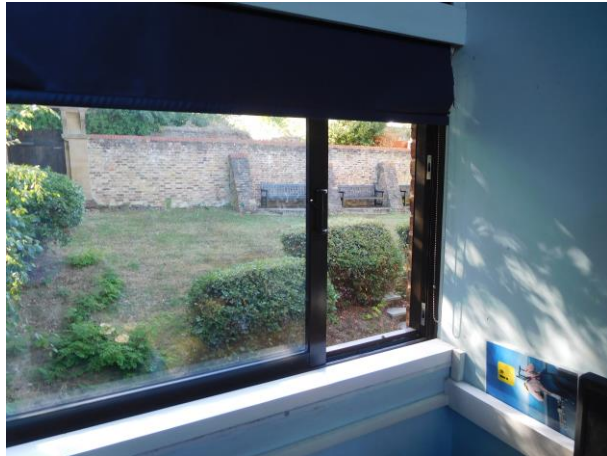
The windows to the block are predominately of aluminium double-glazed construction with a sliding mechanism, the windows are original and showing signs of deterioration as a result with it also noted that timber blocks have been retro fitted to prevent the windows opening fully to reduce the risk of fall. It is therefore recommended that the windows are replaced with modern units to current standards.

Photo shows one of the original sliding aluminium double glazed windows in its fully open position.

01 - Windows	C	£38,250	0	1			2018	Aluminium double glazed horizontally sliding windows: Are original and unsuitable with timber blocks having been retro fitted to prevent windows opening beyond a safe width.	Cost allows to replace windows to current standards.
	01 - Windows	B	£0	10	0			2028	PVCU double glazed windows: In reasonable condition.	No works likely to be required.

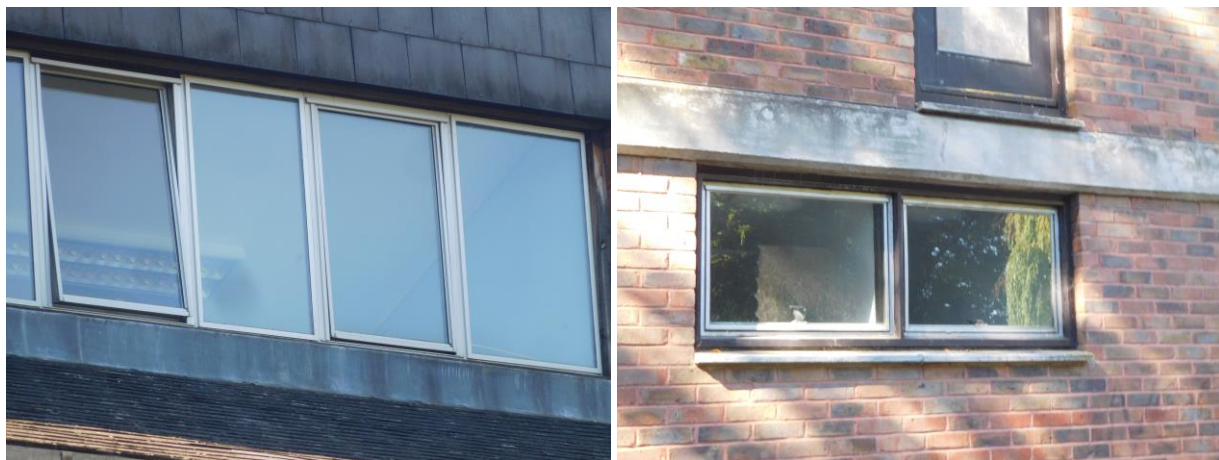
In addition, the block also has a set of high level aluminium single glazed North lights and a number of softwood timber framed windows with aluminium single glazed inserts, these are all original and are considered to be in deteriorating condition along with offering poor thermal performance.

Photos show a section of the North lights to the roof and two of the timber framed windows with aluminium inserts.

C	£17,000	0	2				2018	North Lights - Aluminium single glazed windows: Are original and considered to be beyond their expected life, along with being thermally inefficient.	Cost allows to replace windows to current standards.

C	£6,750	0	2				2018	Softwood timber single glazed windows with aluminium inserts: Are original and considered to be beyond their expected life, along with being thermally inefficient.	Cost allows to replace windows to current standards.

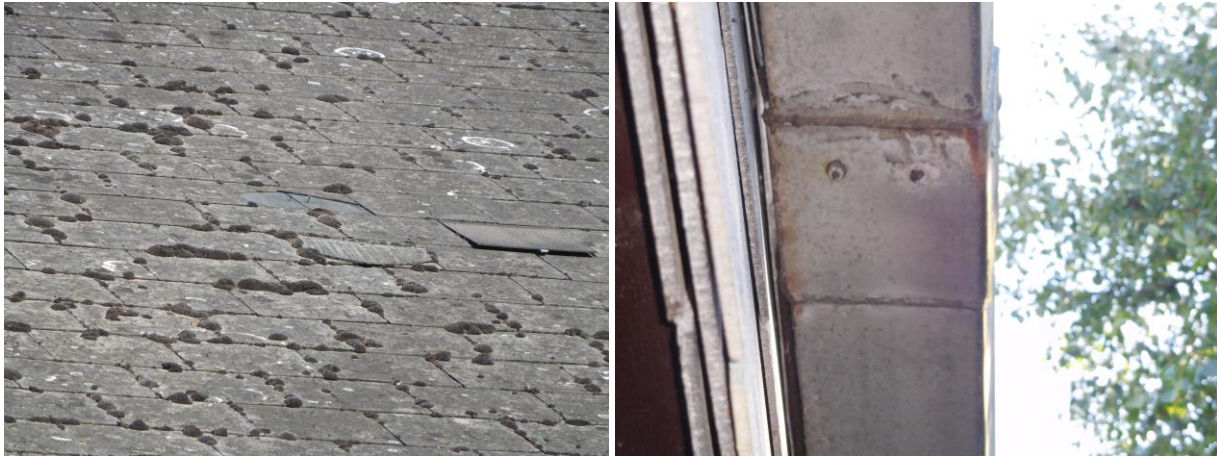
There is a single pitched roof to the block of split construction with a row of North lights situated within the pitch. The roof is covered with manmade (artificial) slate that is original to the build and starting to show signs of deterioration with it considered to be approaching the end of its expected life. A cost has been allocated within the backlog to undertake repairs as a number of broken and loose slates can be seen to the Rear Elevation. On top of this a cost for the complete recovering of the roof has also been included at the end of the maintenance period based on the expected lifecycle of the roof covering.

Also of note is that the steel guttering to the roof is showing significant signs of deterioration with numerous patch repairs visible, a cost for the complete replacement of the guttering has been included within the maintenance period.

Photos show broken and loose slates to the Rear Elevation and typical deterioration of one of the joints to the steel gutters.

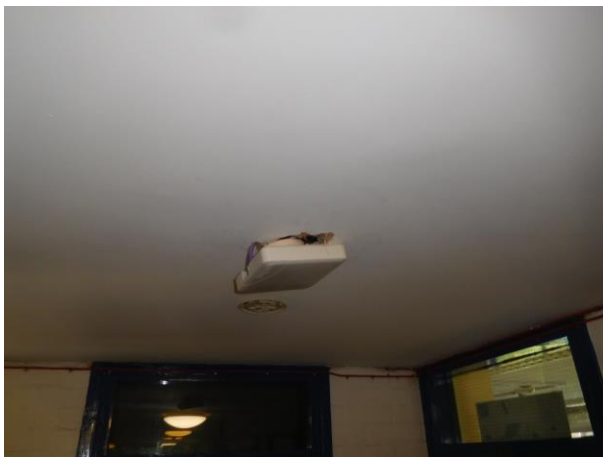
The internal fabric is considered to be generally tired and in poor condition with complete redecoration and replacement of the floor coverings required throughout the building. In addition, it was apparent during the survey that the plasterwork to the ceiling and walls is of poor quality with numerous holes of where fixings have failed due to weak and friable plaster. A cost for re-plastering the building has been allocated on a room by room basis.

Photo shows a wireless router falling away from the plaster ceiling where its fixings have failed.

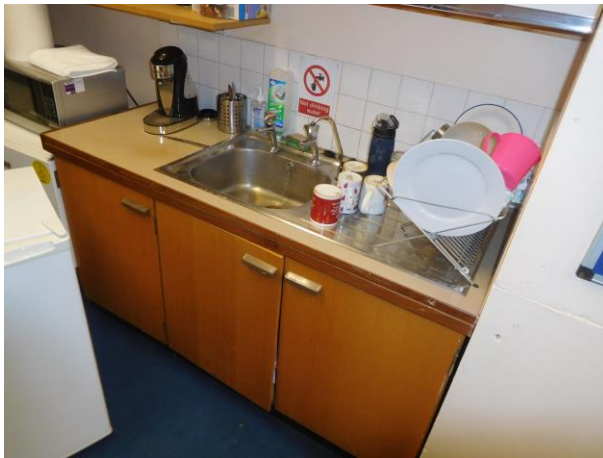
While there are limited fitted units and worktops to the building and it is noted there has been some localised replacement, further works are required to bring the remaining units up to modern standards.

Photo shows an original fitted sink unit to the First Floor Staff Office.

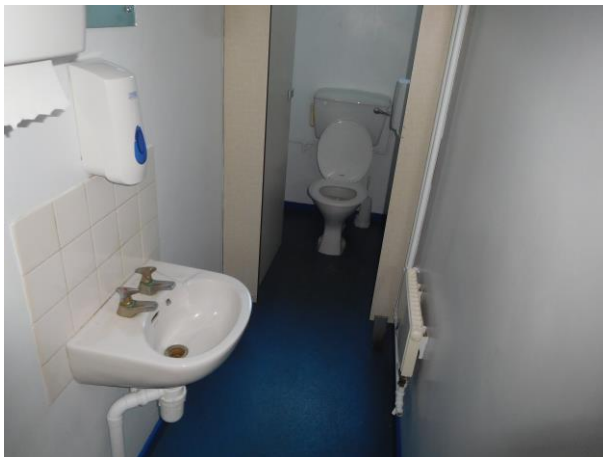
There is also a set of single Male & Female Staff WCs to the Ground Floor which are original and in poor condition, a cost for their complete upgrading has been included.

Photo shows one of the original Staff WCs to the Ground Floor.

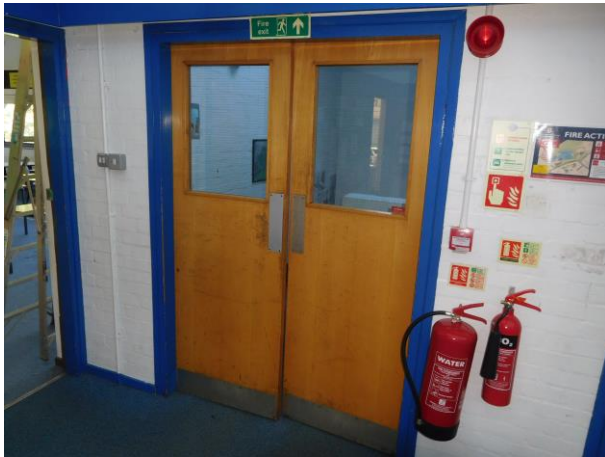
The internal doors throughout the building are all original and tired in appearance with reports that a number of the doors do not function properly. In addition, it is noted that the double doors from the stairwell leading into the Ground and First Floor hall areas are not compliant fire doors and pose a significant risk as such, therefore a cost for the complete replacement of all the doors within the building has been allocated on a room by room basis.

Photo shows the set of double doors leading from the First Floor hallway onto the stair landing.

07 - Internal Doors	D	£1,500	0	1			2018	Internal door: Is original and does not comply to current fire regulations (BS476), with no intumescent strip visible to door or frame.	Cost allows for replacement.

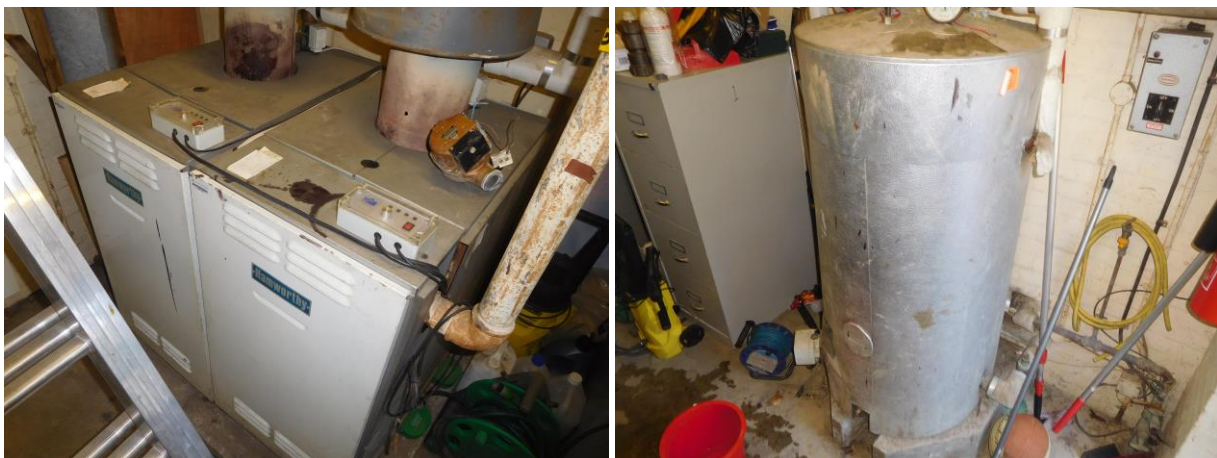
The Plant Room is situated to the Ground Floor and is externally accessed, within it are located 2No Hamworthy boilers, a calorifier and associated pipework and pumps. In addition, the main incoming electricity cable and distribution board are also present along with a number of redundant items such as a fire panel and optimiser.

The 2No boilers are original and exhibiting signs of general wear along with being beyond their expected life, a cost for their replacement along with associated commissioning works has been included. The calorifier while unlikely to be original is considered to be beyond its expected life span with a cost for its complete replacement included.

Photos show 2No Hamworthy boilers and the calorifier situated to the main Plant Room.

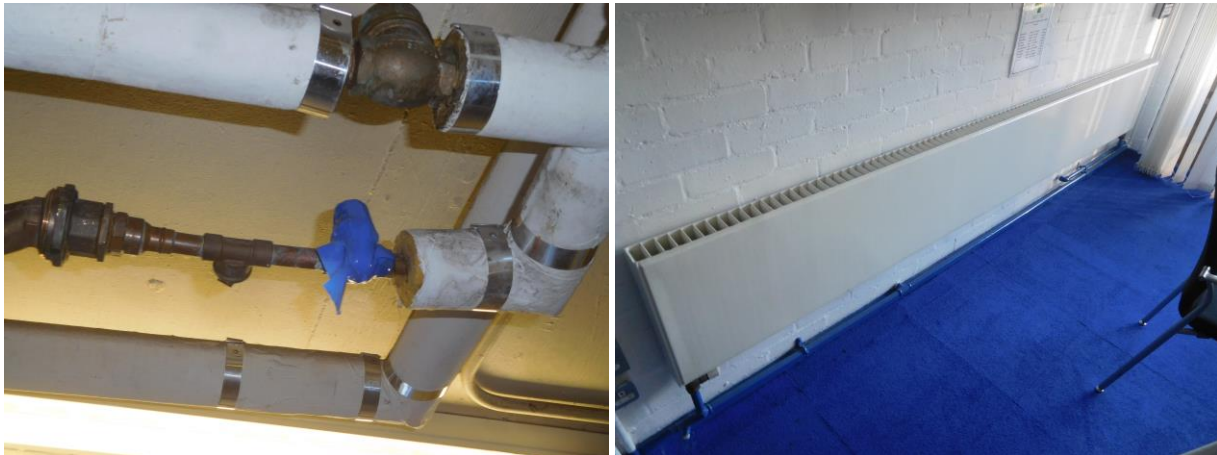
In addition to the boilers and calorifier it is reported that the hot and cold water pipework and the heating pipework is in generally poor condition with on-going issues throughout the block, with it noted at the time of survey that a section of the hot water pipework within the plant room was leaking. A cost for the complete replacement of the pipework throughout the building has therefore been included. Along with the pipework, the majority of the radiators to the block are original and therefore not only inefficient compared to modern units but lack the ability of local control, a cost for their replacement has been included on a room by room basis.

Photos show section of leaking hot water pipework to Plant Room and one of the original radiators found throughout the block.

Property Appraisal - Detail Report											
		Cond.	Cost to B	Rem Life	Priority	C	L	R	Year	Notes	Remedial Action
01 - Heat Emitters		D	£600	0	1				2018	Steel panel radiators despite some localised replacement are largely original with reports of on-going failures along with lack of local control.	Cost allows for replacement.
R - Engineering - Electrical											
04 - Lighting Installation		C	£2,400	0	1				2018	T12 lighting requires lifecycle replacement.	Cost allows for replacement.
Location: F06											
C - Building - Internal Fabric											
01 - Decorations		C	£800	0	4				2018	Redecoration required as part of a regular maintenance schedule.	Cost allows for two coats of emulsion and includes for gloss work.
02 - Ceiling		D	£3,500	0	1				2018	Plaster work is in poor condition with numerous holes from previous fixings along with general deterioration, reports also indicate that the plaster is no longer suitable for new fixings to be fitted.	Cost allows to strip and replace all plasterwork.

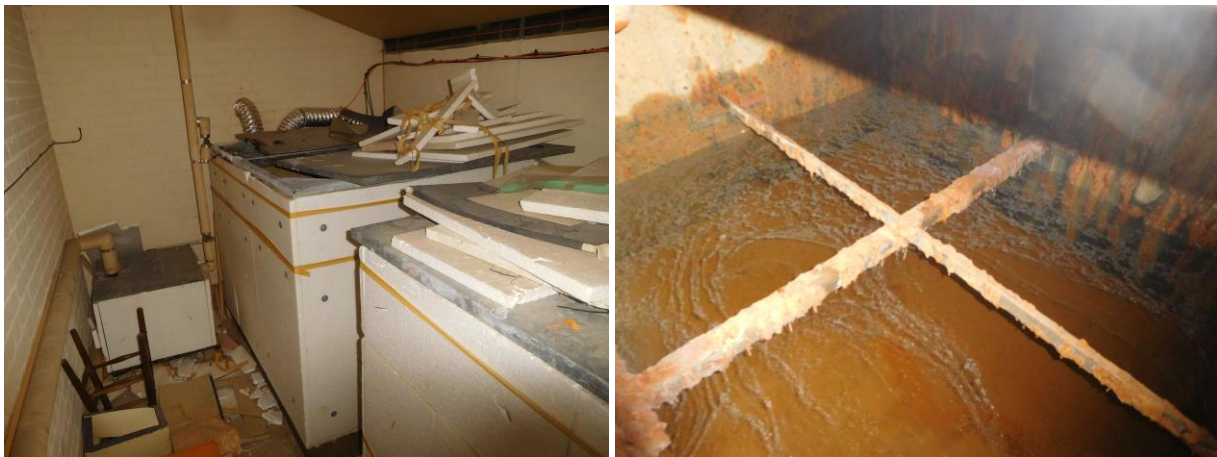
The block does have a small loft situated above the First Floor Office where 2No cold water storage tanks are situated along with a feed and expansion tank; all three are of galvanised steel construction and are original to the building. They appear to be in poor condition with it also reported that the legionella company employed by the school having noted that the inside of the tanks are pitted. It is therefore recommended that the tanks are decommissioned with it recommended that the system goes mains fed negating the need to replace the tanks, the cost associated with this is included as part of the boiler and pipework costs already allocated.

Photos show the 3No water tanks and the inside of one of the cold water storage tanks.

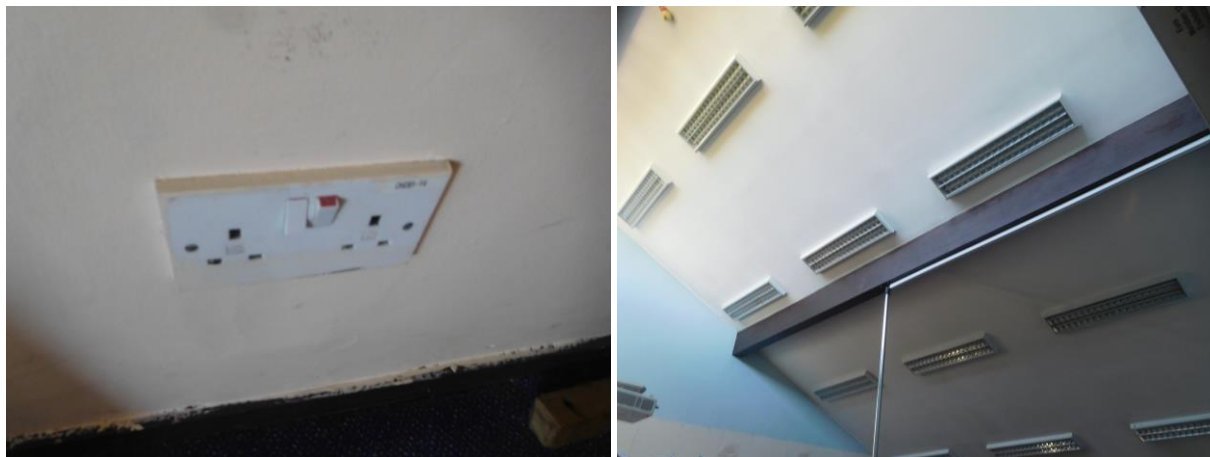
The main incoming electric cable to the block while original is considered to be in serviceable condition with the adjacent distribution board having been upgraded and is also in serviceable condition. The wiring beyond the distribution board however is considered to be largely original with the majority of switches and sockets throughout the building also original, a cost therefore to re-wire the building and to upgrade the switches and sockets has been included.

In addition to the sockets and switches the lighting throughout the block is also considered to be beyond its expected life with the classrooms and offices all having T12 units that are unlikely to comply with modern lighting standards.

Photos show one of the sockets typical of those located throughout the building and a bank of T12 lighting units to one of the classrooms.

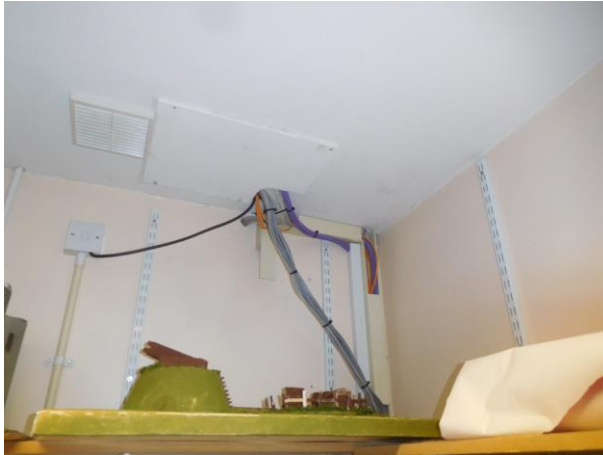
In terms of statutory Compliance there are two items of note, asbestos located within the building and fire compartmentation throughout the building. Oakleaf were informed that all the asbestos has been removed from the building however it is still advised that a full refurbishment and demolition survey be undertaken before any intrusive building works are carried out, a cost for the survey has been included within the report. The fire compartmentation side is to ensure that all compartments within the building are fully sealed to prevent/delay the spread of fire and smoke with it noted that during the survey there are a number of breaches within the walls and ceilings throughout the building, a cost to identify and secure the breaches has been included.

Photo shows unsecure cabling going through the ceiling within the First Floor Office.
