JCR Statement of Case PART 2 OF 6 - Appendix 1

# ANNUAL STRUCTURAL SURVEY 2019

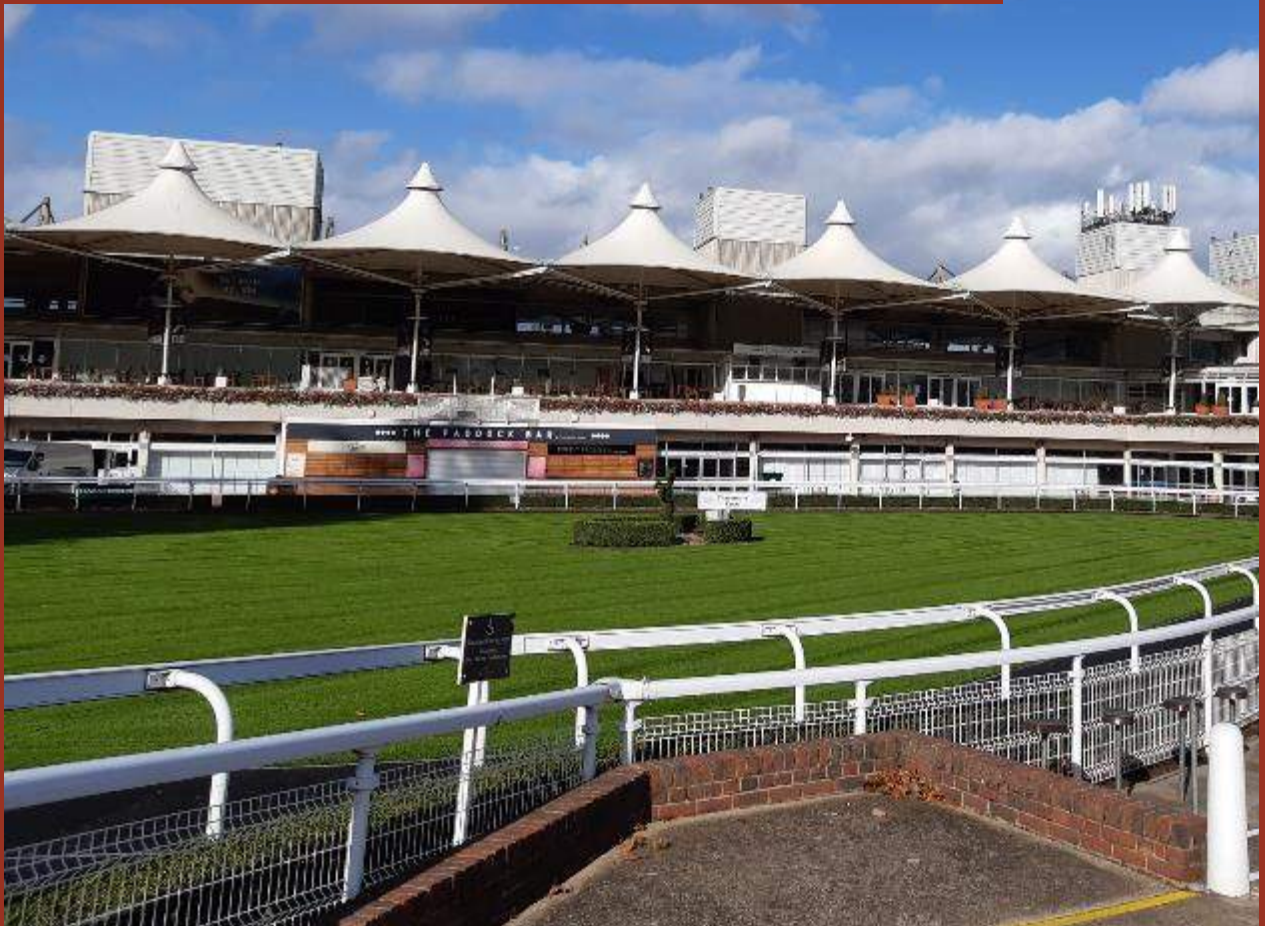
## Sandown Park Racecourse Annual Structural Survey 2019

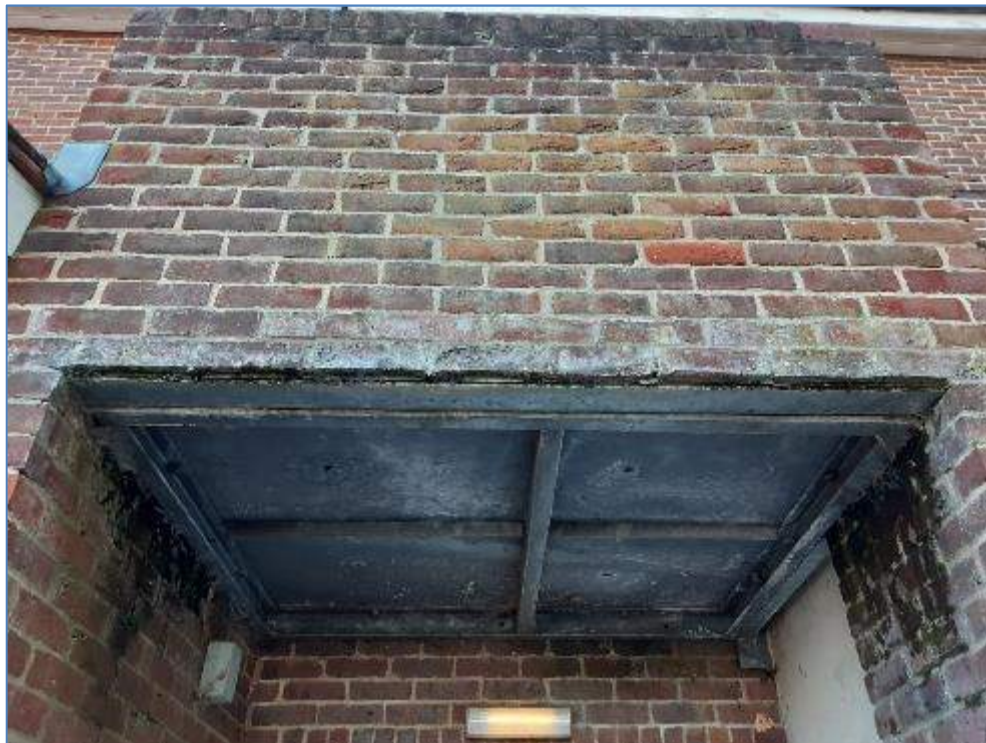
3-01 Bricks spalling over side entrance

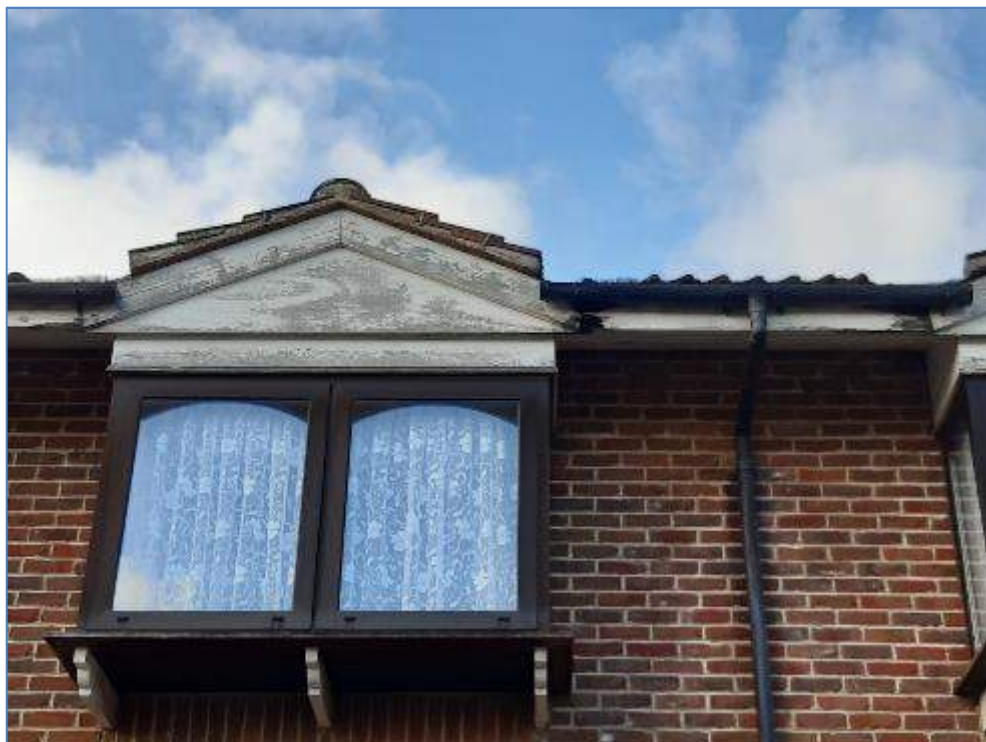
3-02 Timber fascias rotting adjacent to feature windows

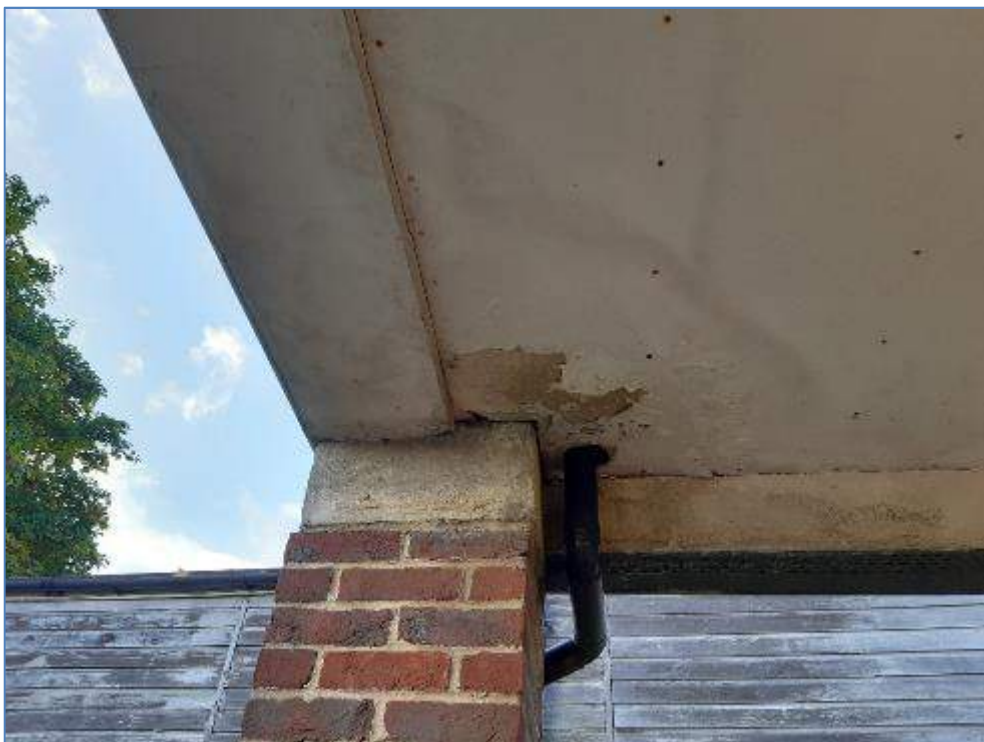
3-04 Water damage to soffit of carport

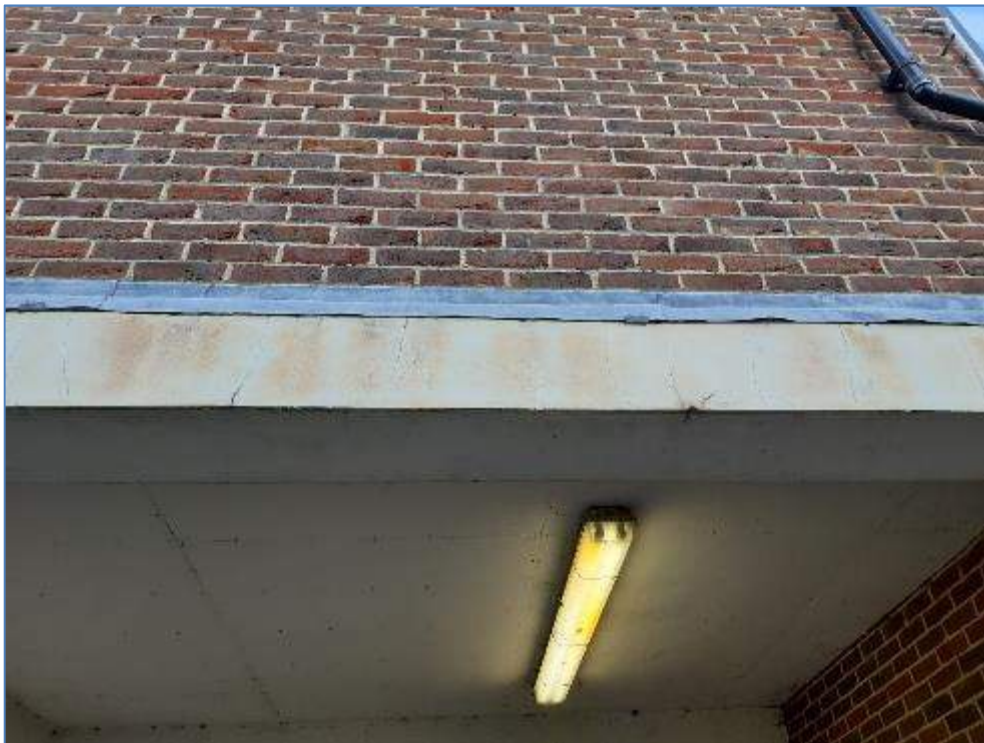
3-05 Cracks in lintel over carport

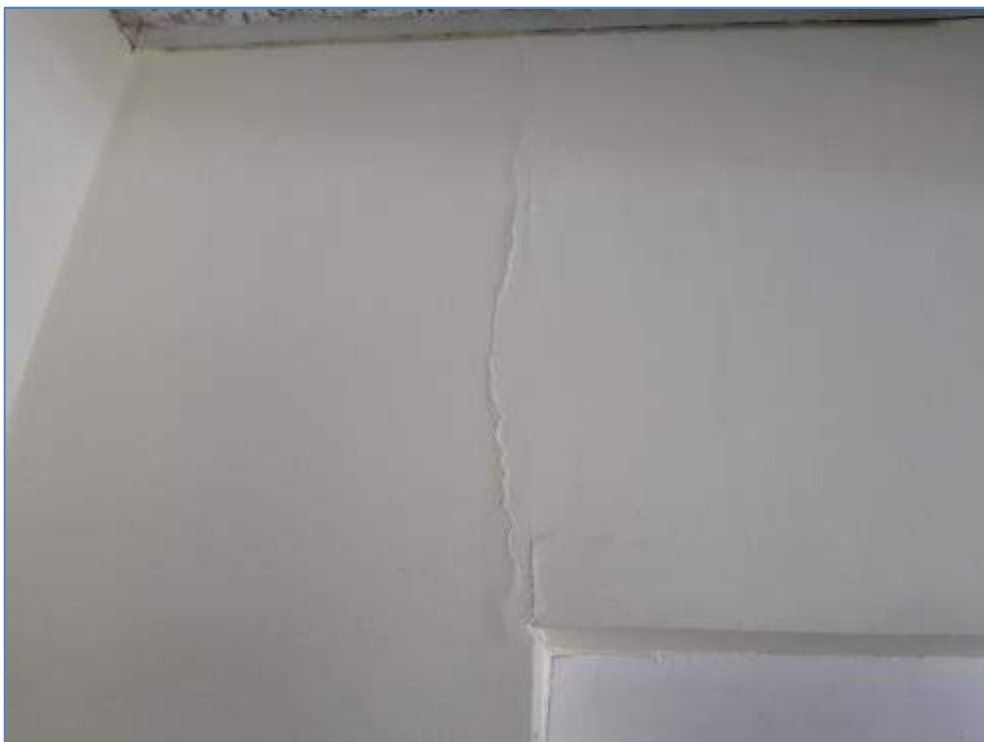
3-06 Crack over door in dining room

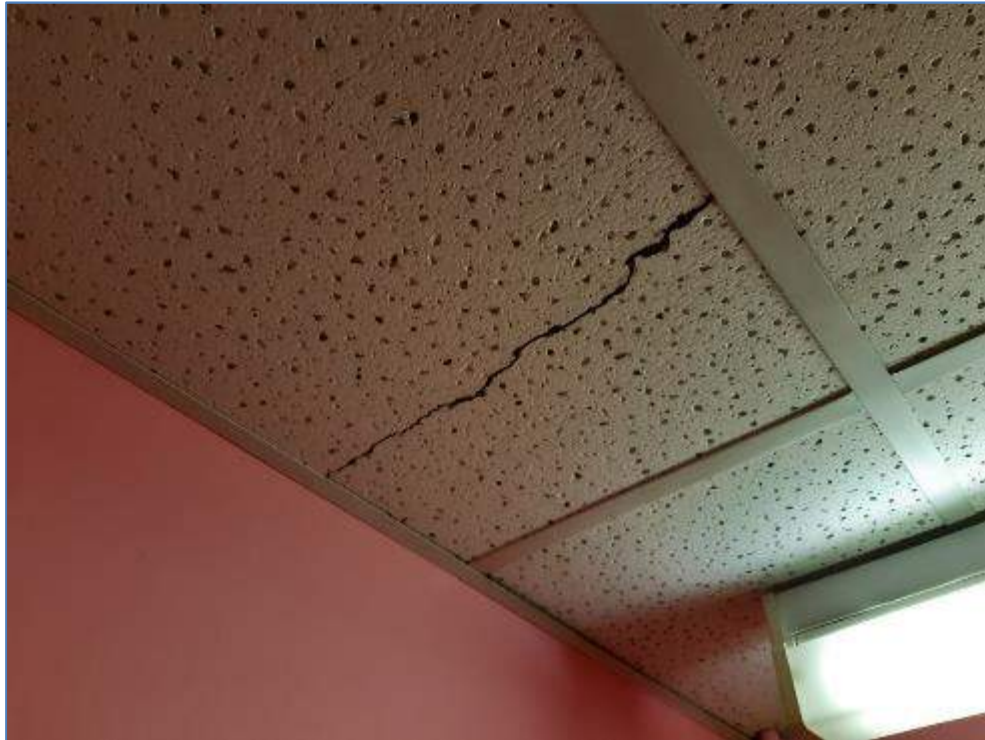
3-07 Crack in ceiling of female toilet

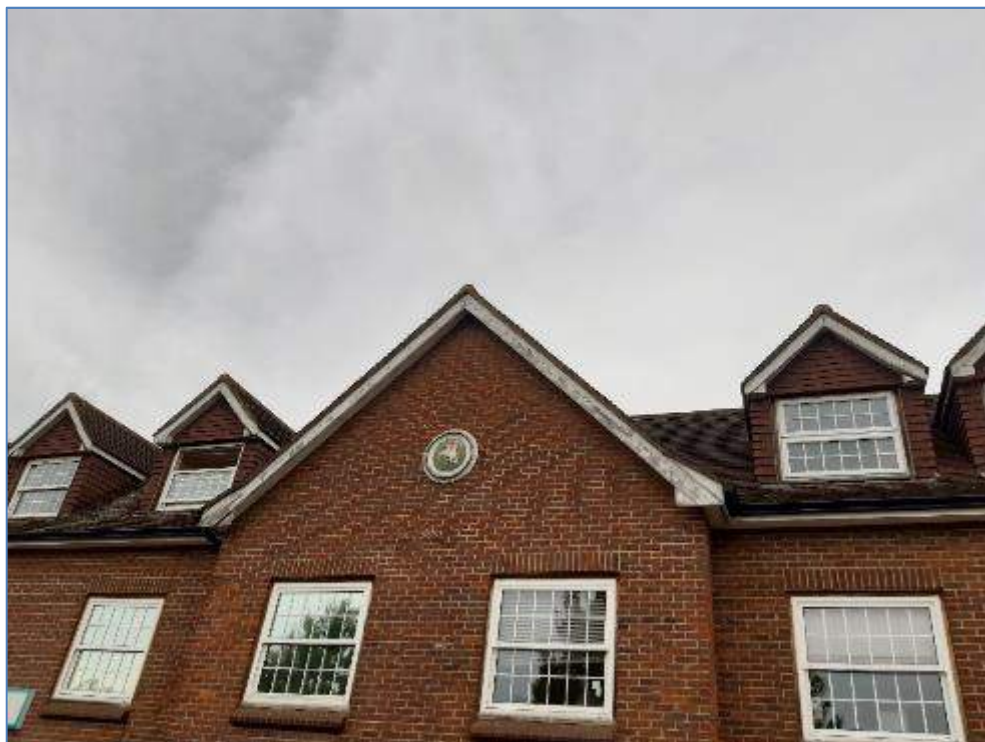
4-01 Paint peeling from timber fascias

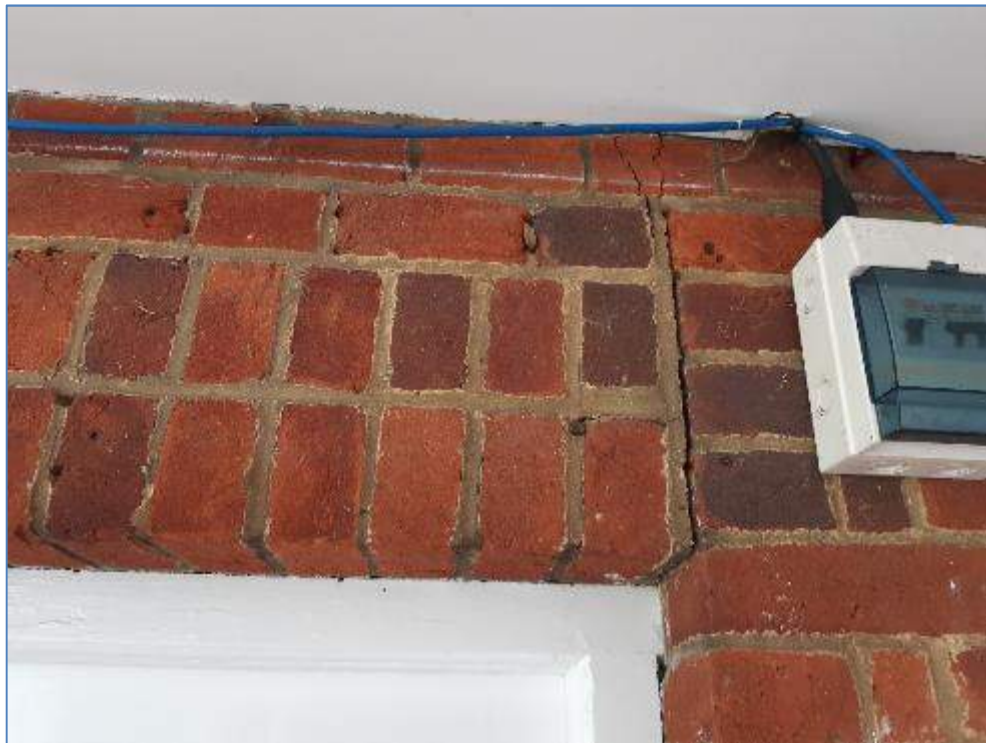
4-02 Crack in brickwork at end of lintel

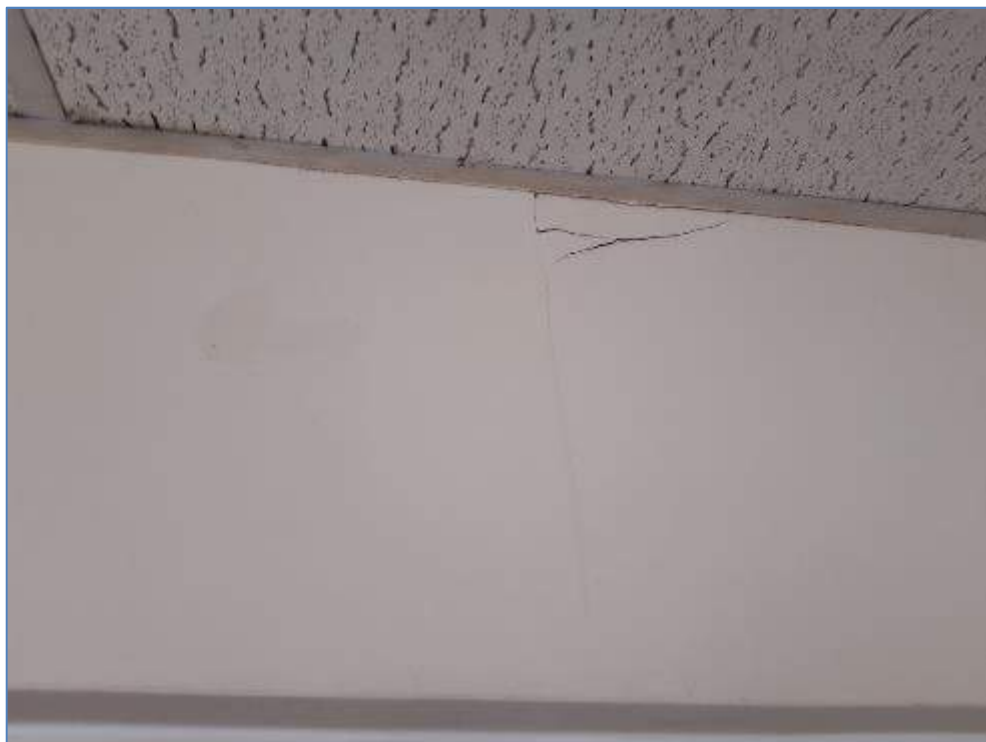
4-03 Minor cracking in office walls

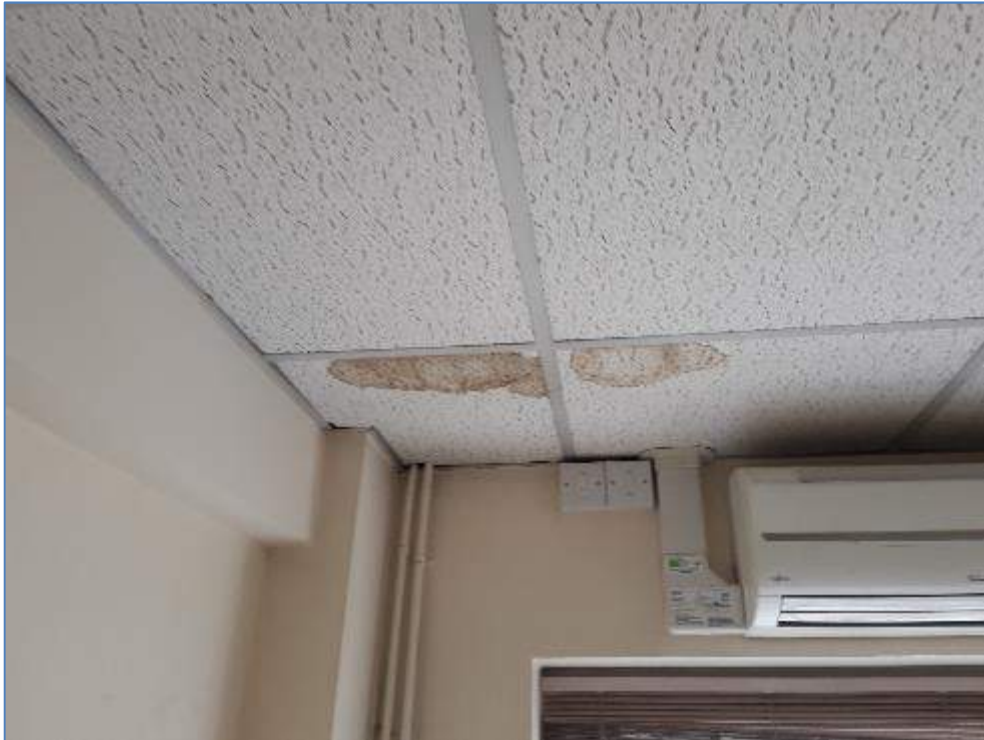
4-04 Damp damage to ceiling in offices

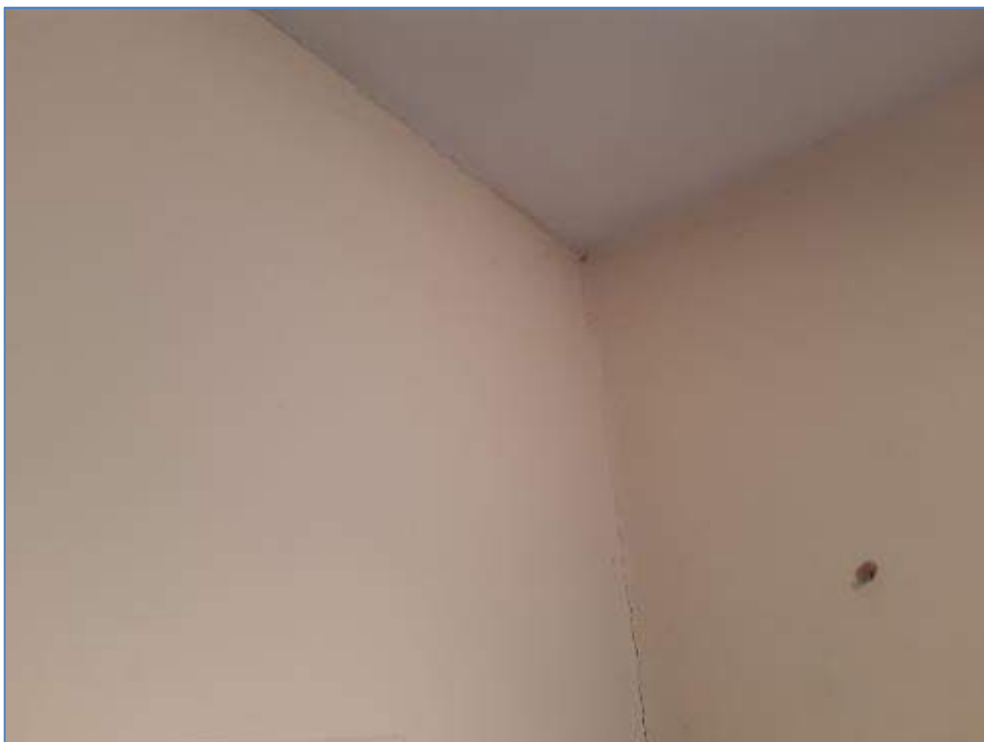
4-05 Cracking in corners of office walls

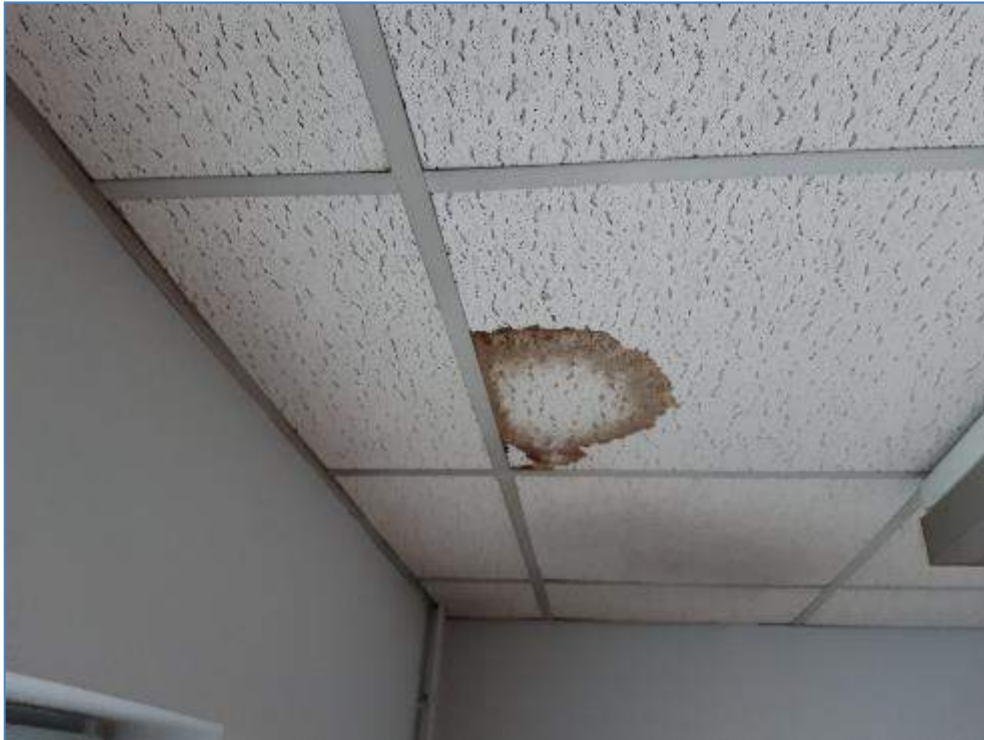
4-06 Damp damage to ceiling in lady jockeys changing room

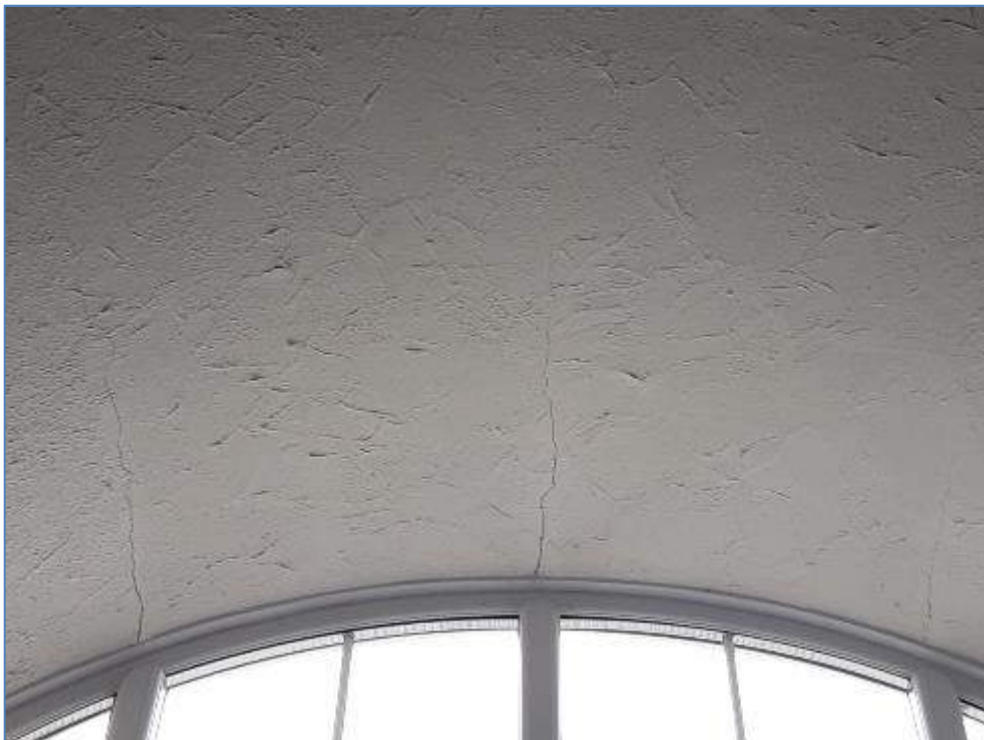
4-07 Cracking in vaults over windows in weighing room

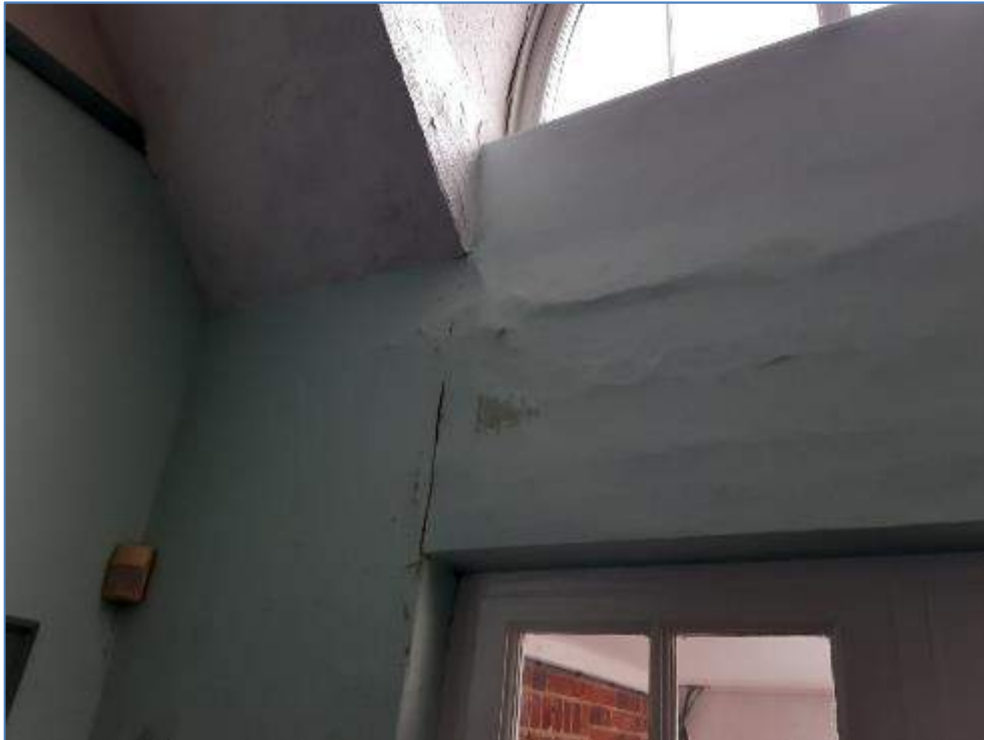
4-08 Cracking and damp damage over door

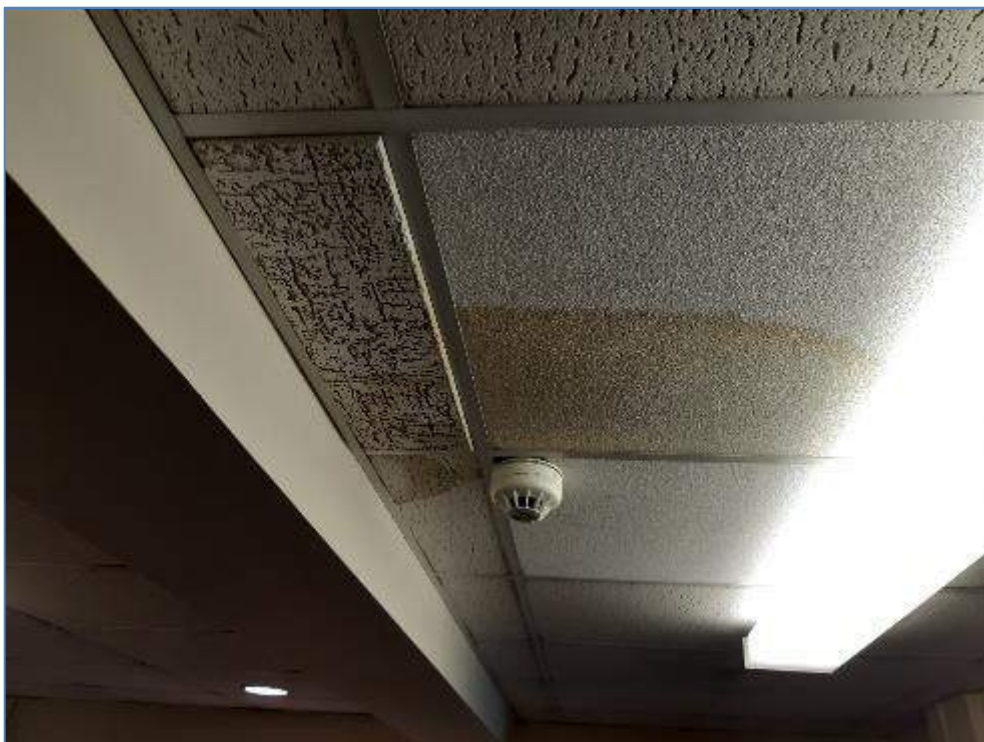
4-09 Water damage in ceiling of Stewards Room

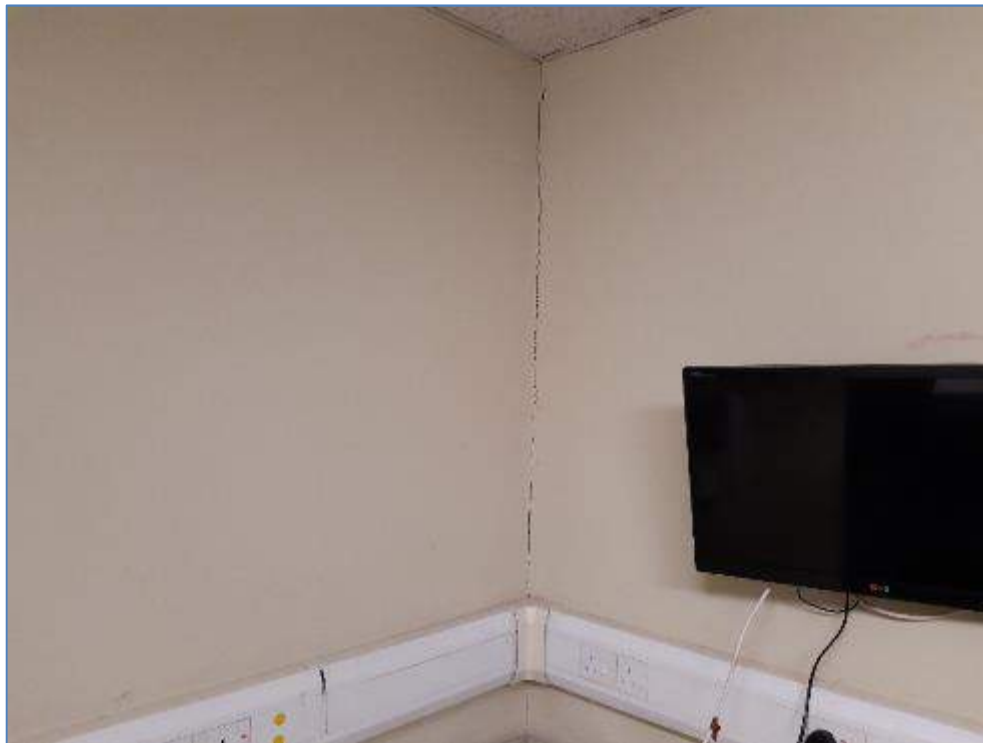
4-10 Minor crack in corner of Broadcast office

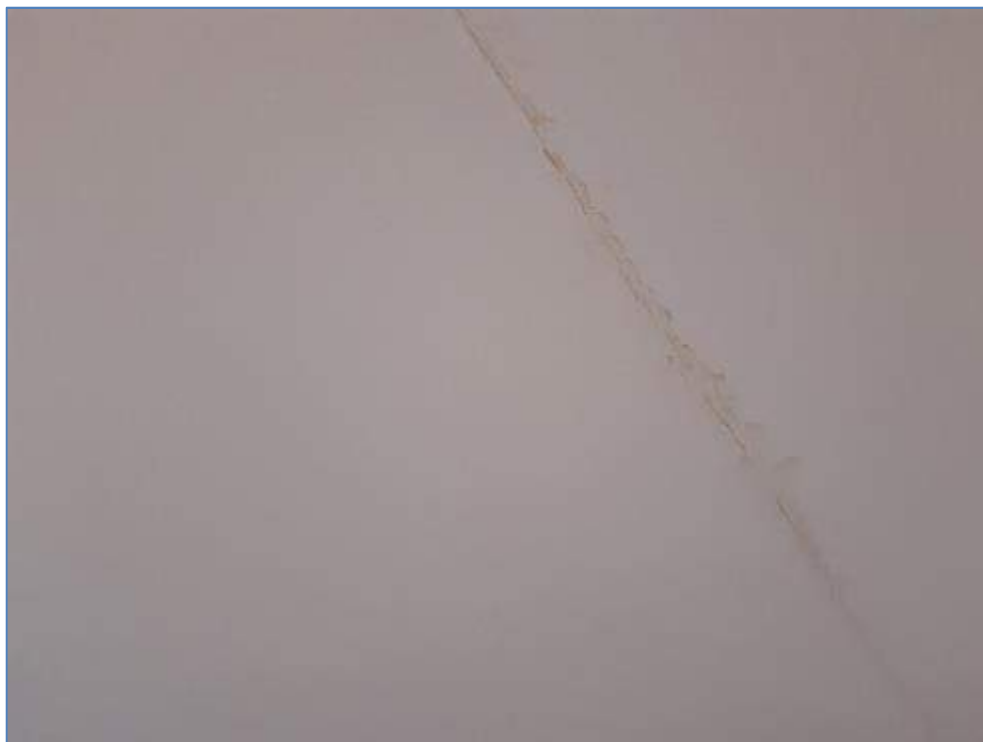
4-11 Minor damp in ceiling of offices

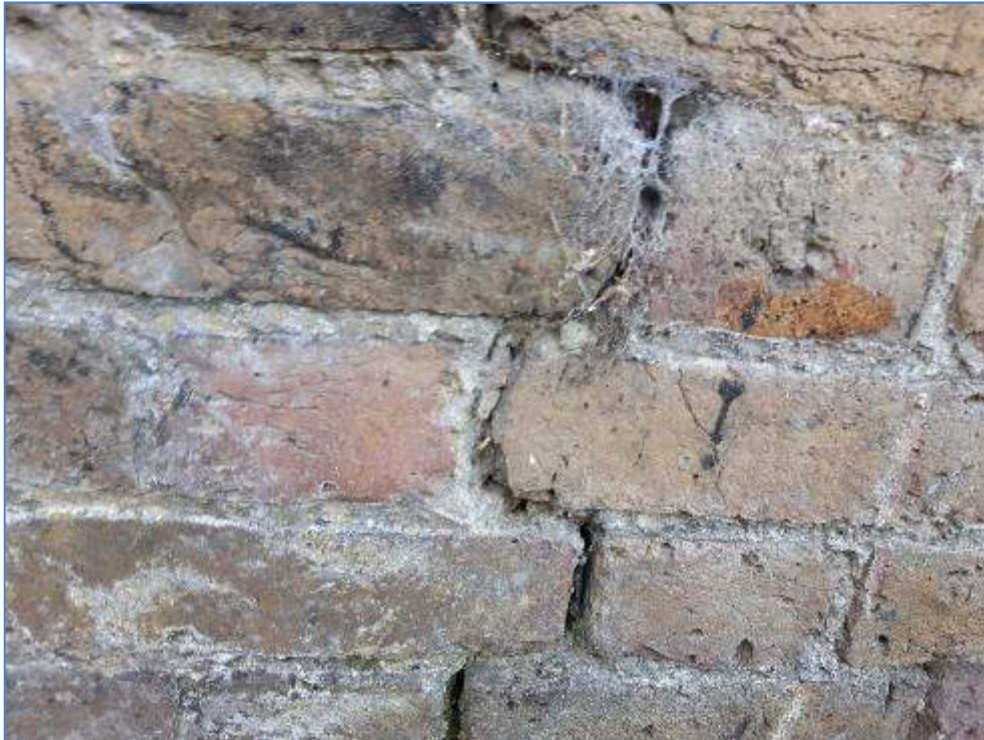
5-01 Cracks in brickwork to rear elevation

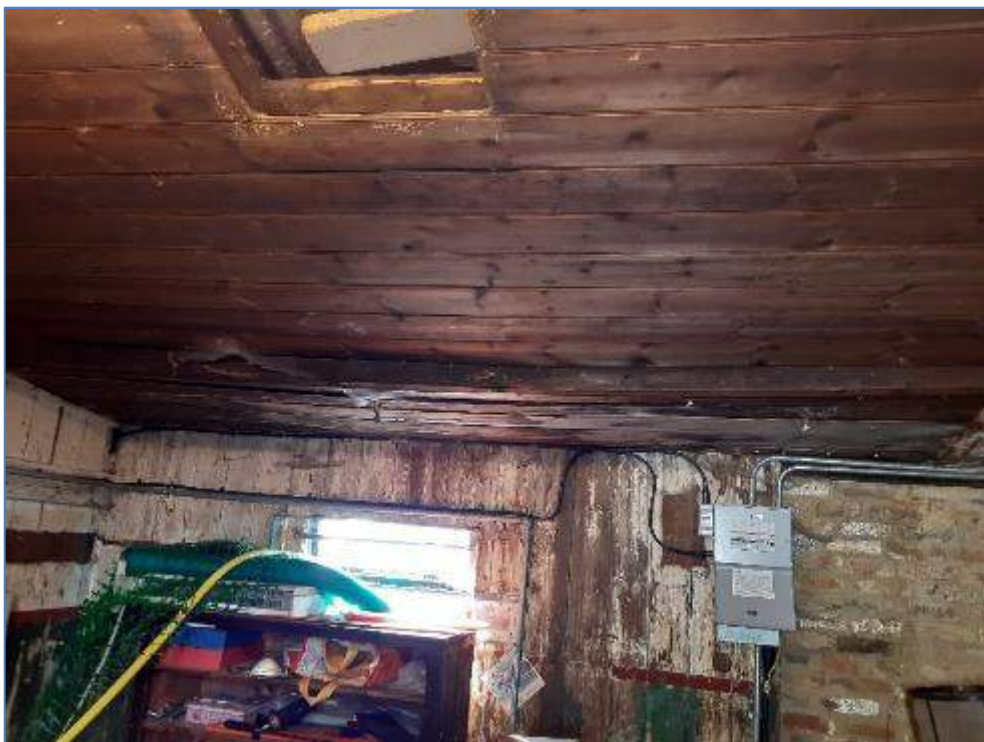
5-02 Timber beam sagging in maintenance store

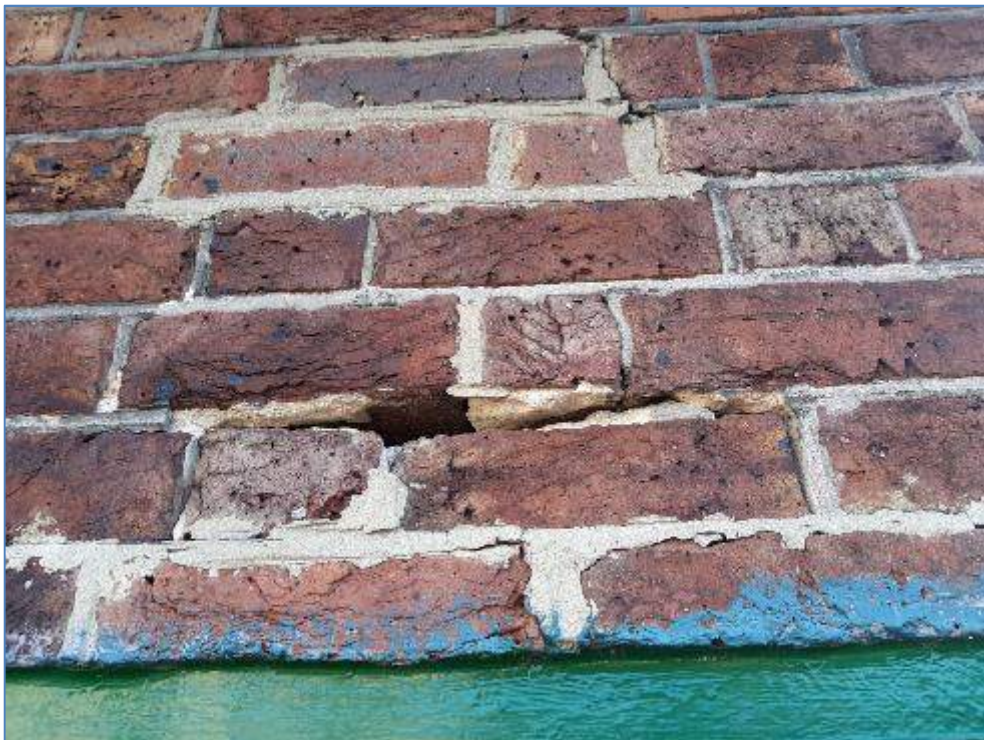
5-04 Loose bricks and cracking over stable manager door

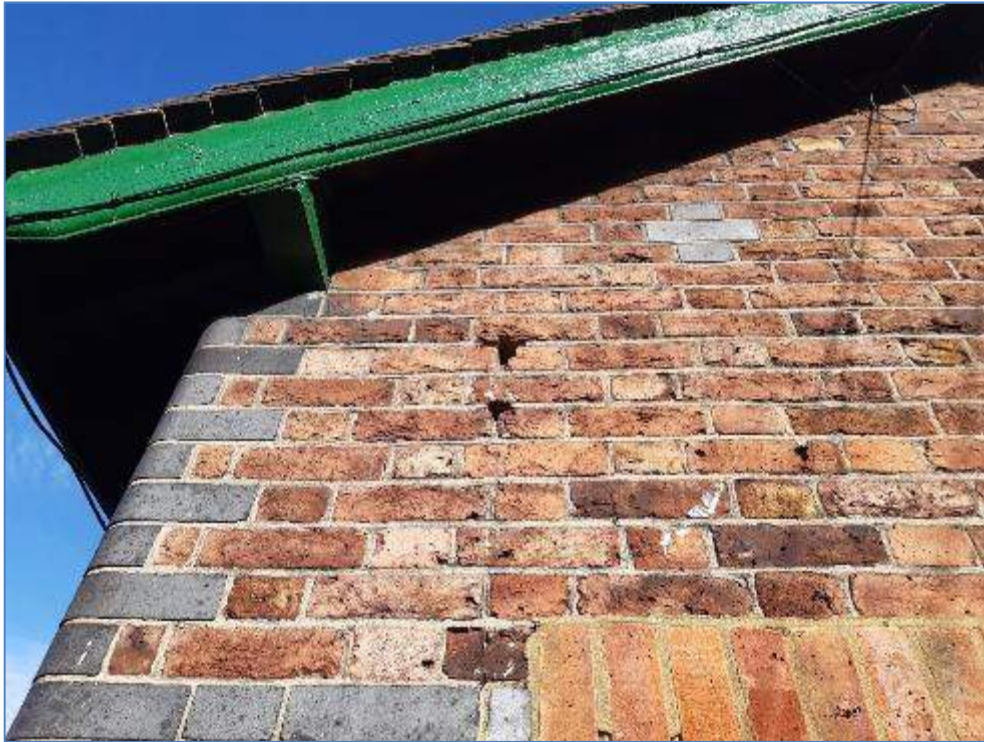
5-05 Bricks spalling on end wall

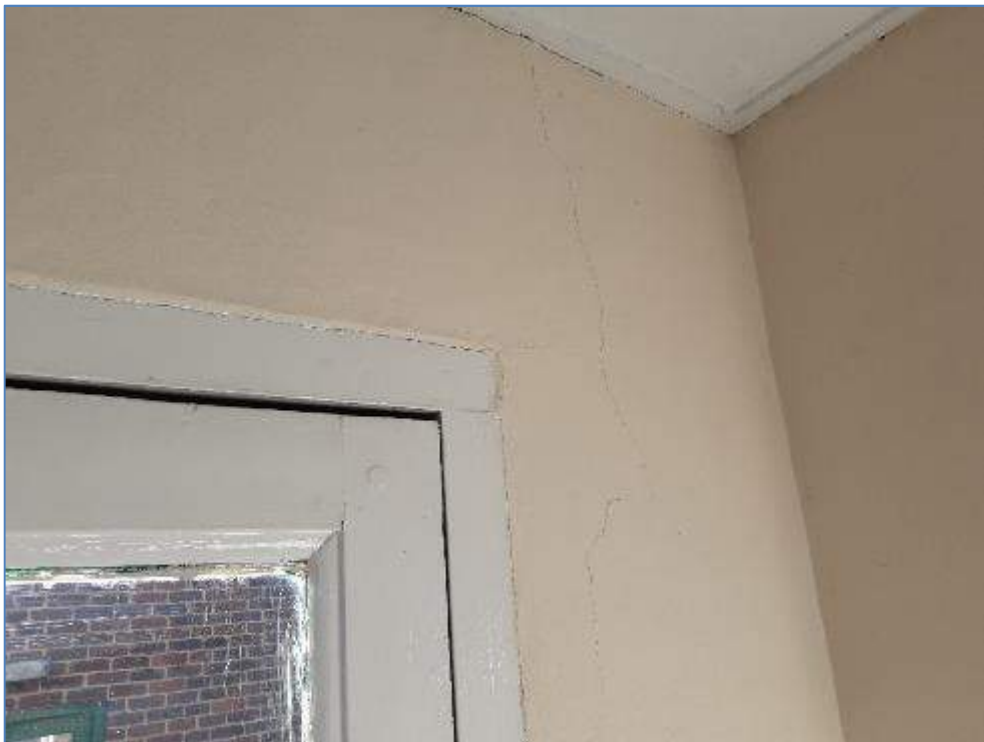
5-06 Cracking internally in the stable managers office

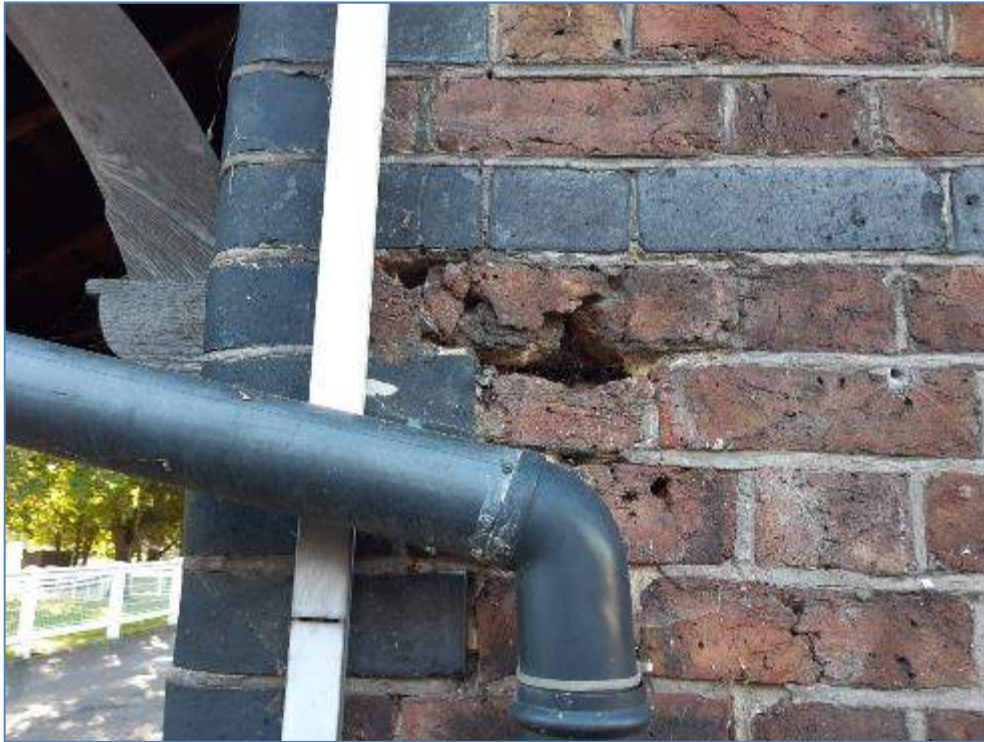
5-07 Damaged brickwork on external corner of veterinary block

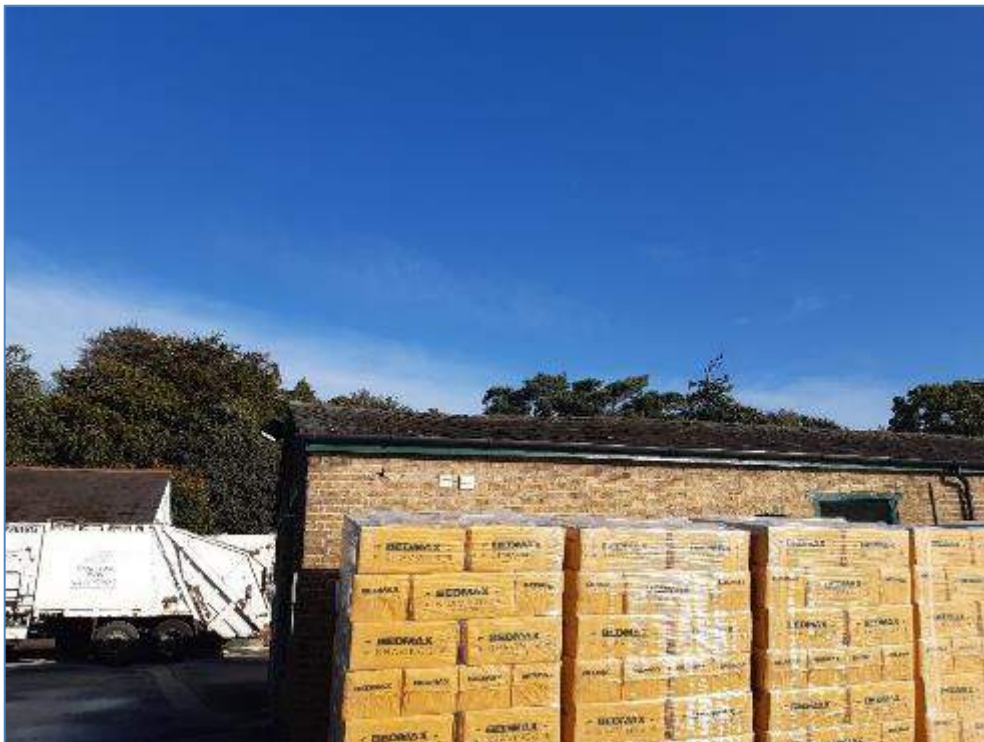
5-08 Roof ridge sagging

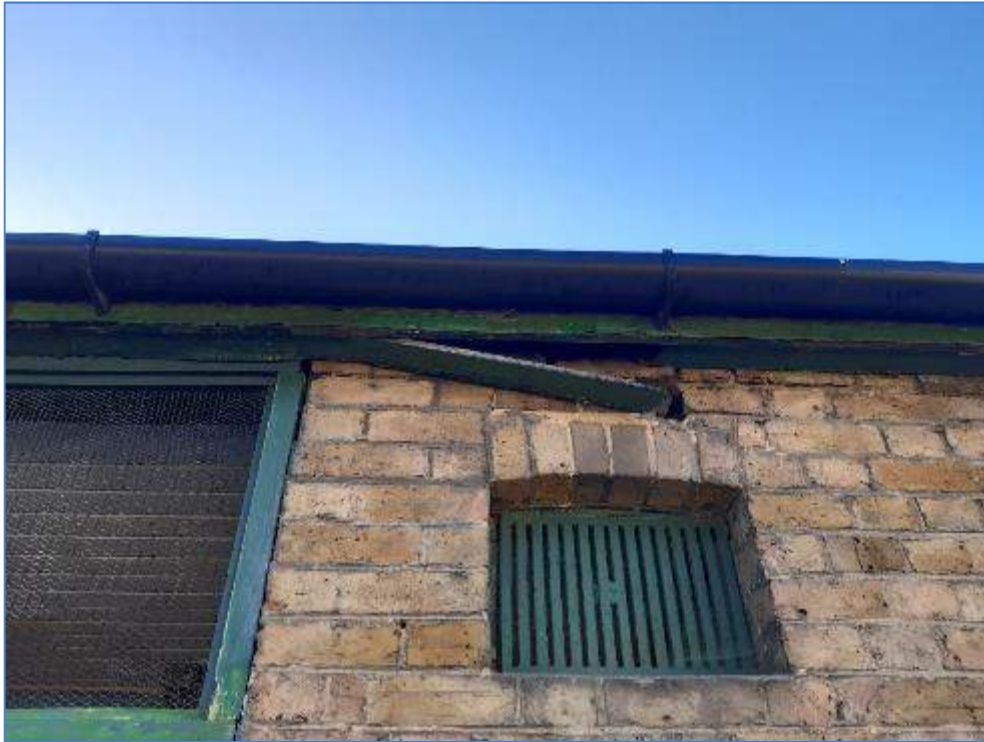
5-09 Eaves soffit board loose over stable 73

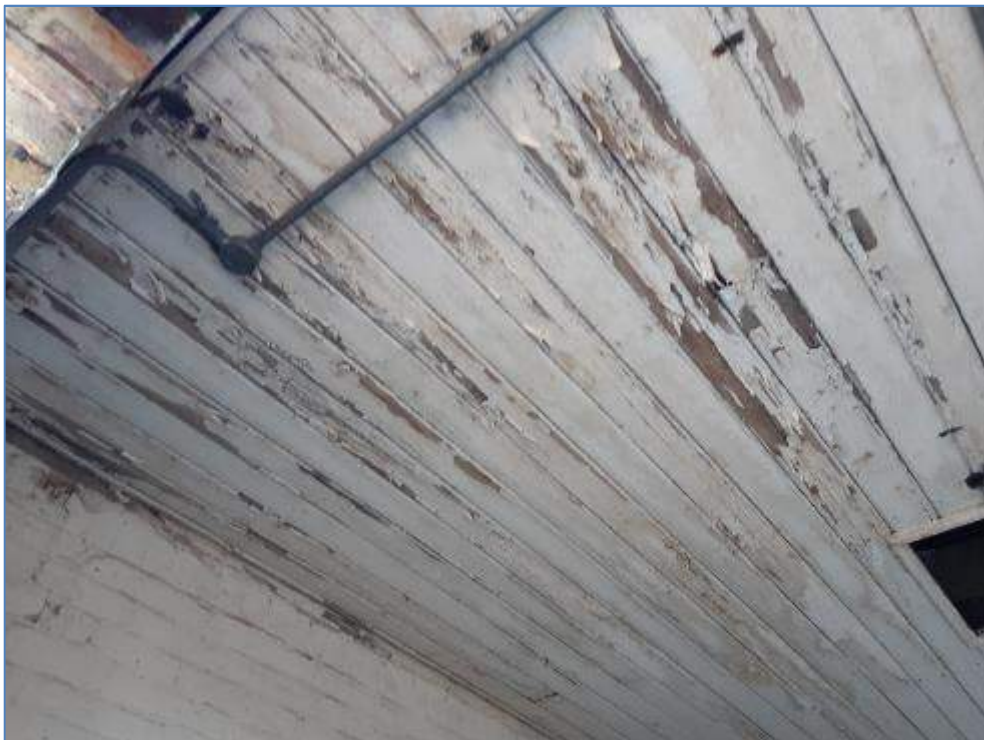
5-10 Timber soffit boards rotting in several stables

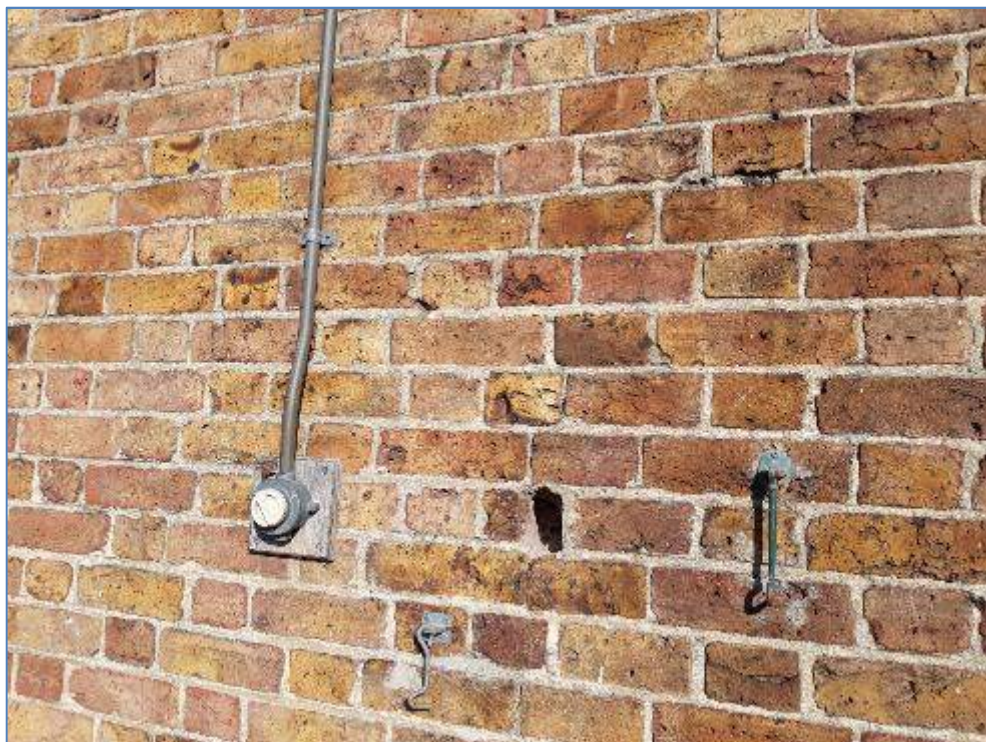
5-12 Damaged areas of brickwork

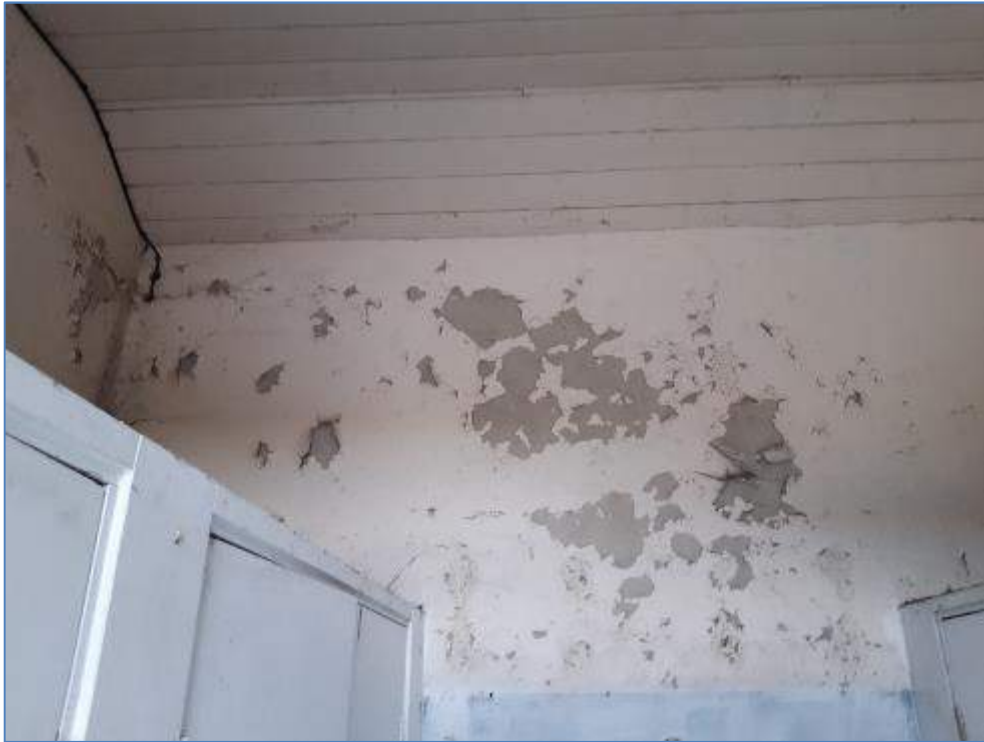
5-13 Paint peeling from walls by tack boxes

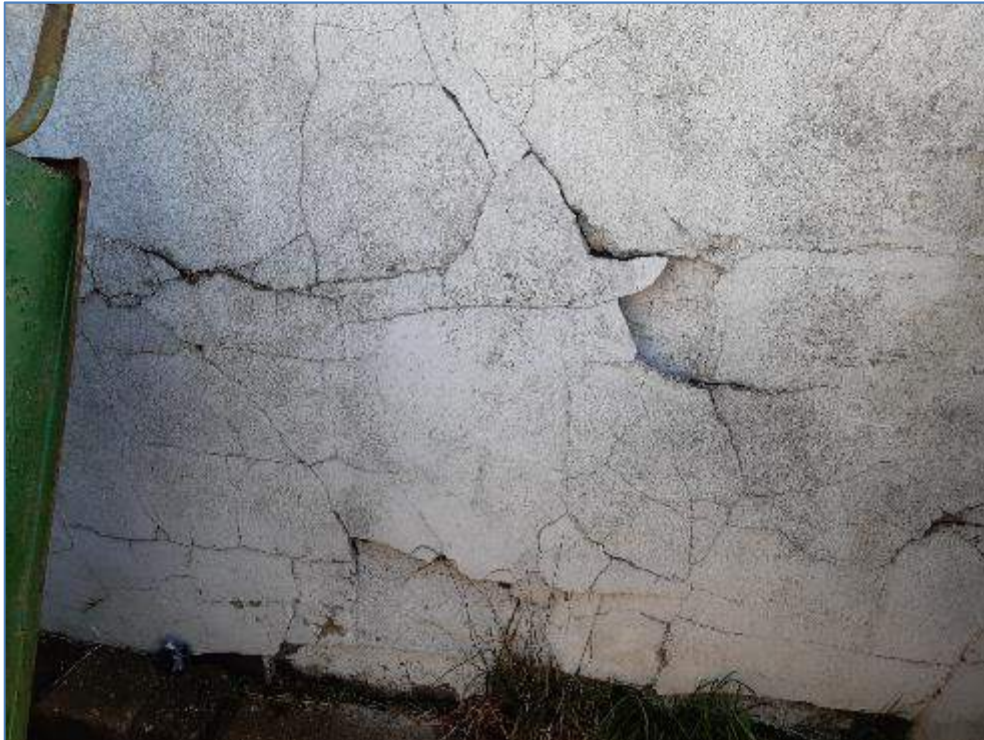
5-15 Render cracking and spalling heavily on external end wall
