JCR Statement of Case PART 2 OF 6 - Appendix 1

# ANNUAL STRUCTURAL SURVEY 2019

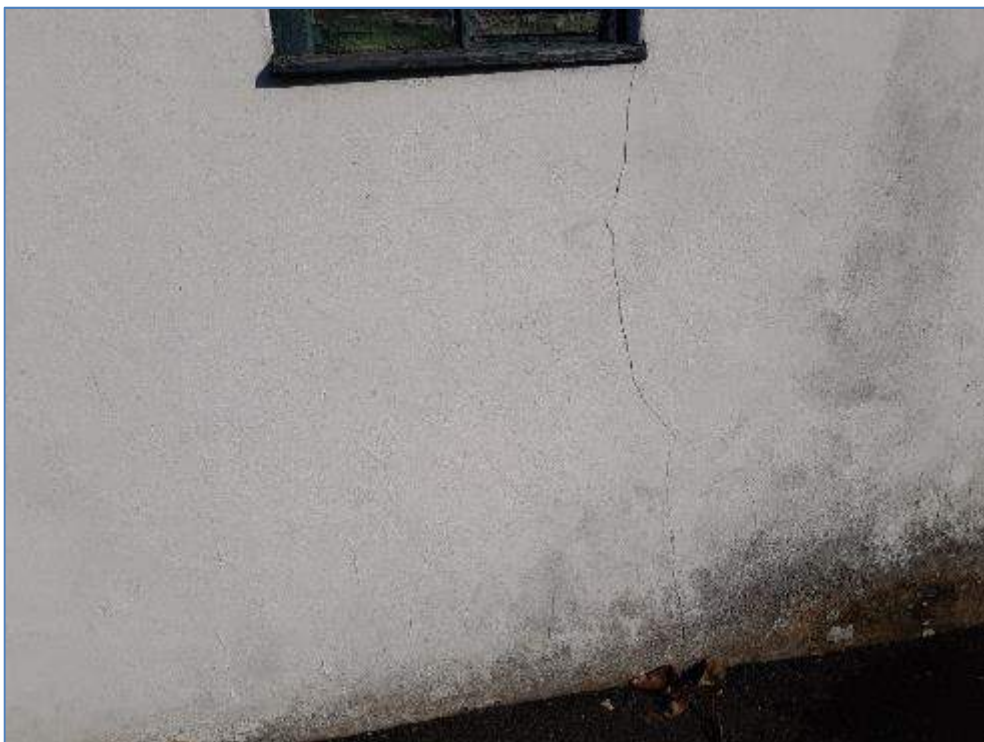
5-16 Cracking in external render

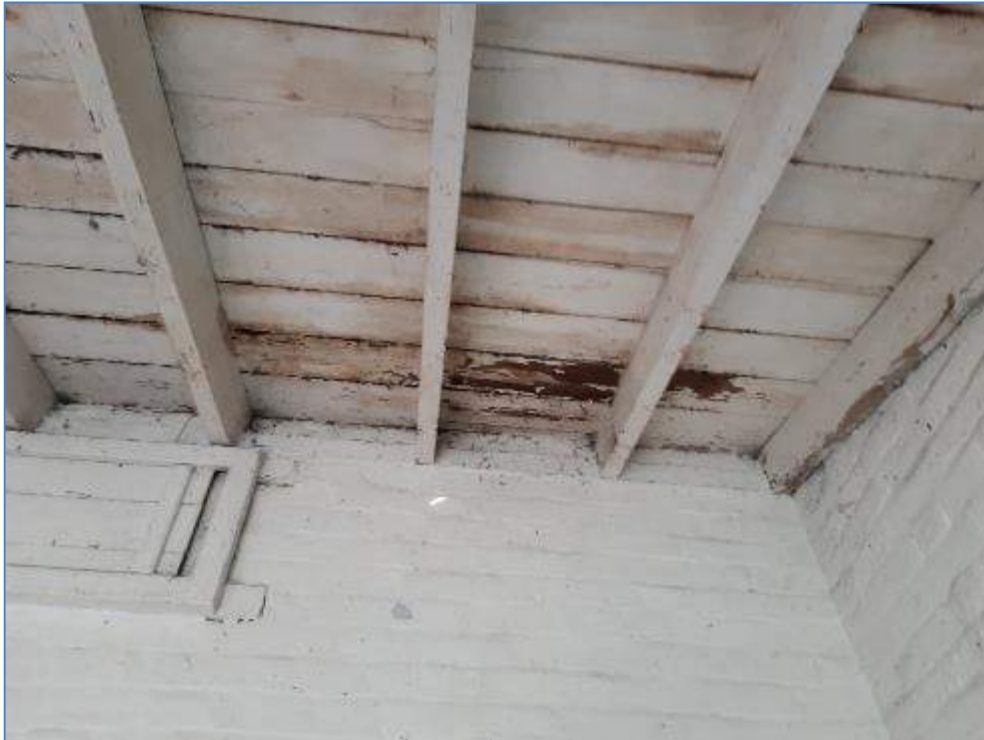
5-17 Timber soffit boards decaying in several places

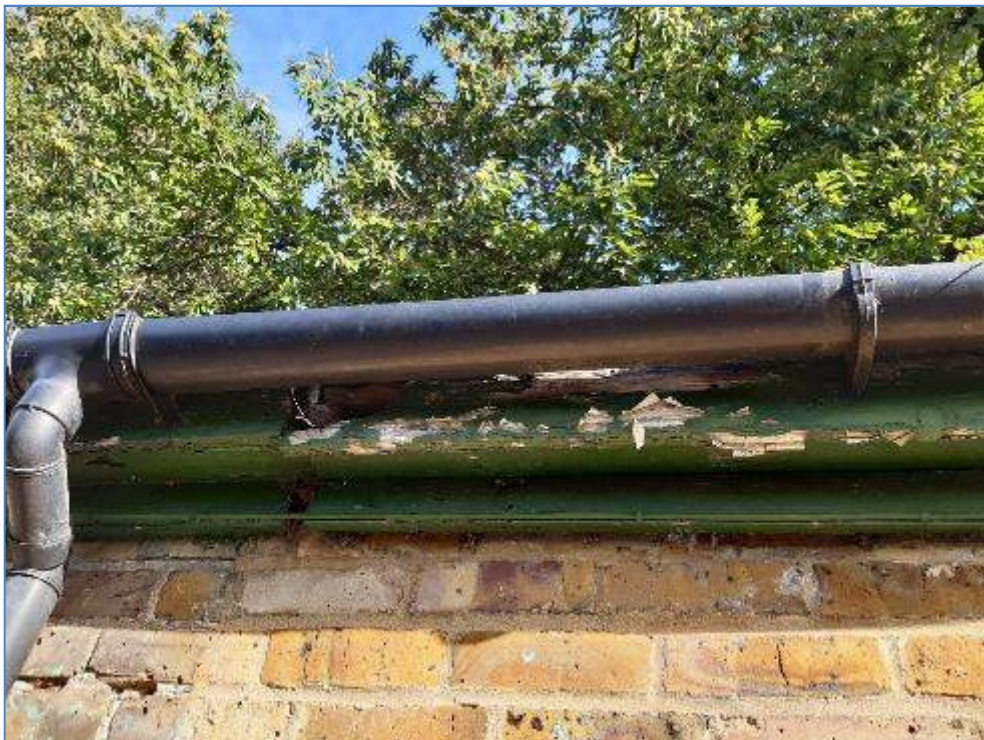
5-18 Paint peeling from timber eaves in several places

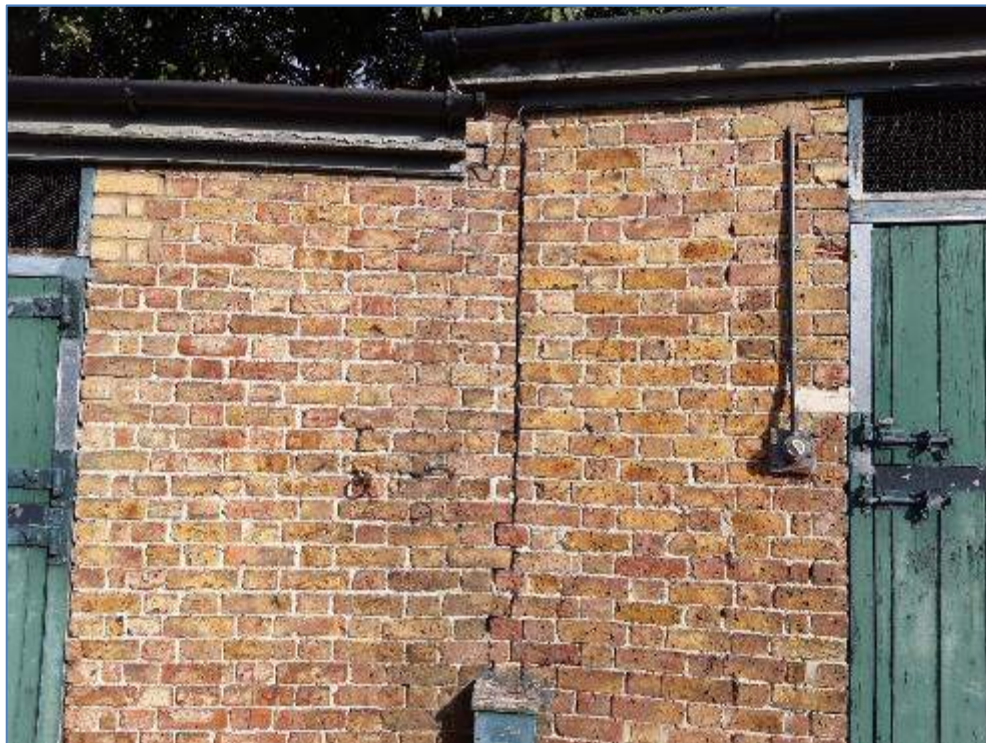
5-19 Crack in wall at steps between stables

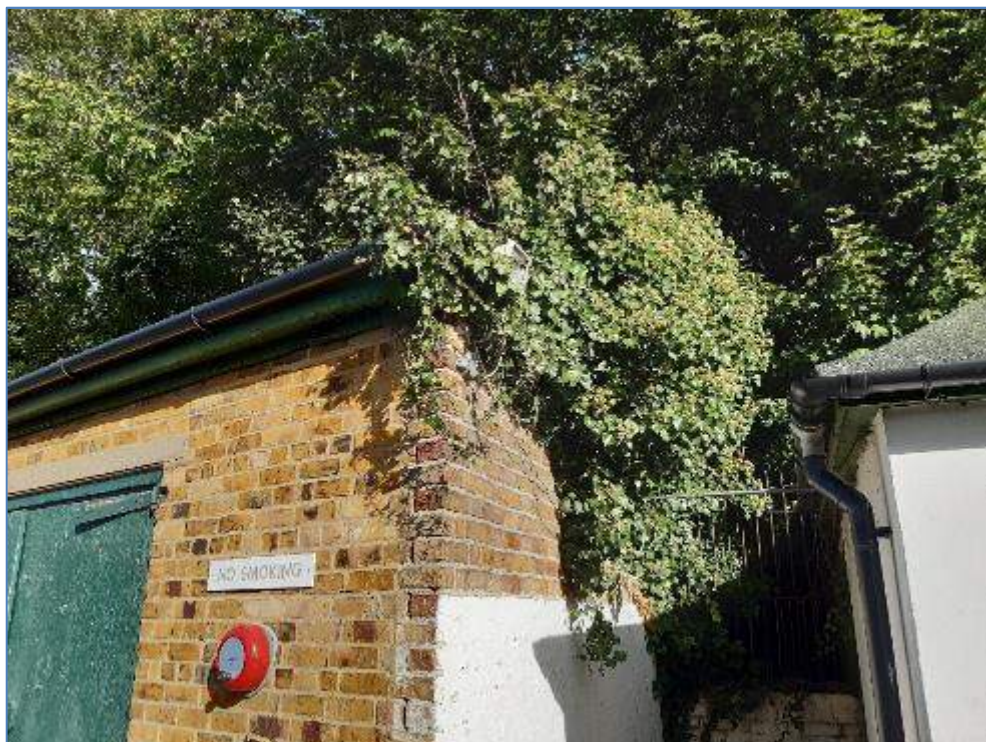
5-20 Heavy plant growth on end wall of stores

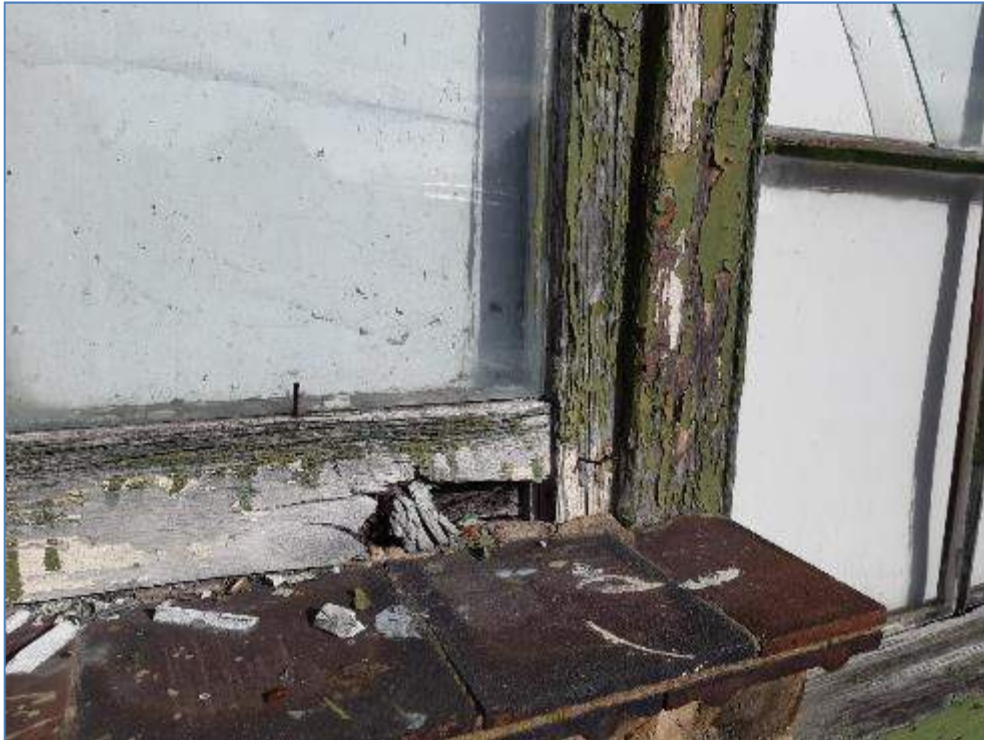
5-21 Timber window frames decaying

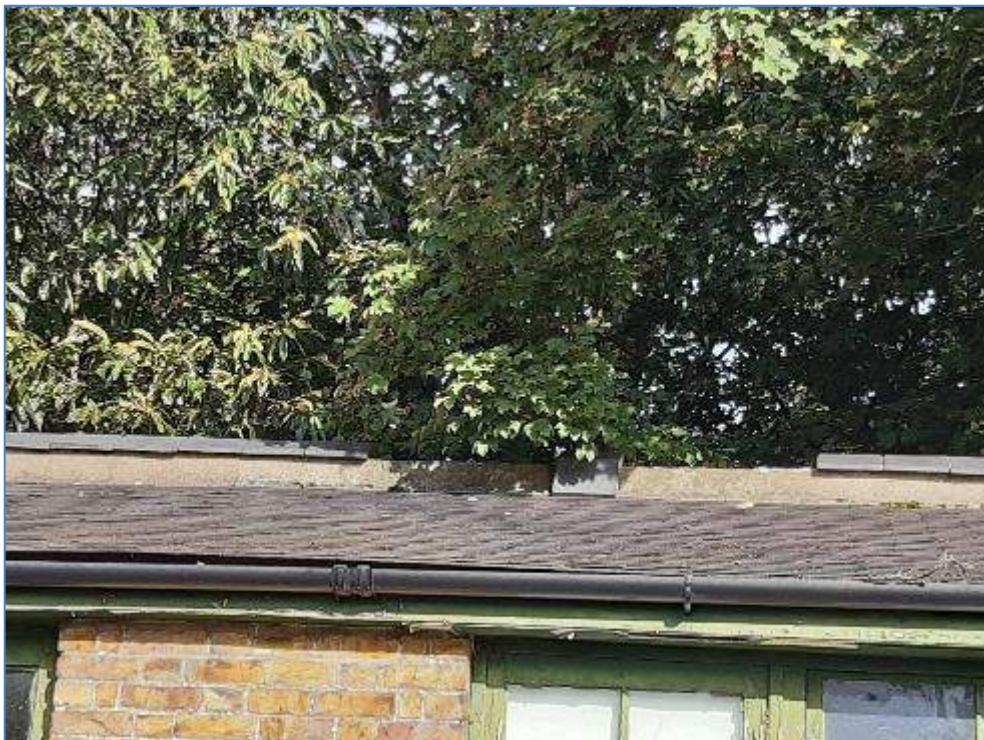
5-22 Copings missing from roof ridge

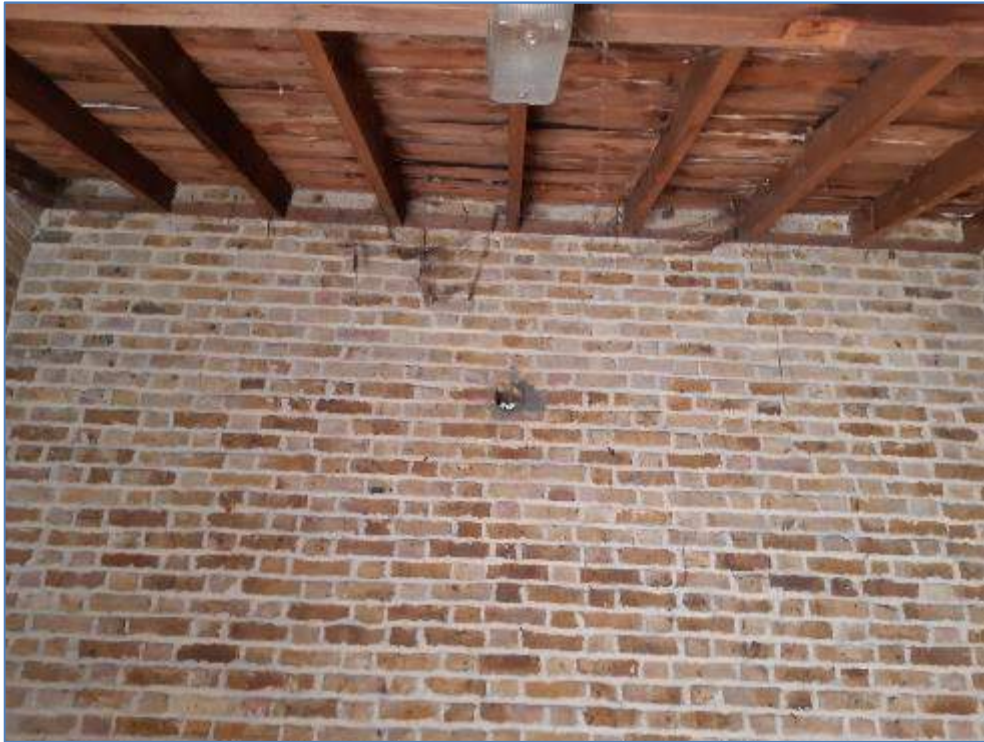
5-23 Brick missing from rear wall of store

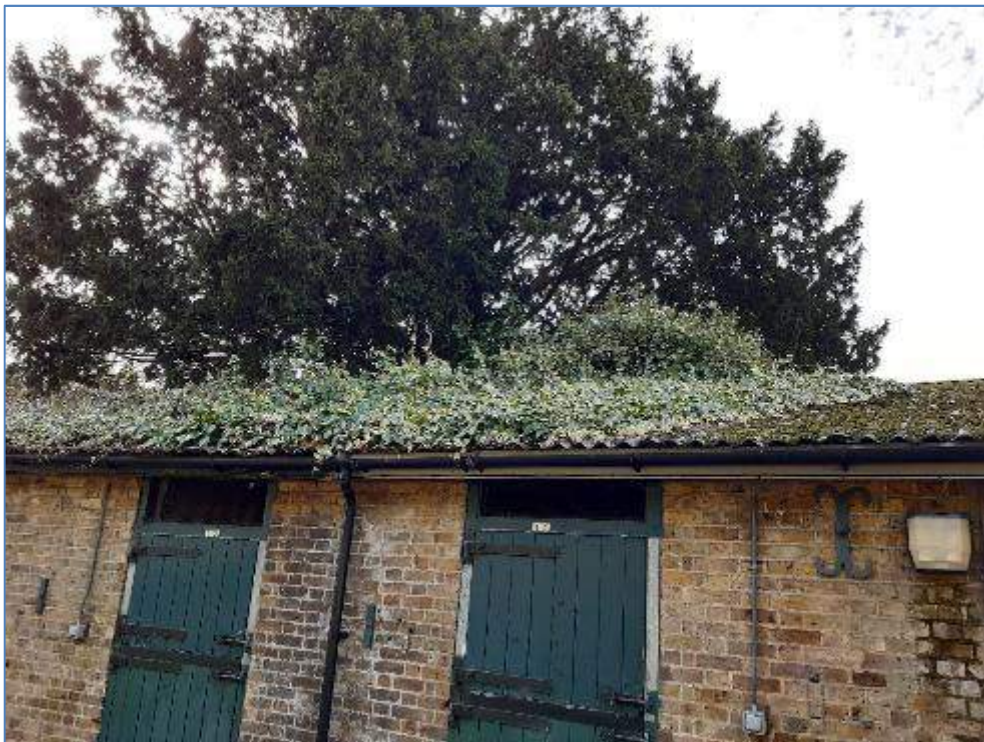
5-24 Heavy plant and moss growth on stable roofs

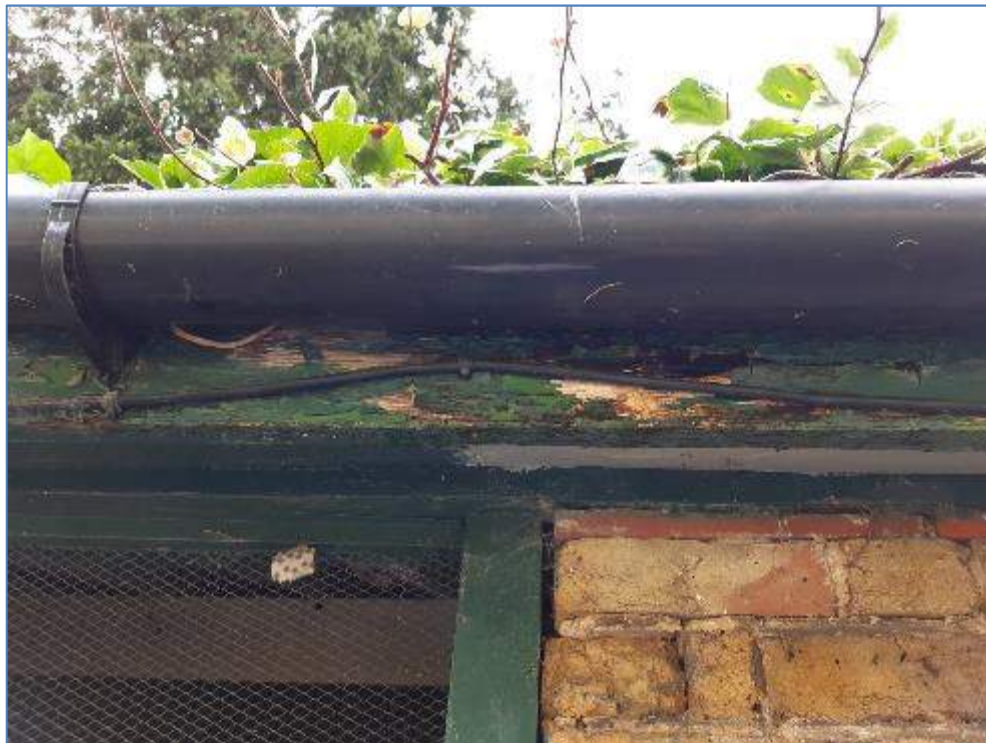
5-25 Timber eaves board decaying

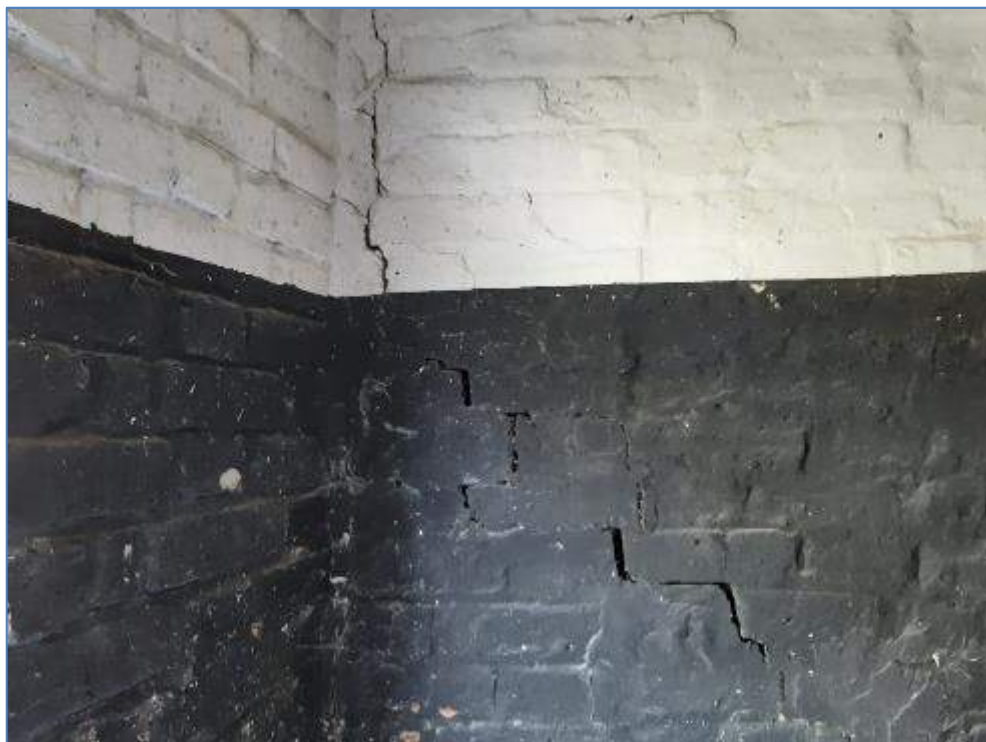
5-26 Crack in dividing wall of stable 17 and the tack boxes

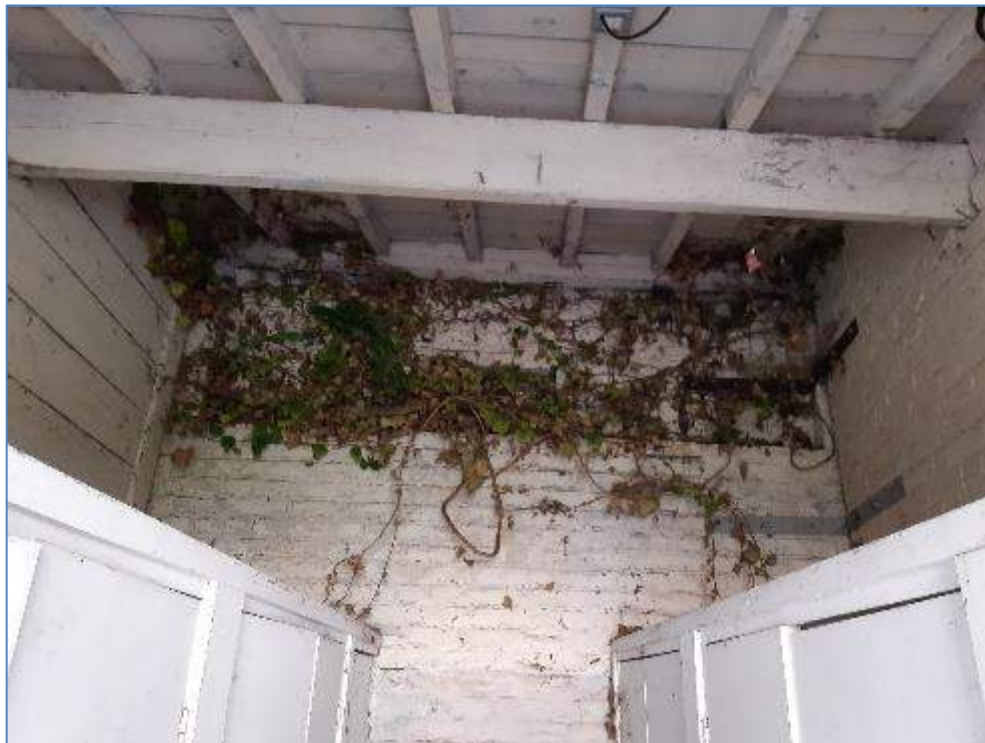
5-27 Plant growth to rear wall of tack boxes

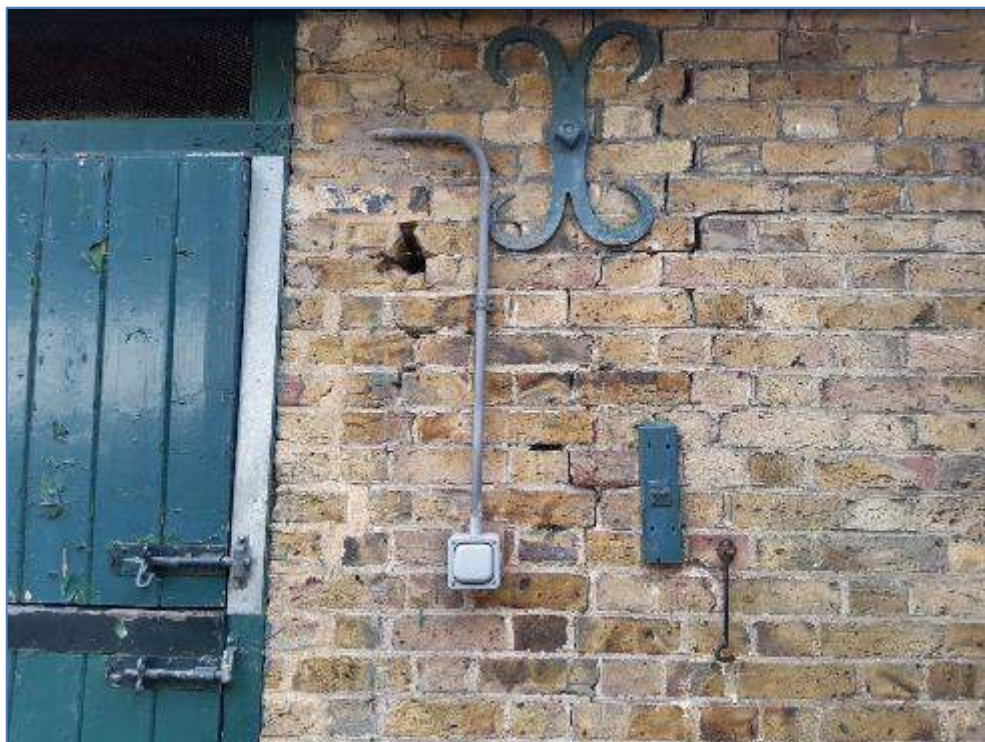
5-28 Crack in external wall of stables

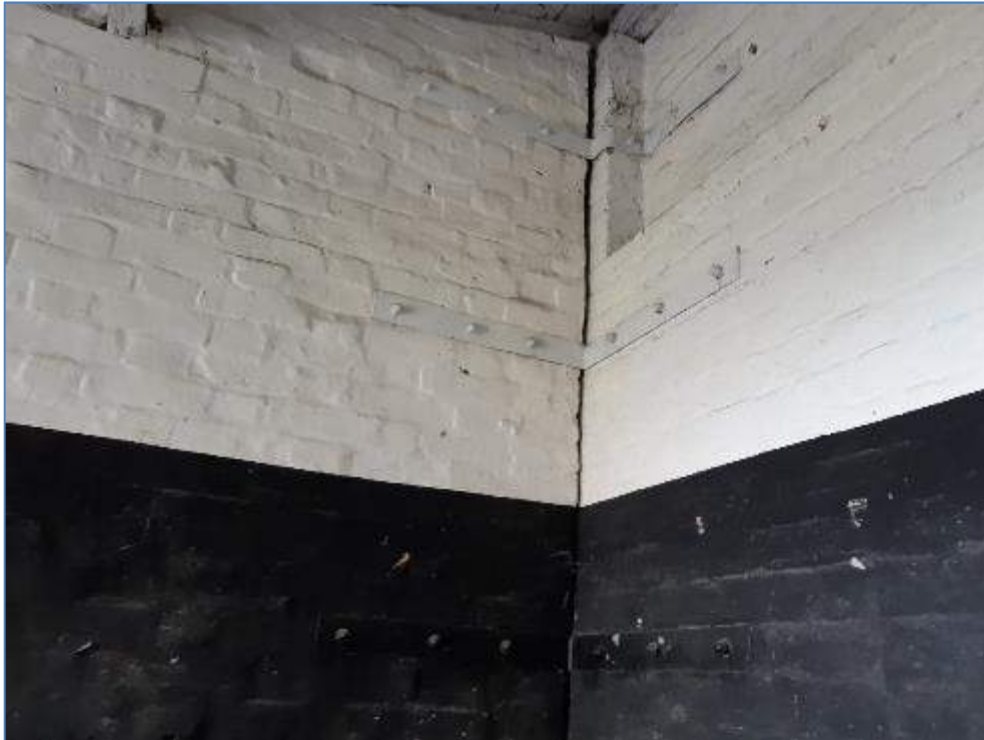
5-29 Cracking in corners of stables, restraint straps have been installed previously

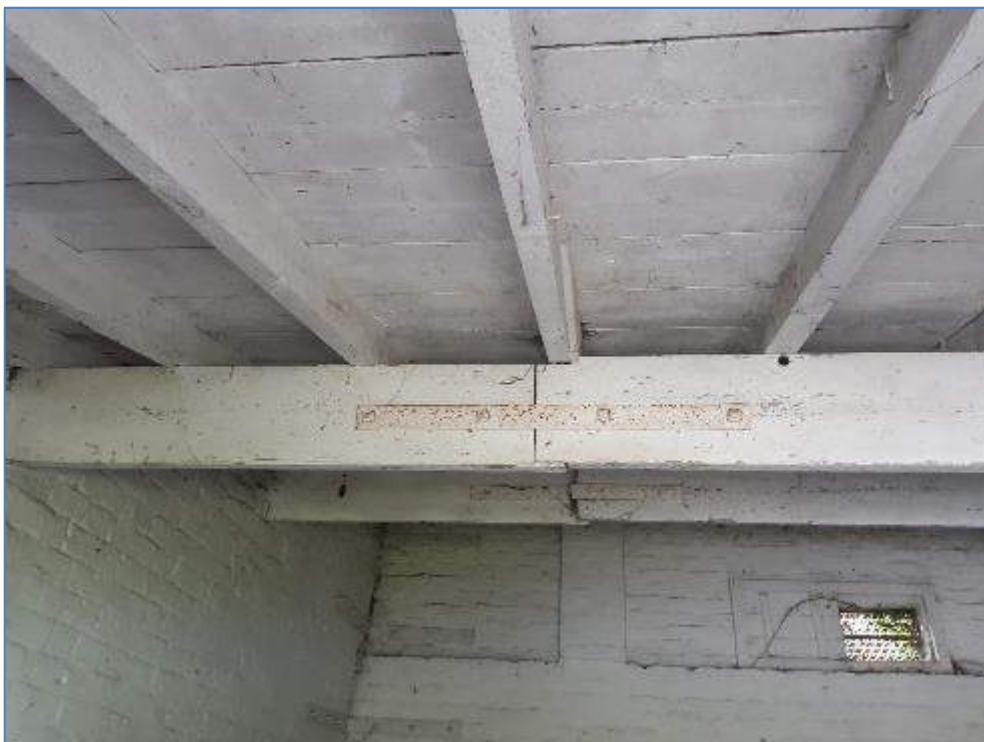
5-30 Surface rust to tie straps on timber beams

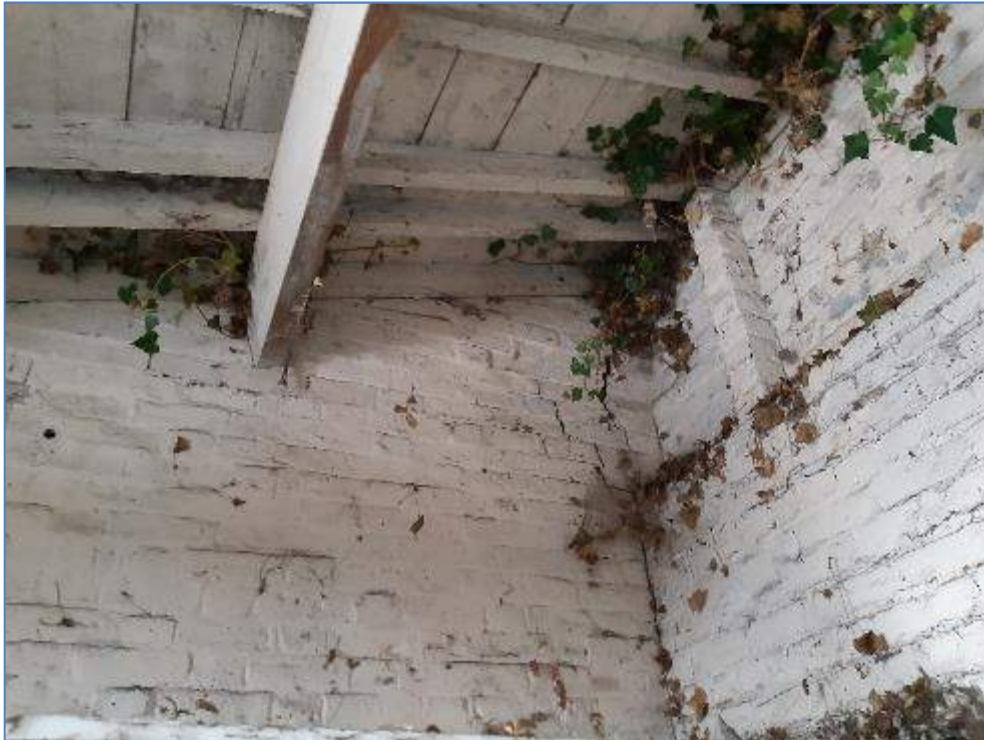
5-31 Cracking and plant growth to tack box walls

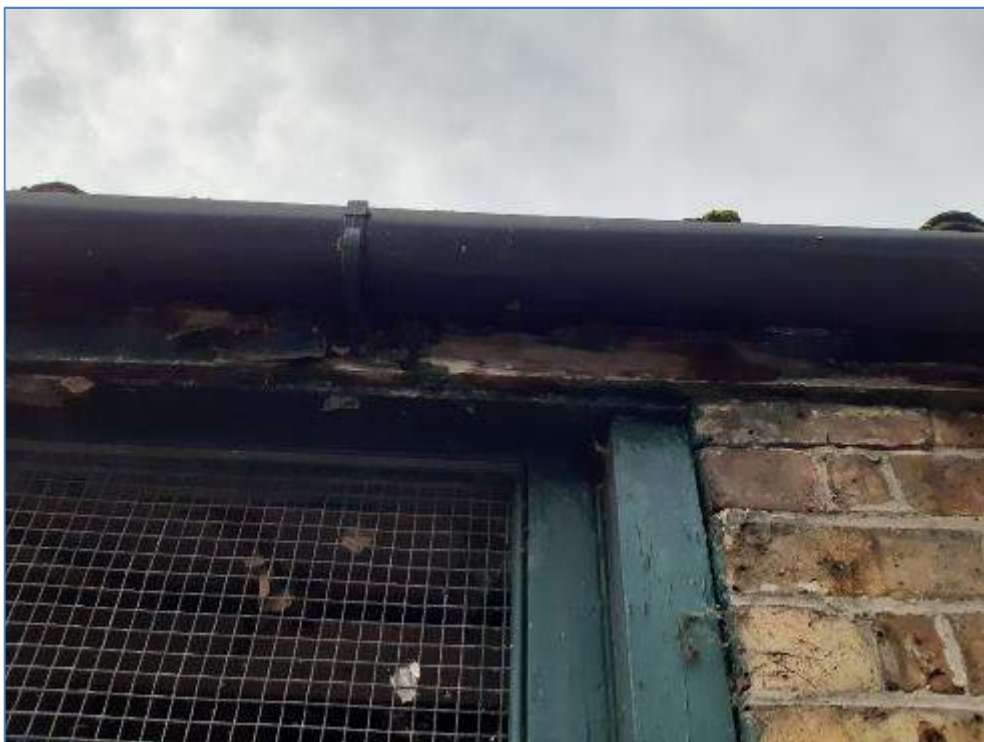
5-32 Timber eaves decaying

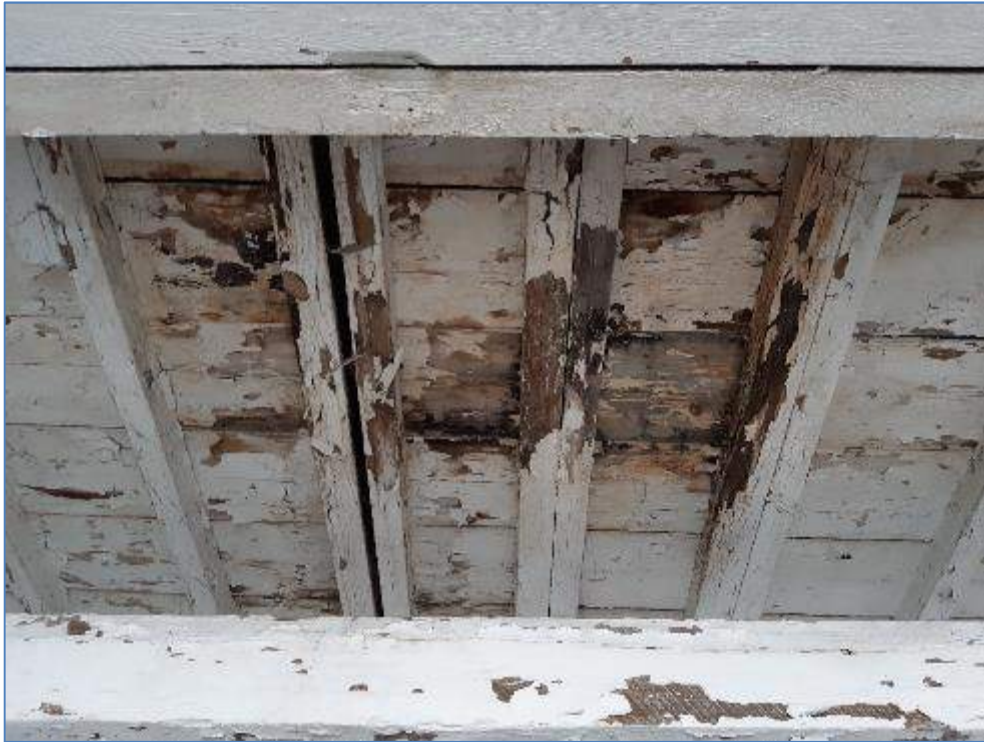
5-33 Timber soffit boarding rotting heavily in stable 46

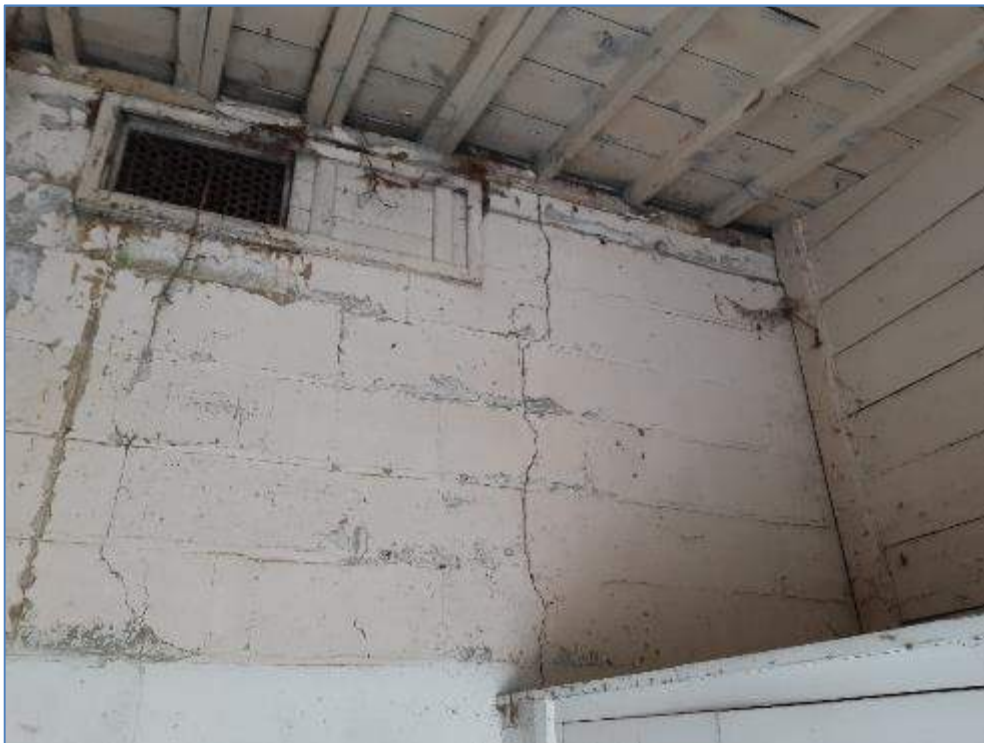
5-35 Cracks in rear wall of tack boxes

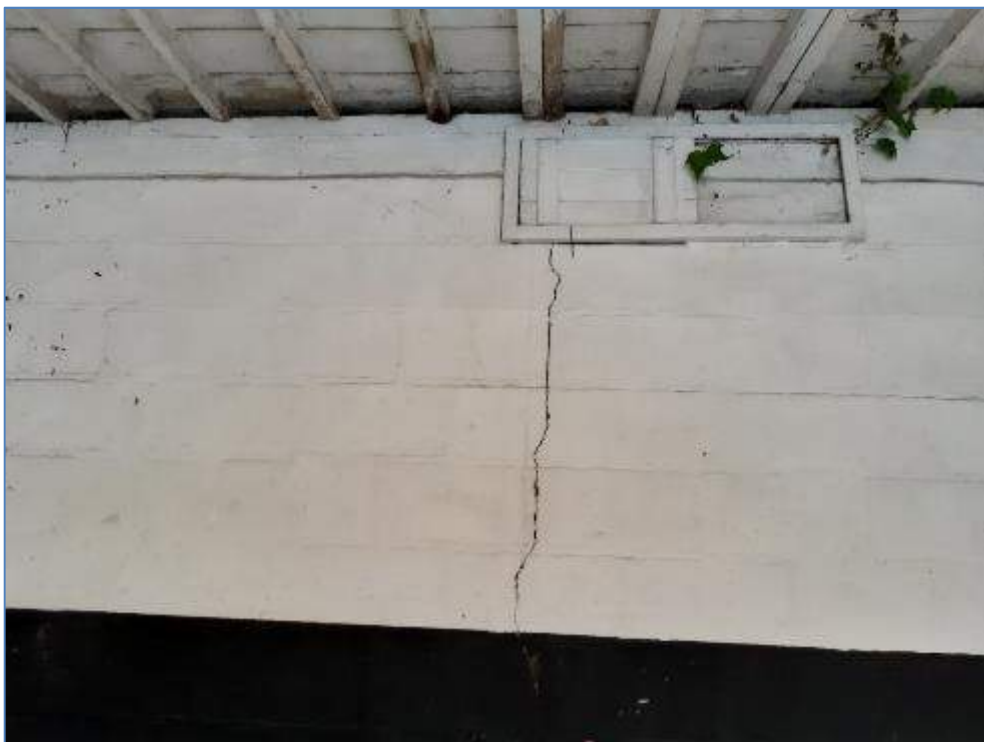
5-36 Vertical crack in rear wall of stable 52

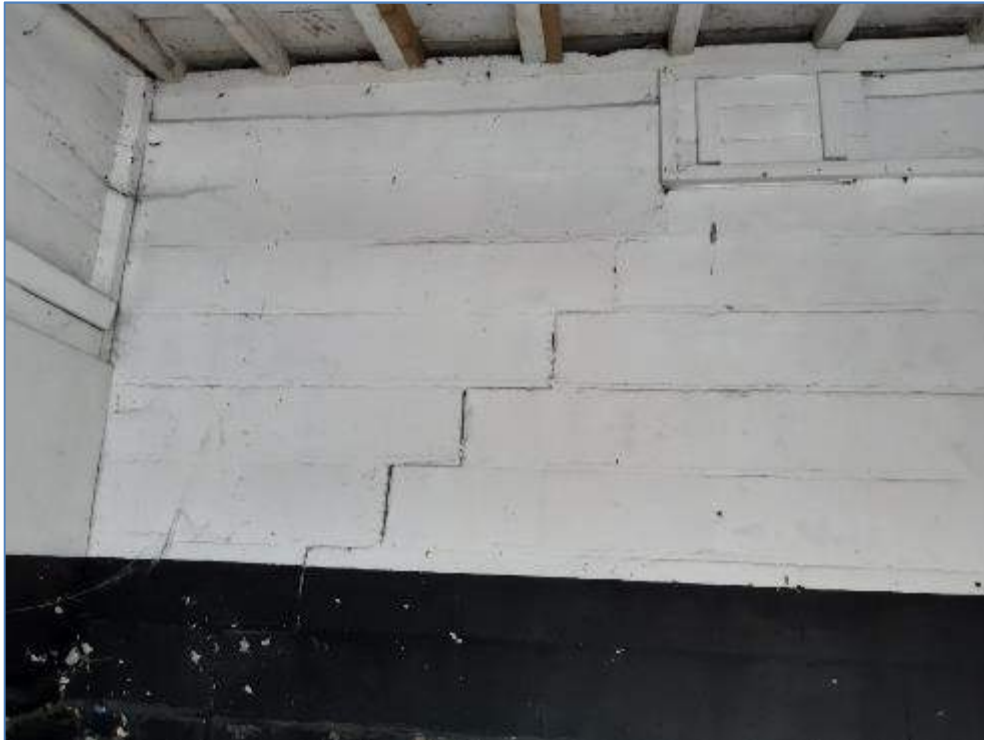
5-37 Diagonal crack in rear wall of stable 48

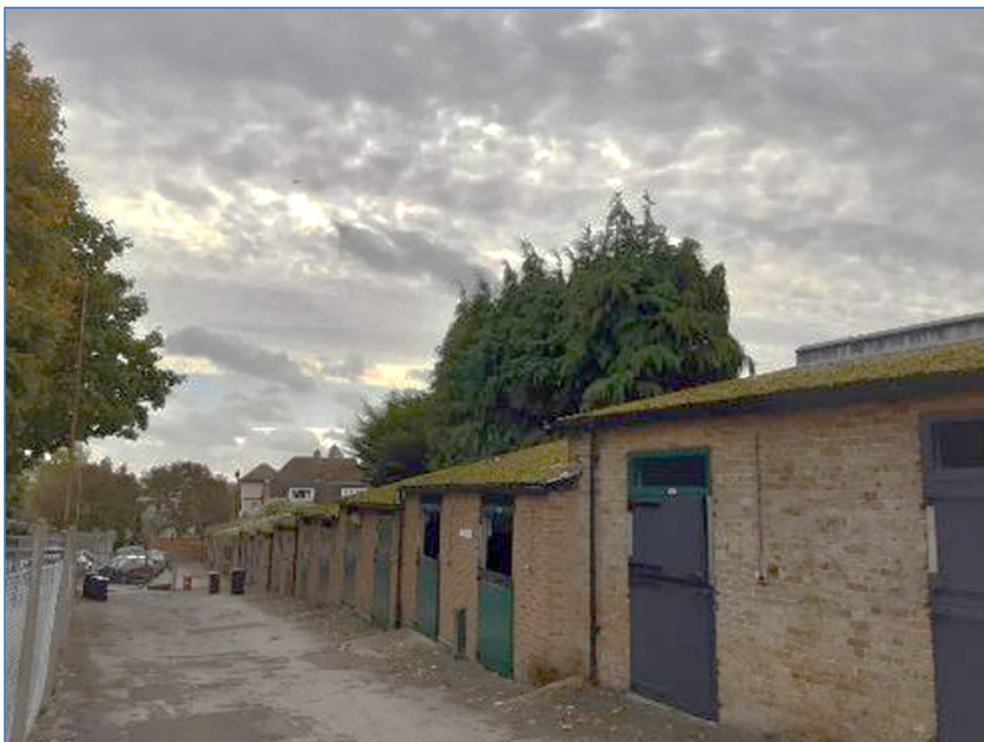
5-38 Heavy moss growth on stable roofs

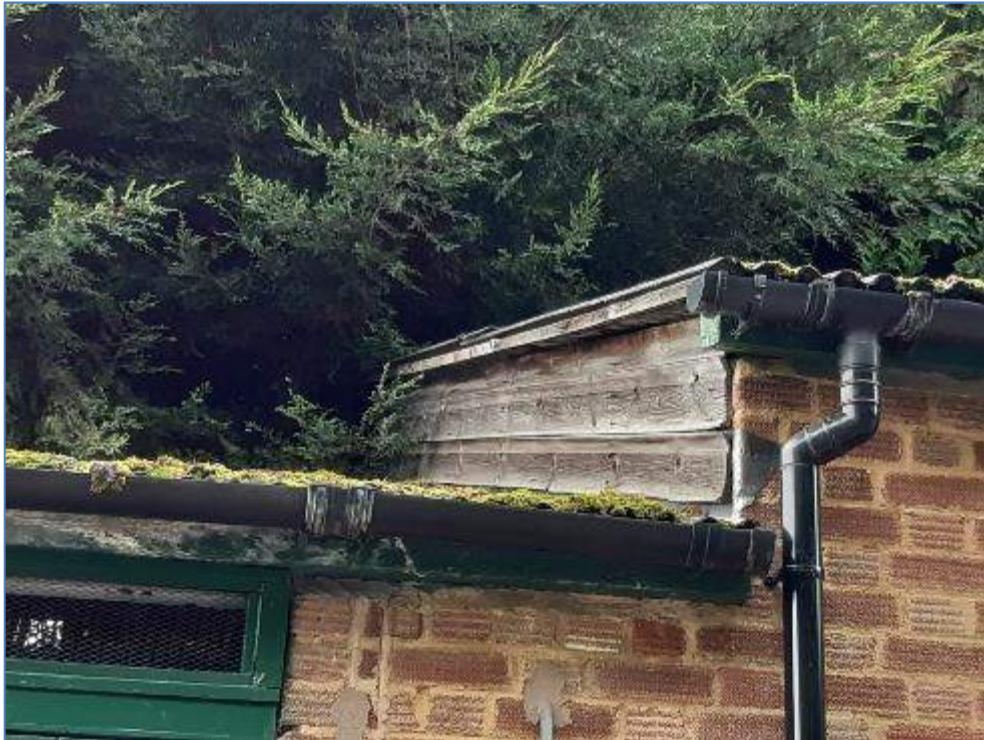
5-39 Timber step boarding decaying and warped in places

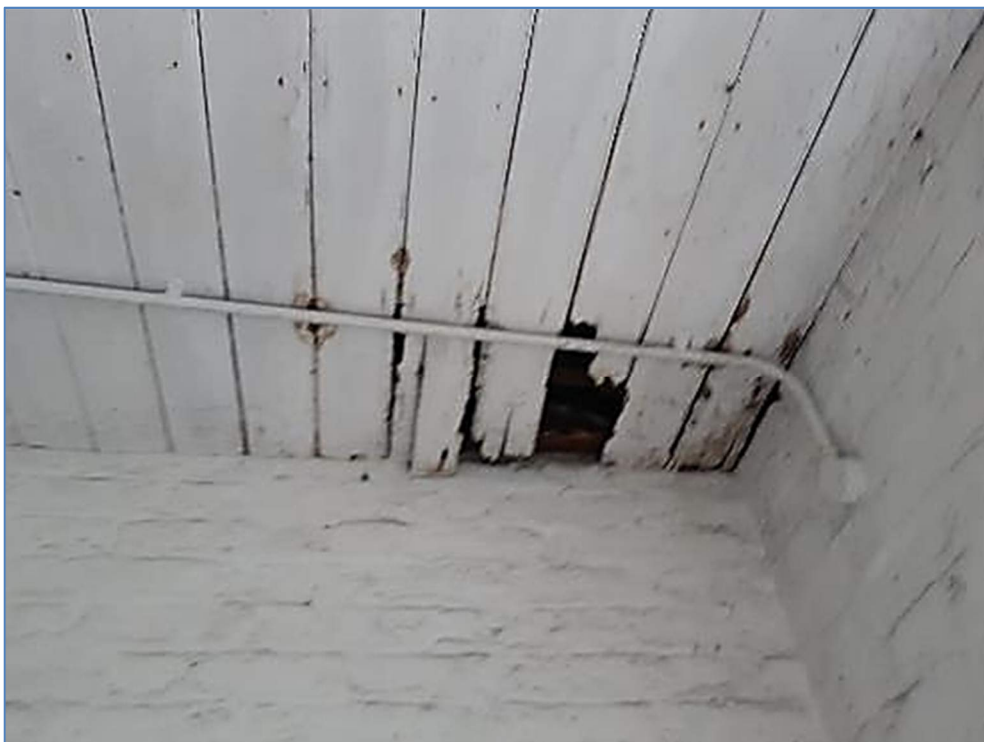
5-40 Timber soffit boards decaying in stable 57

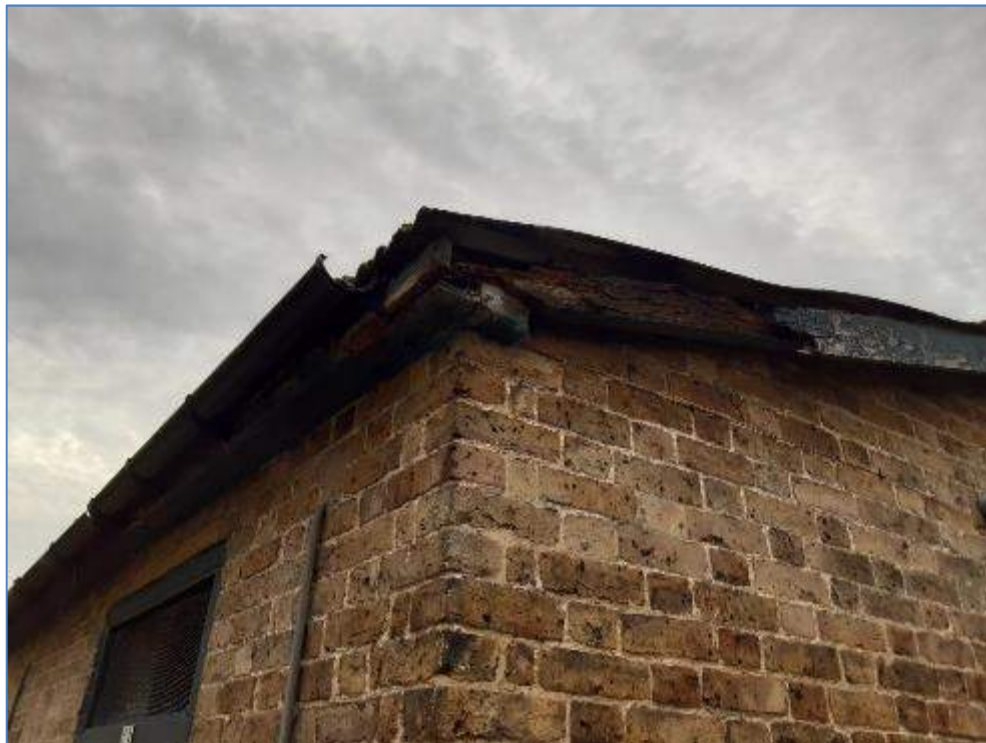
5-41 Timber fascia board decaying

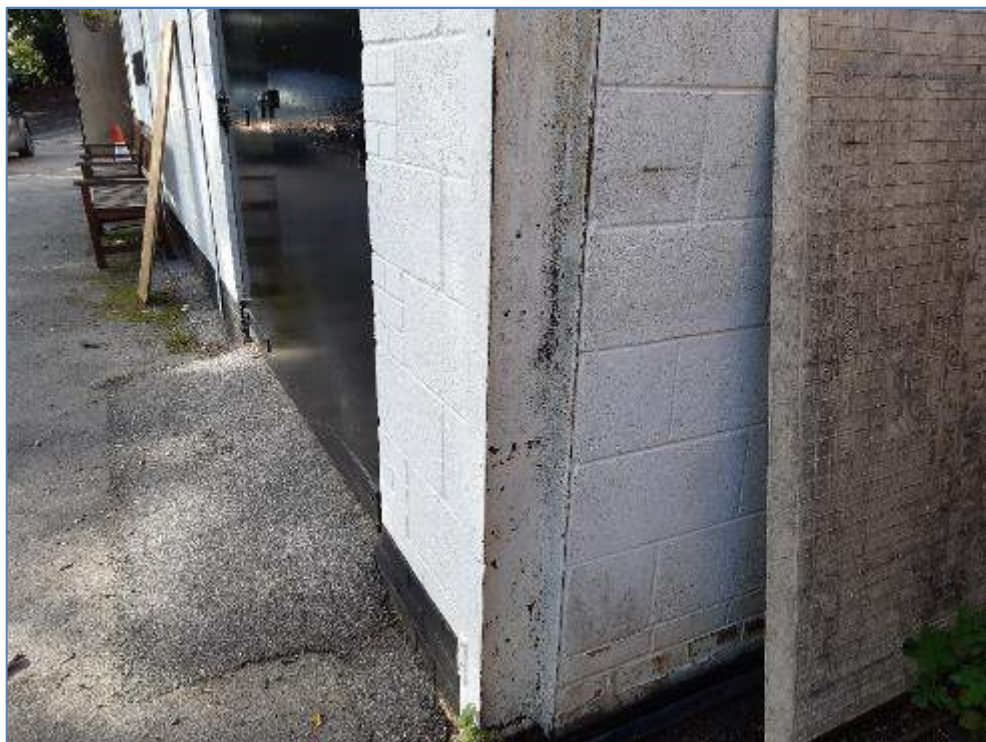
5-42 Paint peeling from steel frame of maintenance workshop

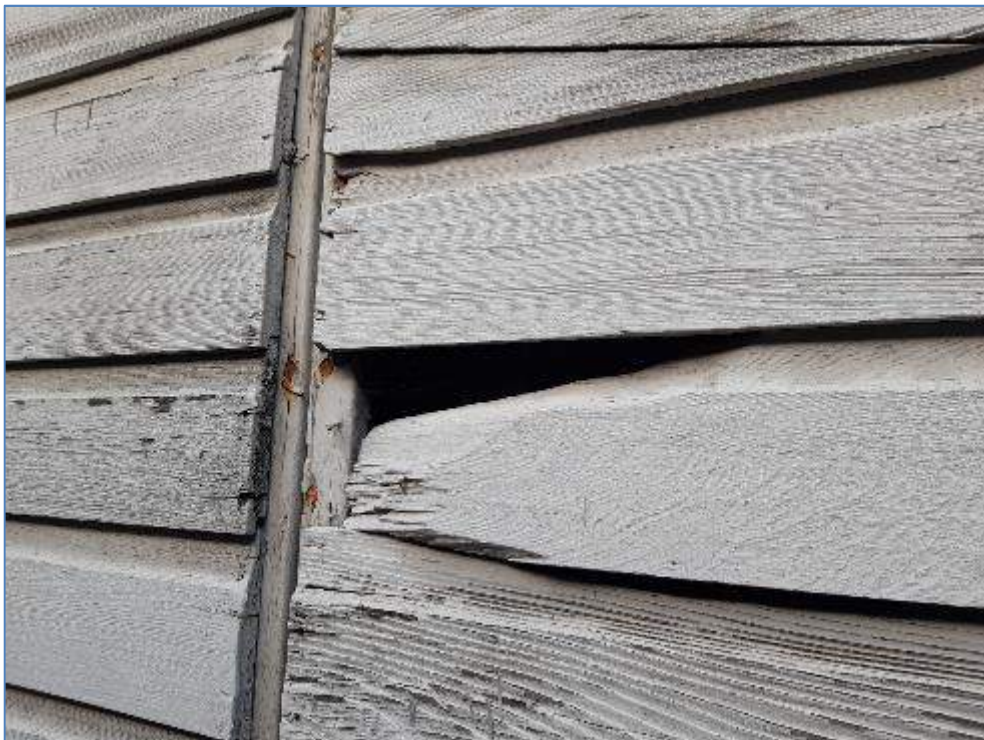
6-02 Timber cladding damaged in places

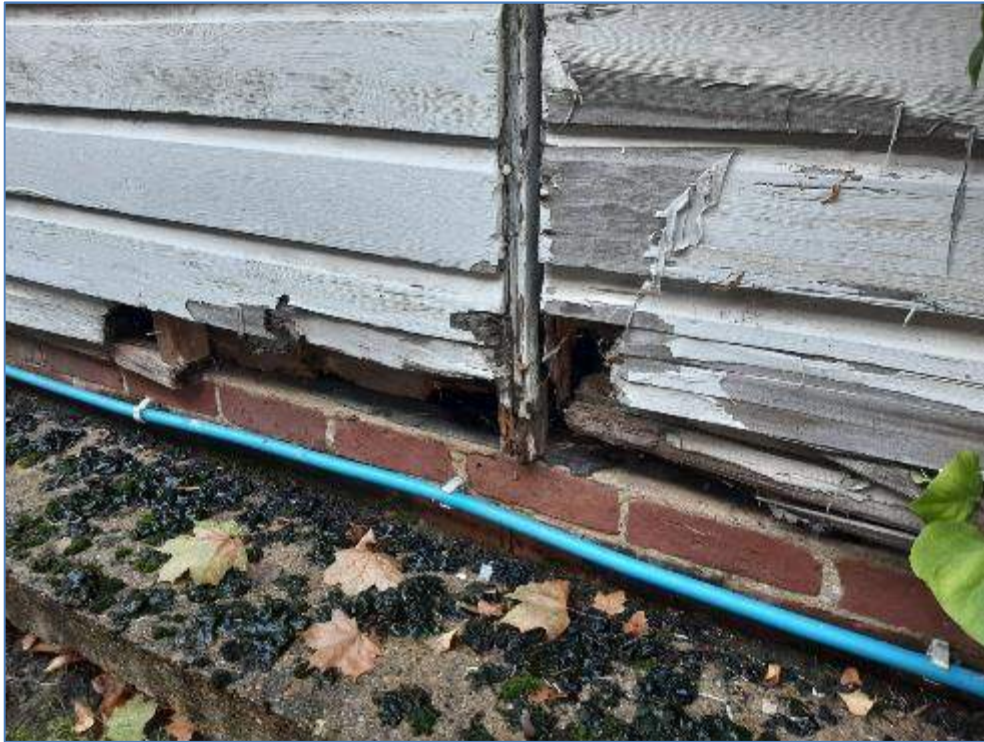
6-03 Timber cladding decaying heavily in places

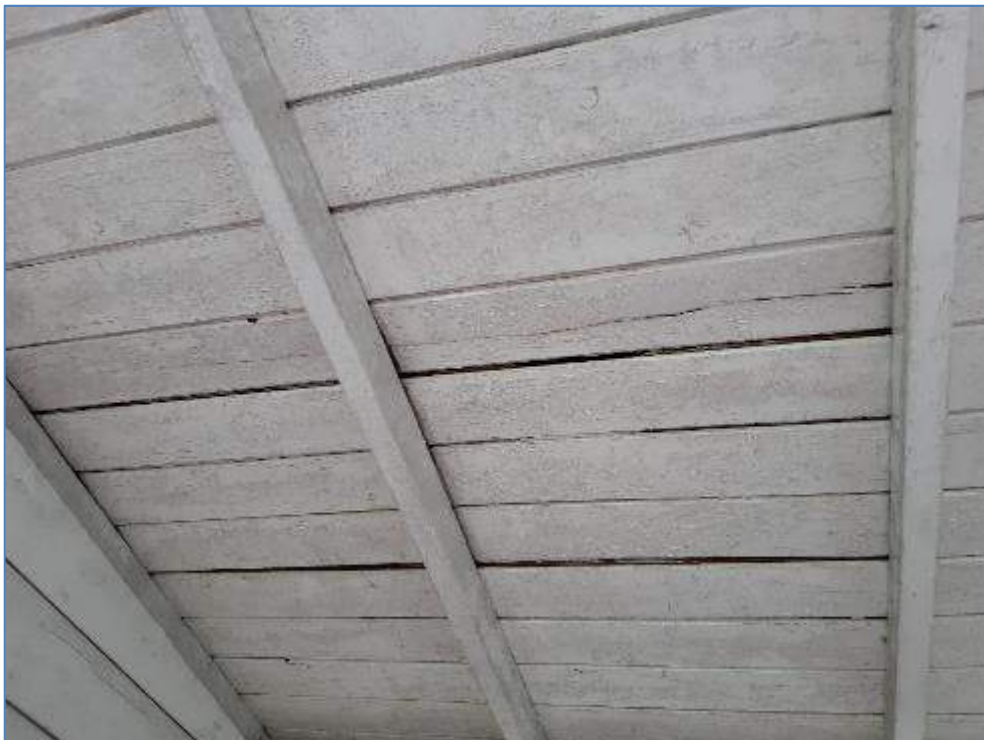
6-04 Timber soffit boards warping in some places

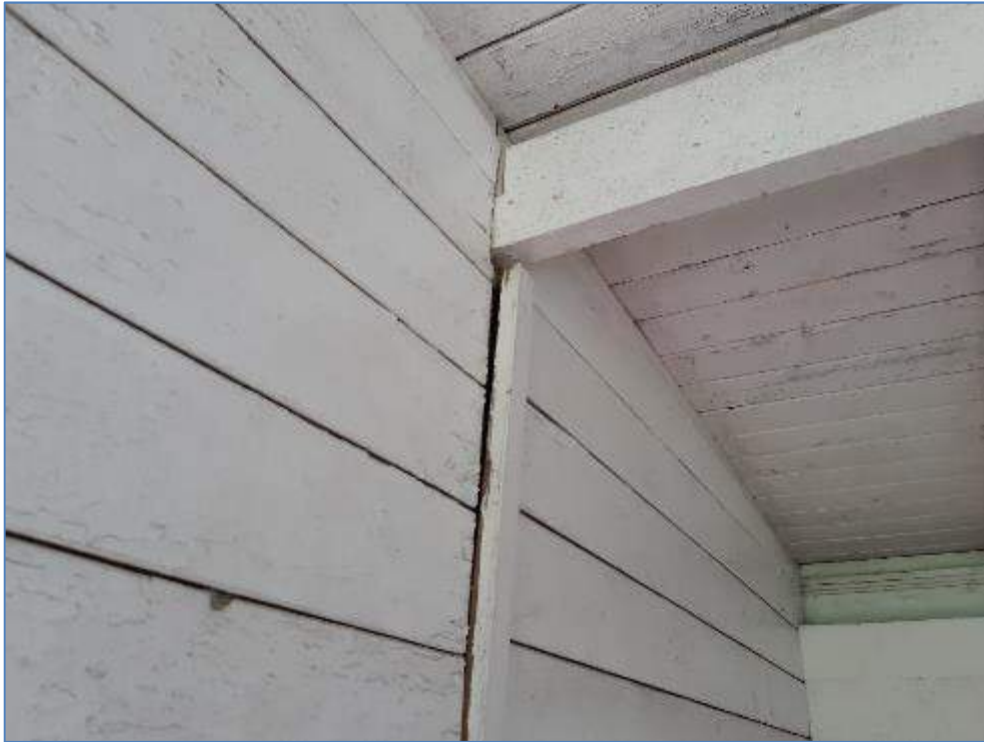
6-05 Timber infill section working loose

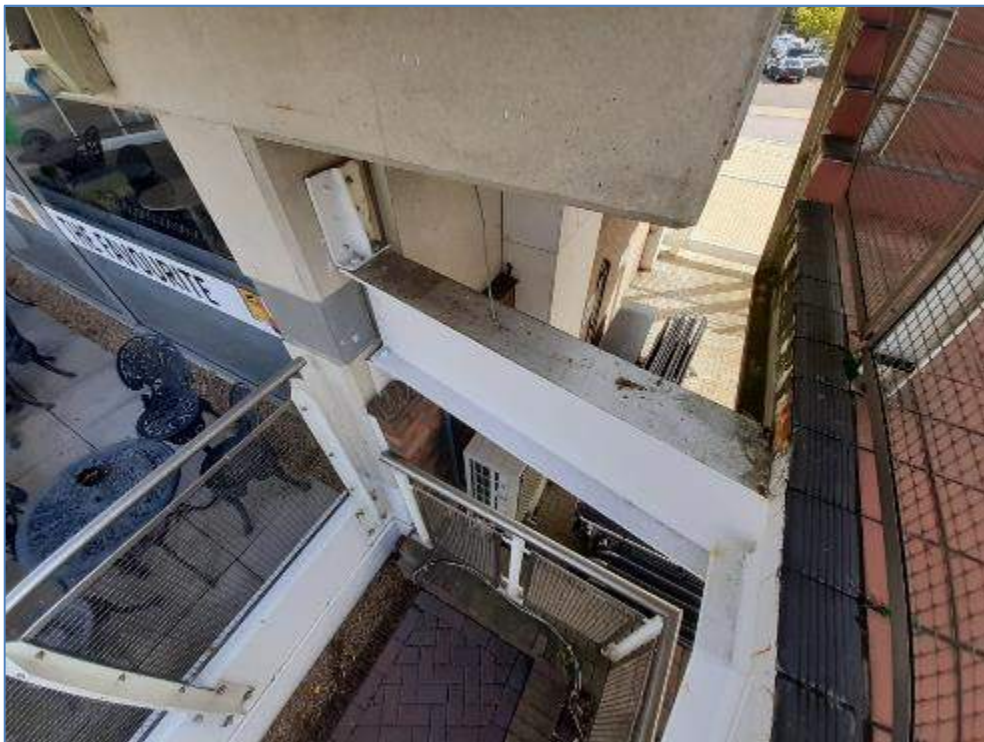
7-01 Minor spots of rust to steel frame of media centre
