JCR Statement of Case PART 2 OF 6 - Appendix 1

# ANNUAL STRUCTURAL SURVEY 2019

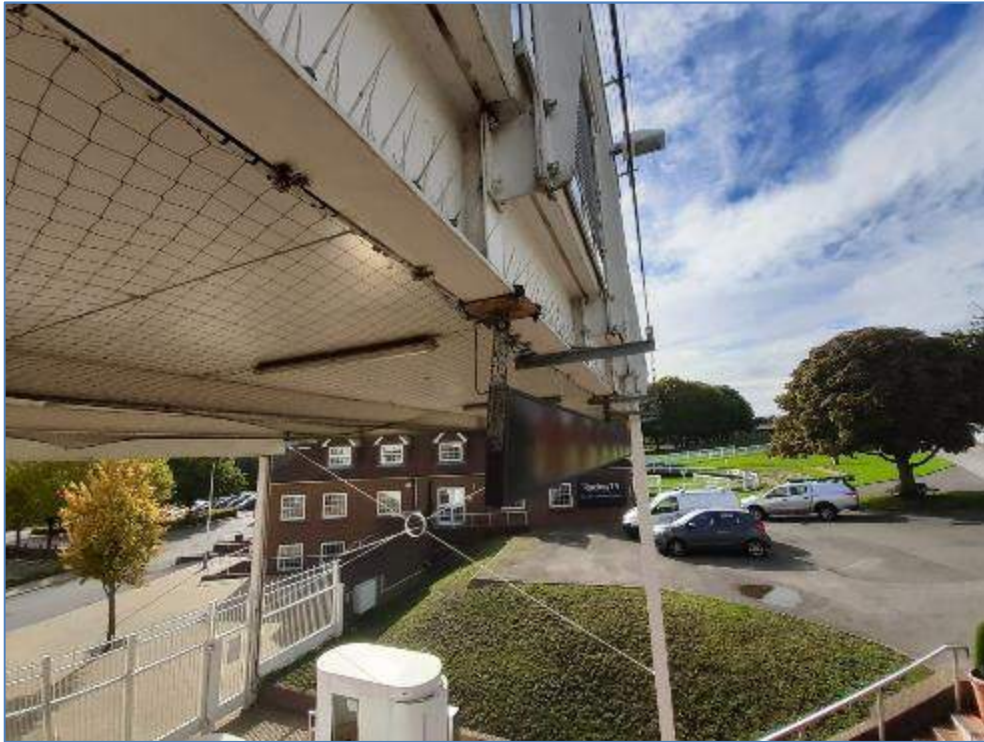
7-02 Brackets to illuminated sign rusting

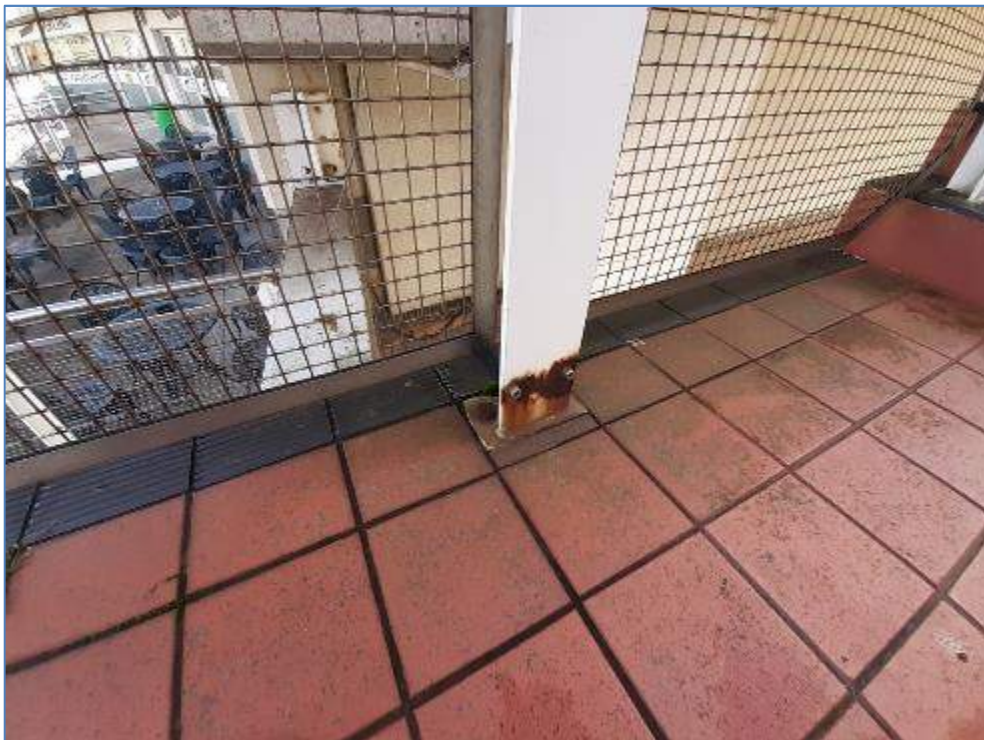
7-03 Steel riser plates to handrails rusting

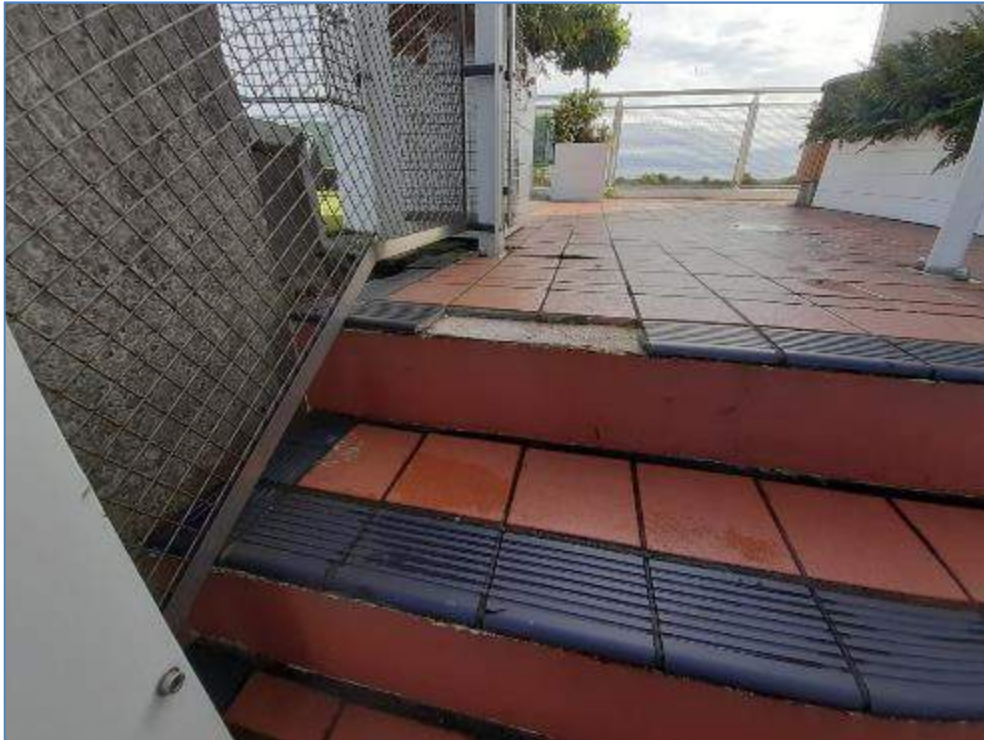
7-04 Tiles missing at top of stair to terrace

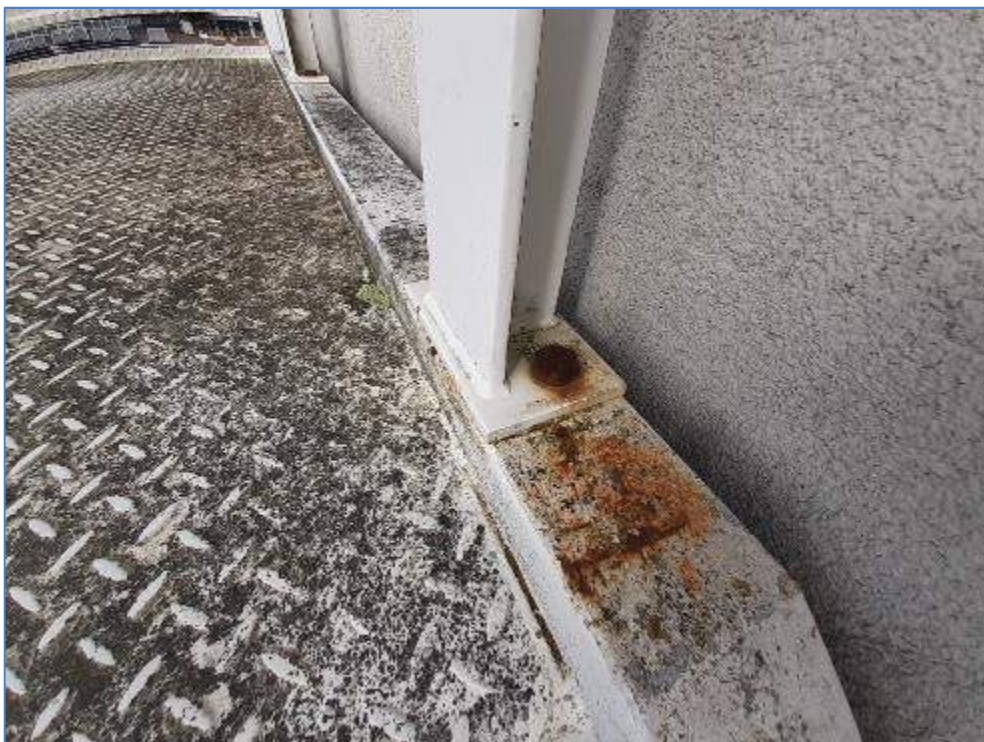
7-05 Bolts rusting on steel stair handrails

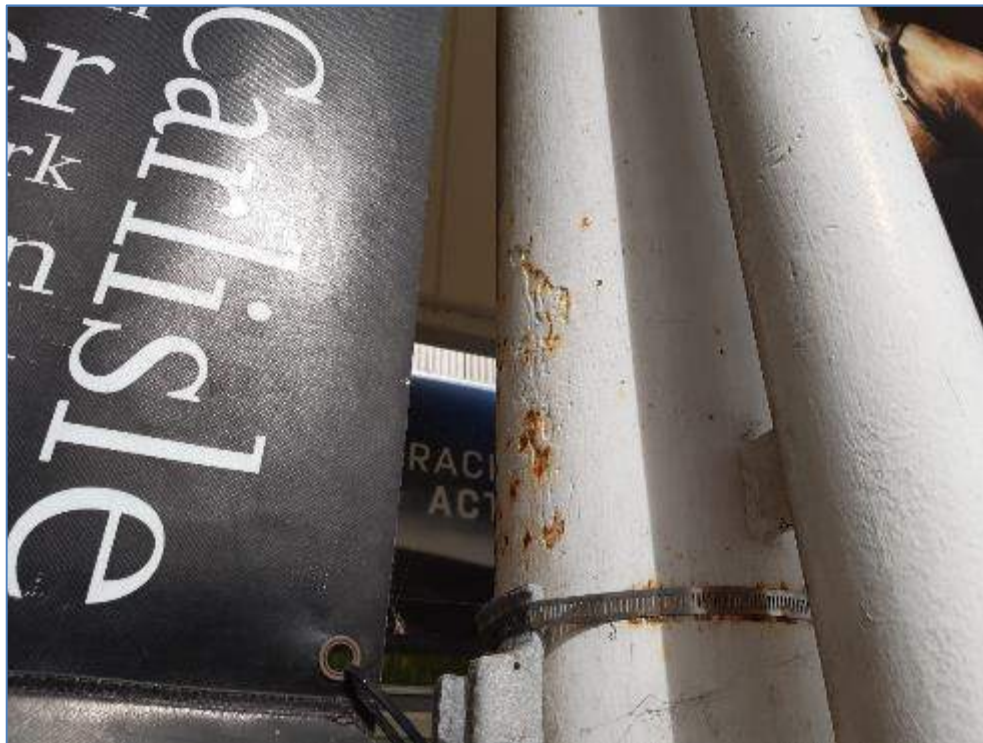
7-06 Minor surface rust to steel frame

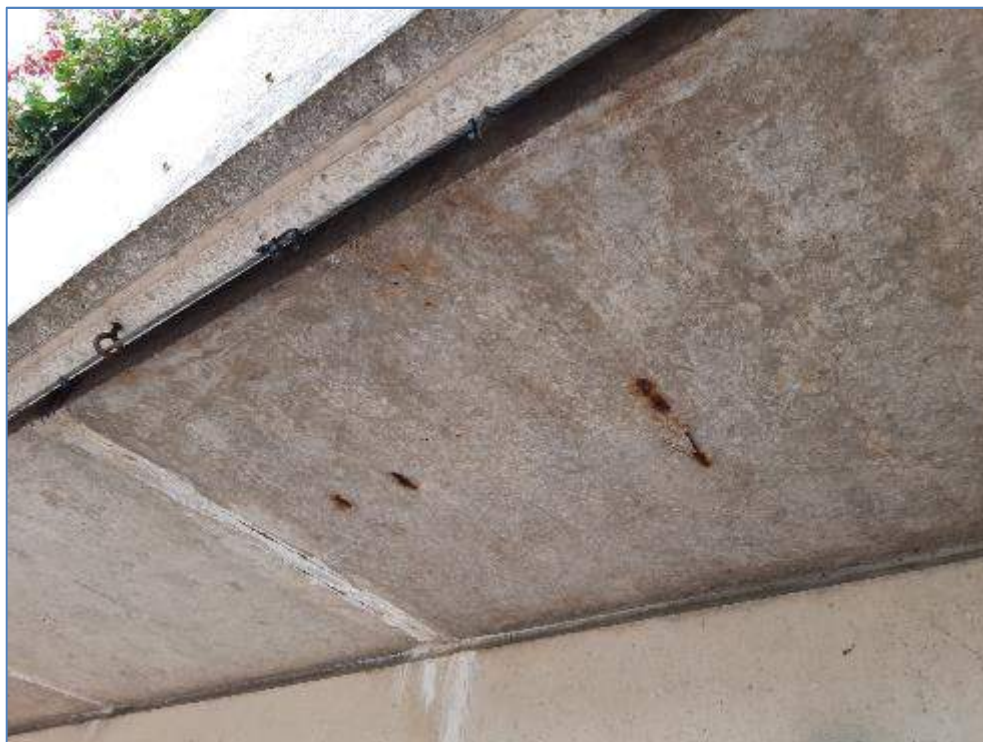
7-07 Concrete spalling on soffit of terrace, rebar can be seen corroding

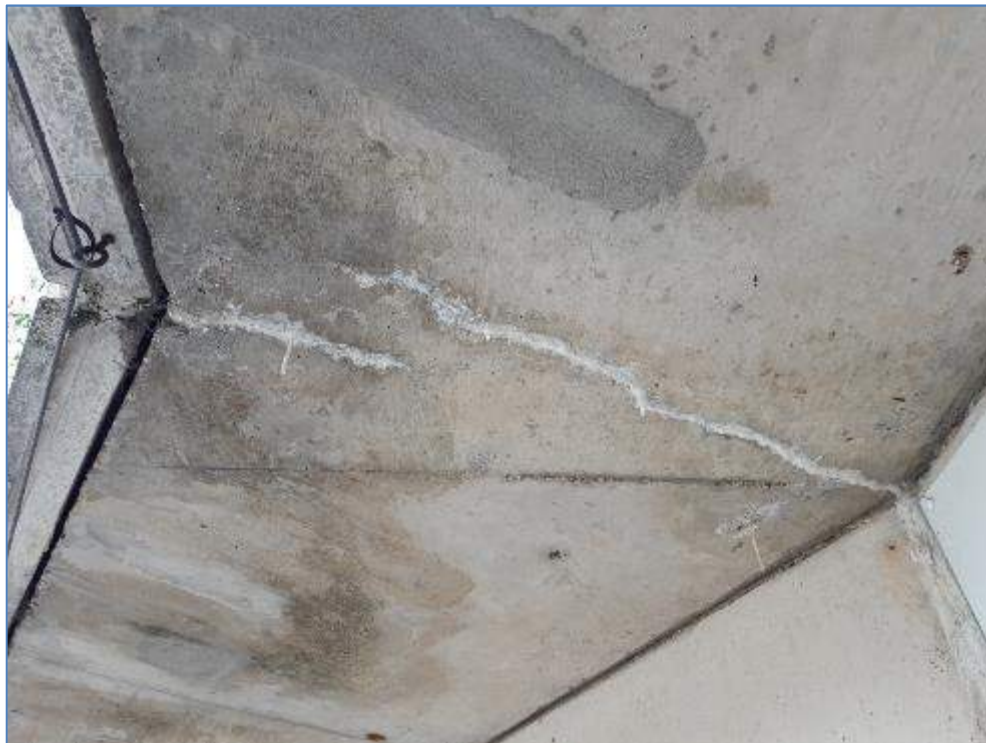
7-08 Areas of leaching on soffit of viewing terrace

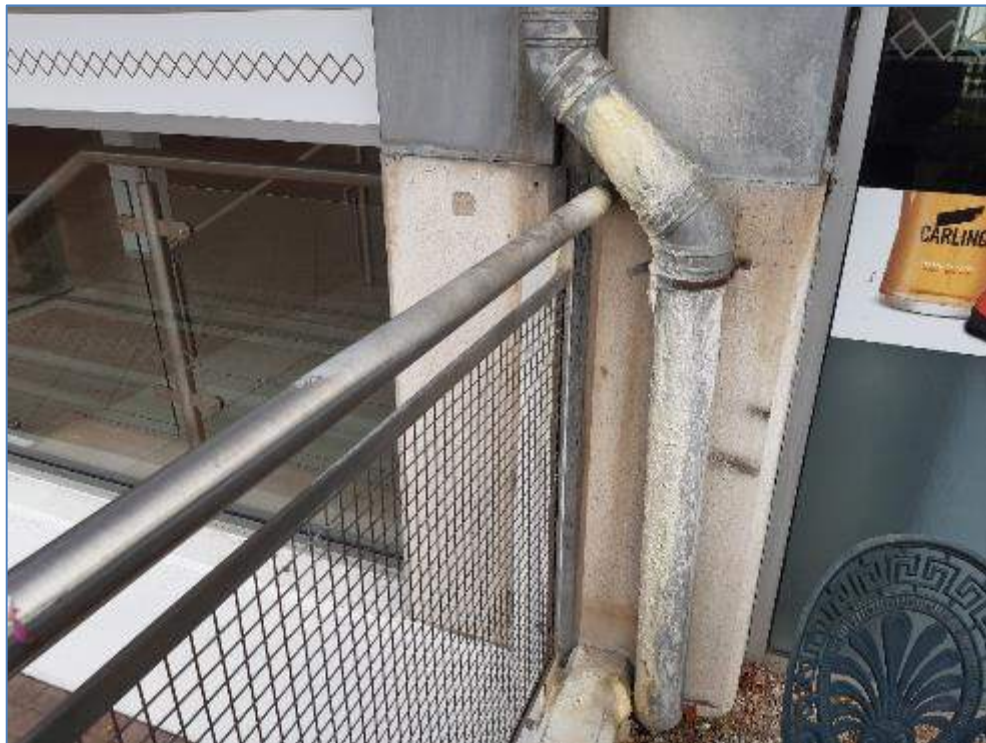
7-10 Substance leaking onto handrail and downpipe underneath terrace

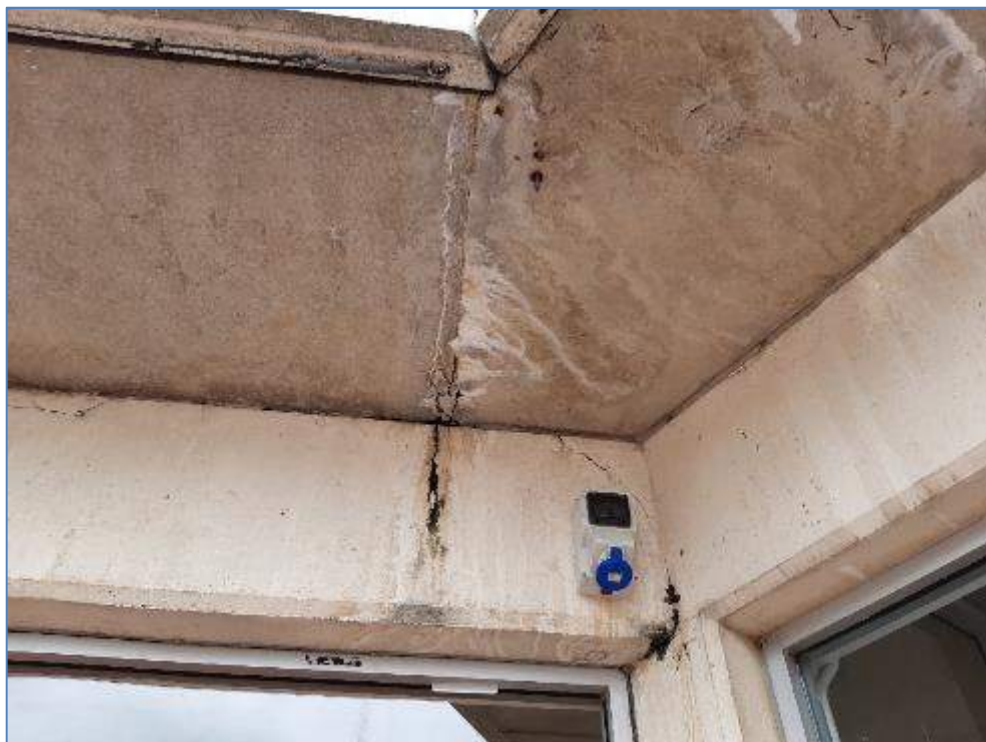
7-11 Cracking in soffit and corner of viewing terrace

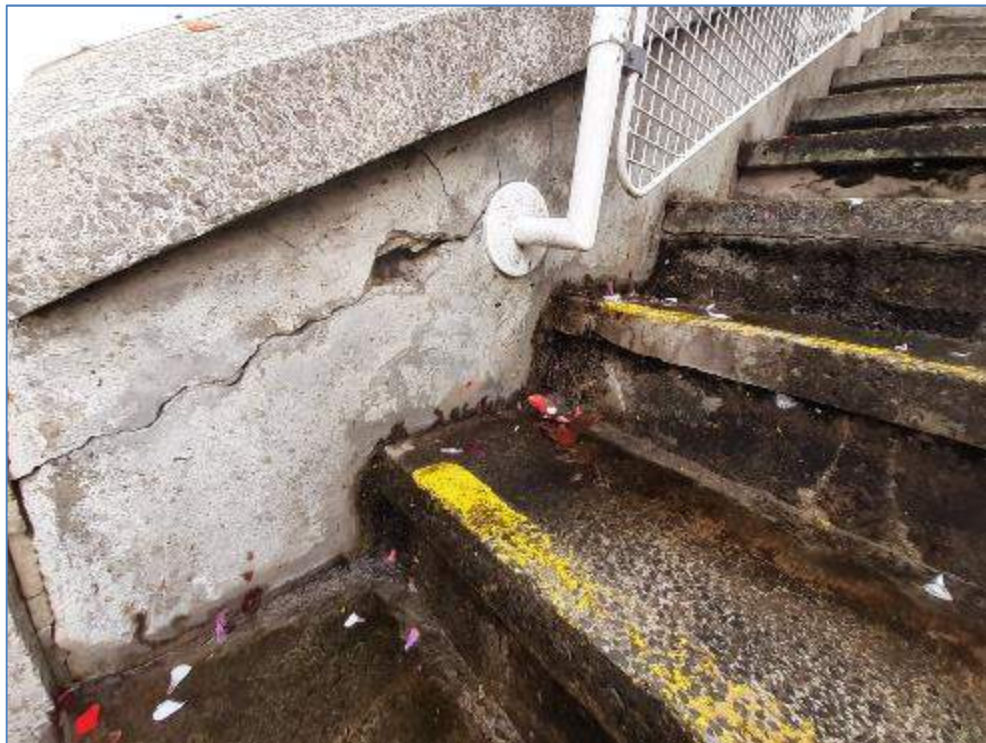
7-12 Cracking in concrete of central steps

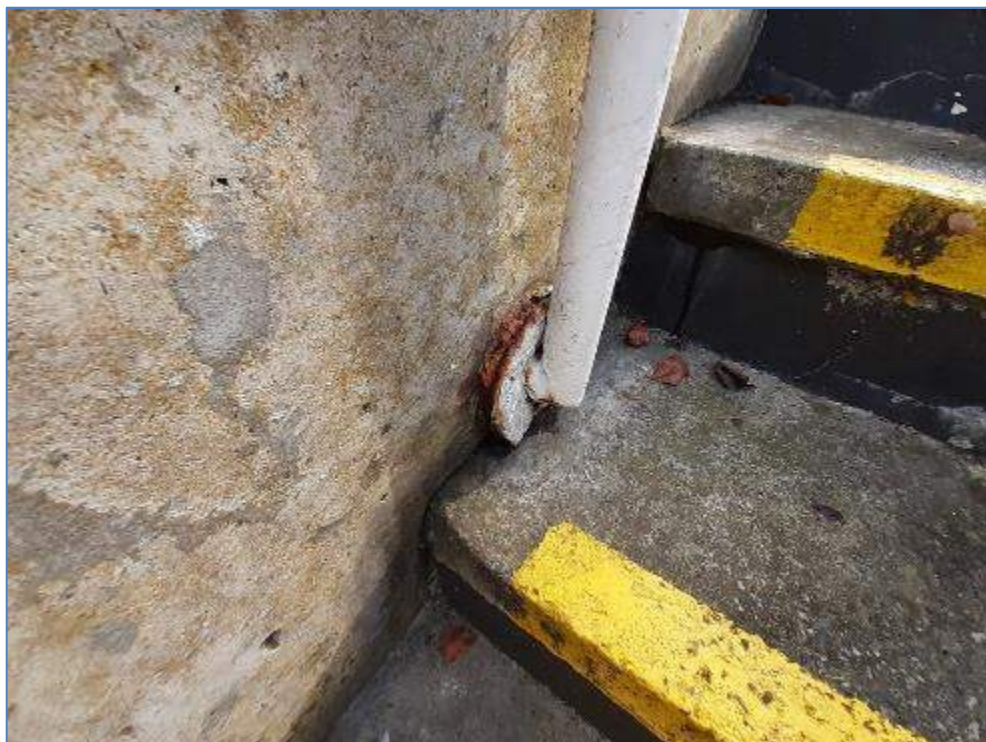
7-13 Steel handrail rusting at fixings

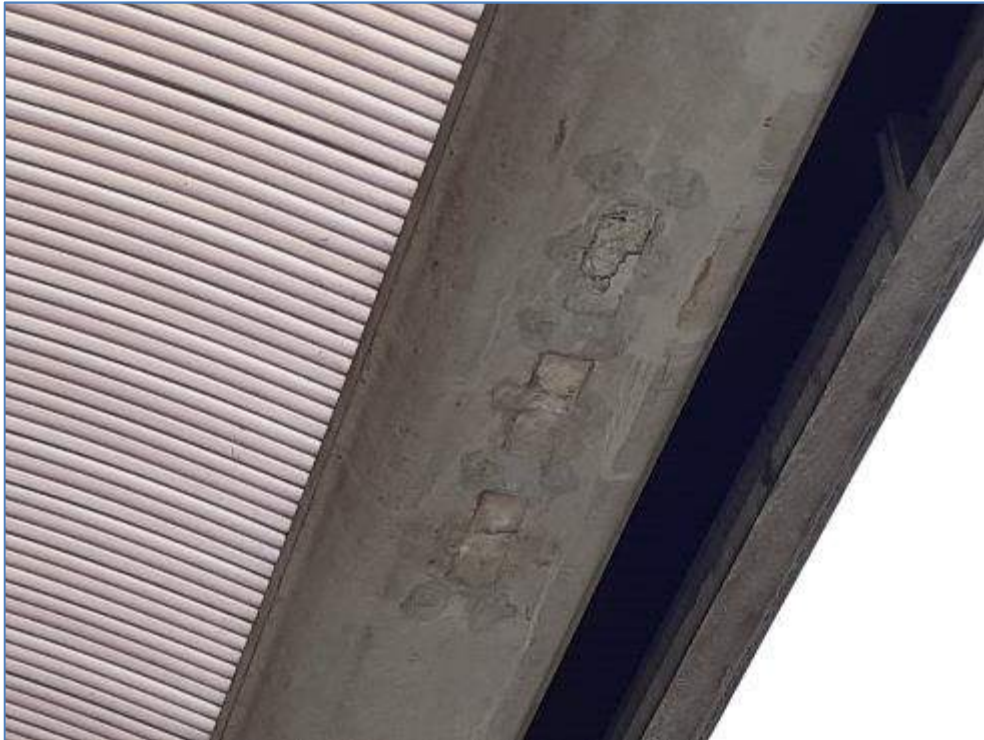
7-14 Concrete spalling from roof beams

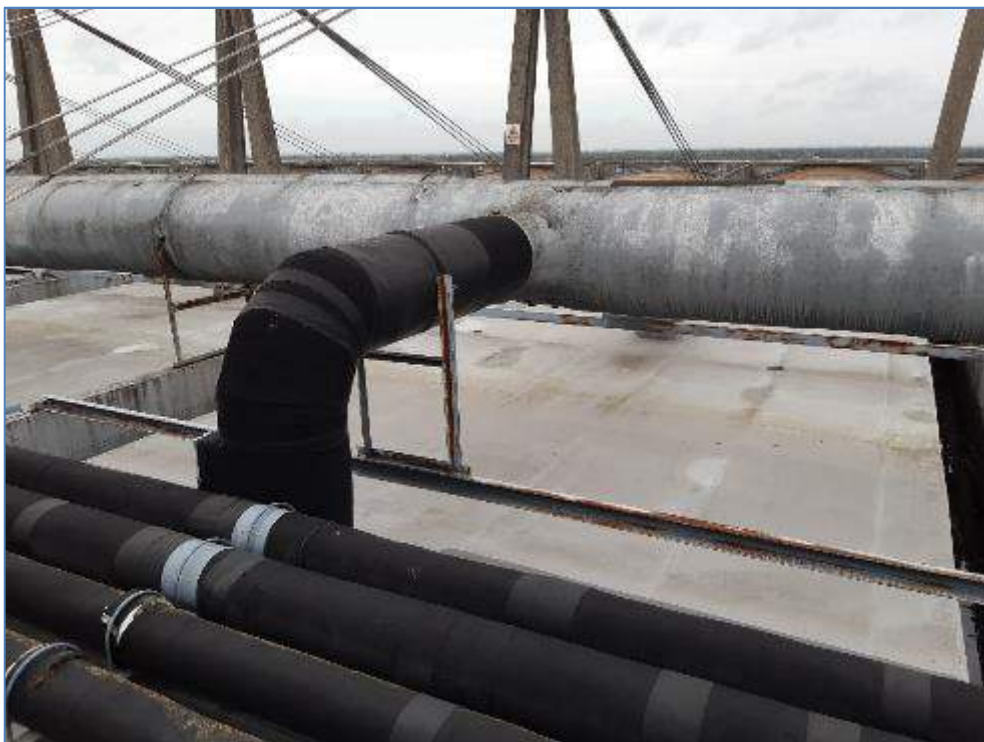
7-15 Secondary steelwork for plant equipment is rusting

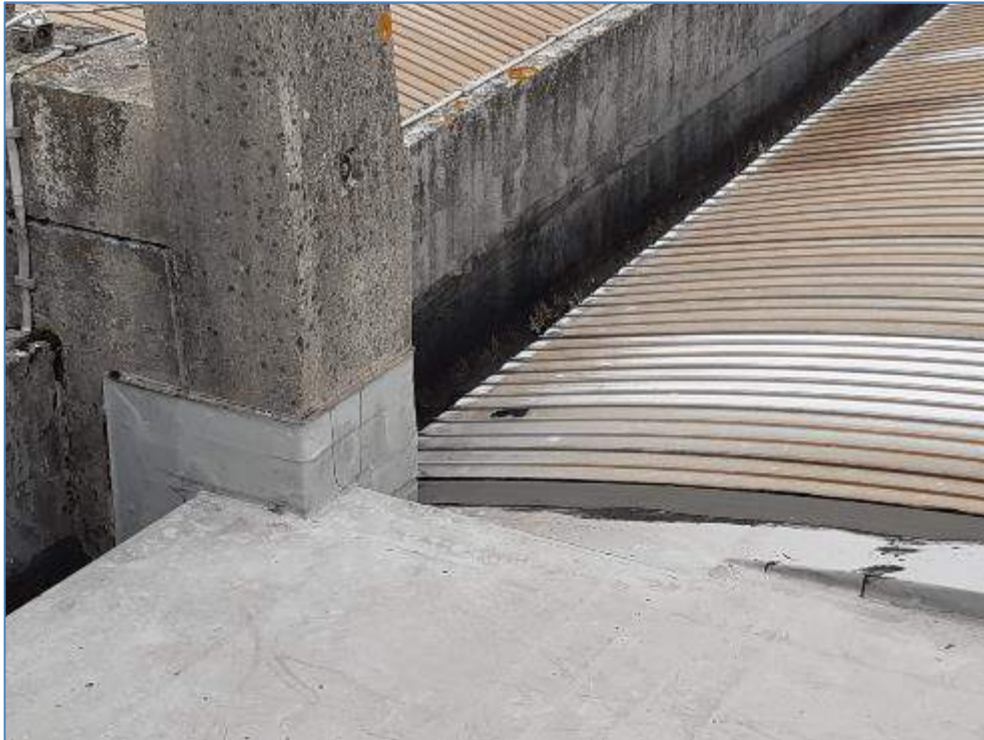
7-16 Some sections of roof infill panels damaged

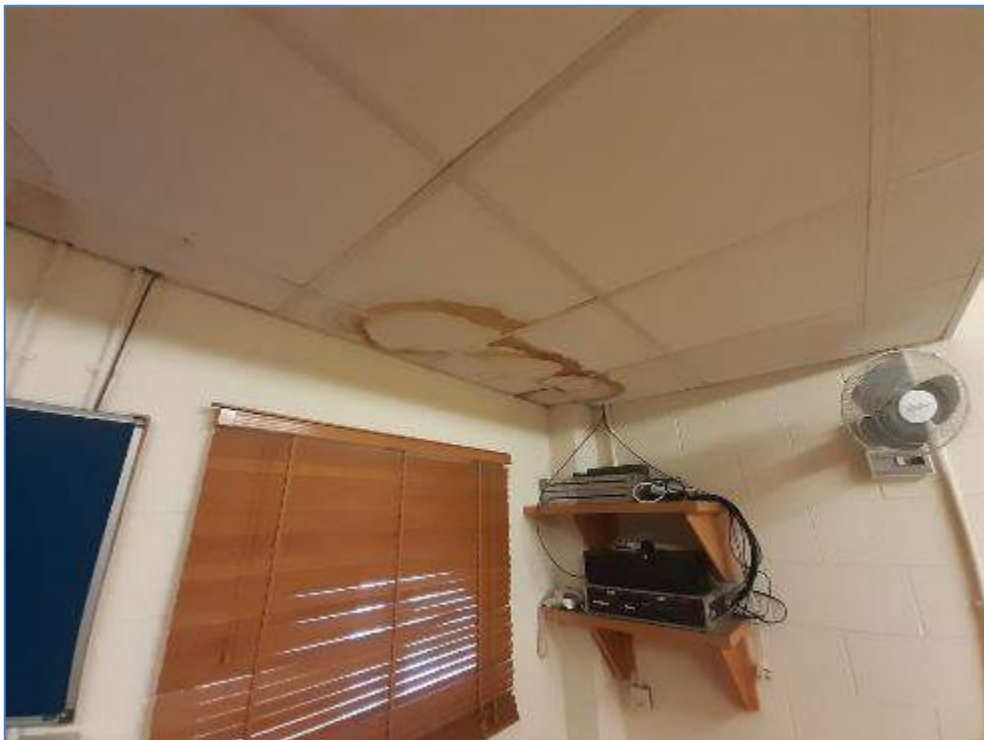
7-17 Damp in ceiling of switch room / staff kitchen area

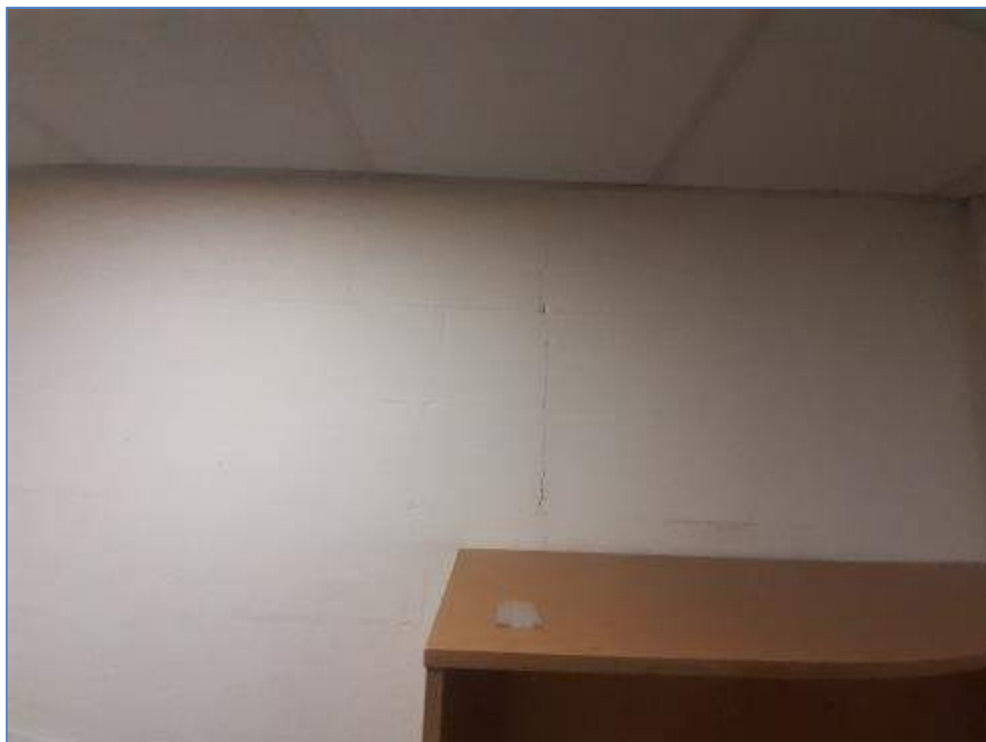
7-21 Cracking in wall of organisers office

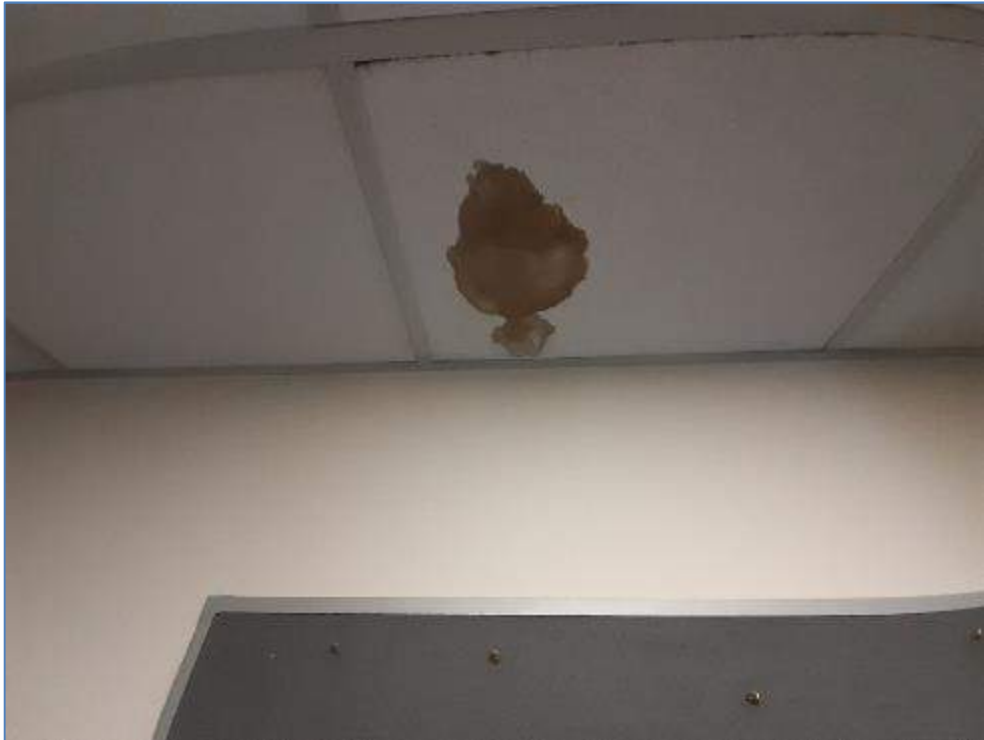
7-22 Minor damp in ceiling of organisers office

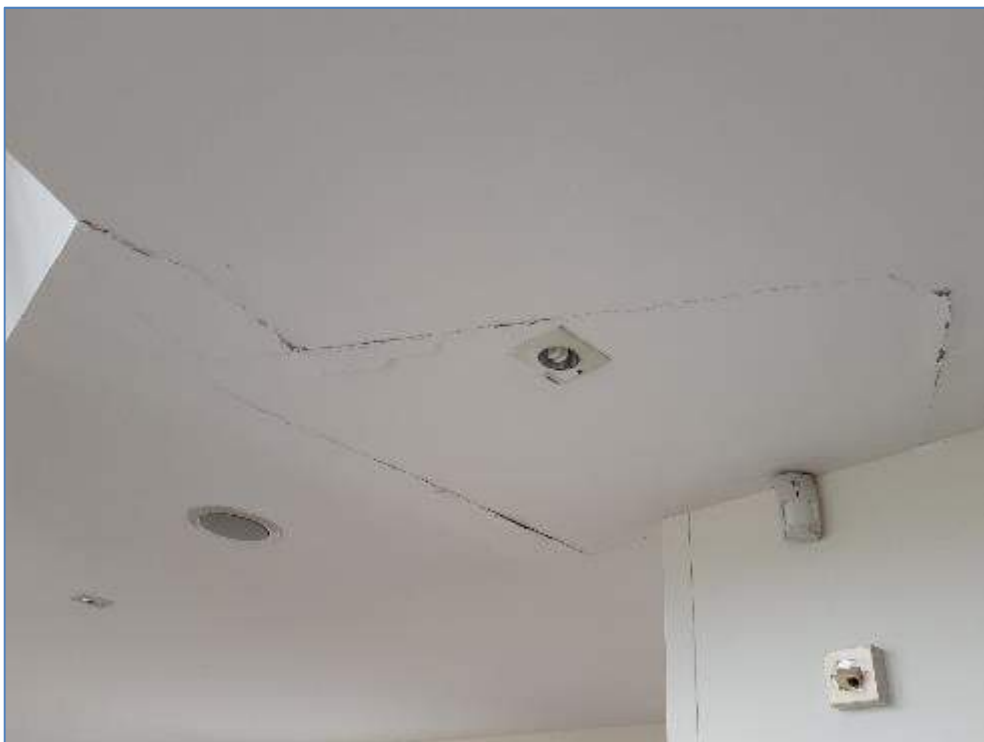
7-23 Cracks in ceiling of foyer by main entrance

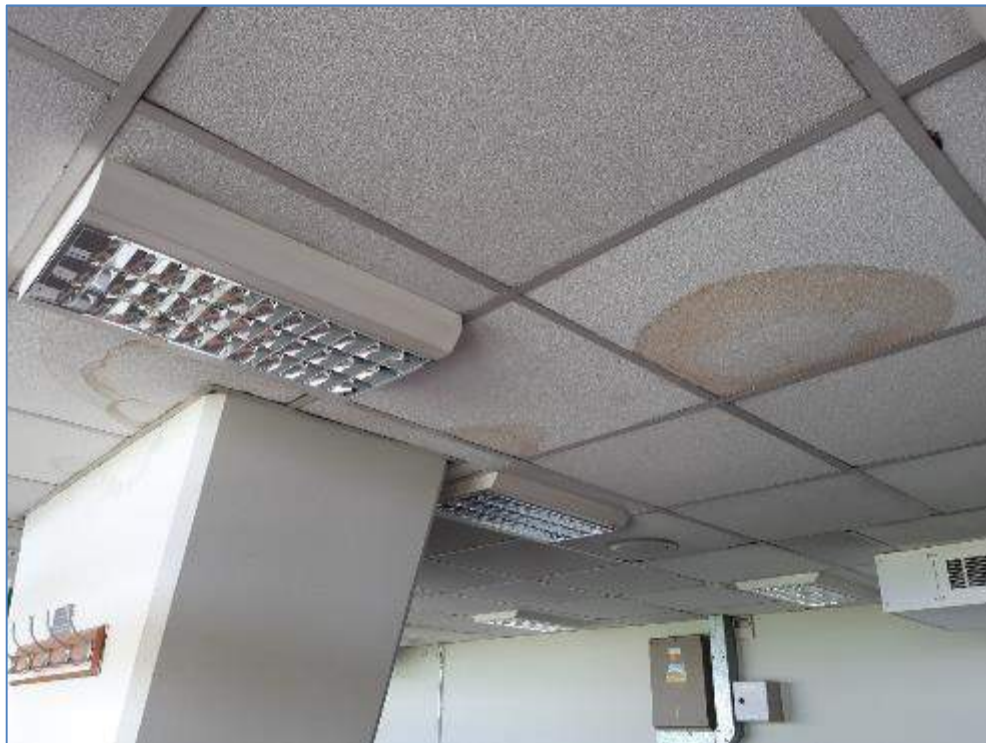
7-24 Damp damage to ceiling in press box

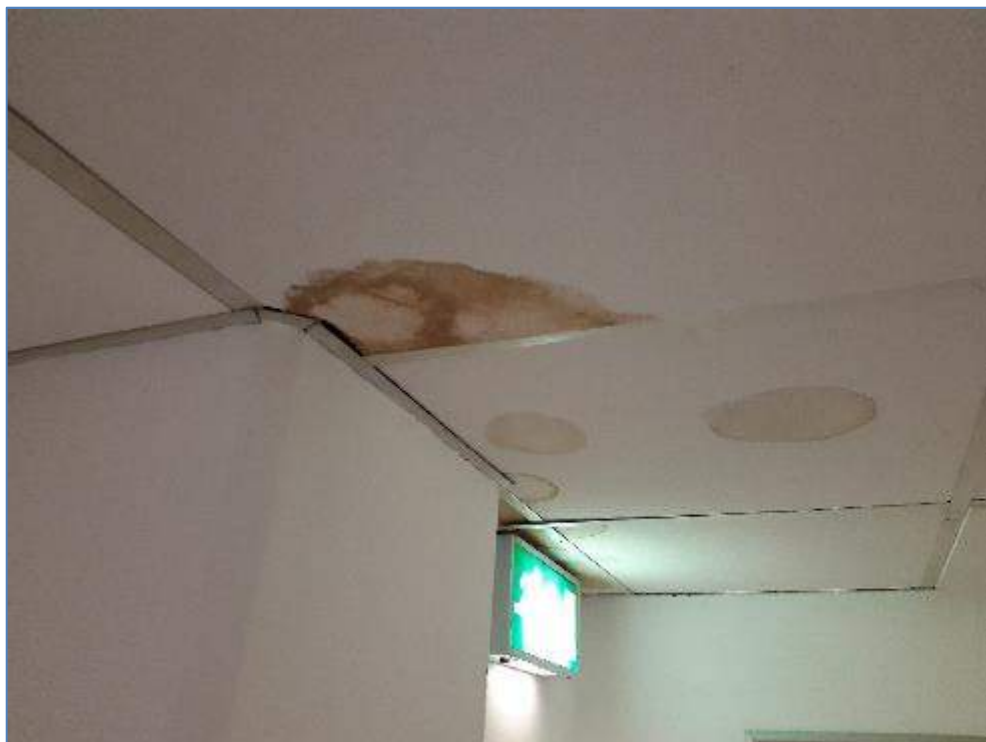
7-25 Damp in ceiling of men's toilets

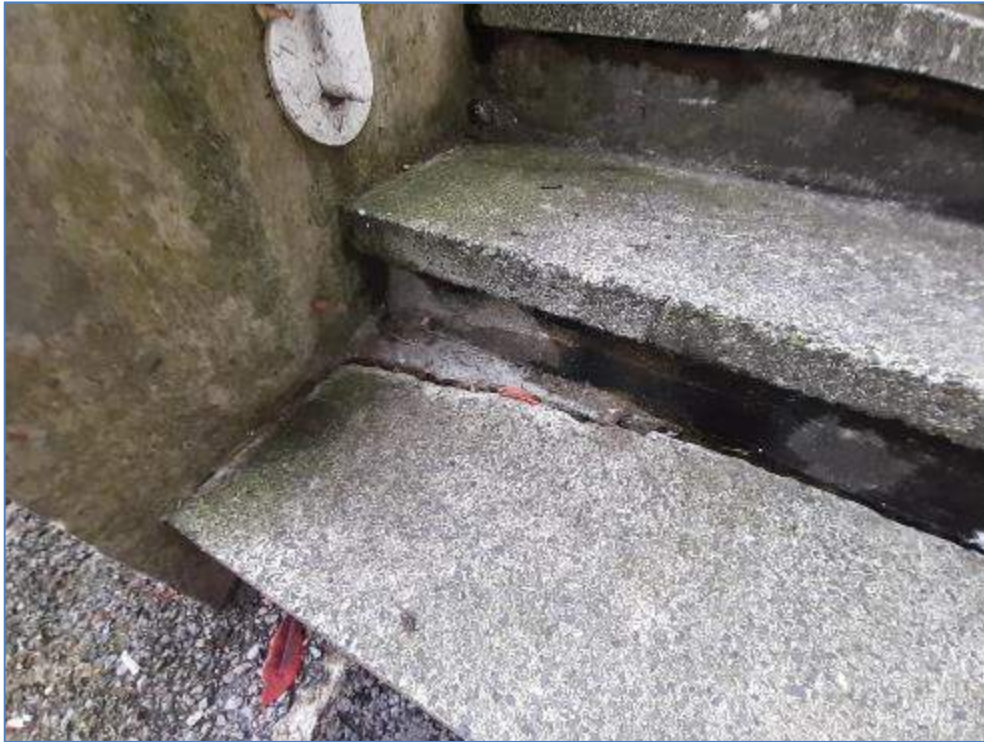
7-26 Crack in steps to terrace from Brasserie

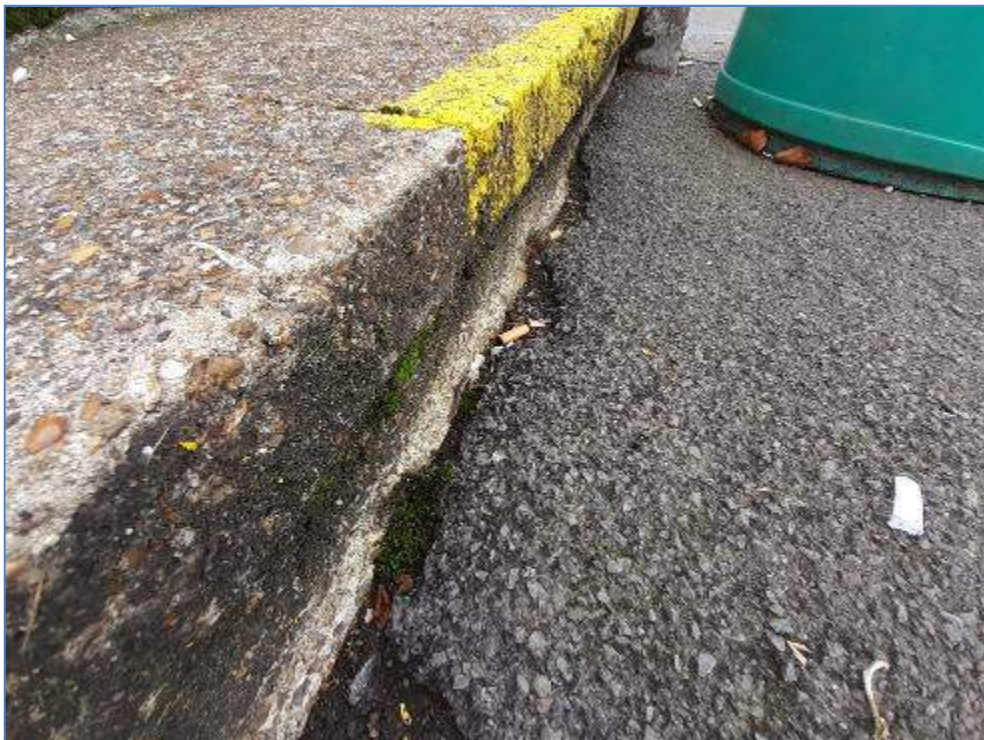
7-27 Gap between concrete steppings and asphalt

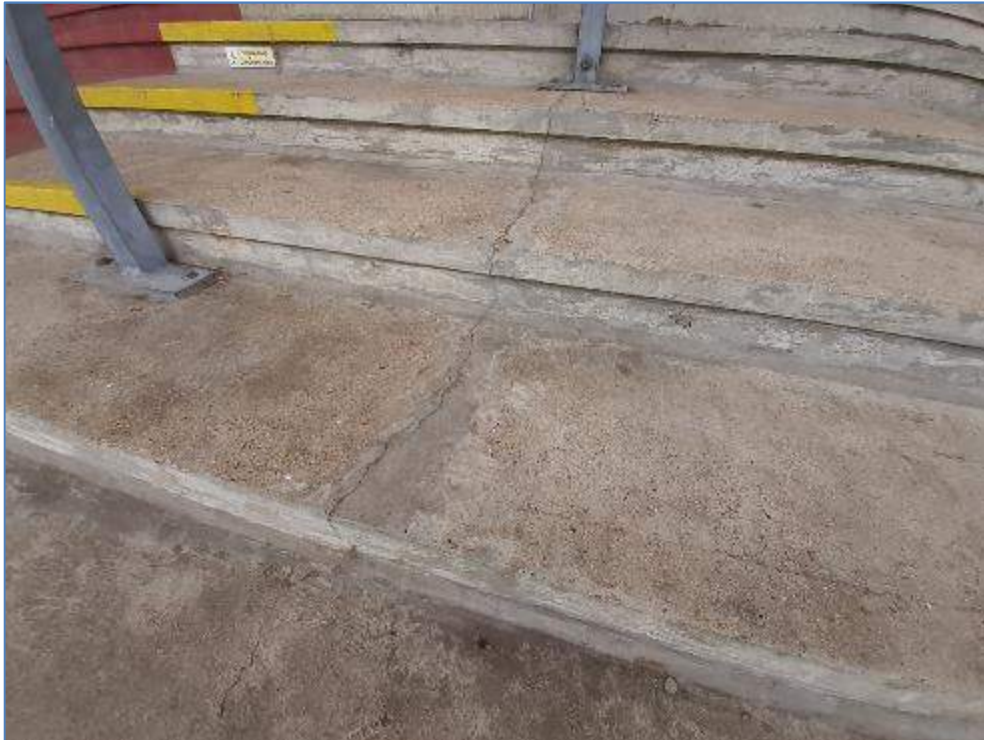
7-28 Cracking running down front terrace steps

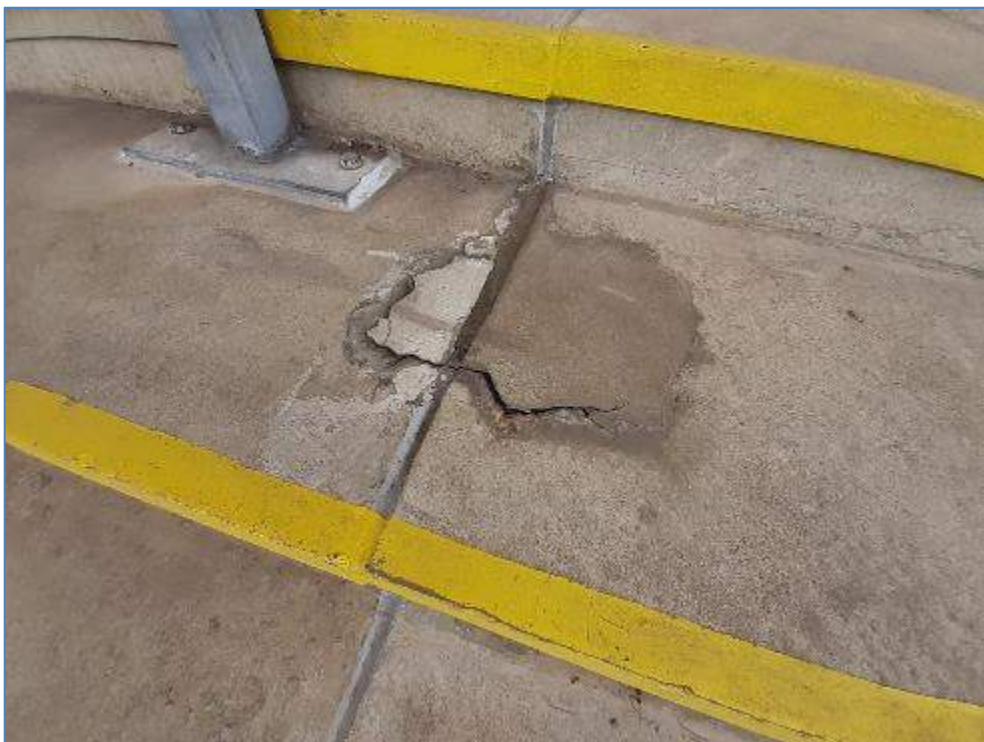
7-29 Concrete spalling on front terrace

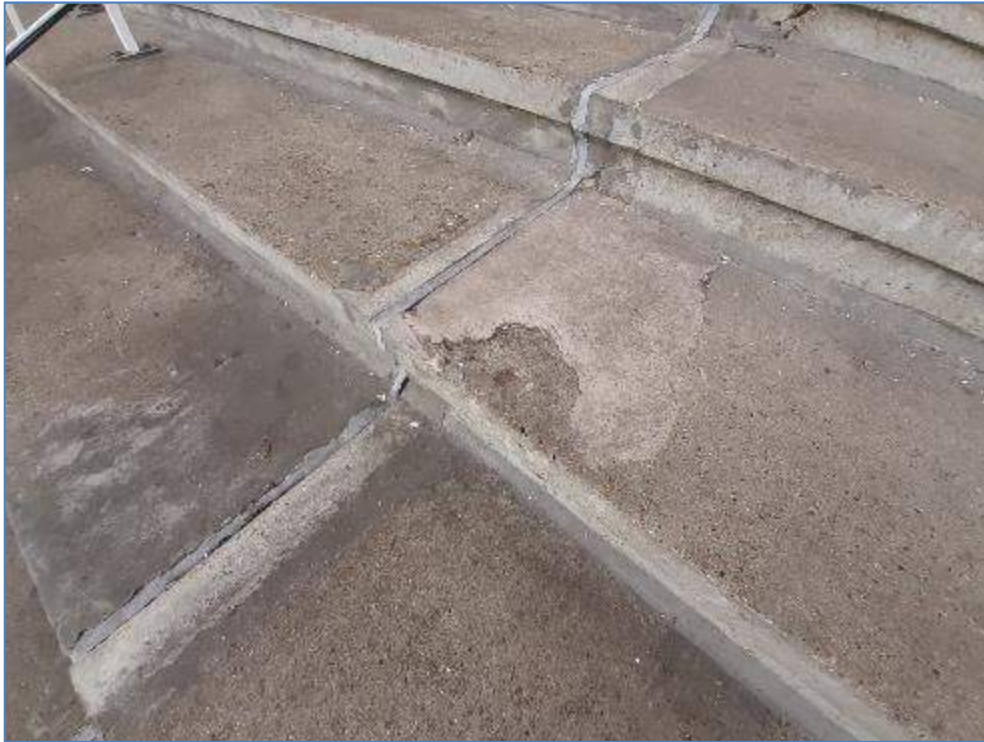
7-30 Concrete spalling on front terrace

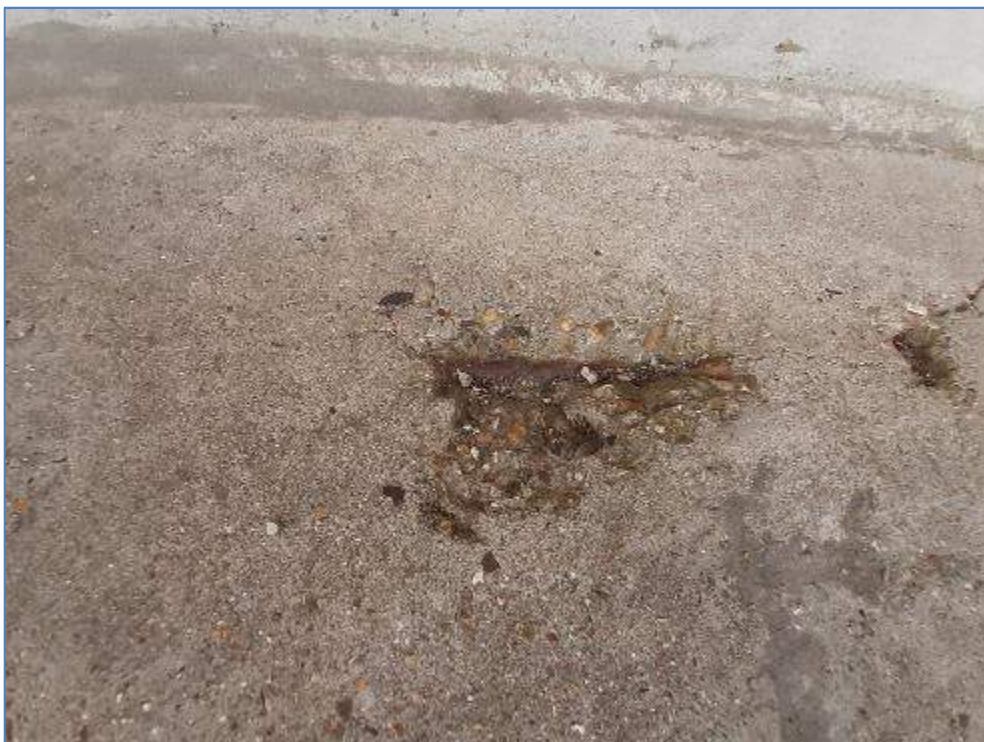
7-31 Concrete spalling on front terrace

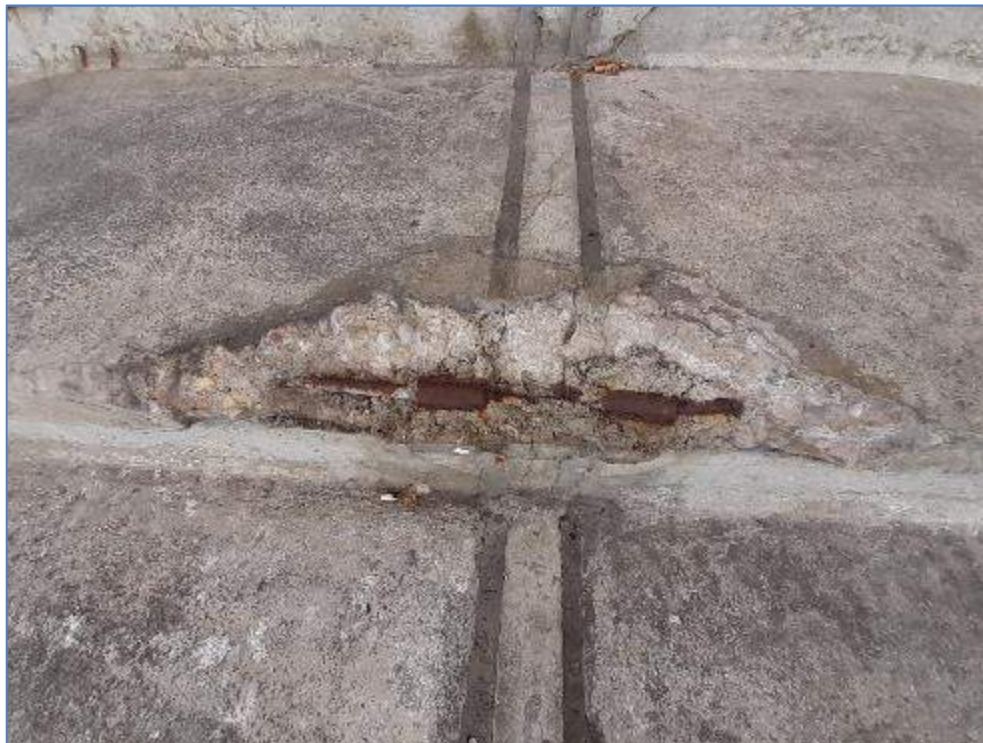
7-32 Concrete spalling heavily, exposing rebar on front terrace

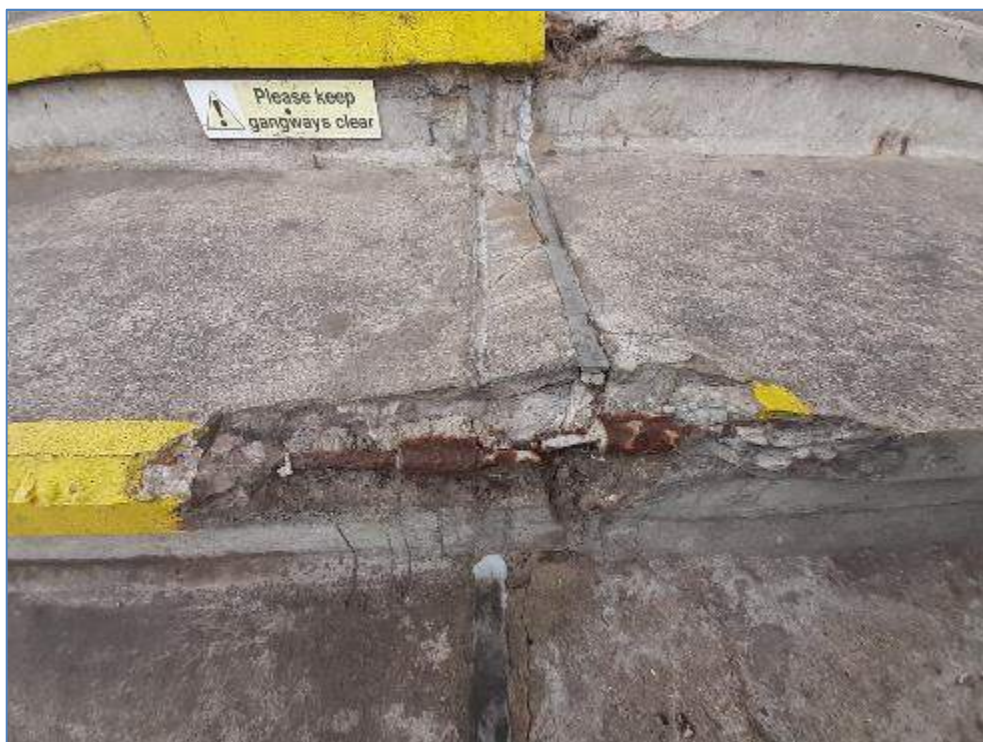
7-33 Concrete spalling heavily, exposing rebar on front terrace

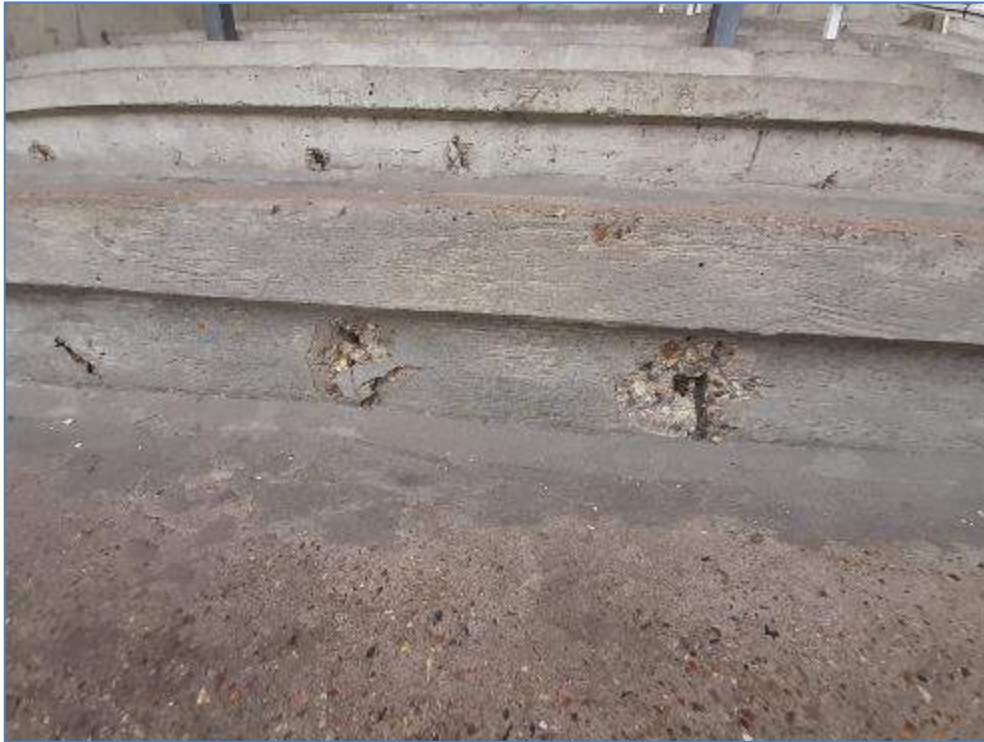
7-34 Vertical sections of front terrace steppings spalling

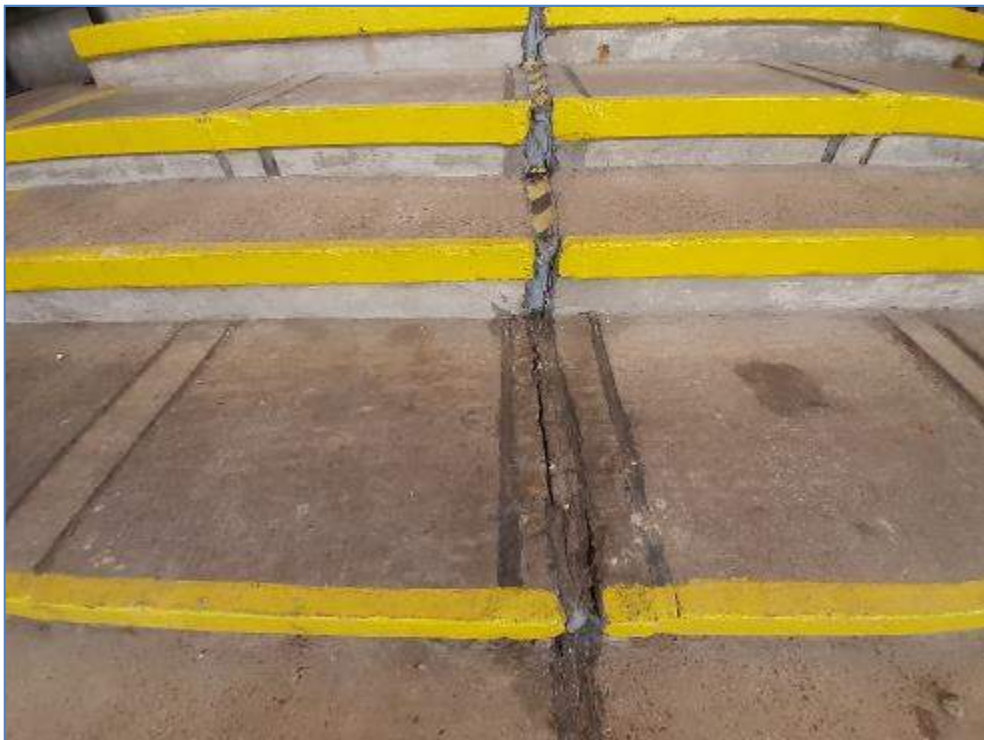
7-35 Movement joints opening up on seating terrace

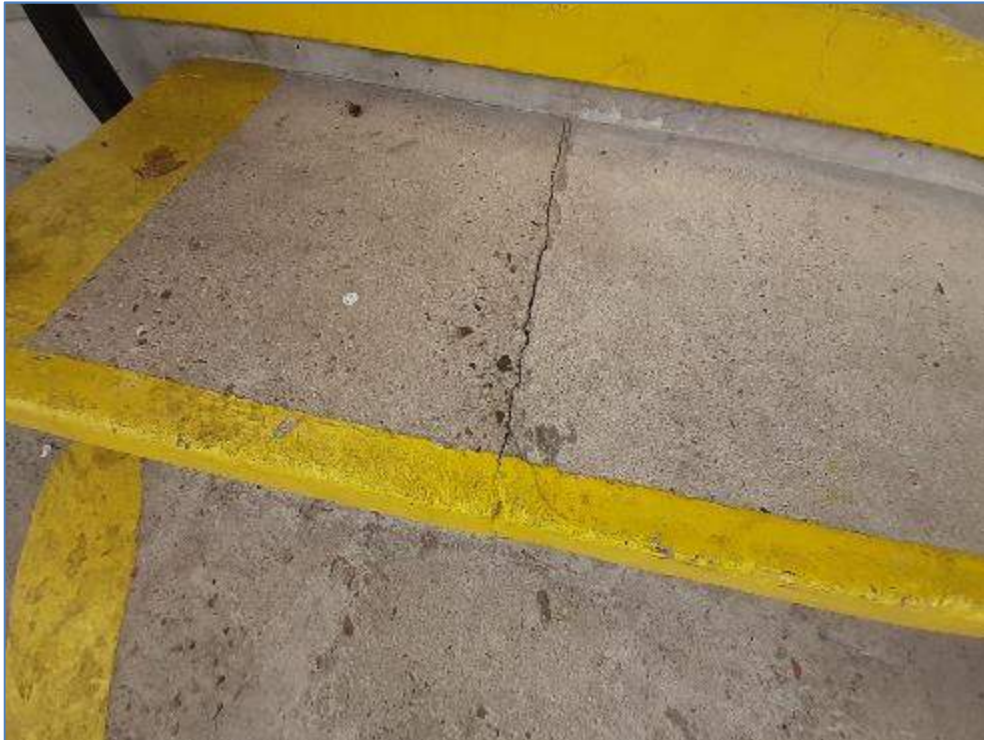
7-36 Cracking in front seating terrace steppings
