JCR Statement of Case PART 2 OF 6 - Appendix 1

# ANNUAL STRUCTURAL SURVEY 2019

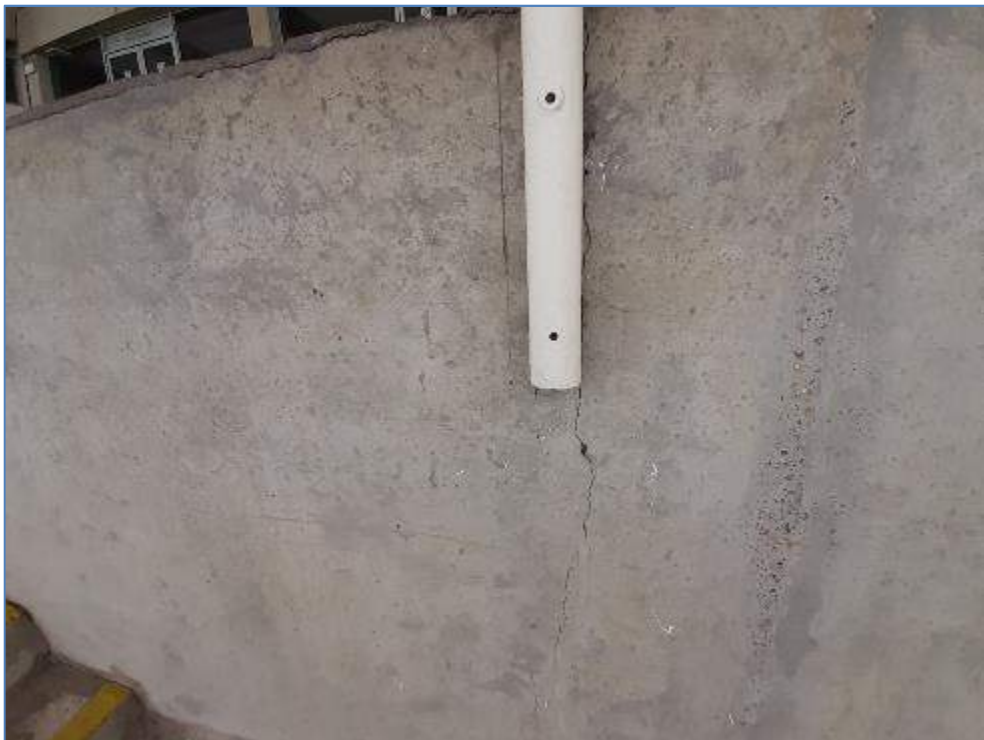
7-37 Crack in rear dividing wall

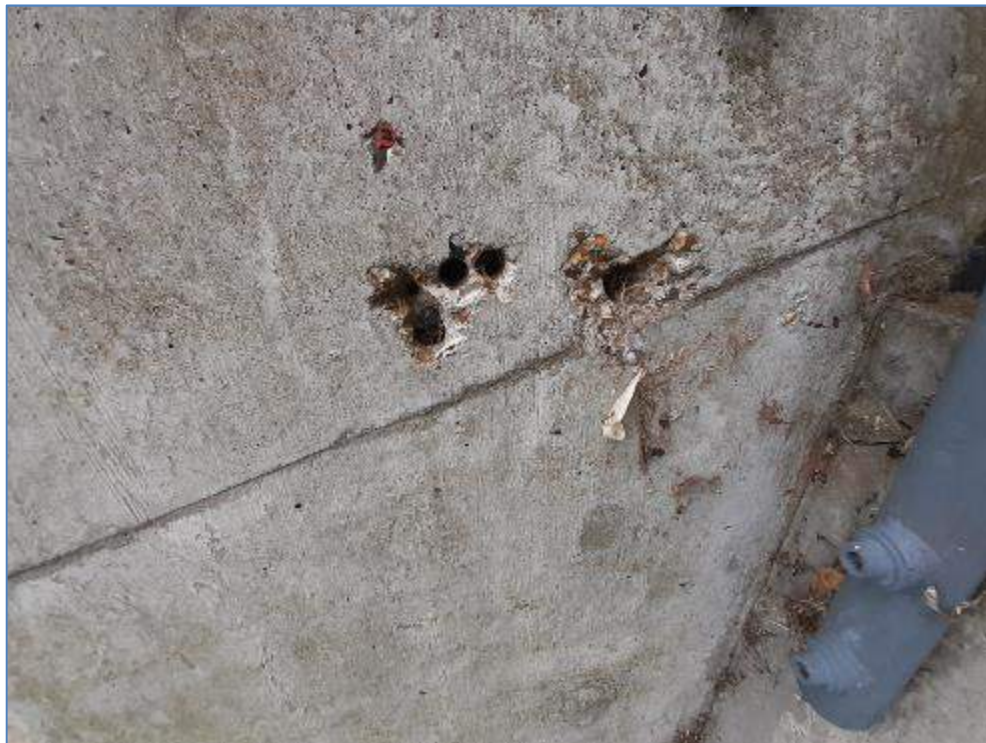
7-38 Concrete spalling on vomitory walls

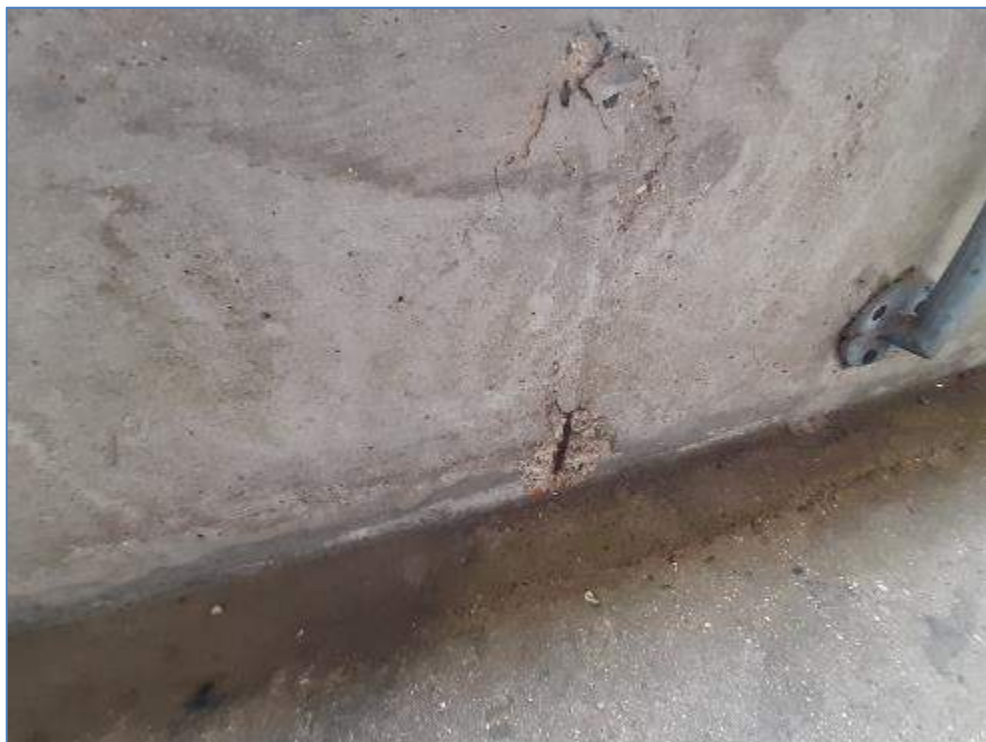
7-39 Concrete spalling on wall of disabled ramp

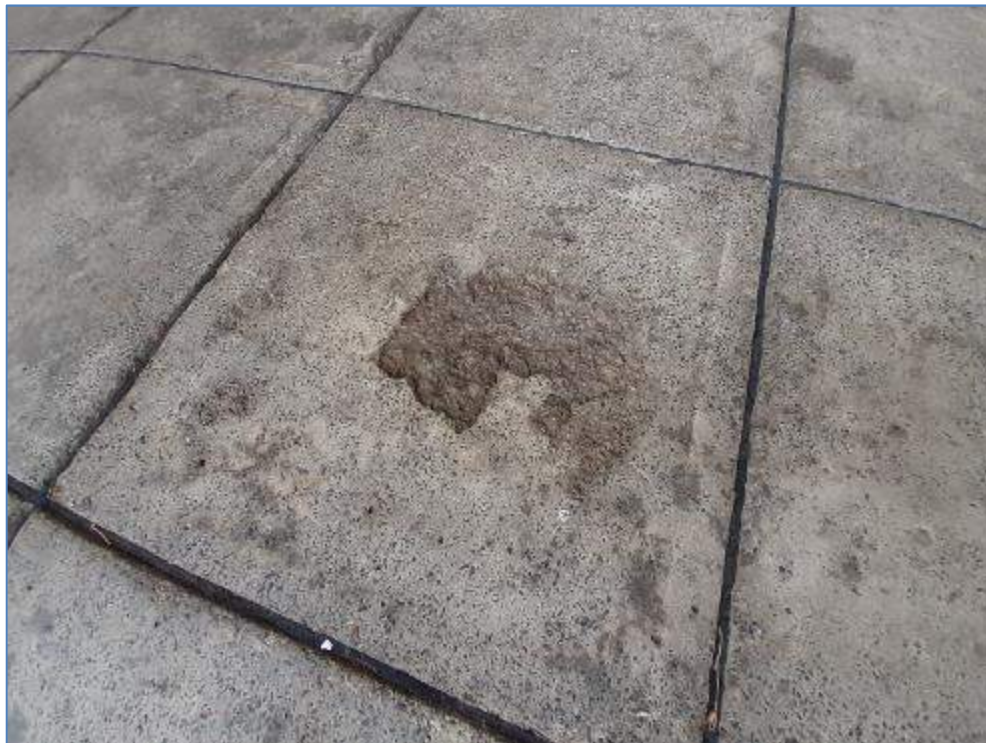
7-40 Top surface of paving slabs spalling

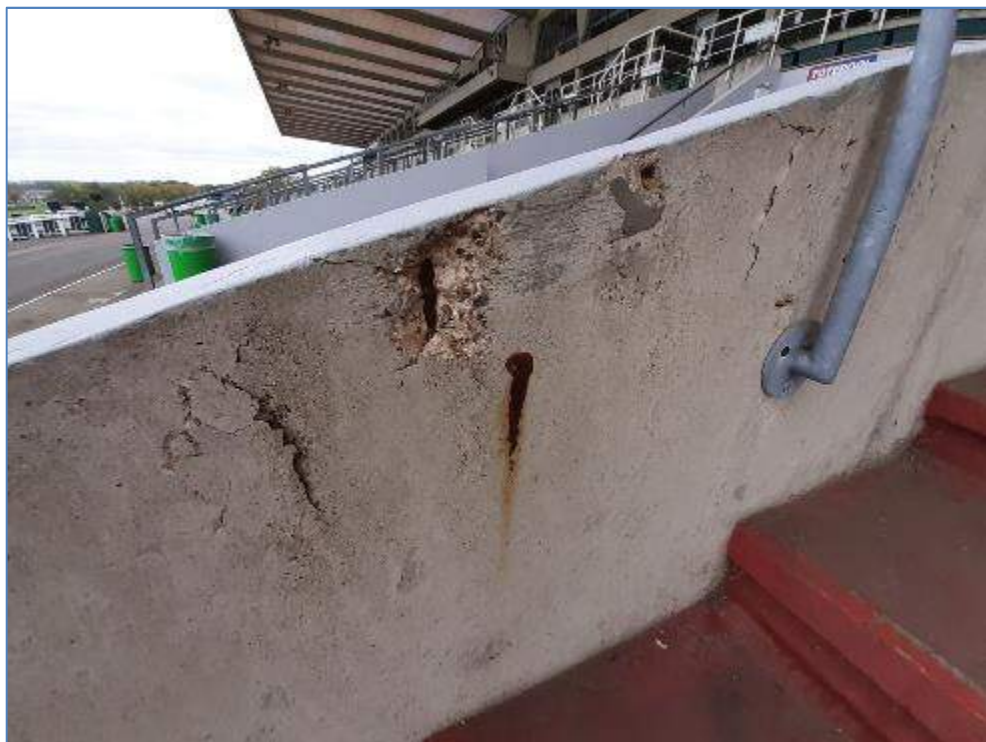
7-41 Concrete wall to vomitory spalling and exposing rebar

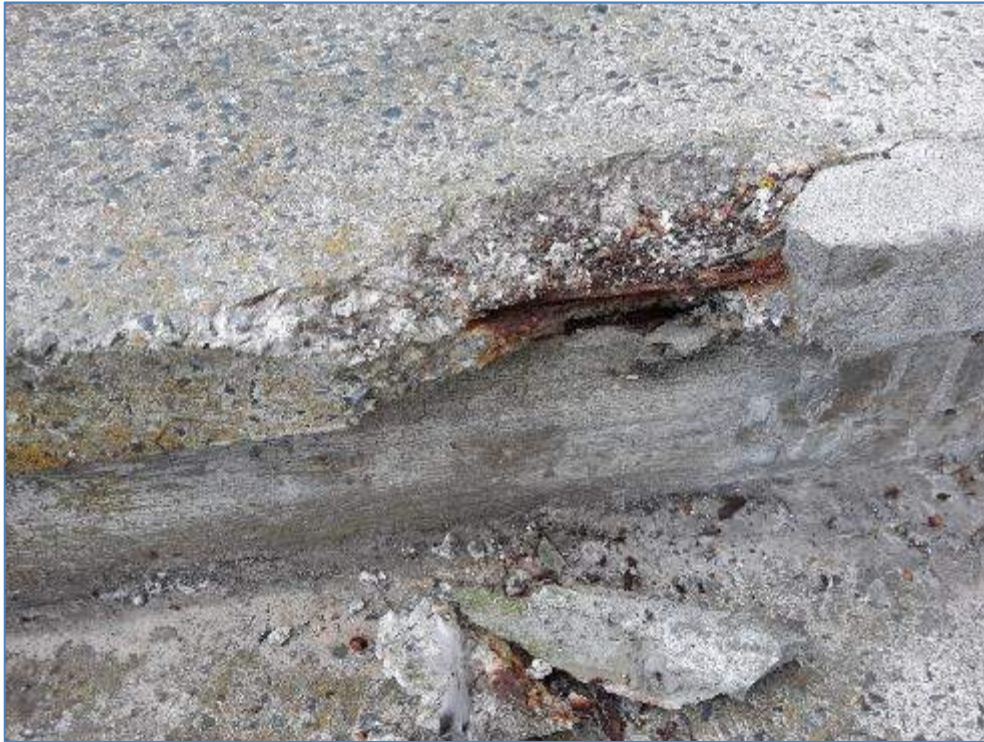
7-42 Concrete spalling on steps, exposing rebar

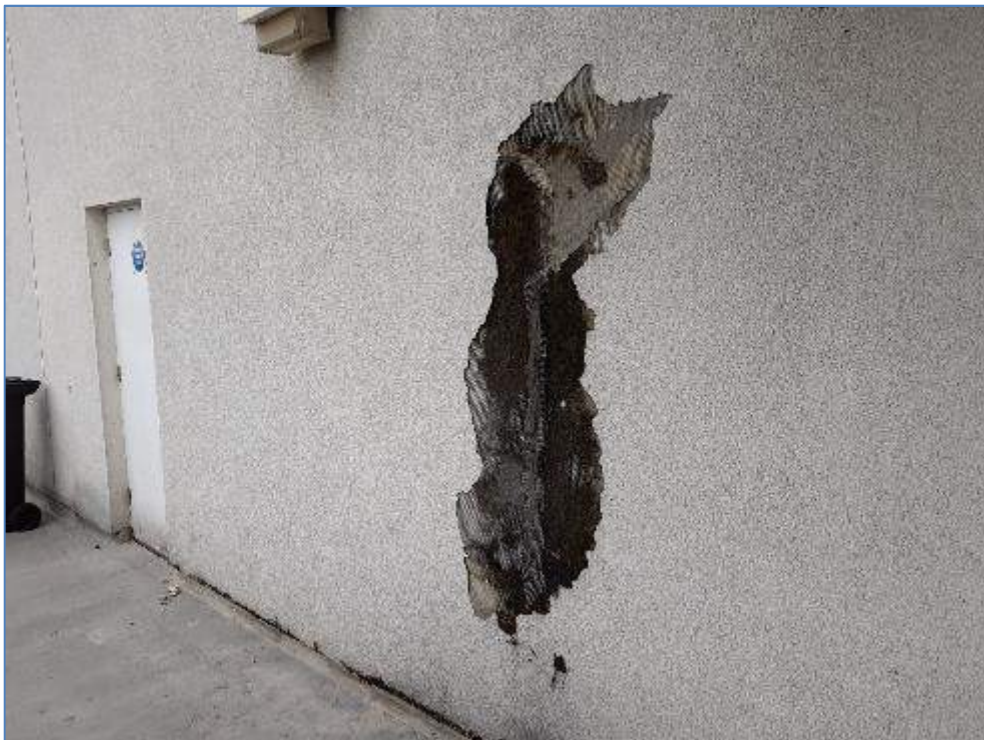
7-43 Section of wall render has spalled

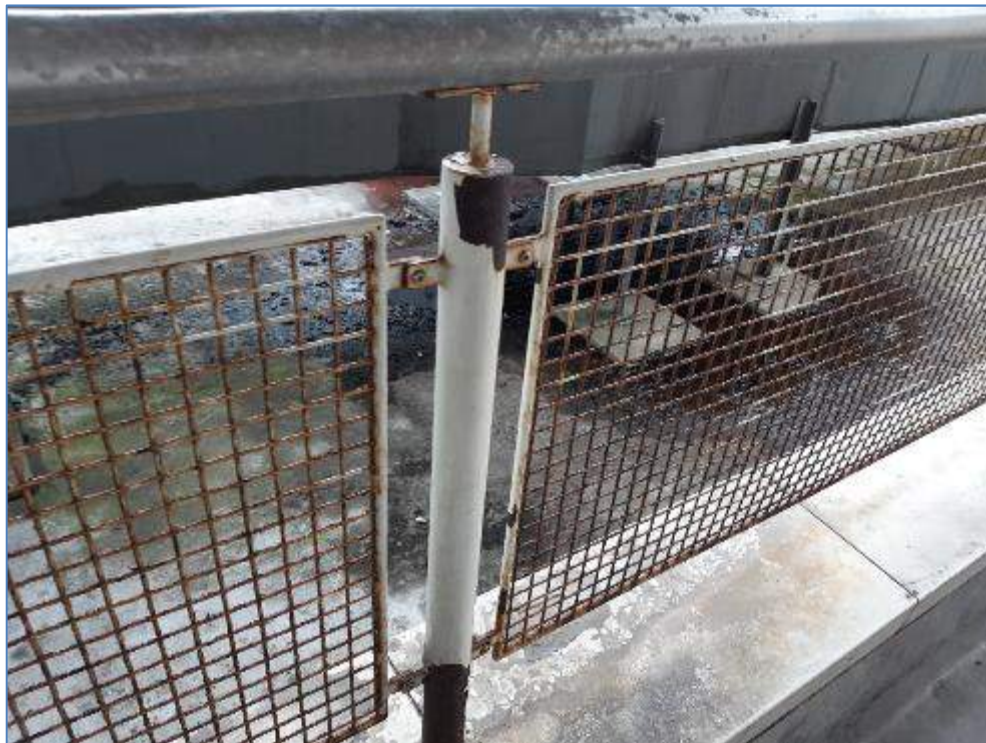
7-44 Balustrades and infill panels corroding

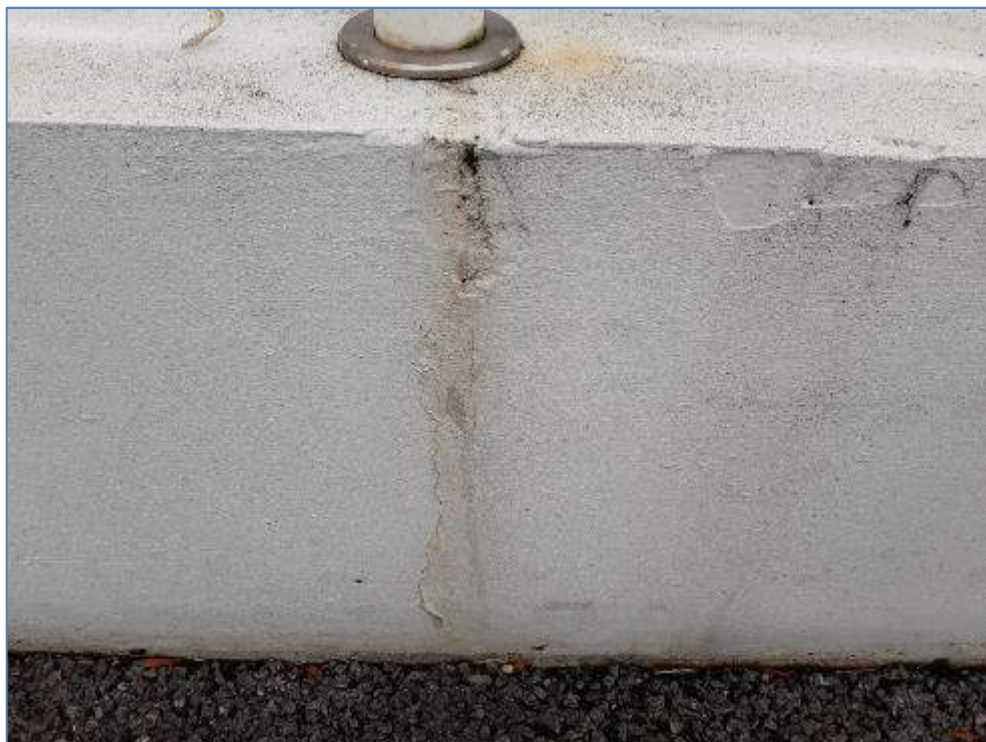
7-45 Cracking in walls to disabled ramp at Esher Hall entrance

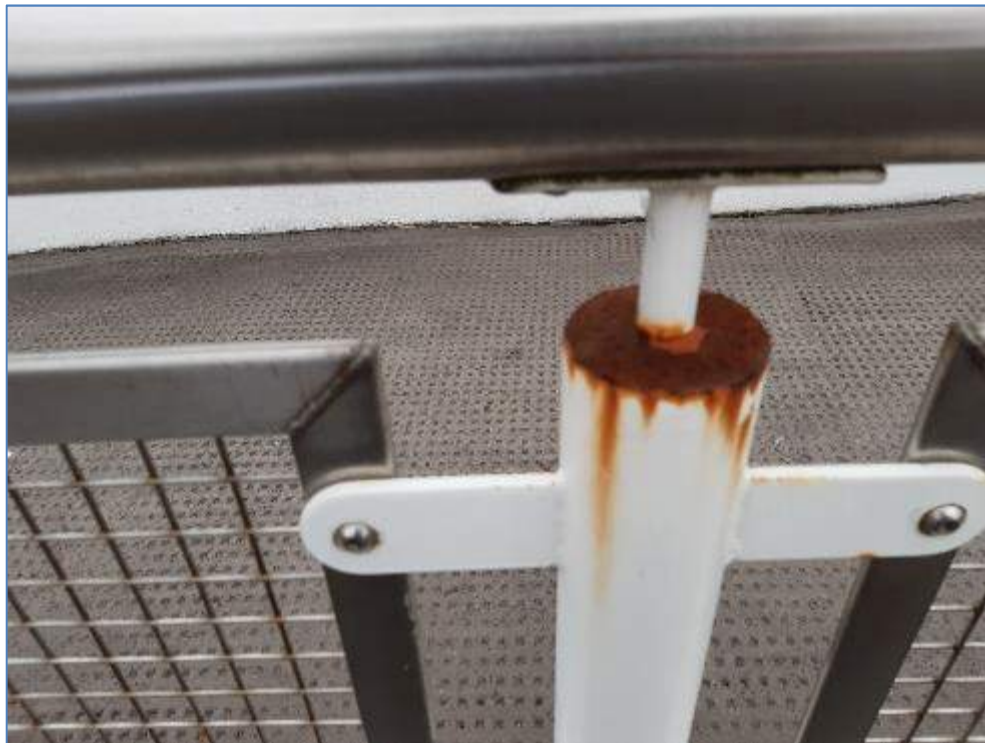
7-46 Surface rust to barriers

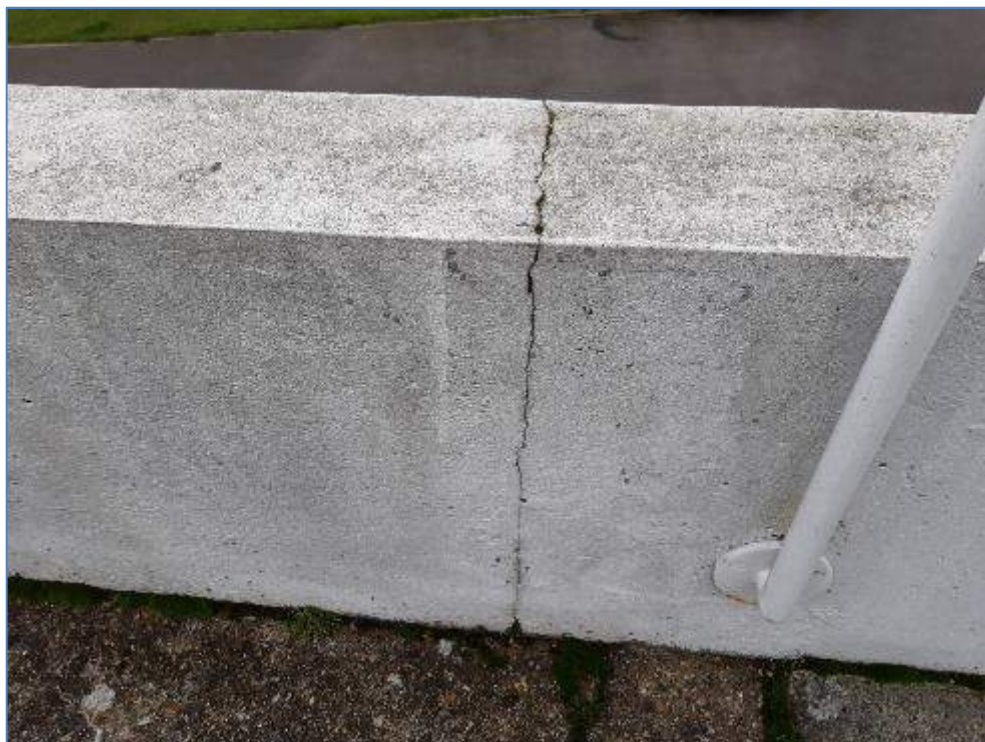
7-47 Cracks in concrete wall to steps

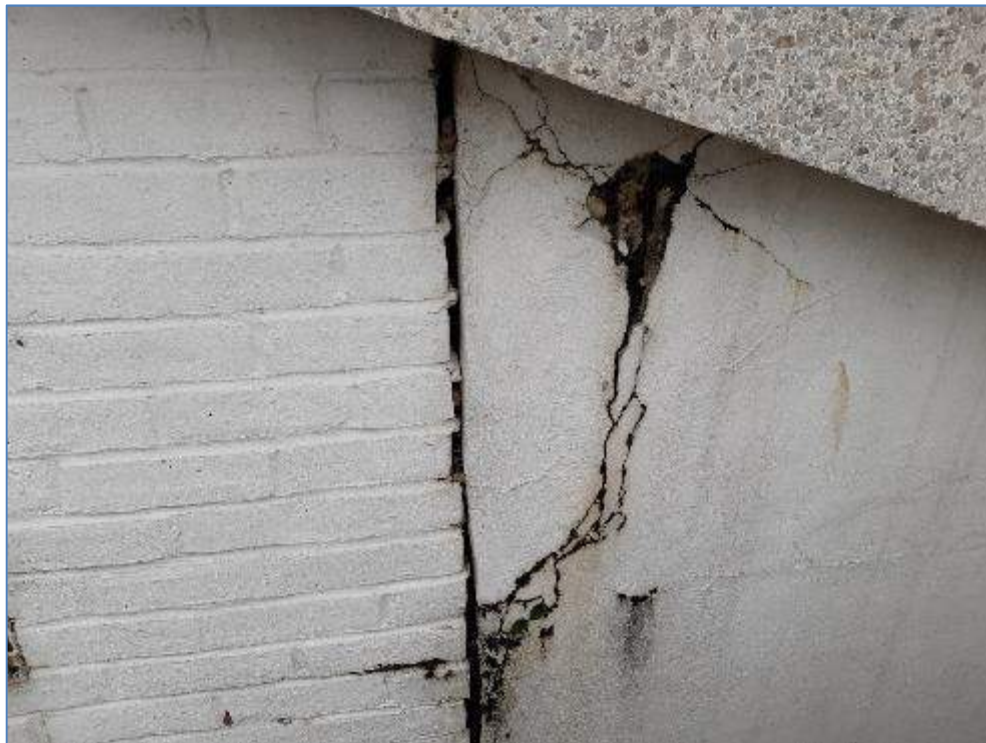
7-48 Cracks in render to terrace end wall

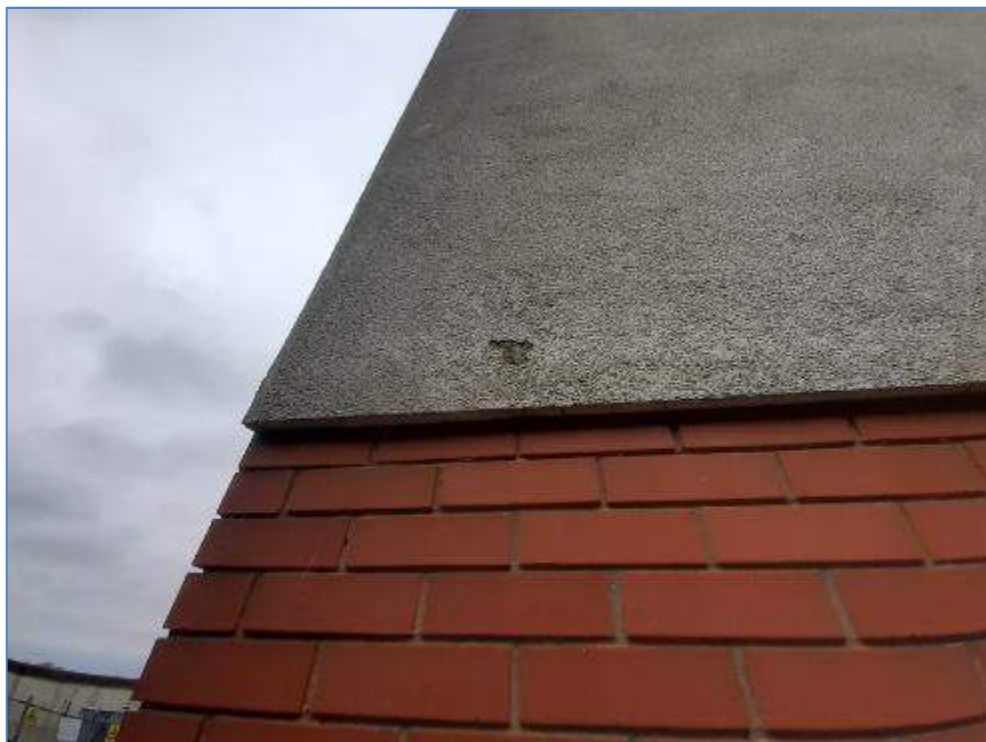
8-01 Minor area of render spalled new bin store

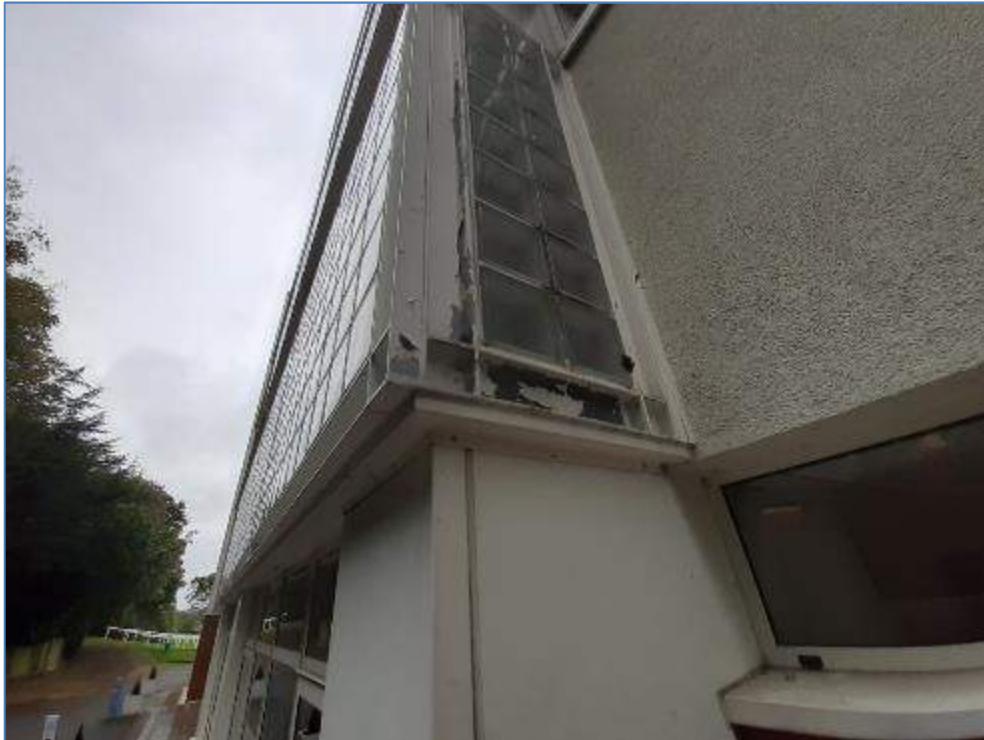
8-02 Paint peeling from steel around feature windows

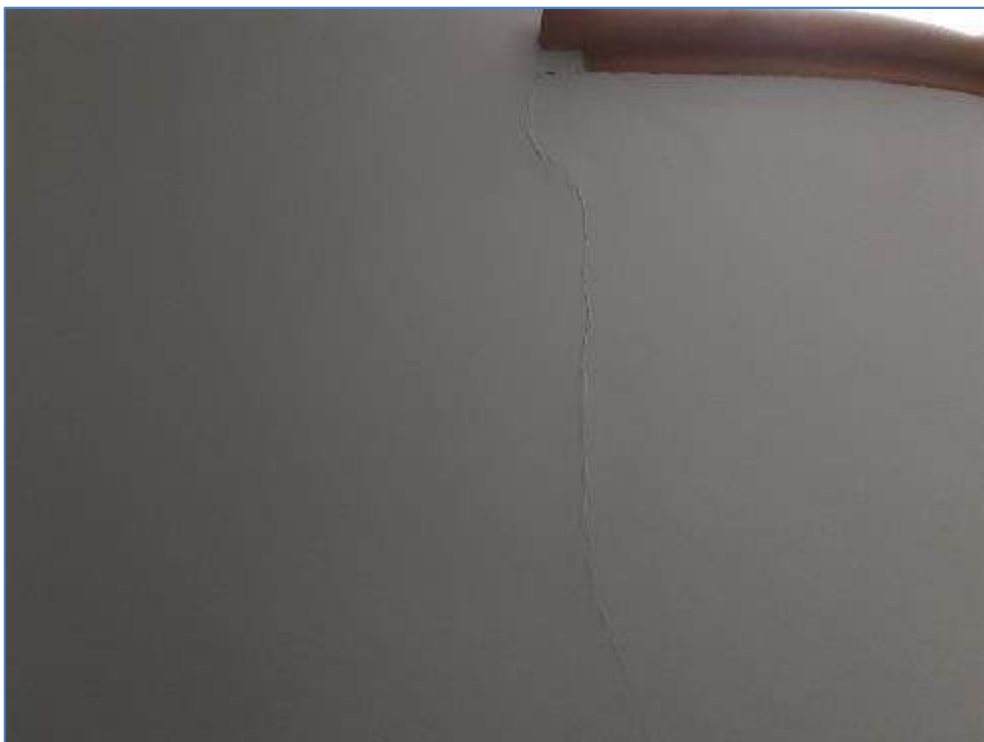
8-05 Crack in wall under window of male toilets

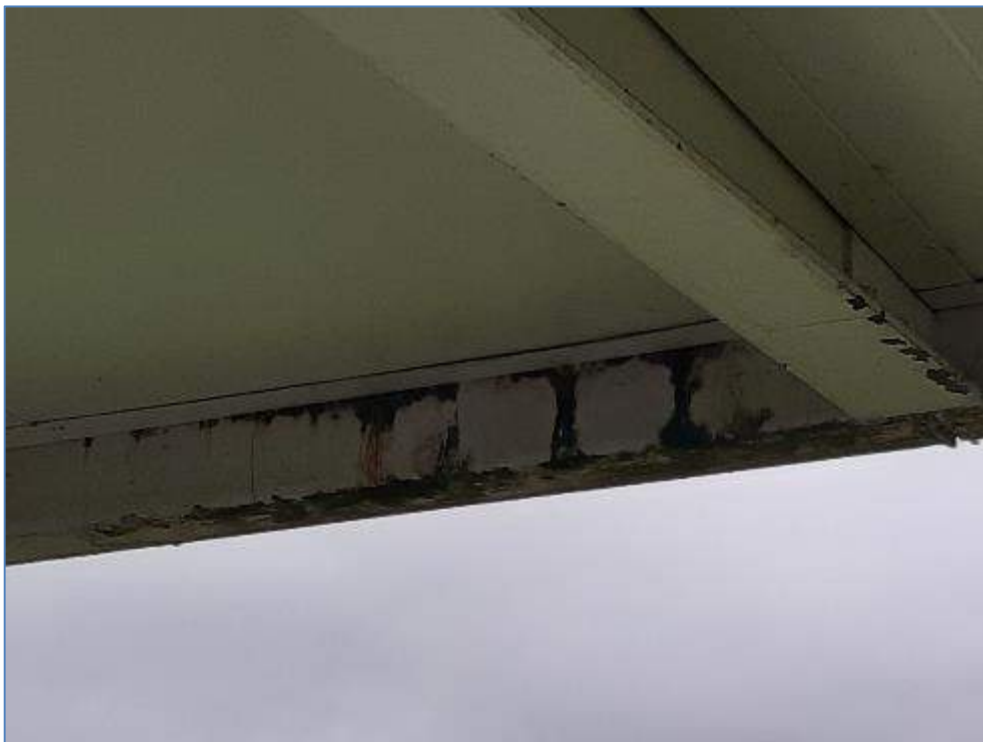
8-07 Surface rust to balcony support steelwork

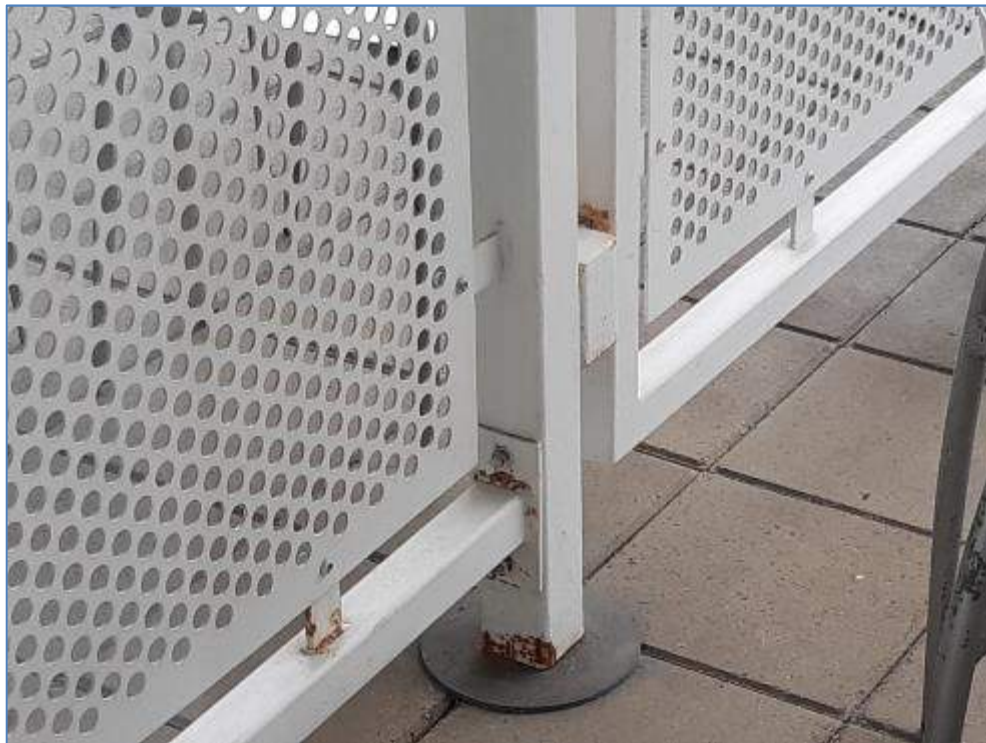
8-08 Rust at base of dividing barriers on balconies

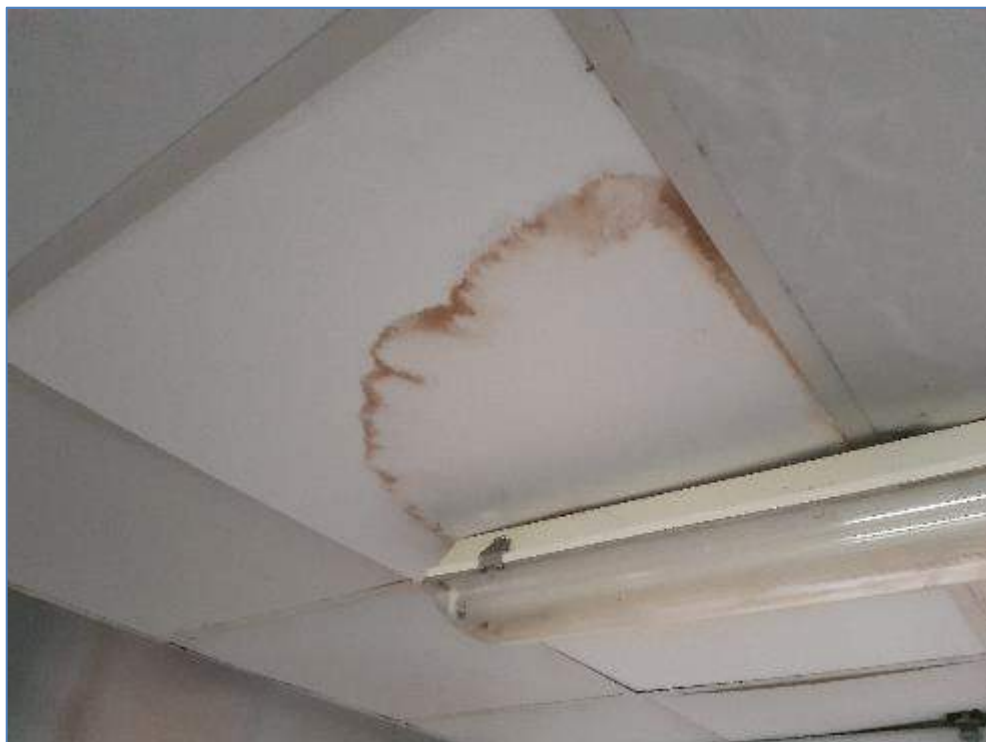
8-09 Water damage to ceiling in kitchen

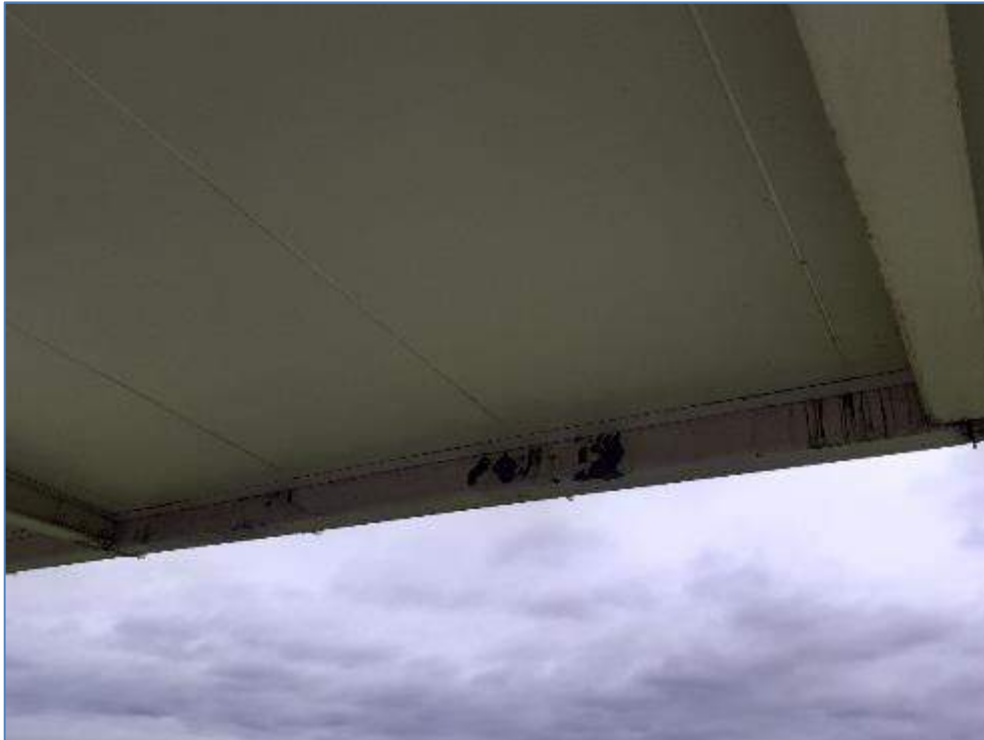
8-10 Minor surface rust to support steelwork over balconies

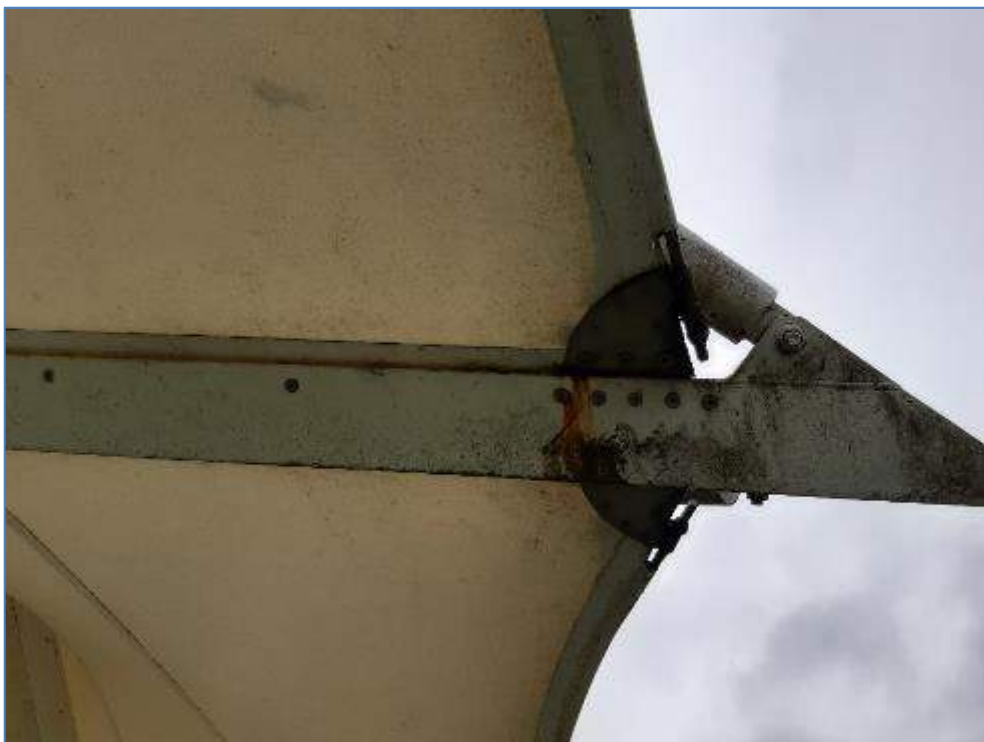
8-11 Surface rust to canopy support steel over balconies

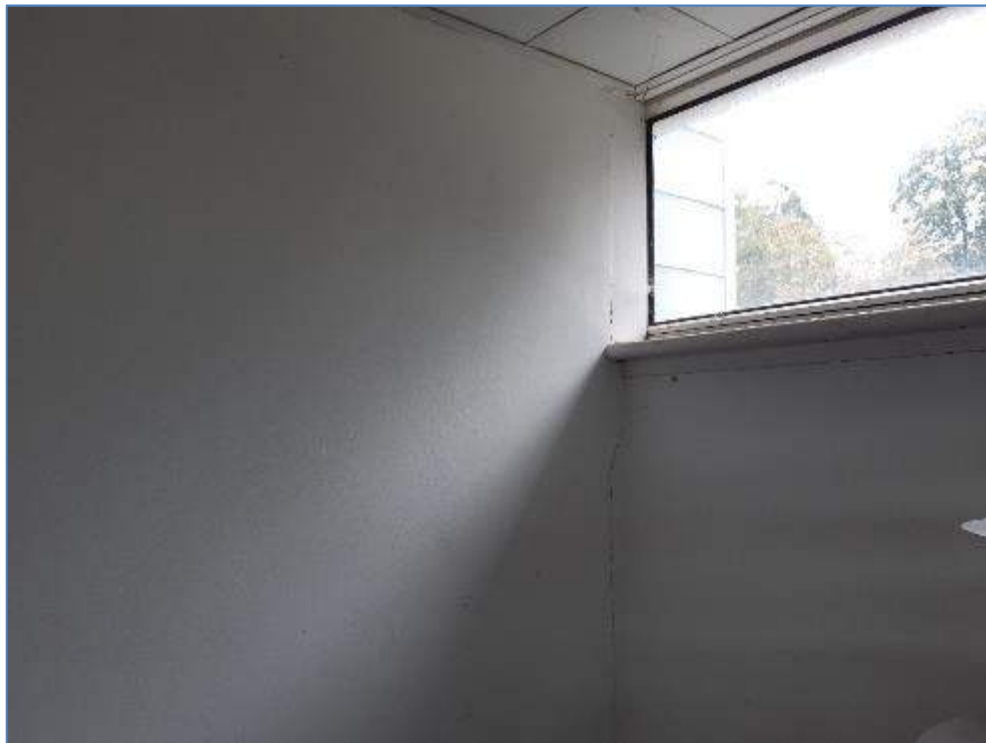
8-12 Crack in corner of kitchen

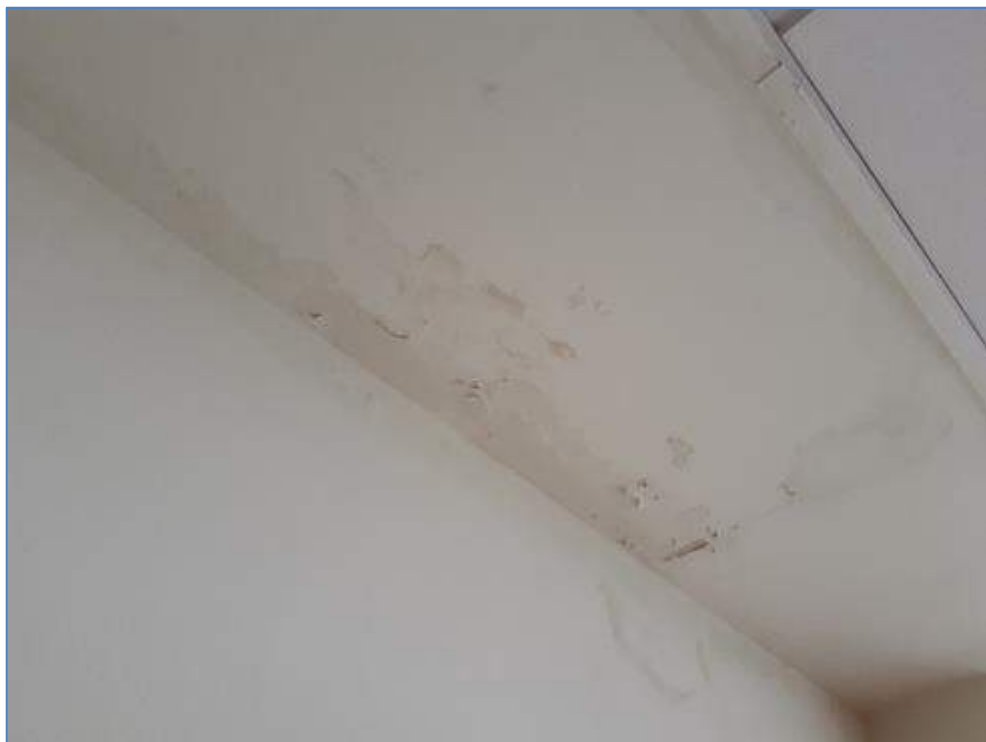
8-13 Damp in ceiling of box 3.3

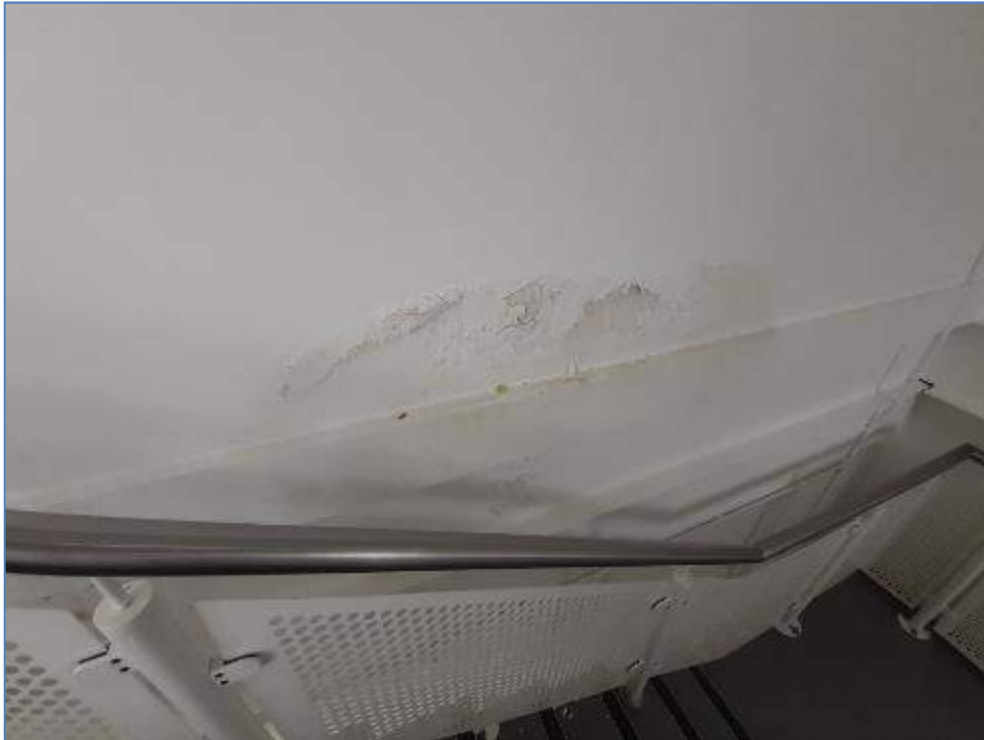
8-14 Wall spalling in service stairs

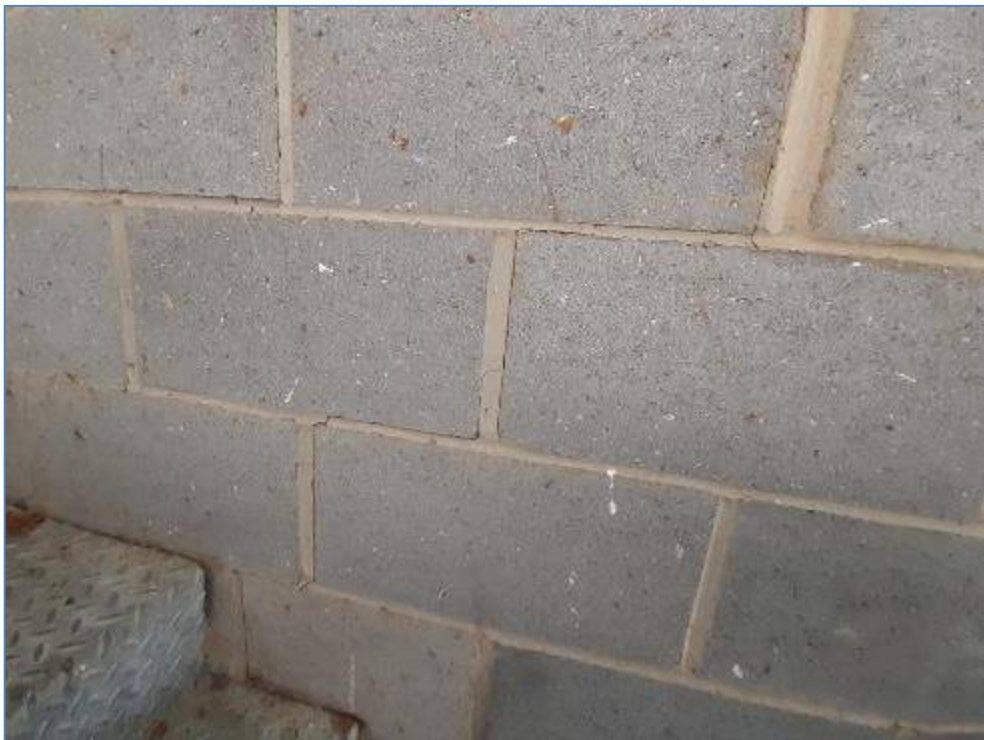
8-15 Cracking in block wall of stairs going up to roof

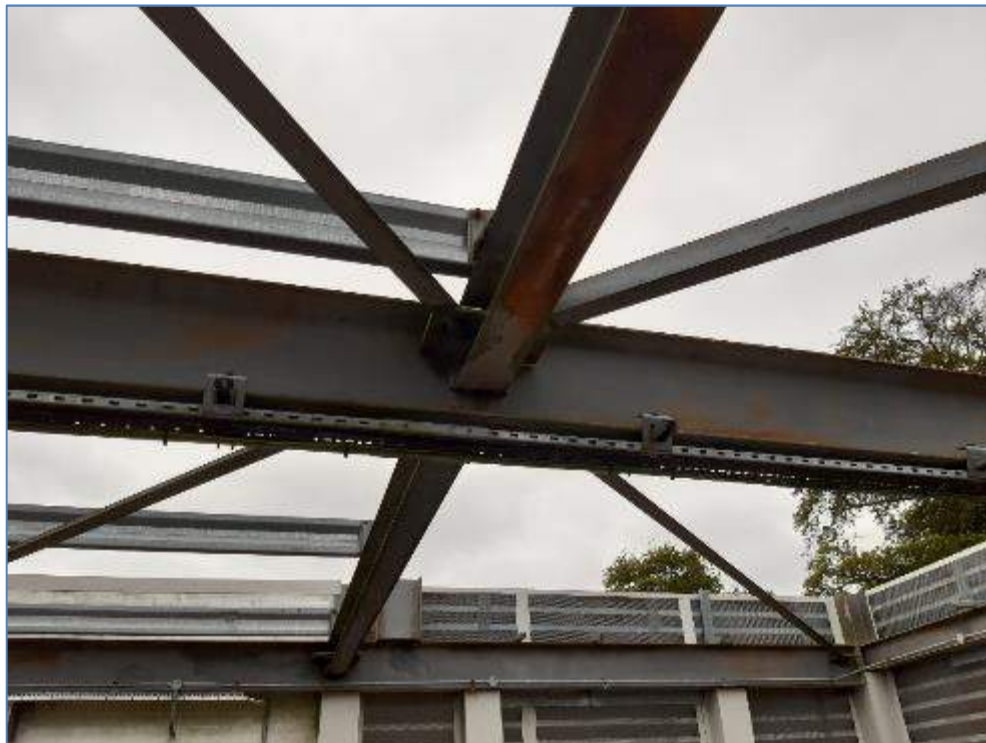
8-16 Surface rust to steel frame at roof level

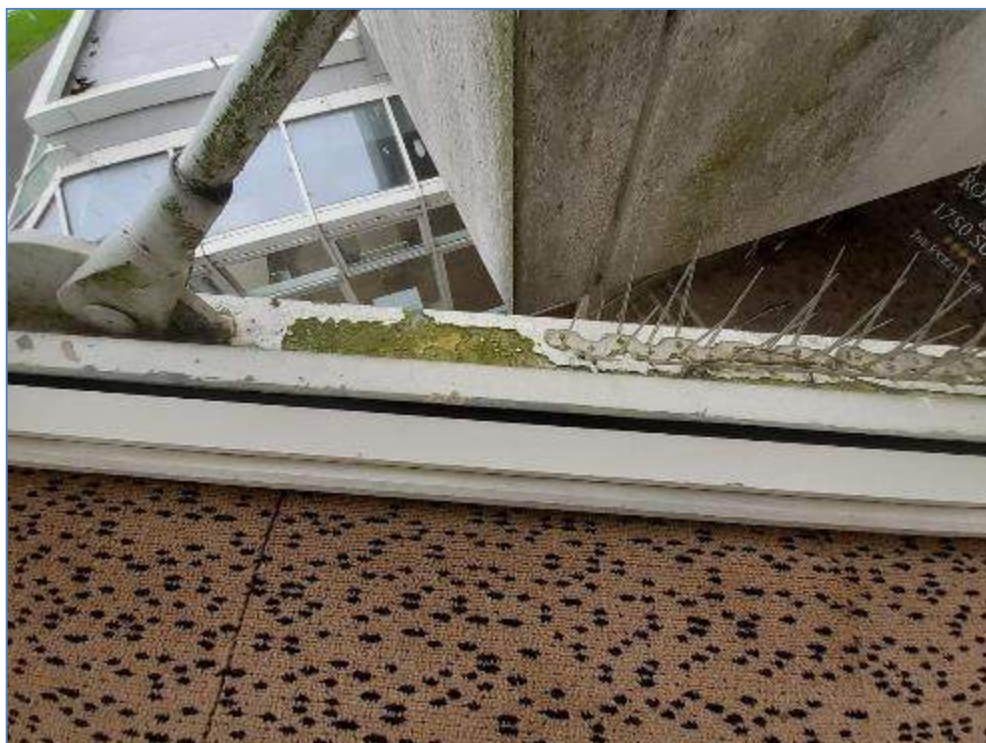
8-17 Paint peeling from link bridge support steelwork

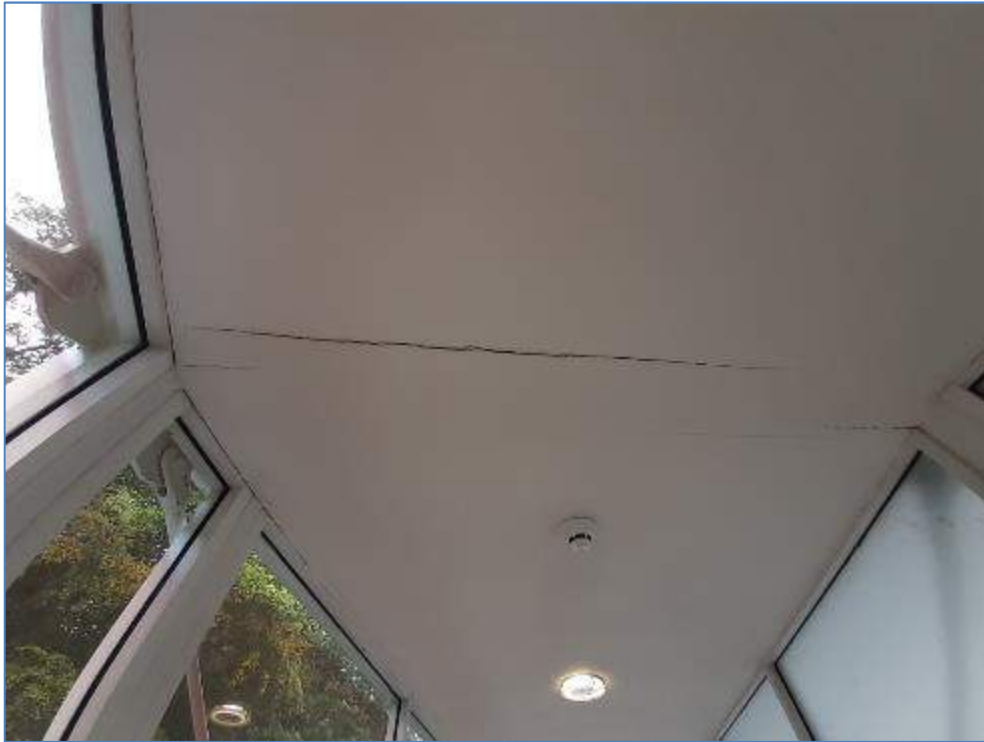
8-18 Cracking in ceiling of link bridge

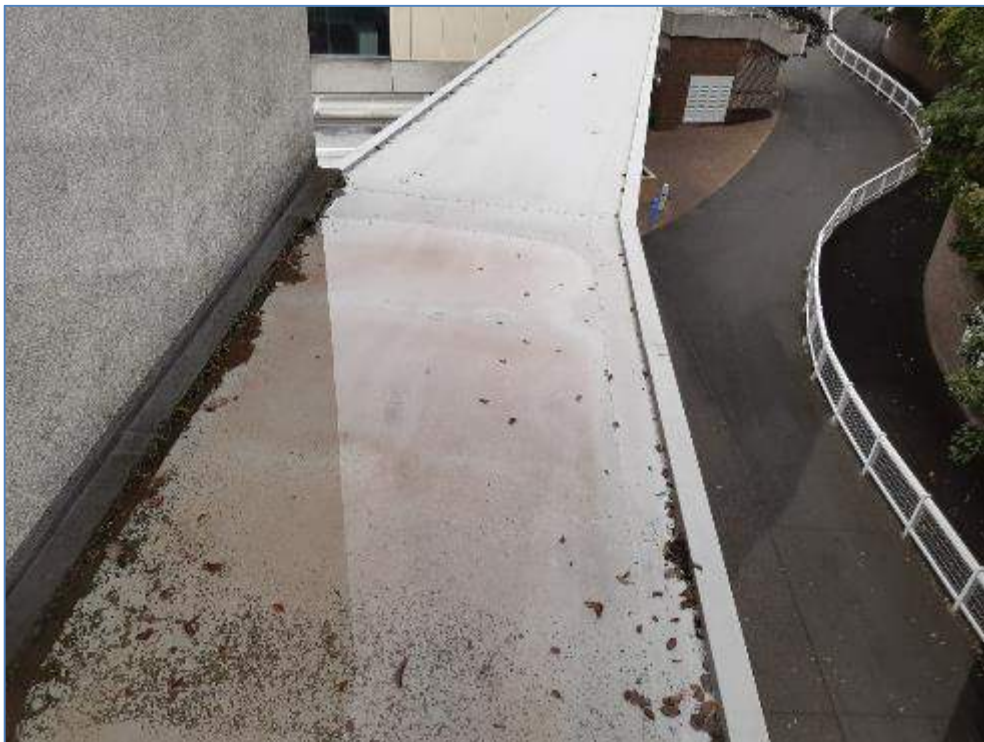
8-19 Water ponding on roof of link bridge

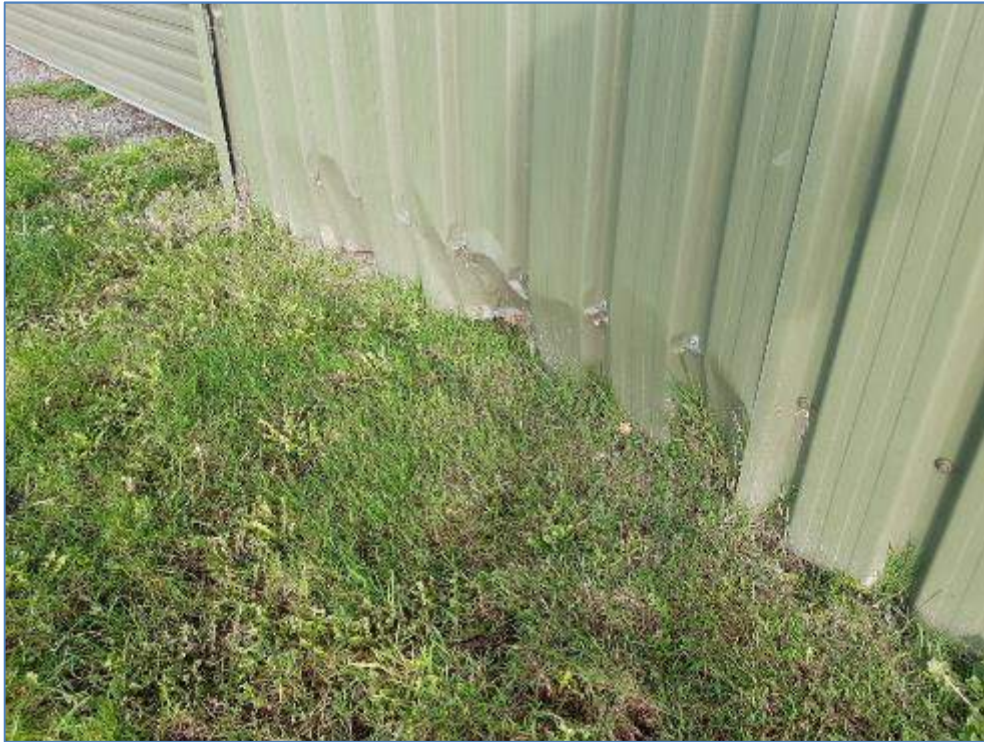
9-01 Steel cladding damaged in places
