SANDOWN PARK

Sandown Park Racecourse
Annual Structural Survey 2018

October 2018

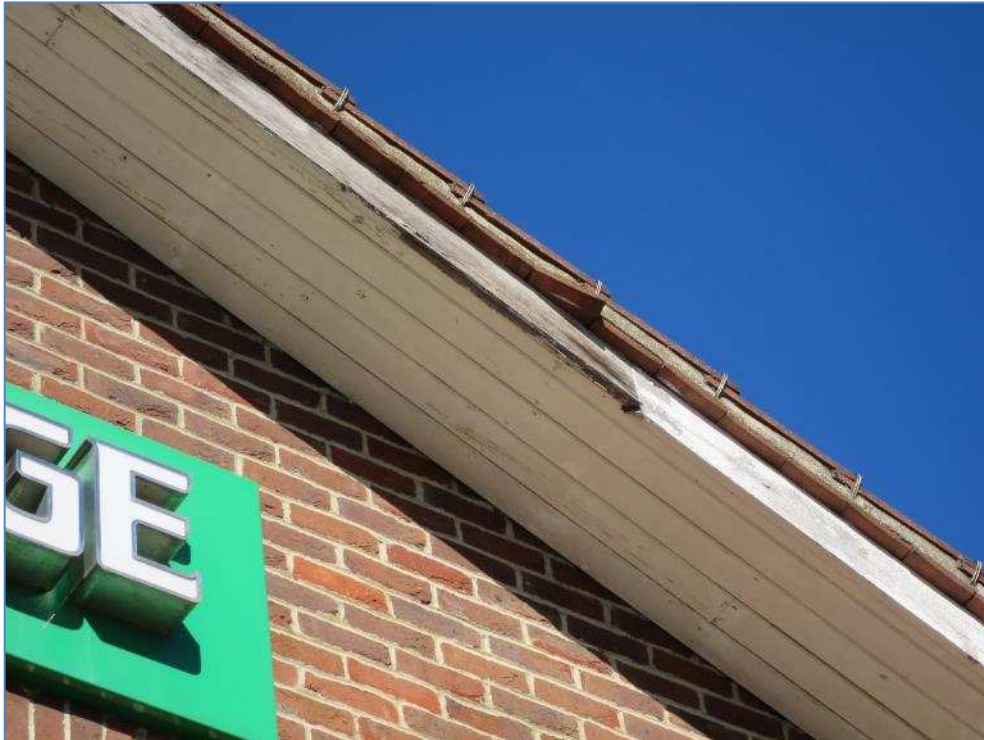
3-01 Loose roof tile over main entrance

The loose roof tile over the main entrance to the lodge should be made good as a matter of urgency. The cause of the water damage to the carport soffit should be investigated and remedied prior to making good.

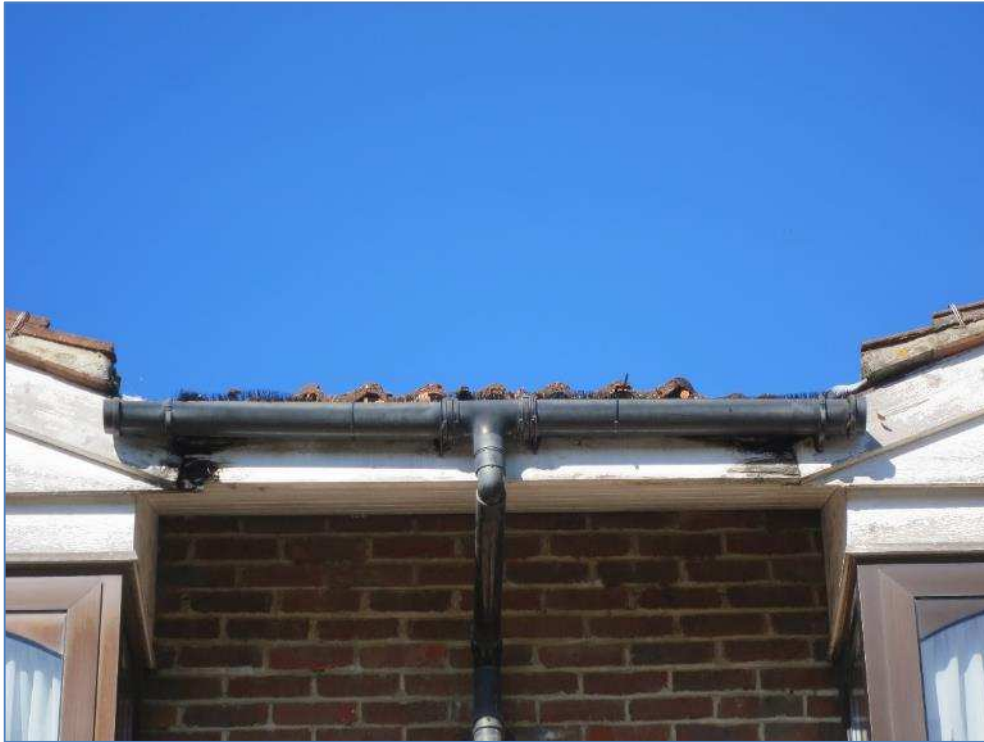
3-03 Timber eaves boarding rotting

The building is generally in good condition. All external timber and metal will need to be prepared and painted as part of the maintenance programme.

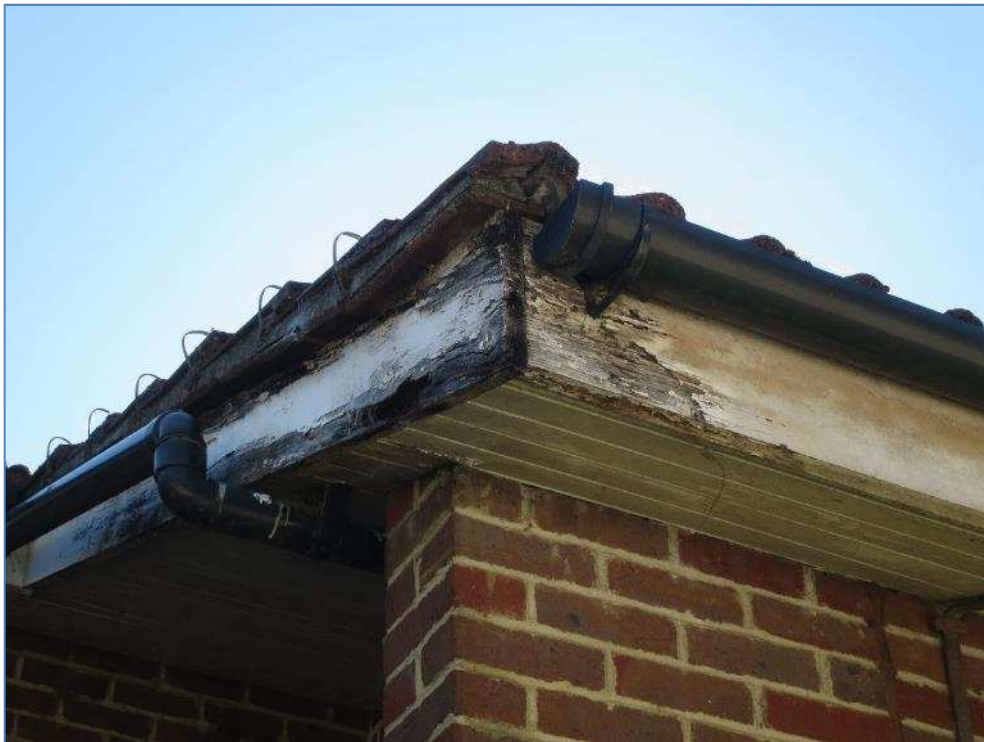
3-04 Timber fascia on rear elevation rotting heavily

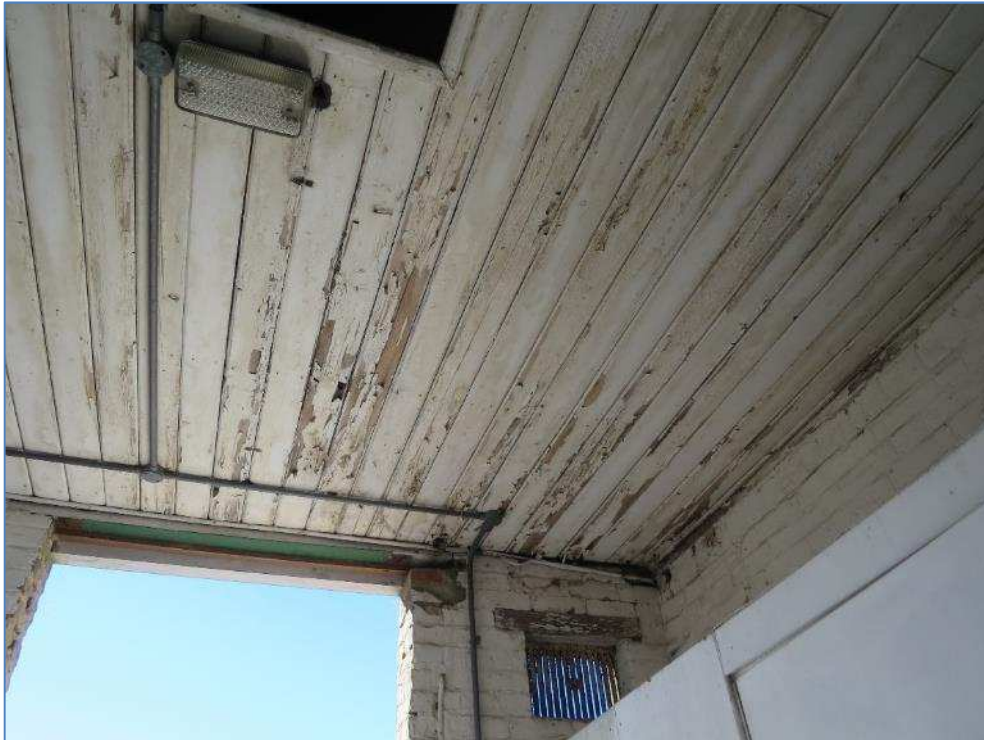
5-08 Damp and rot to timber soffit boards in tack boxes 25-30

The stables are in a fairly run down state and in need of work in a number of areas. The timber is rotting in many places and generally in need of repainting to prevent further deterioration. The loose eaves boards should be re-fixed straight away.

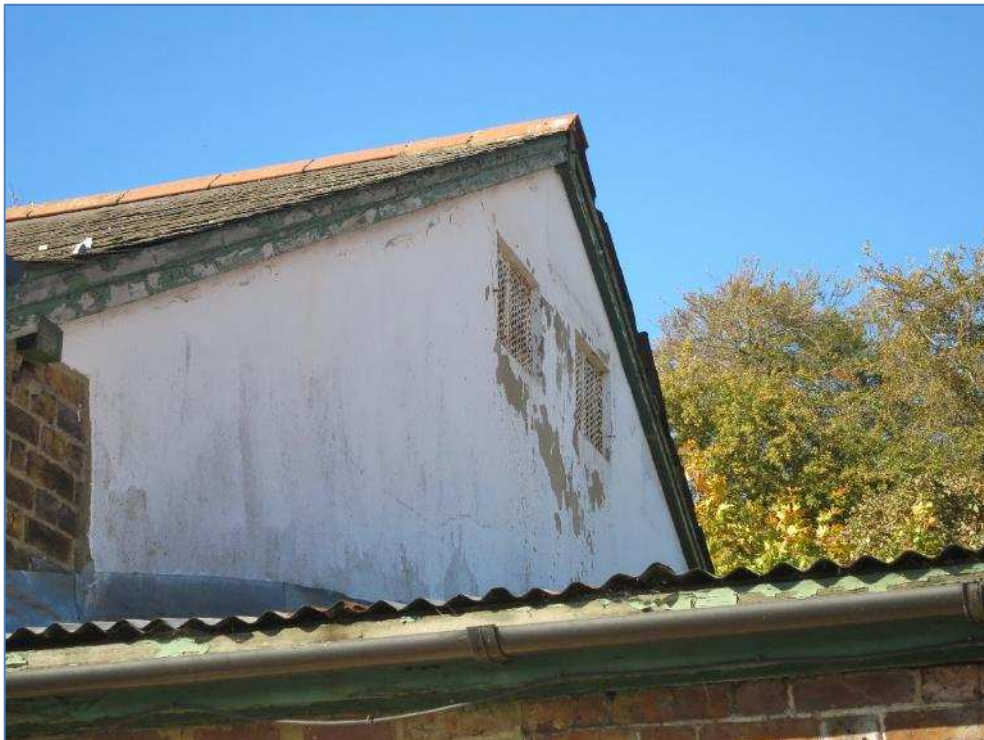
5-09 Paint peeling from end wall of stable 81

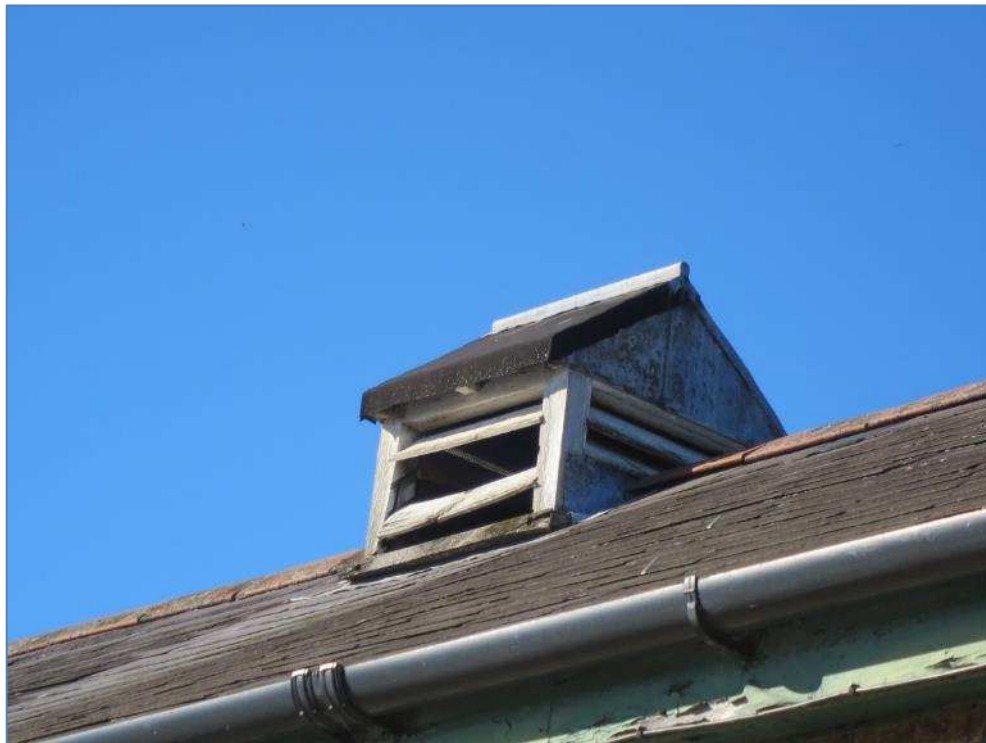
5-10 Timber roof vent box breaking up

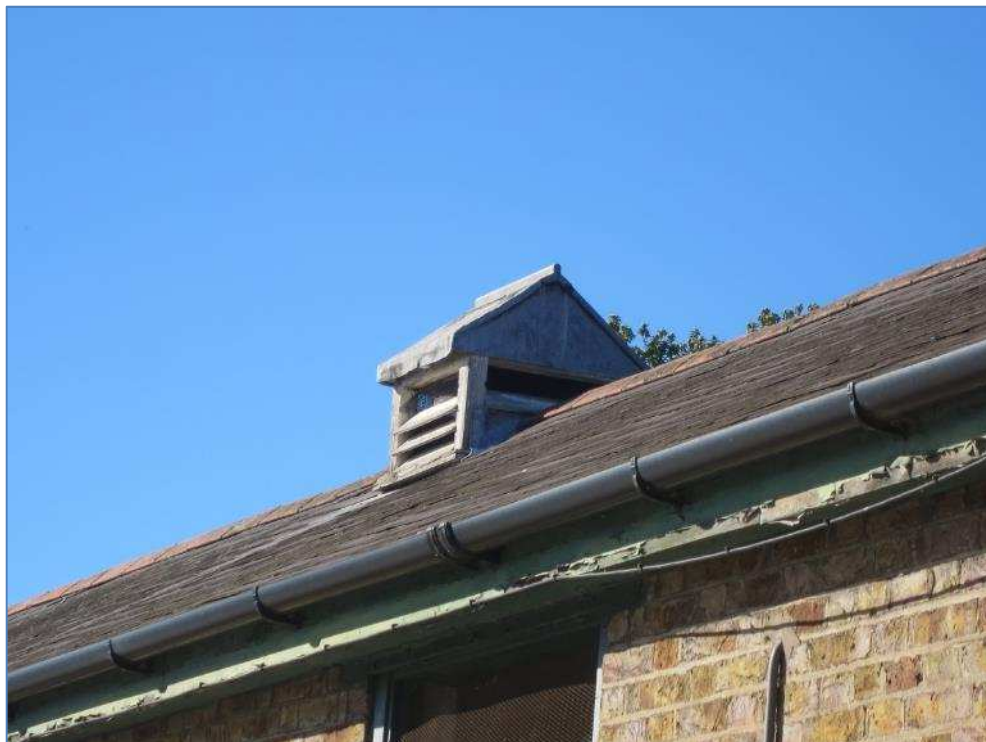
5-11 Timber roof vent box breaking up

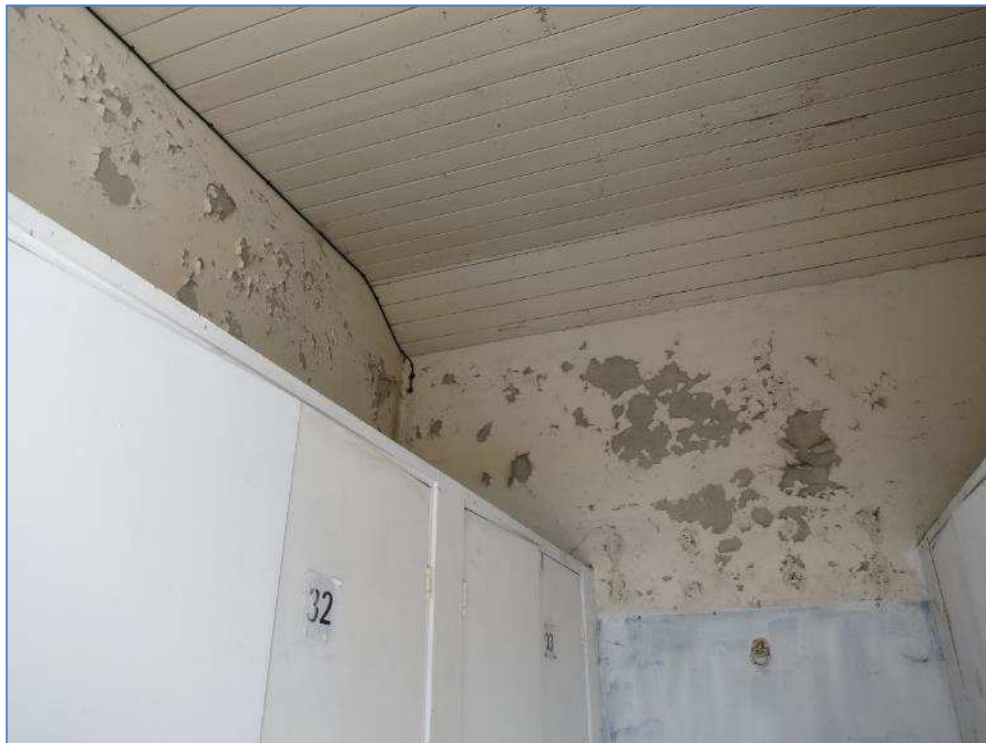
5-12 Paint peeling heavily from walls in tack boxes 31-36

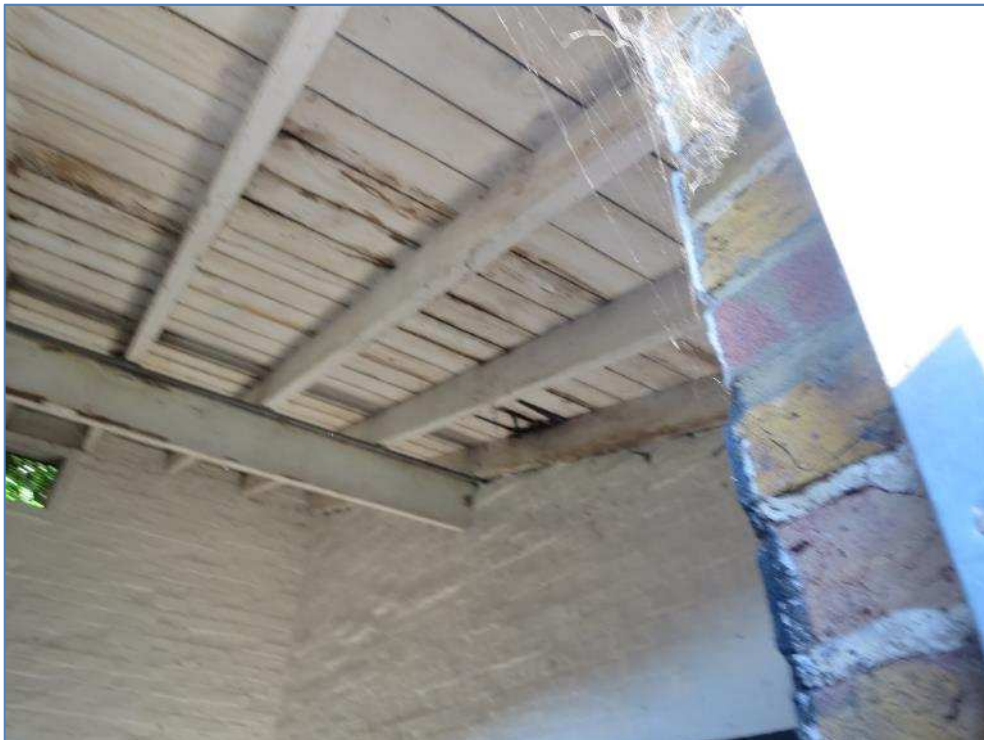
5-19 Minor rot to timber soffit boarding in stable 103

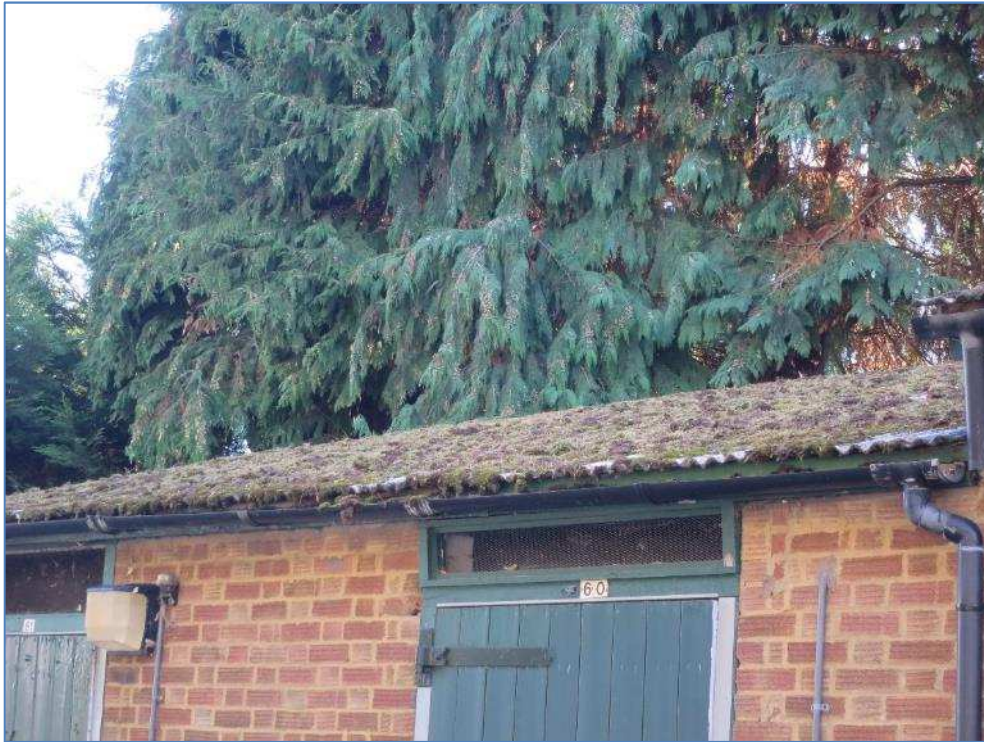
5-26 Heavy moss build up on roof

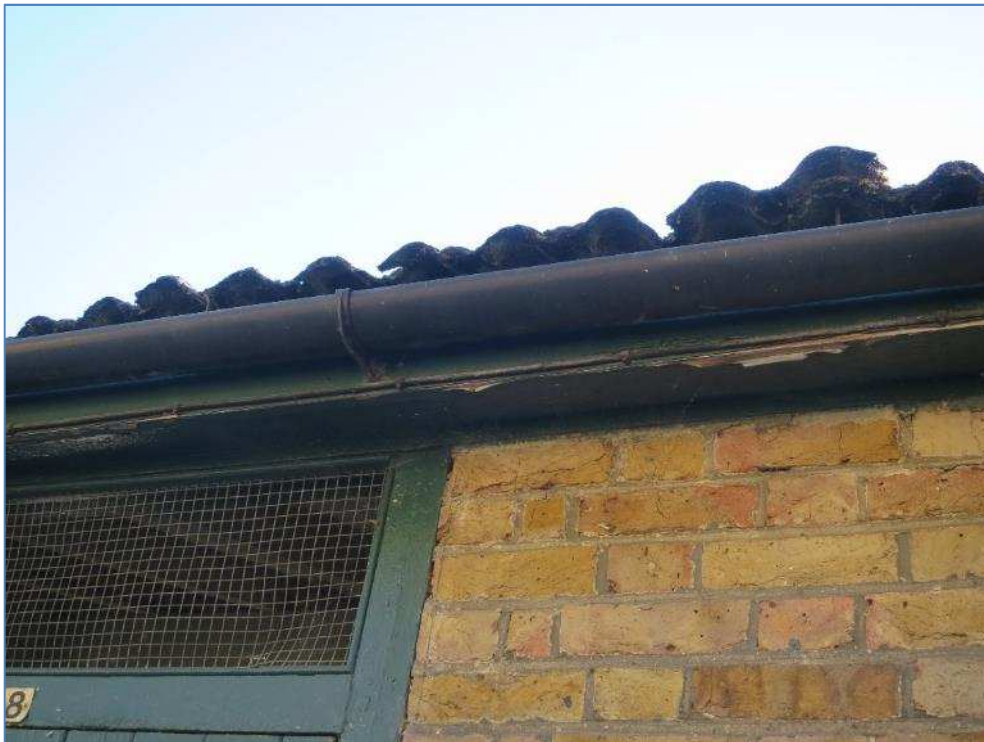
5-27 Asbestos roof sheeting fraying at edges

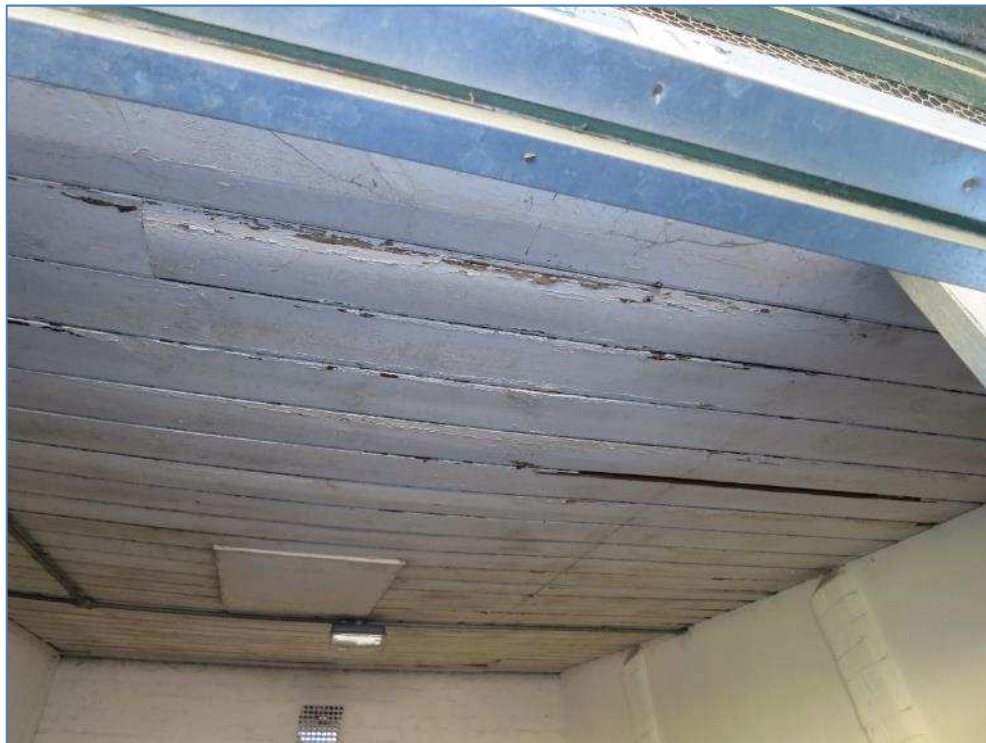
5-28 Timber soffit boarding rotting in stable 1

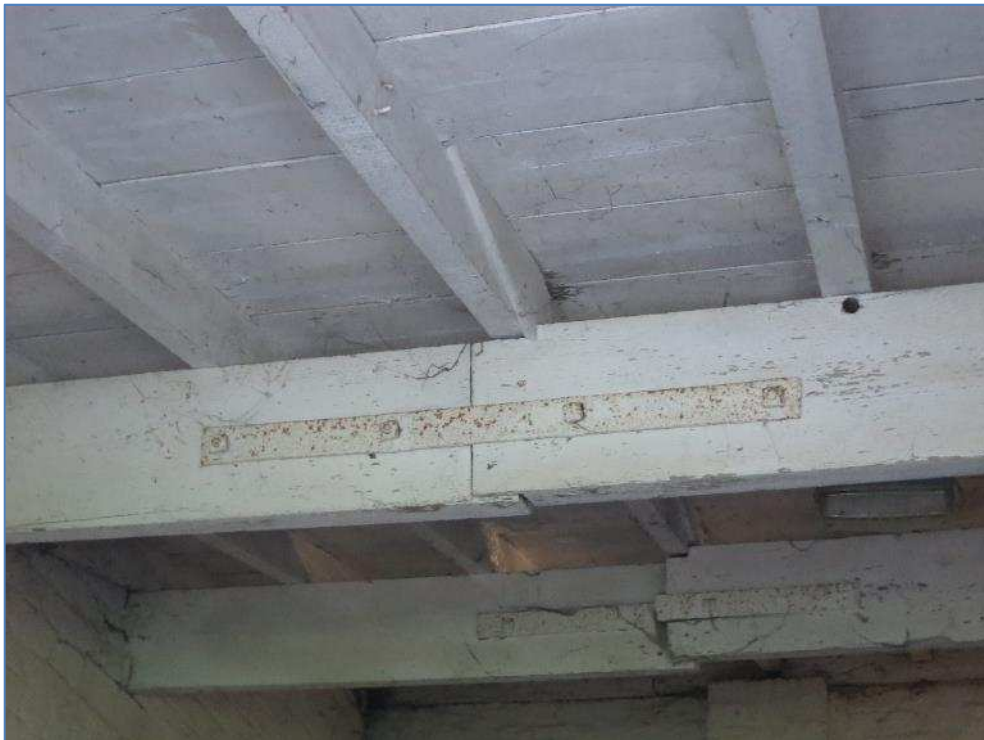
5-31 Minor surface rust to roof timber tie straps

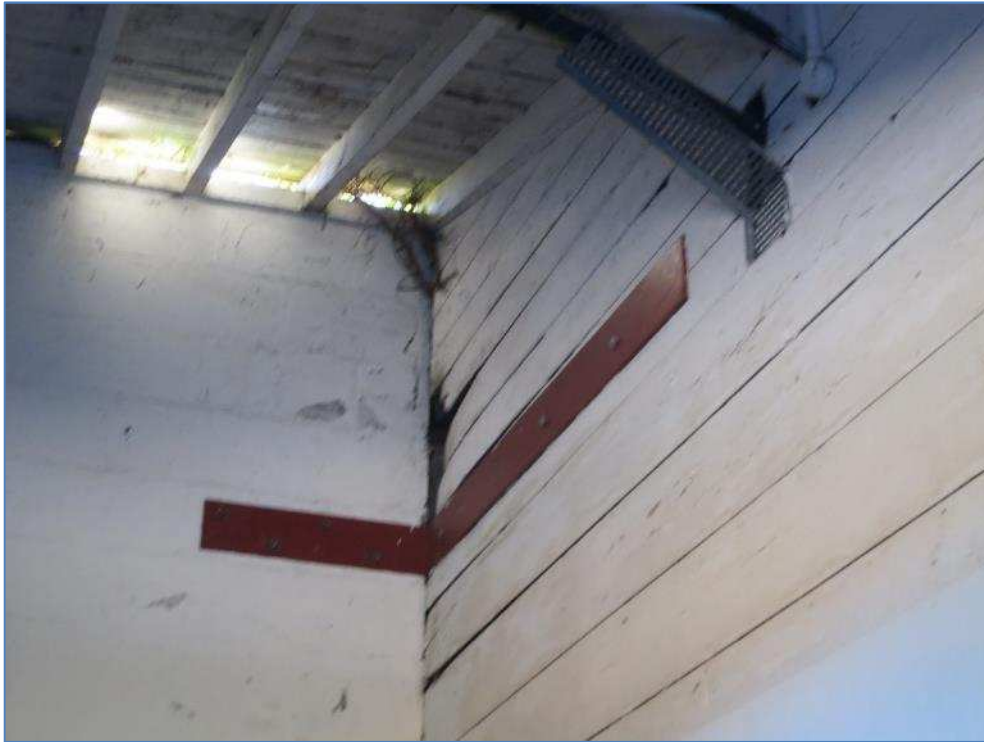
5-34 Wall timber rotting heavily in stable 51

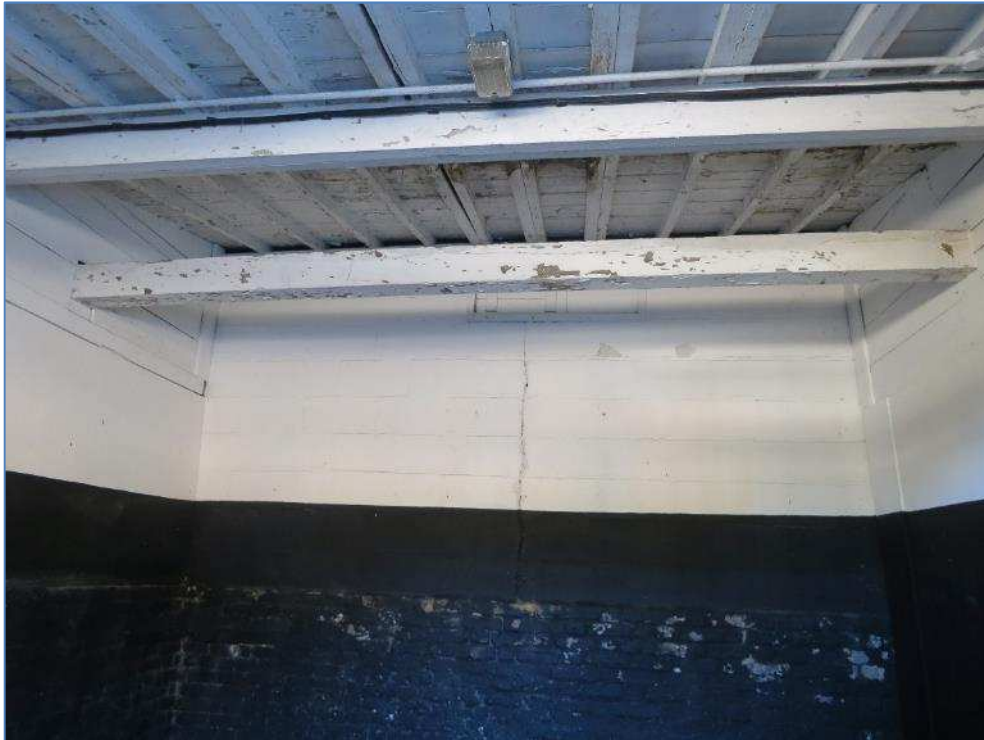
5-36 Crack in rear wall of stable 46

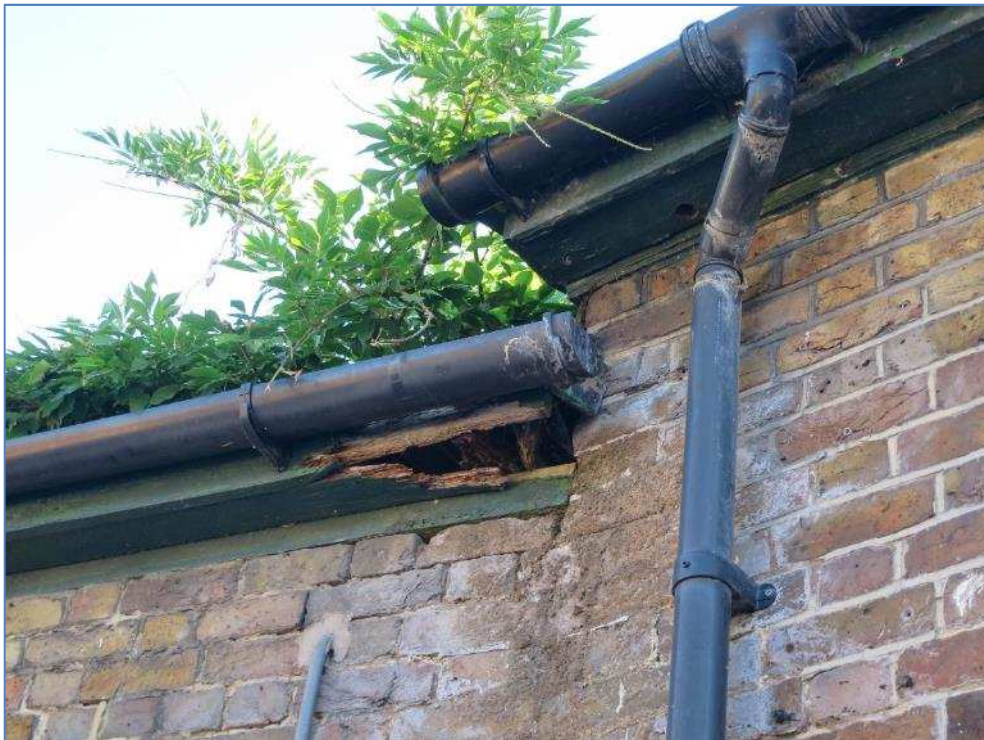
5-37 Timber eaves boarding rotting heavily between stables 53 & 54

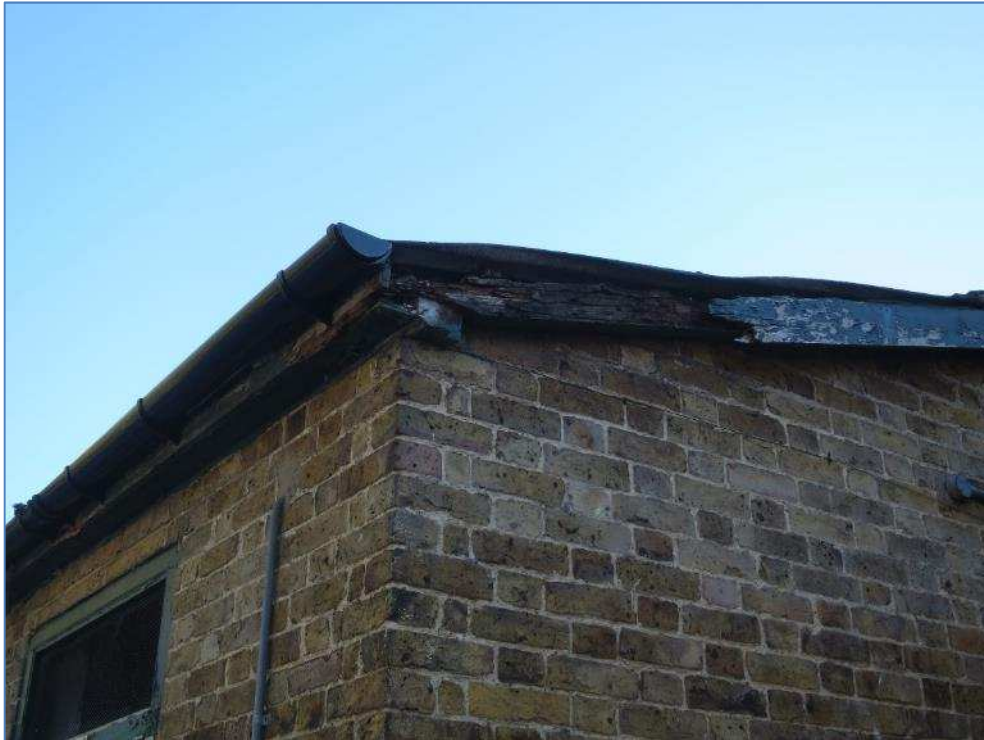
5-38 Timber eaves boarding rotting heavily outside stable 56

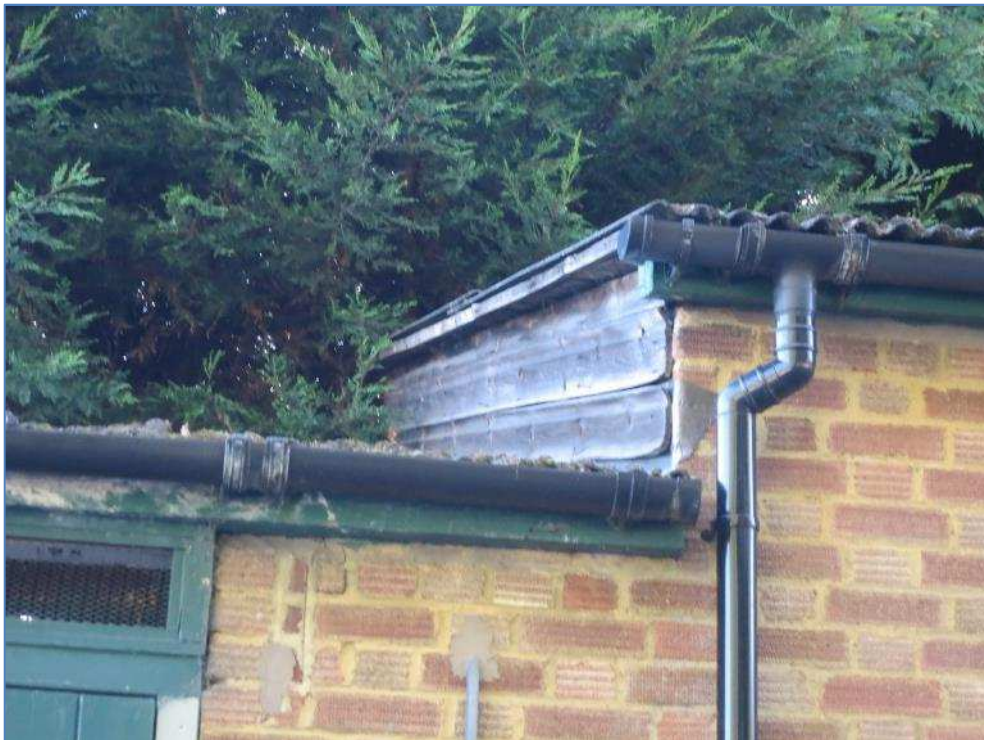
5-39 Roof step timber to stable 63 rotting and warping heavily

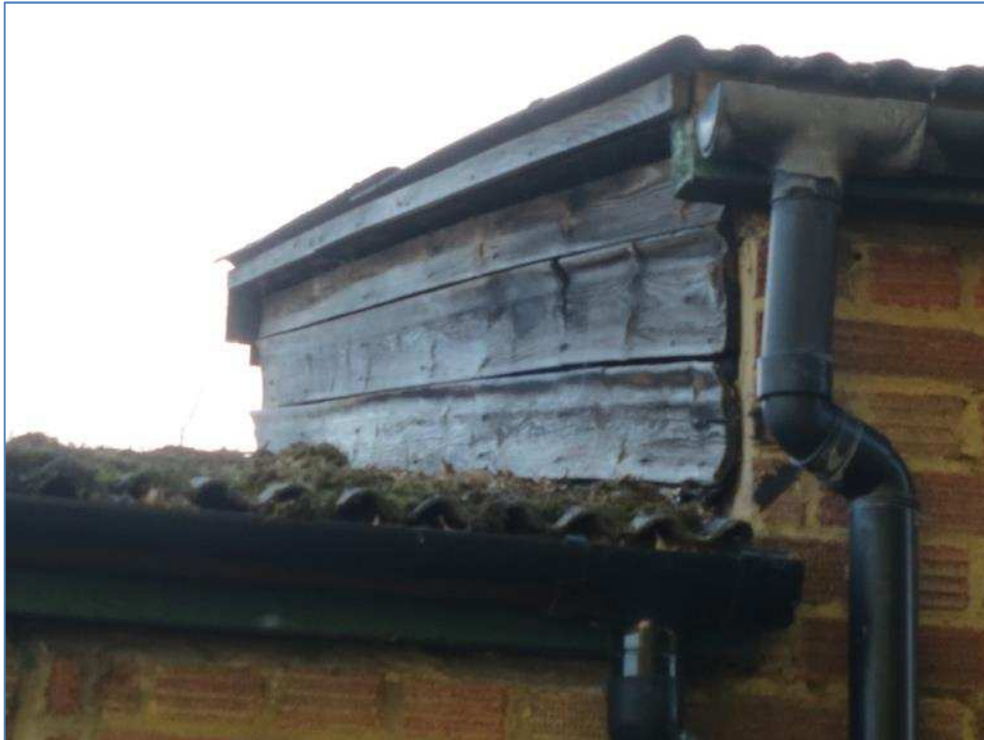
5-40 Roof step timber to stable 65 rotting and warping heavily

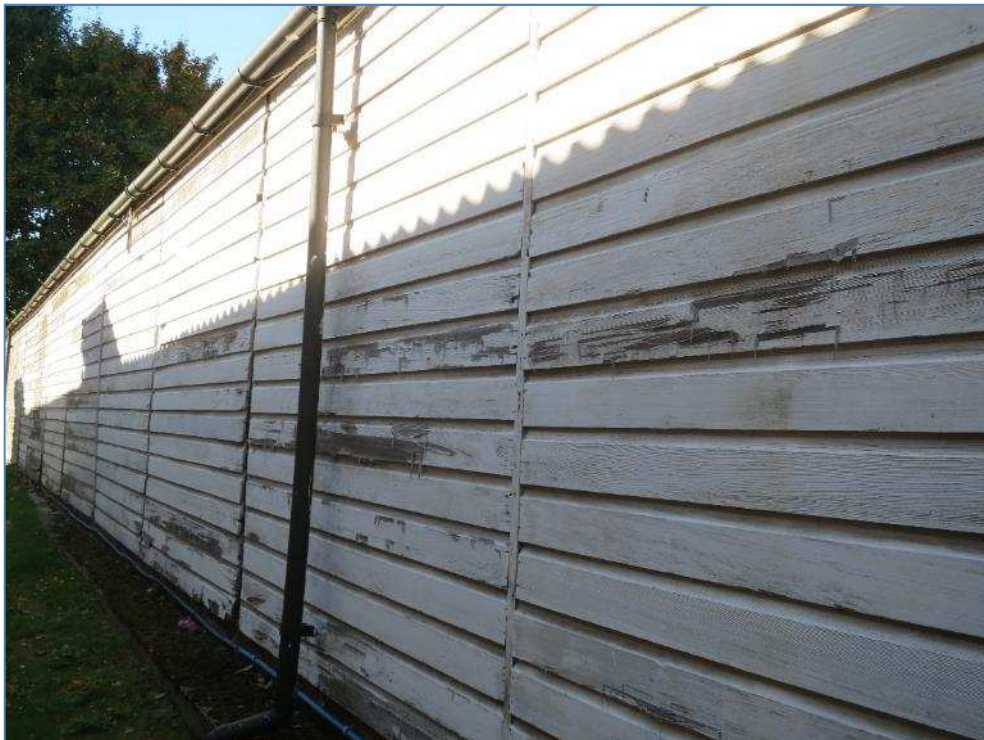
6-01 Paint peeling heavily from timber cladding

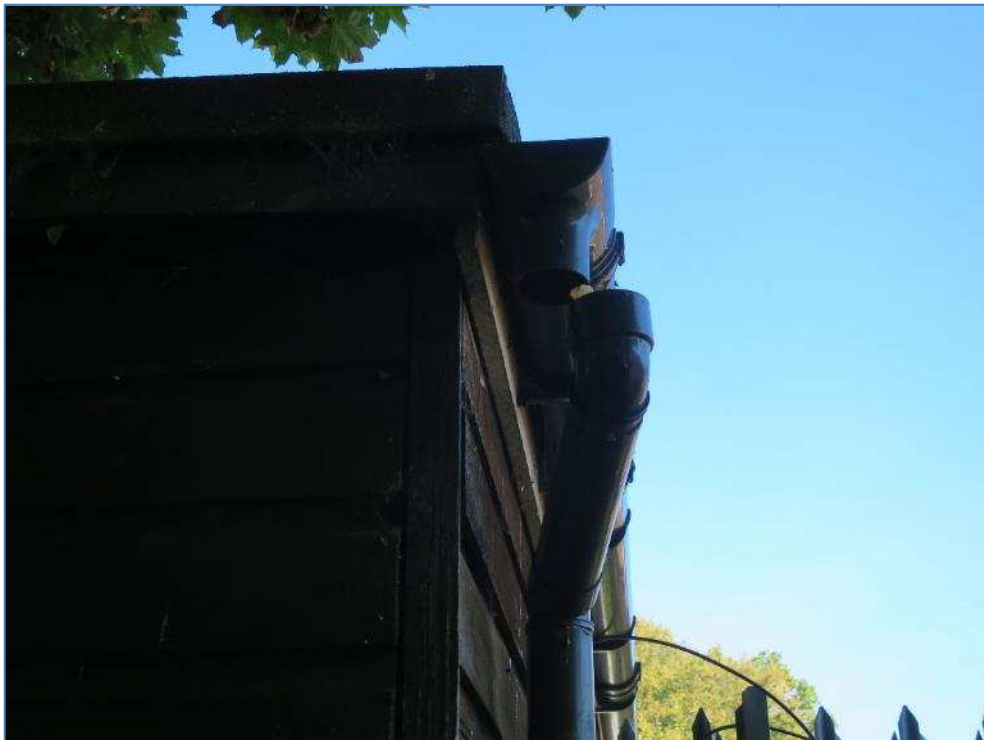
6-04 Gutter downpipe damaged

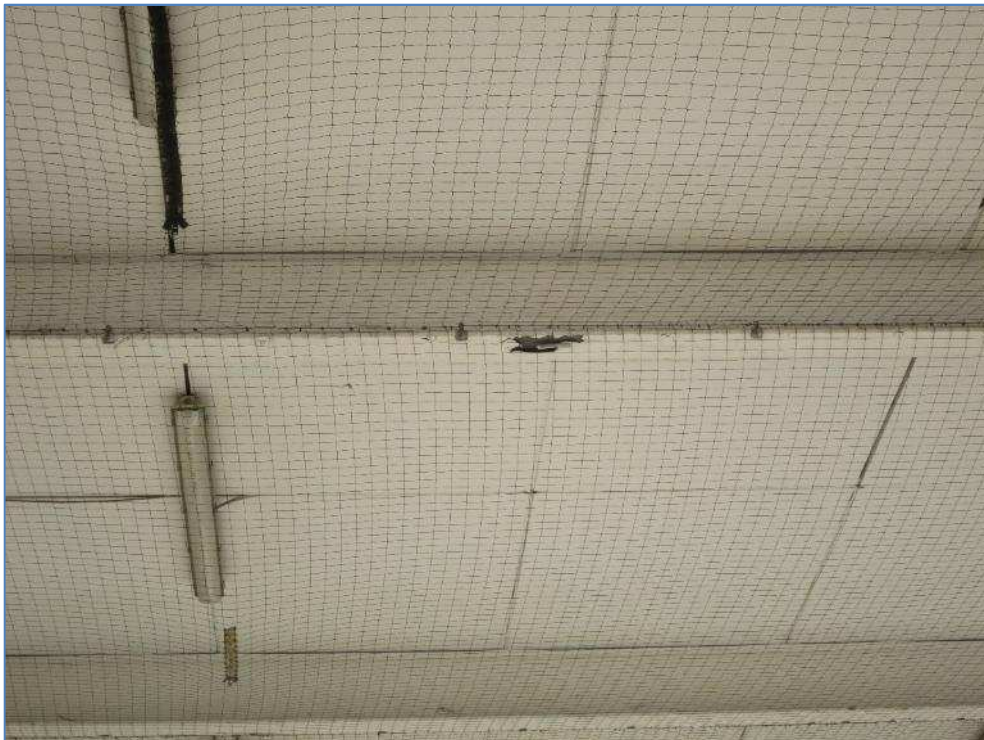
7-01 Paint peeling from media centre support steelwork

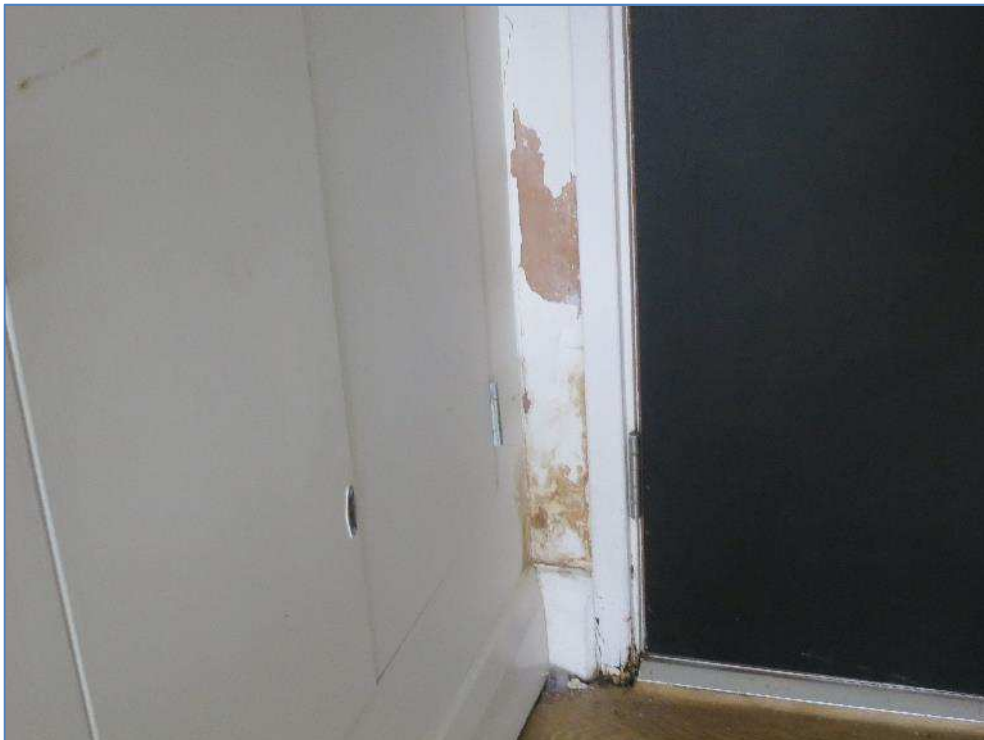
7-05 Water damage to wall in media centre entrance foyer

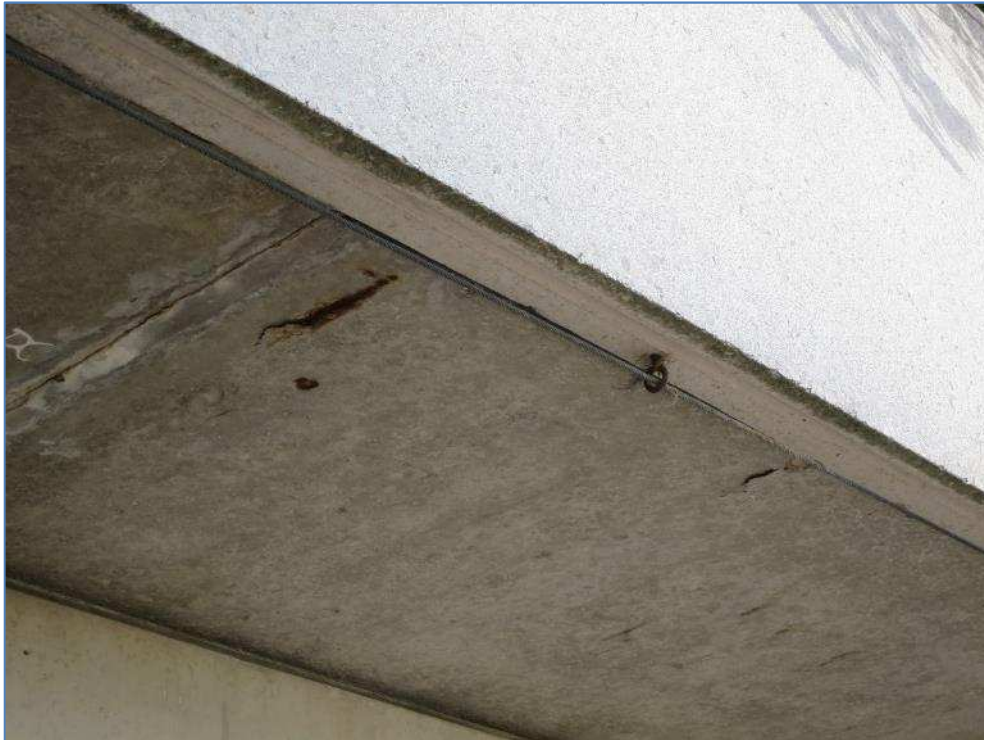
7-08 Concrete spalling on underside of viewing terrace new Champagne Bar

Any loose spalling render on the underside of the parade ring viewing balcony should be removed. It is recommended that regular checks be carried out.

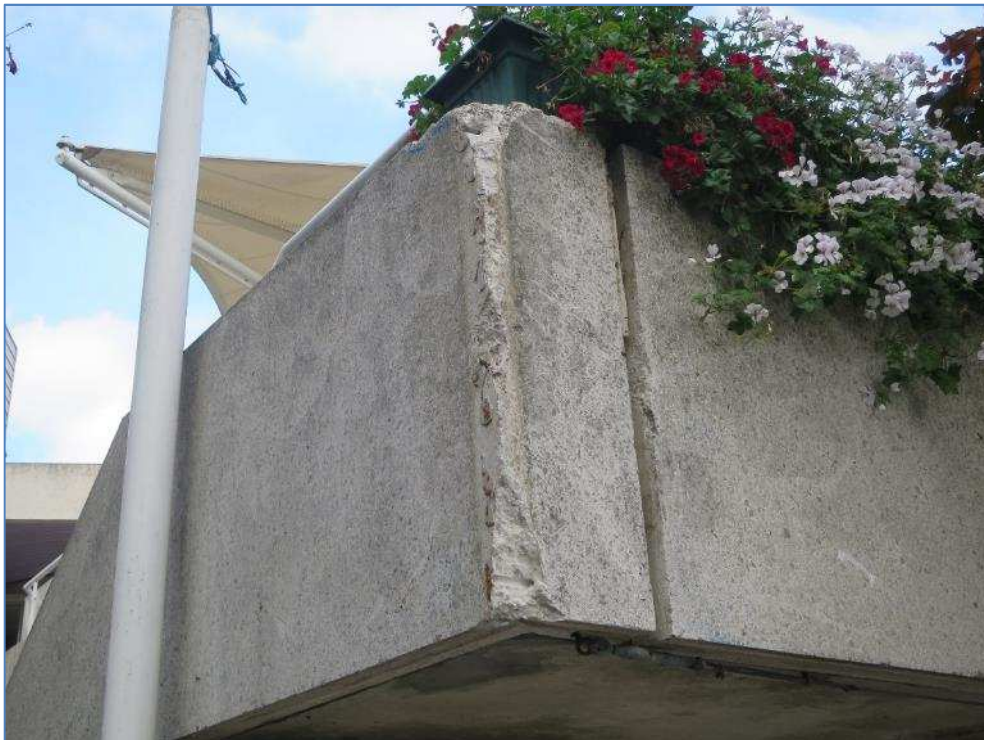
7-09 Minor movement of precast concrete unit due to impact damage

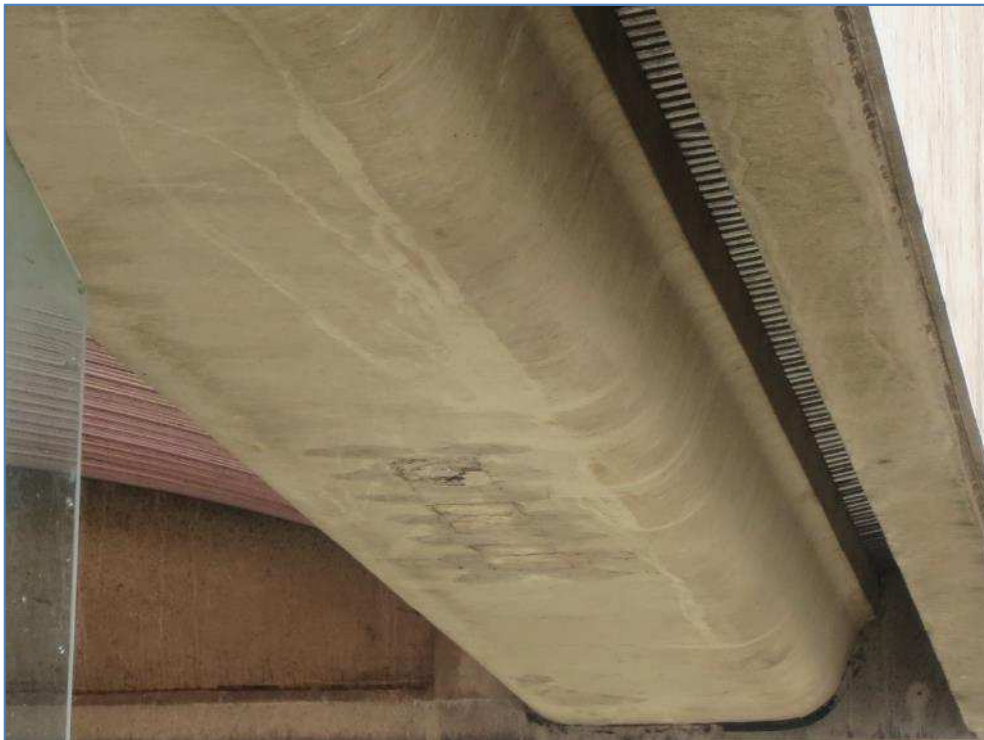
7-13 Minor area of concrete spalled to roof beam

A closer check is required to the roof beam where concrete appears to have spalled.
