**LAND OFF PUMP LANE  
RAINHAM  
KENT  
ME8 7TJ**

**INQUIRY DOCUMENT: Mott Macdonald Road Safety Audit**

# **Pump Lane, Lower Rainham**

Road Safety Audit  
Stage 1

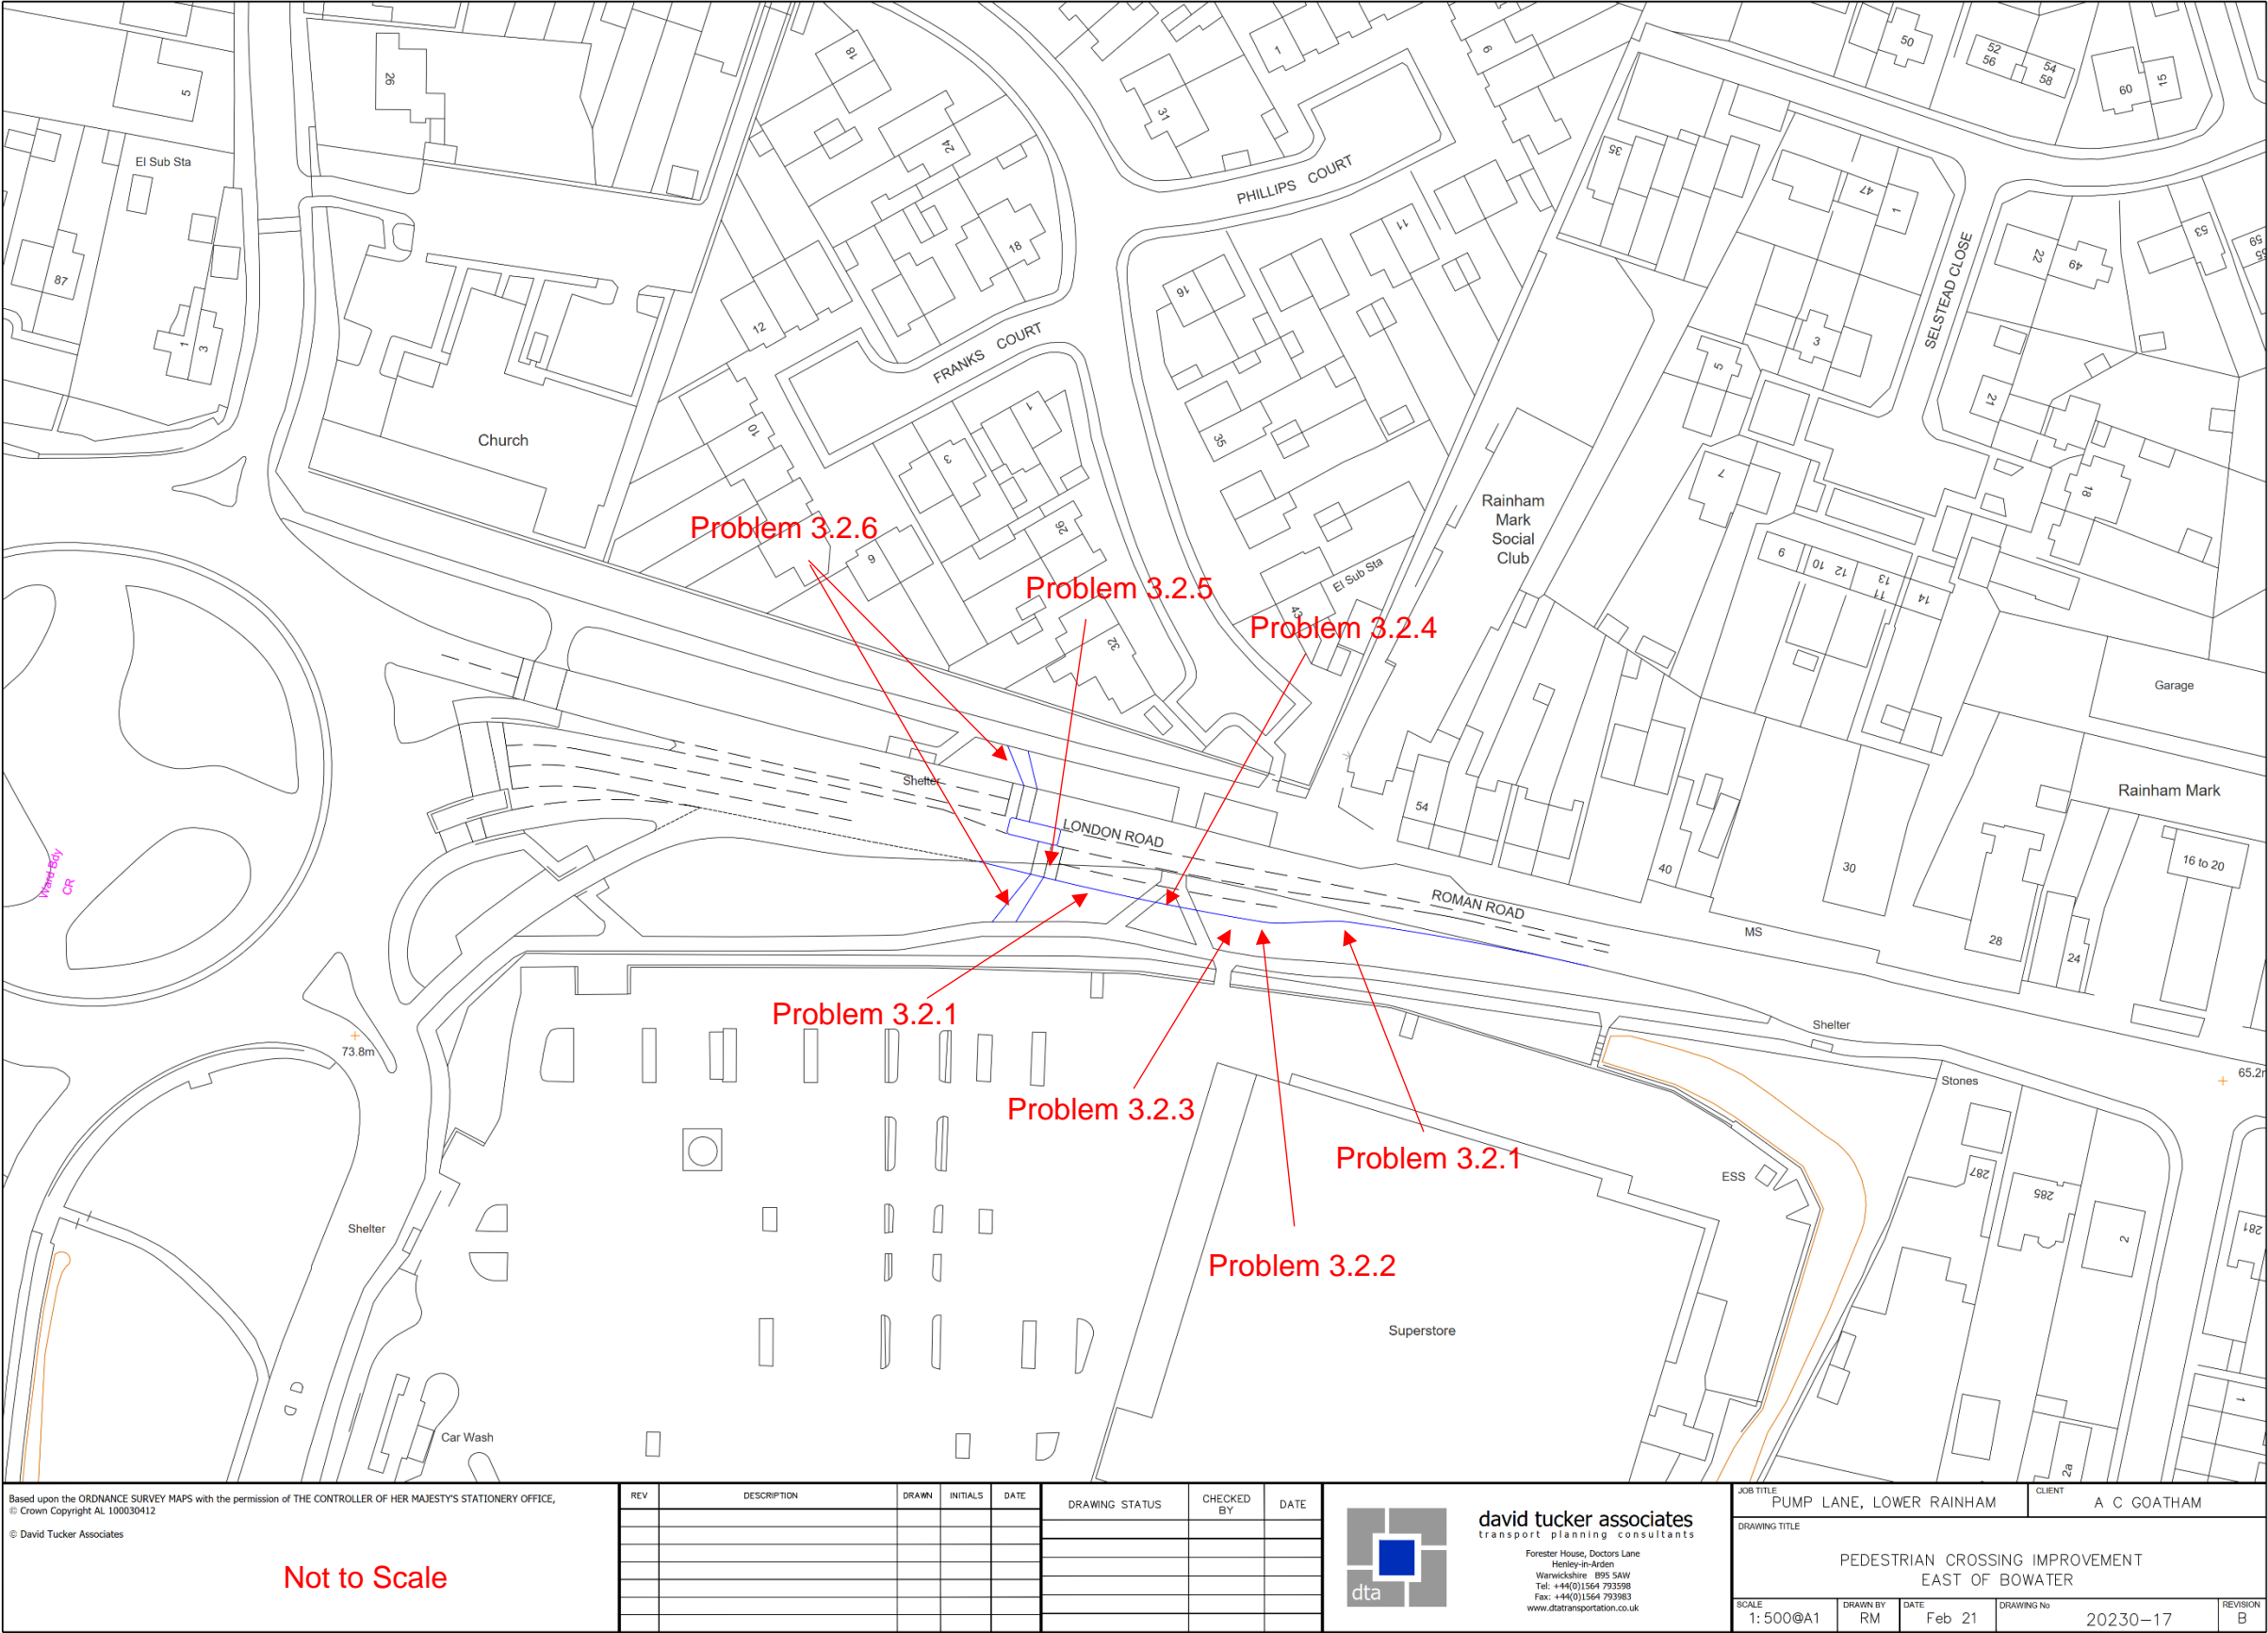
C. Location Plan – A2 London Road Toucan Crossing

On both sides of the A2 London Road the carriageway is notably lower / higher than the adjacent footways / cycleways. This requires 'ramps' leading from the footway / cycleways to the Toucan Crossing. It was noted that the gradient leading to the existing Toucan Crossing appeared inappropriate and a person using a mobility scooter was observed having difficulty crossing in a north-south direction. Failure to provide suitably graded approaches to the crossing point may hinder its safe use leading to collisions or trips / falls.

It is recommended that the gradient of the footway / cycleway links is no greater than 1 in 12 and that level landings are provided either side of the proposed crossing.

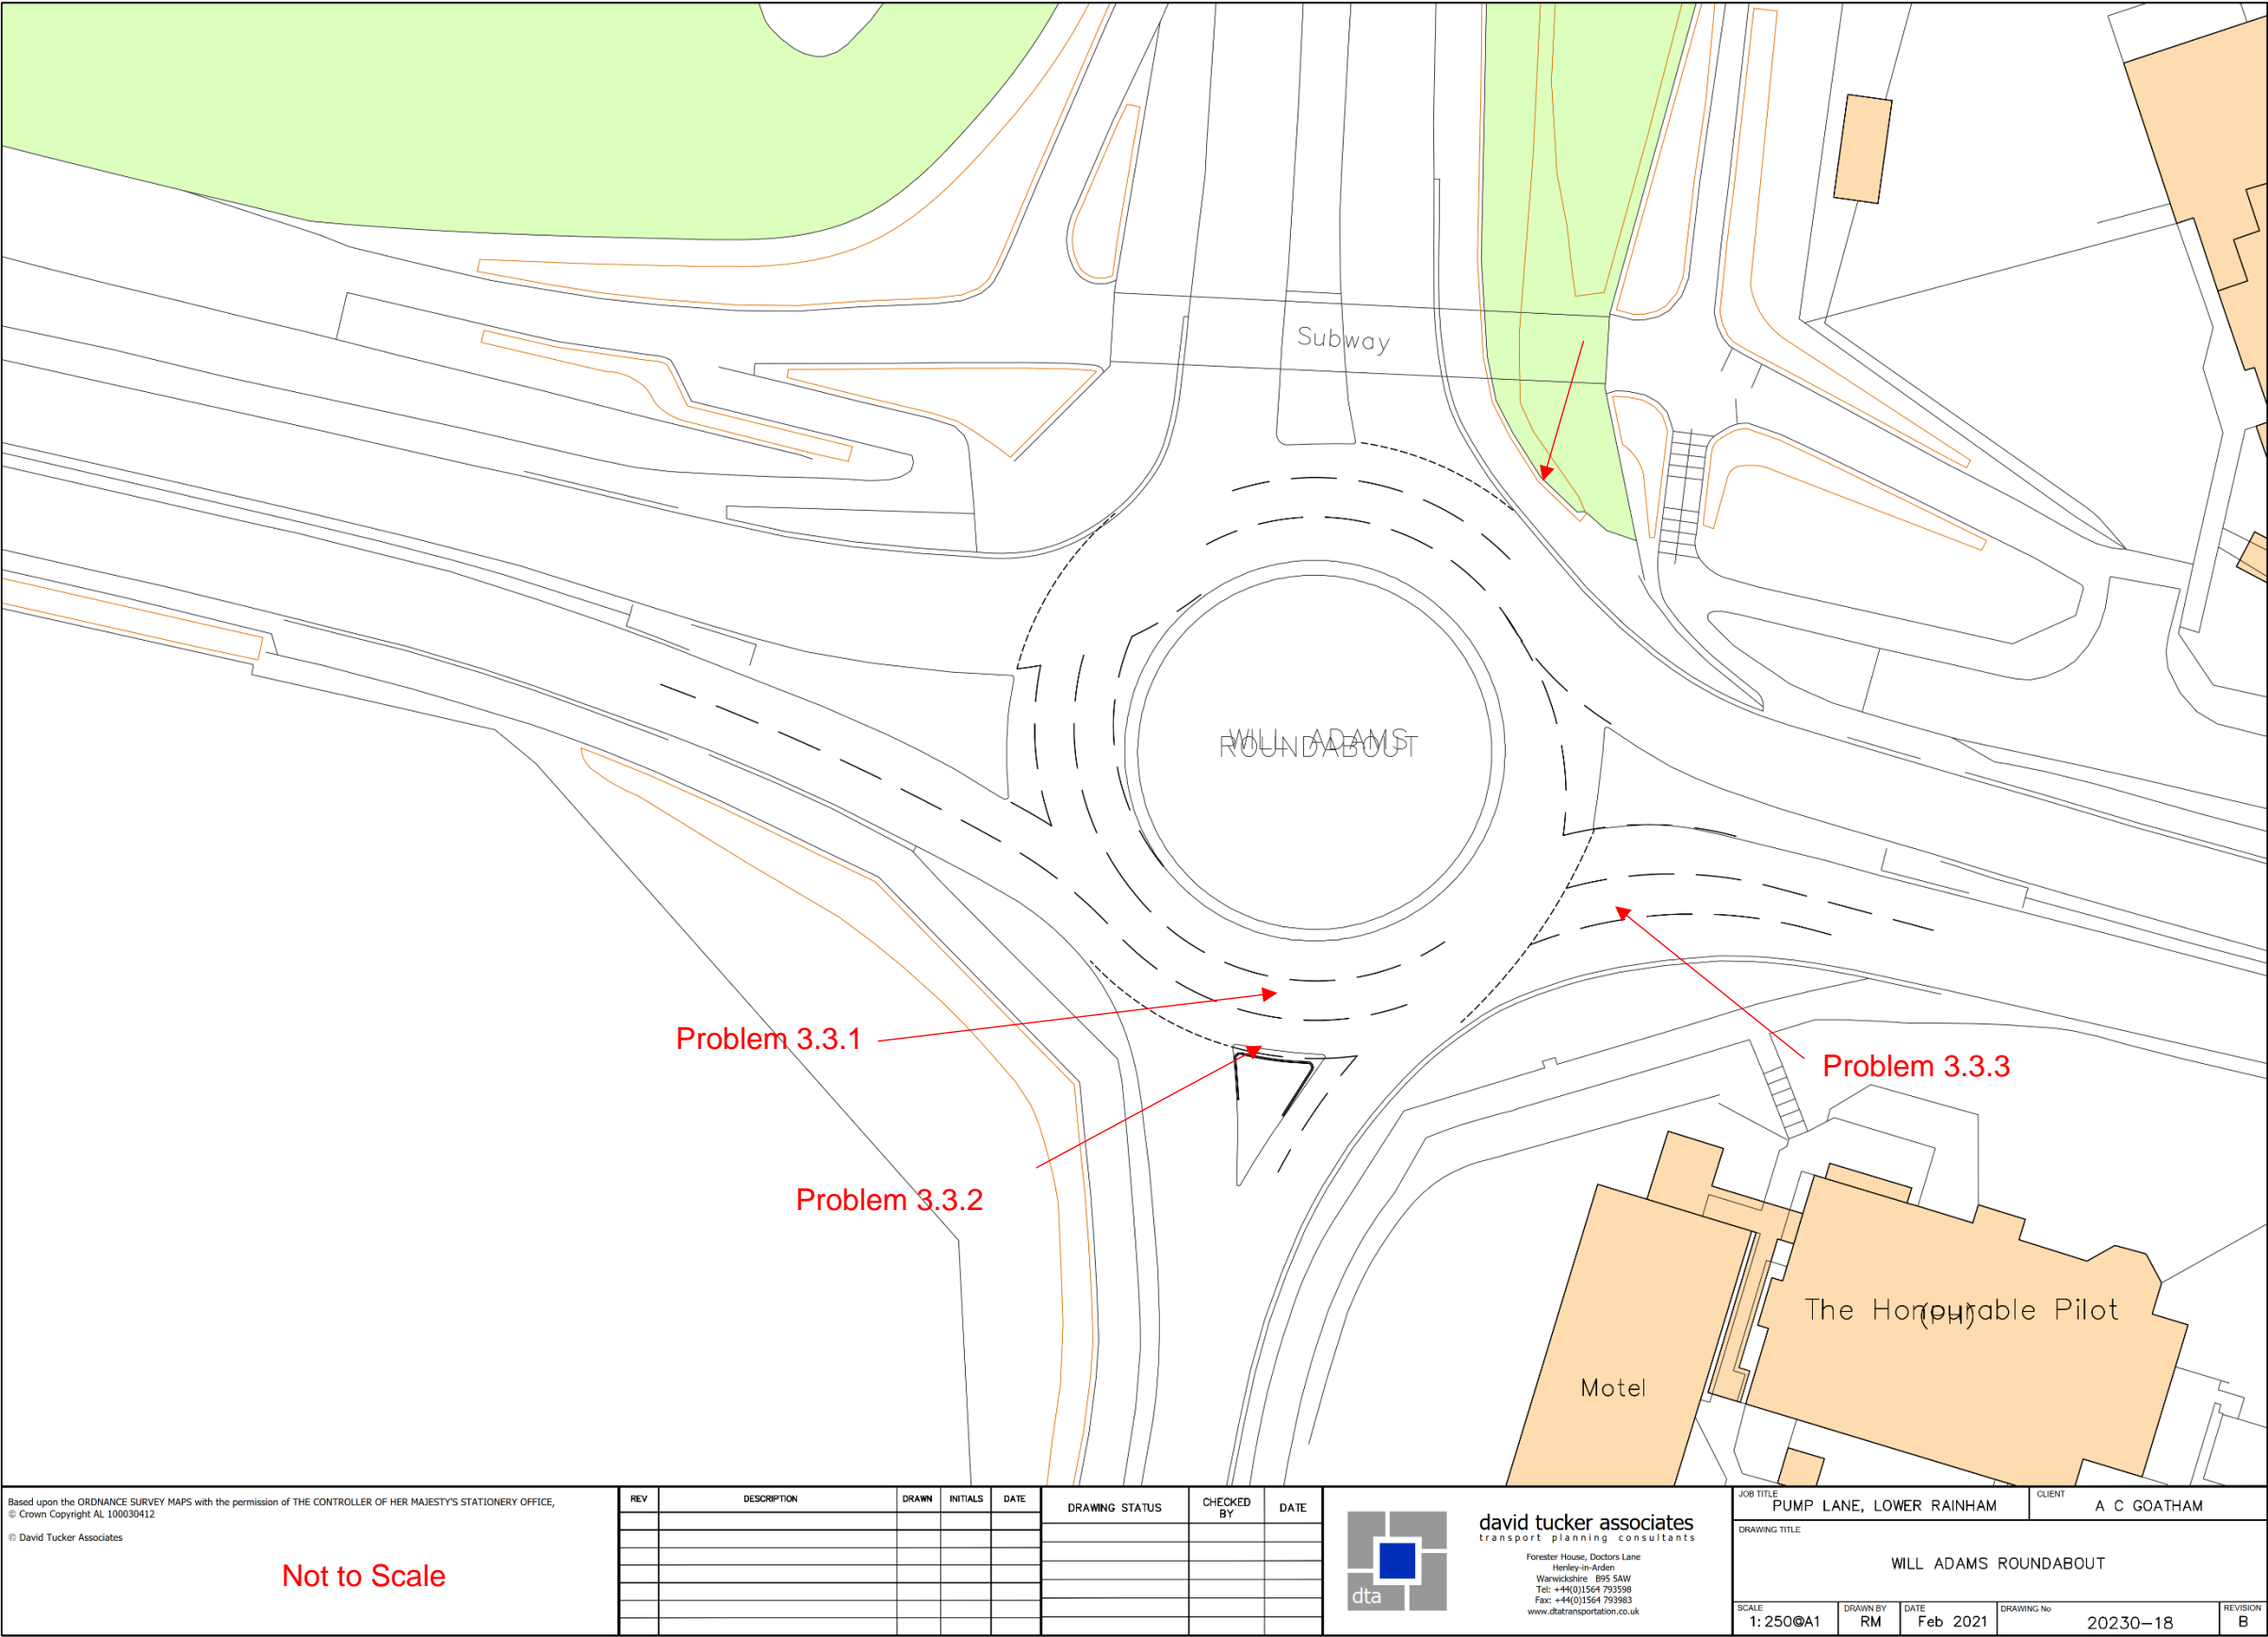
D. Location Plan – Will Adams Roundabout

Three lanes of traffic are present on the A2 London Road westbound entry to the roundabout; these are designated as Lane 1 - 'Left turn only', Lane 2 - 'Ahead only', and Lane 3 - 'Ahead and right'. The proposed modifications to the roundabout will result in the lanes becoming Lane 1 - 'Ahead and Left', Lane 2 - 'Ahead only', and Lane 3 - 'Right turn only'. The design drawings do not indicate that these markings will be modified; failure to do so will result in incorrect lane choice and driver confusion increasing the risk of collisions.

It is recommended that the carriageway arrow markings on the A2 London Road Westbound entry are appropriately modified to provide consistency with the other proposed changes.
