SANDOWN PARK

Sandown Park Racecourse
Annual Structural Survey 2018

October 2018

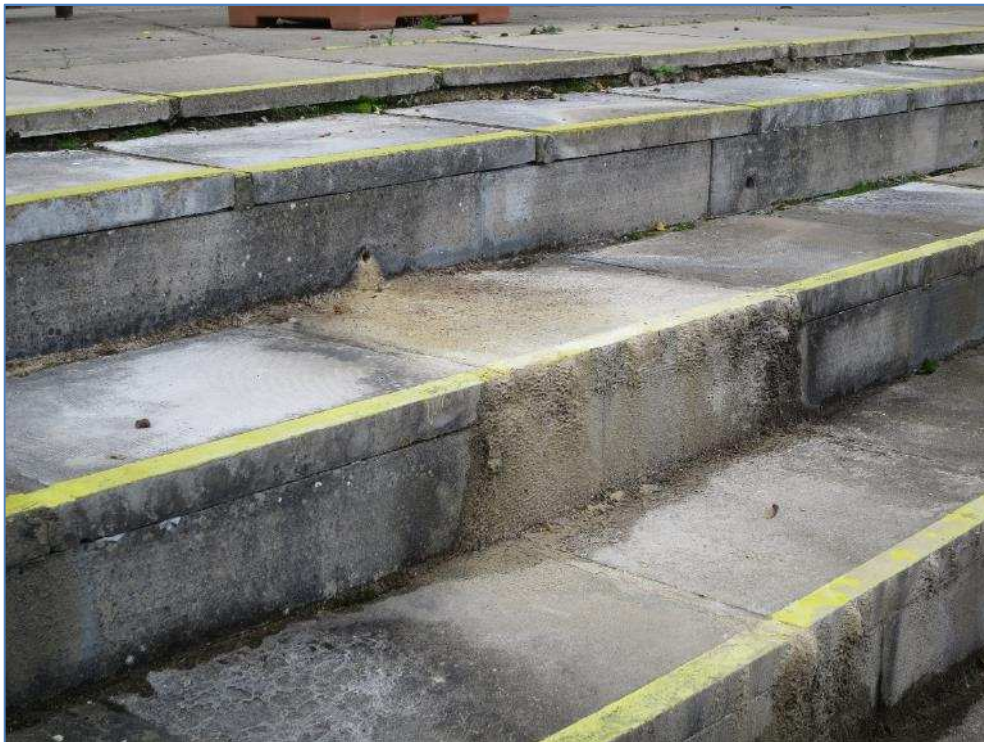
7-07 Leaching to steppings
