BUILDING CONDITION REPORT 2020, INCLUDING M&E CONDITION SURVEY

Summary Building Condition Report for
Jockey Club Racecourses Limited

SANDOWN PARK RACECOURSE
PORTSMOUTH ROAD
ESHER
SURREY
KT10 9AJ

March 2020

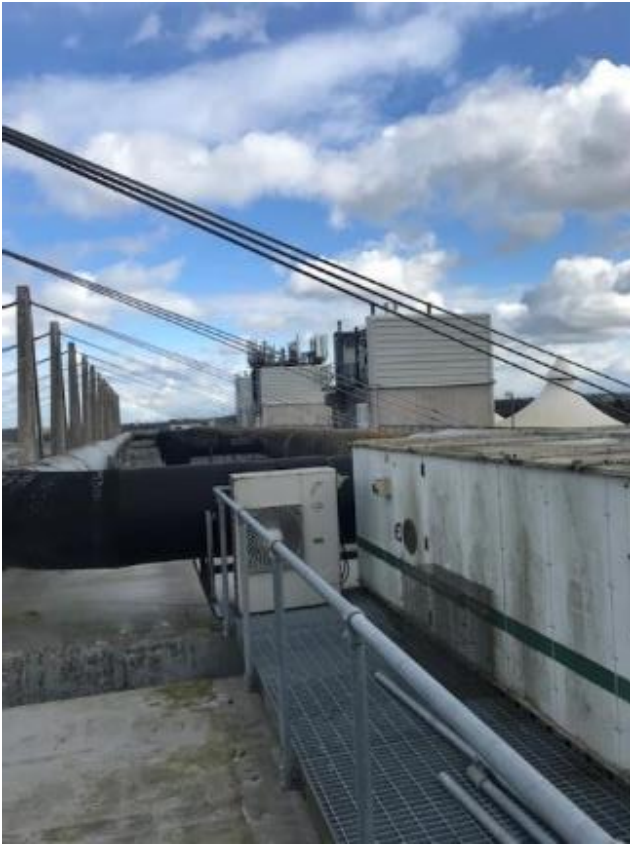
1. General view of the Grandstand roof.

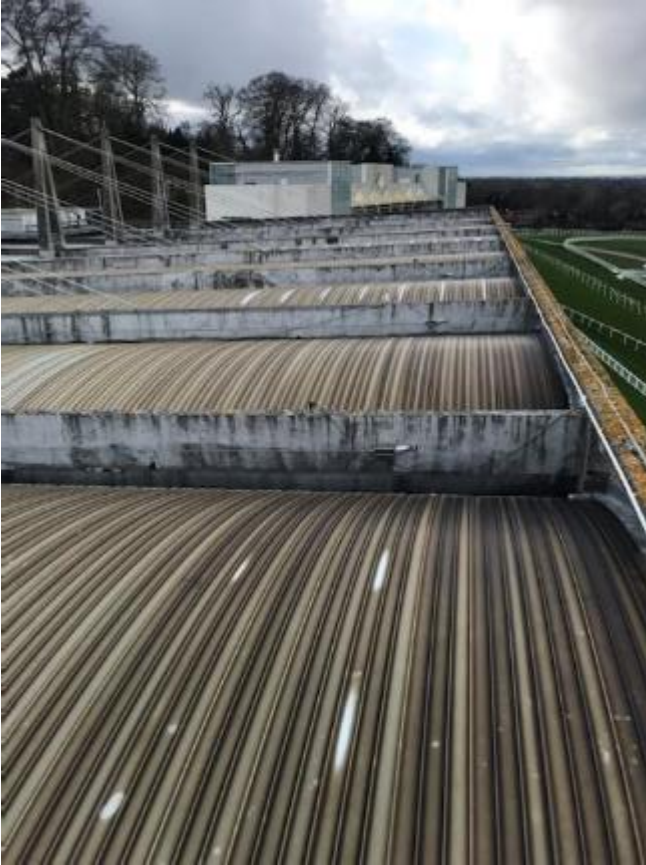
3. General view of the Grandstand roof.

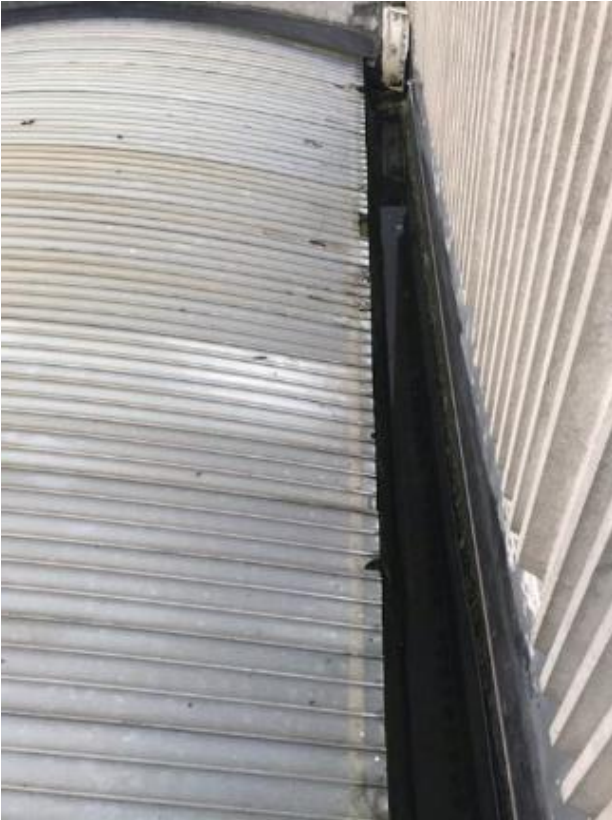
5. Typical close up view of damage to barrel vault canopy sections. UV degradation has caused the barrel vault canopy sections to become brittle.

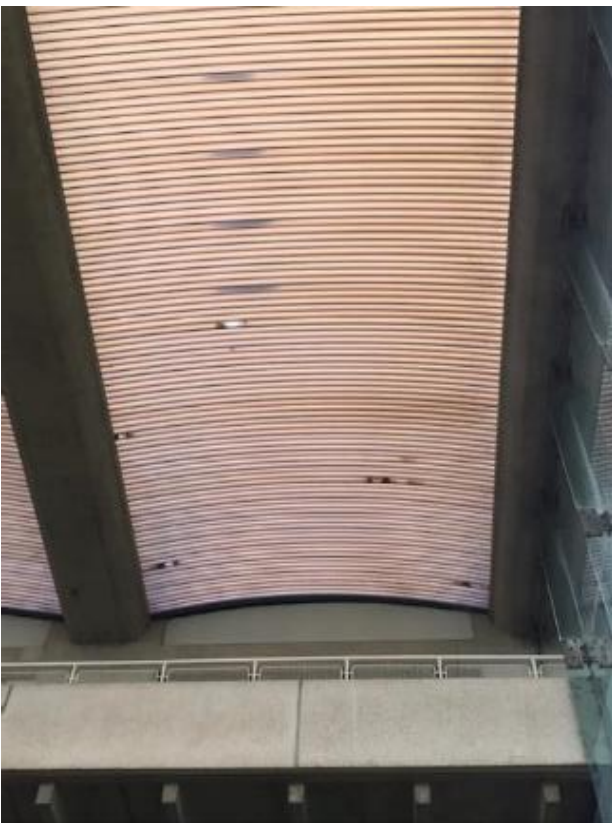
6. Typical view of the underside of the barrel vault canopy sections of roof indicating the damage to the brittle polycarbonate elements.

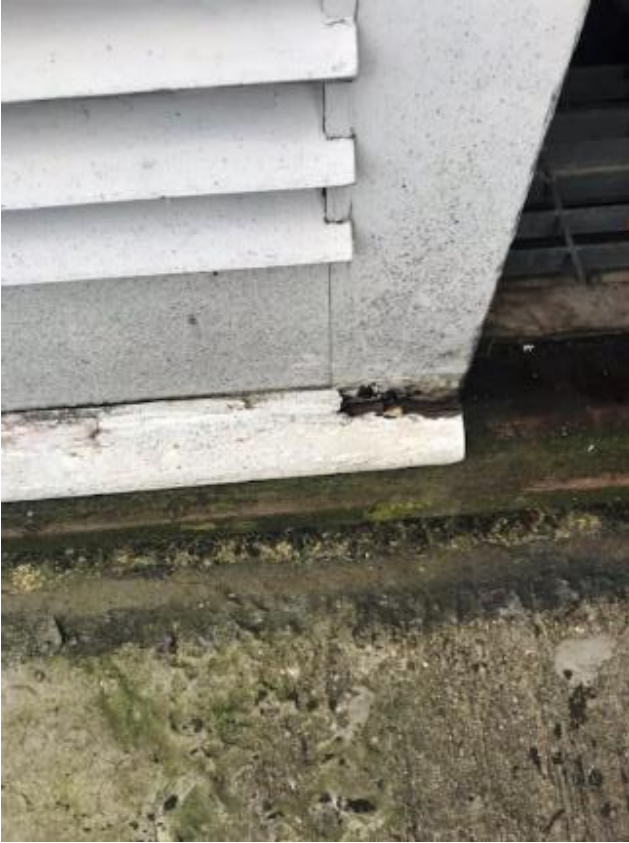
11. Example of rotten timber to external joinery/plant room doors.

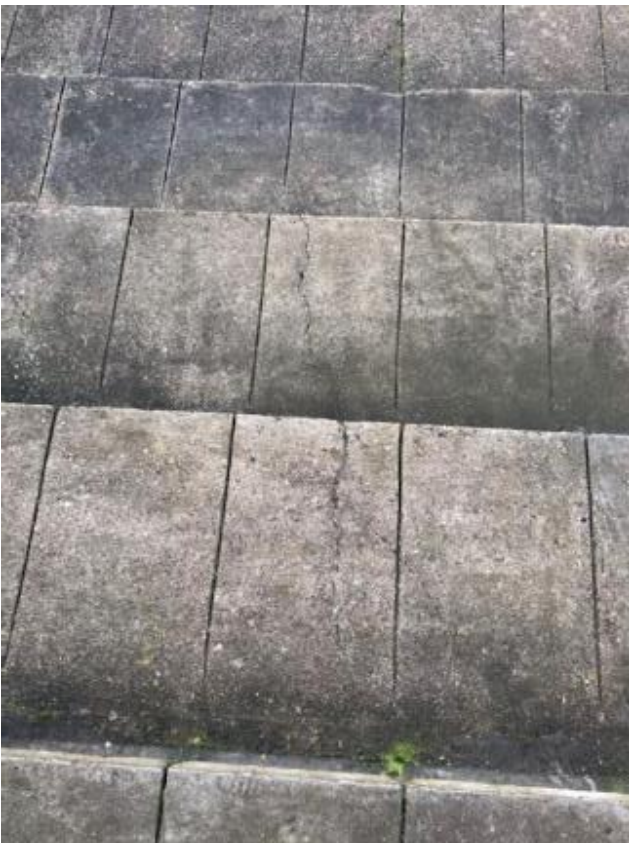
12. Example of cracked concrete steppings causing water ingress internally.

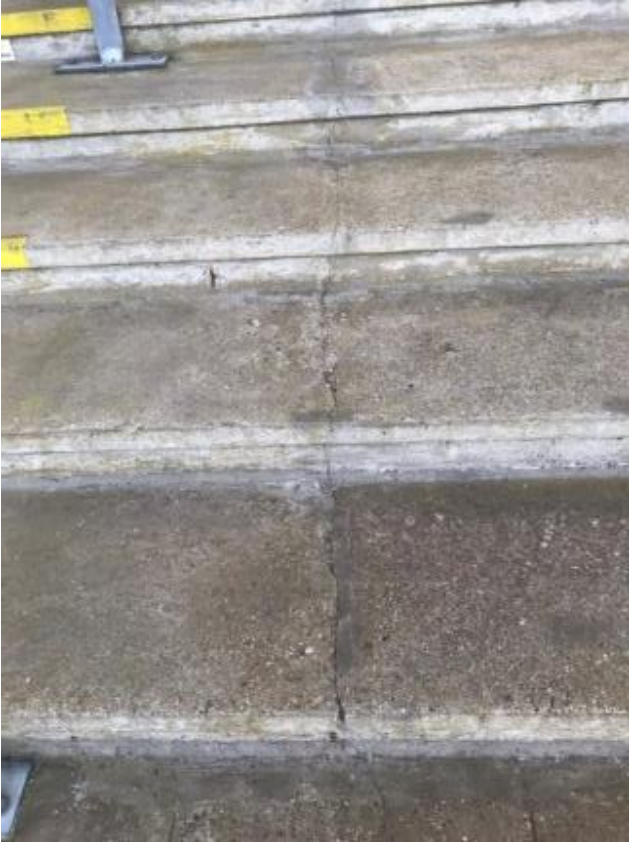
13. Example of cracked concrete steppings causing water ingress internally.

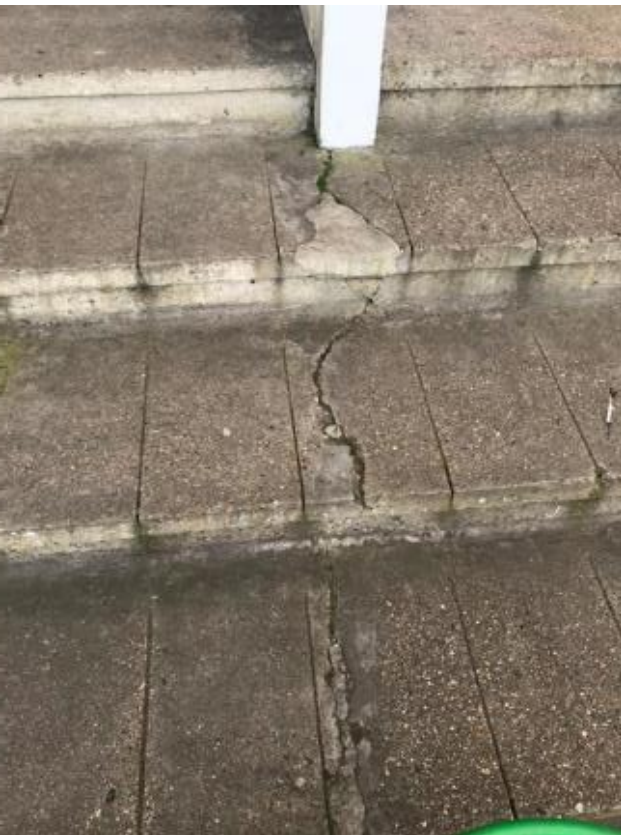
14. Example of cracked concrete steppings causing water ingress internally.

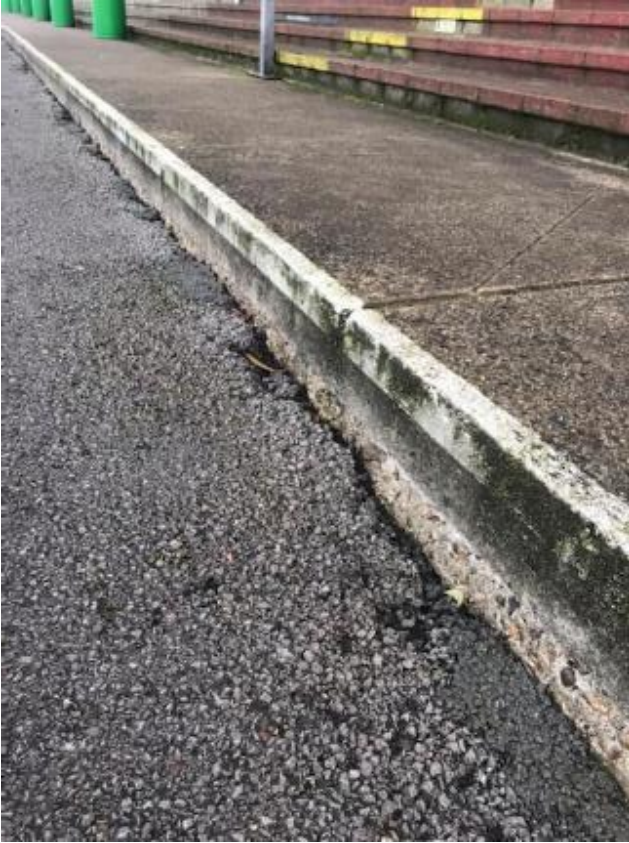
15. Consistent gap between tarmacadam hardstanding and Grandstand concrete stepping, likely to be caused by differential movement

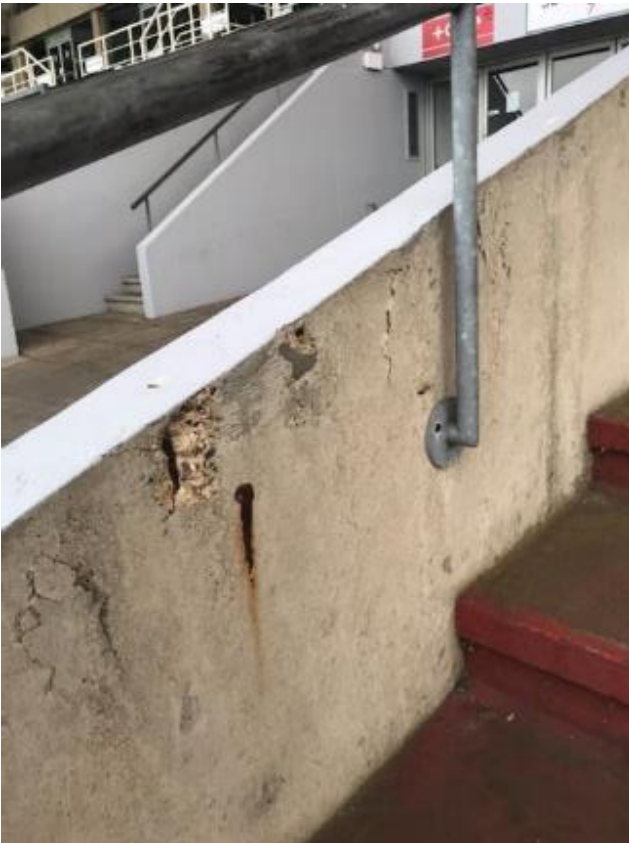
16. Example of spalling concrete retaining walls with exposed corroded steel reinforcement bars.

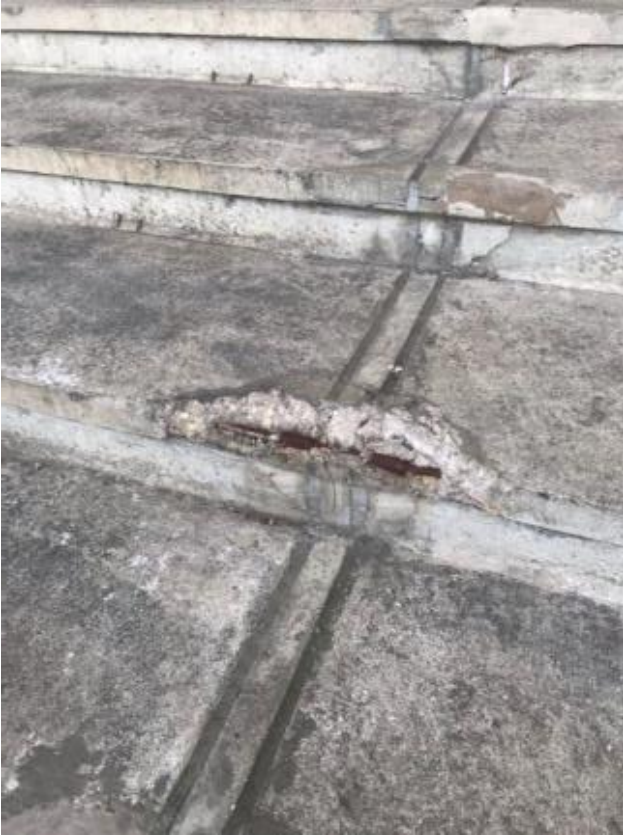
17. Example of spalling concrete risers to steppings due to corrosion of steel reinforcement bars.

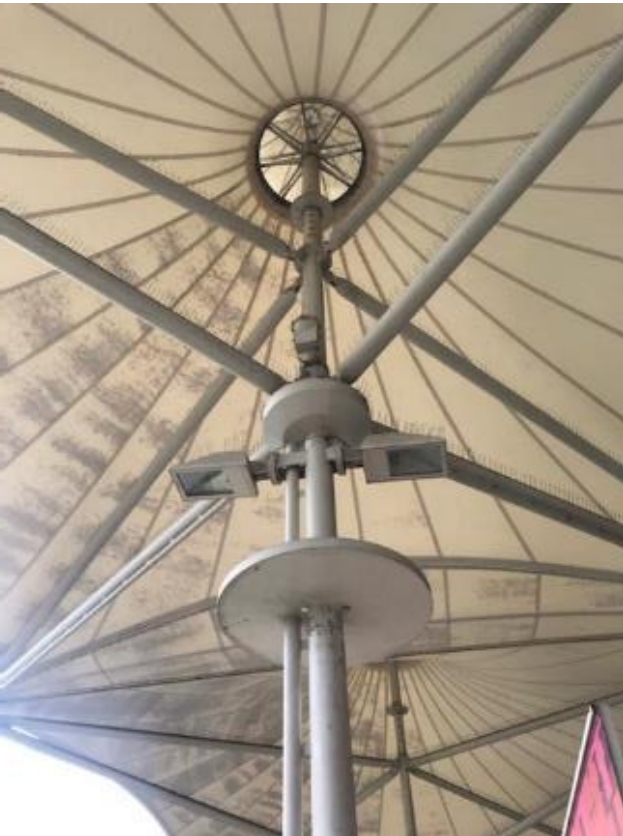
18. Soiled and degraded fabric canopy structure over terrace with leaking rainwater hoppers and pipework.

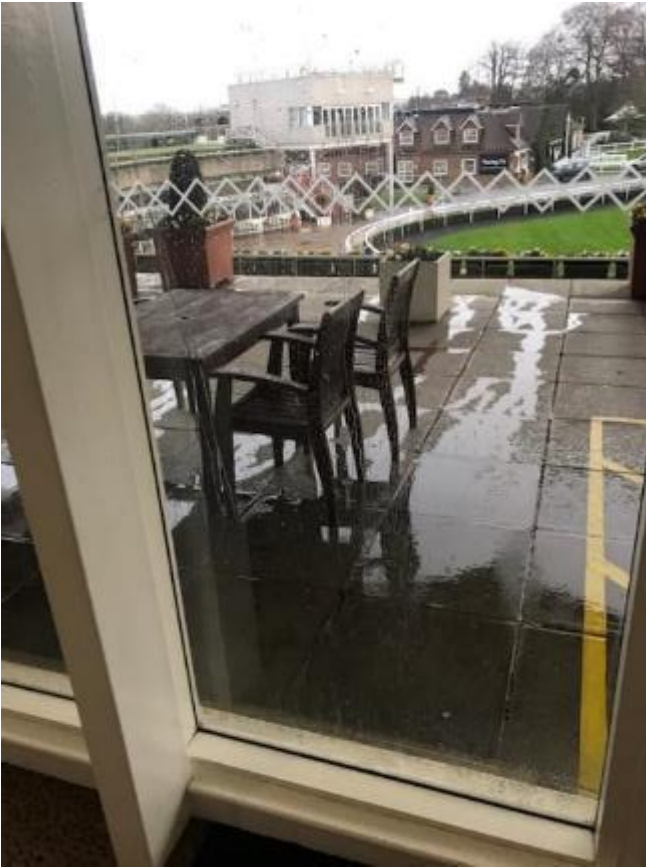
21. View of leaks from fabric canopy cascading down the terrace glazing and across the terrace pavings.

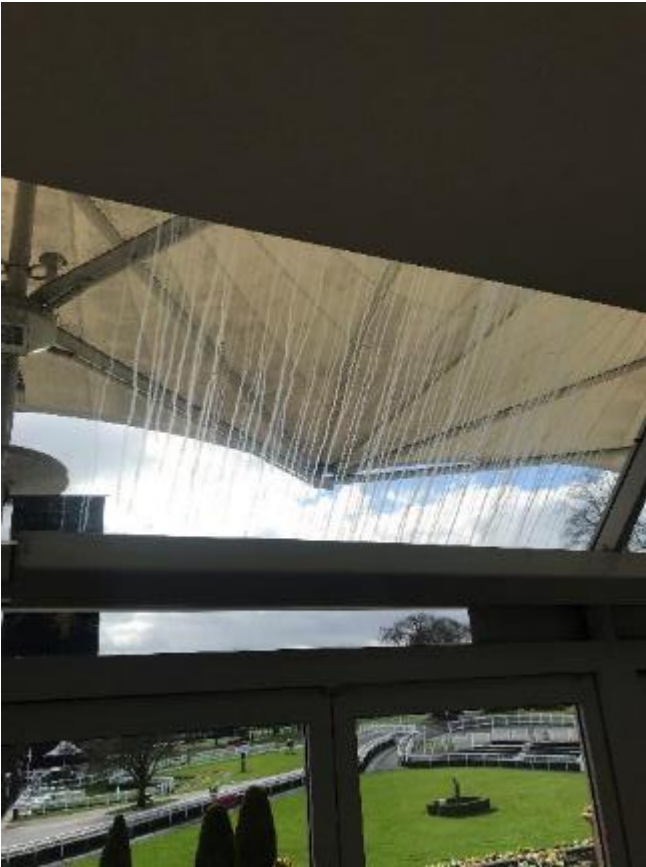
23. Water staining to corridor glazing from leaks from fabric canopy over the terrace.

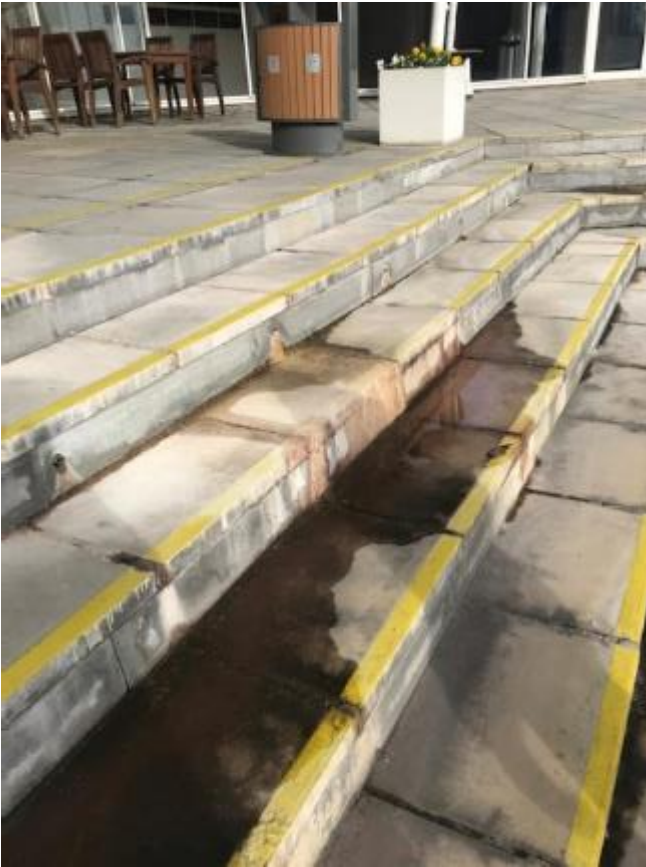
25. Rainwater leaking through the terrace pavings and steppings causing water ingress below.

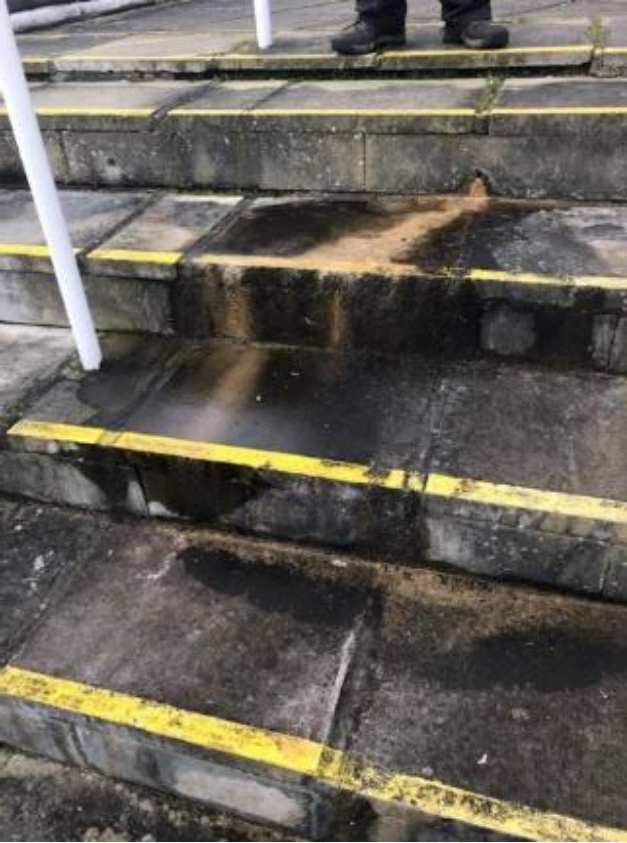
27. Rainwater leaking through the terrace pavings and steppings causing water ingress below.

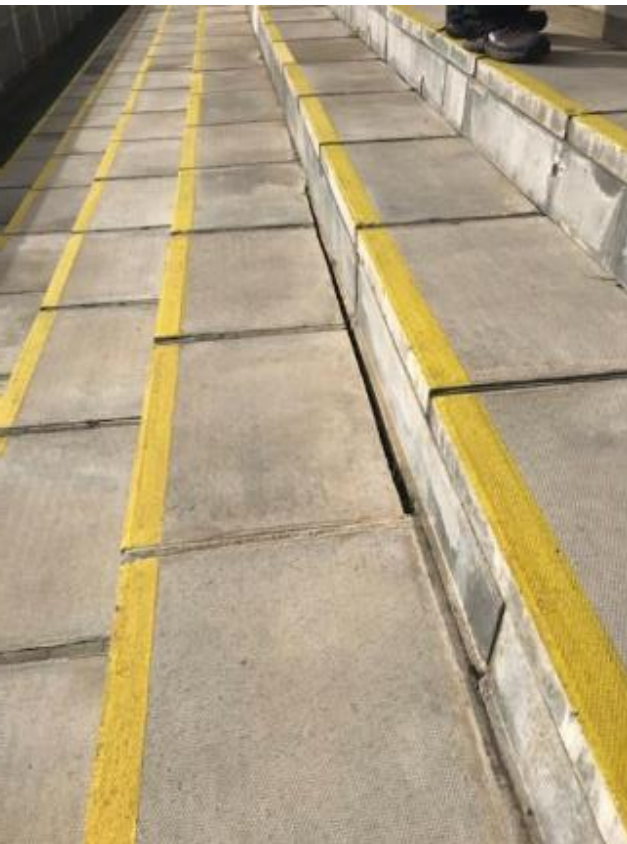
28. Open joints between Terrace and stepping pavings due to thermal movement and causing internal water ingress below.

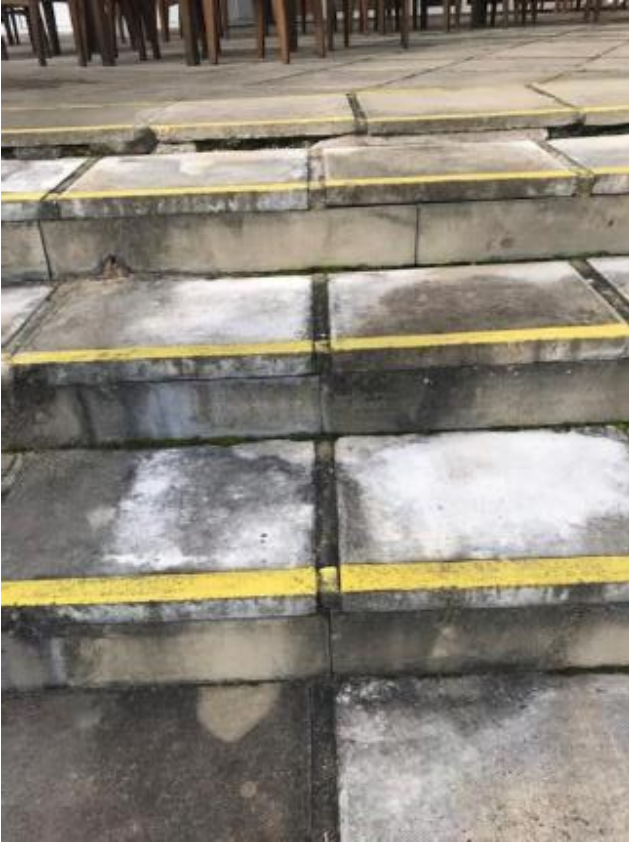
29. Open joints between Terrace and stepping pavings due to thermal movement and causing internal water ingress below.

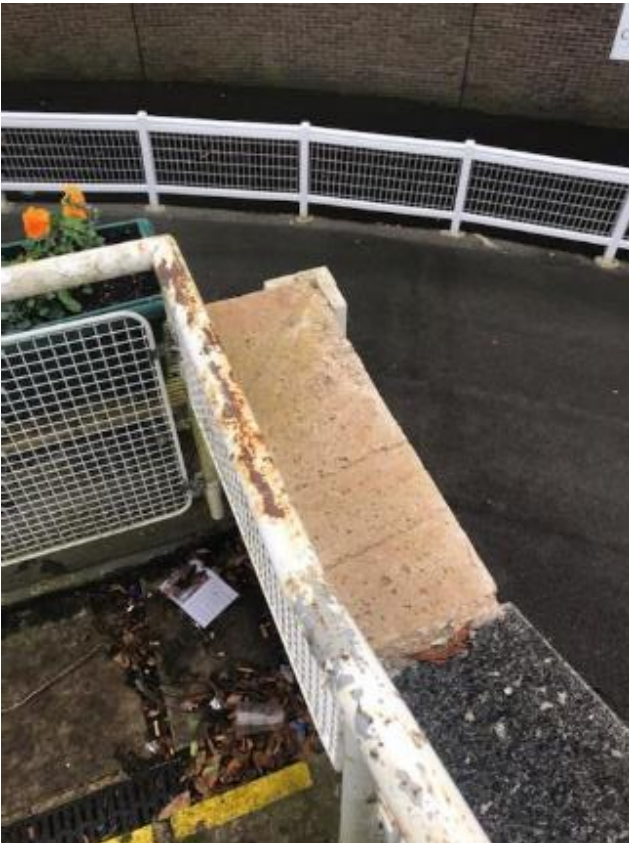
30. Typical corrosion to metal handrails to Terrace.

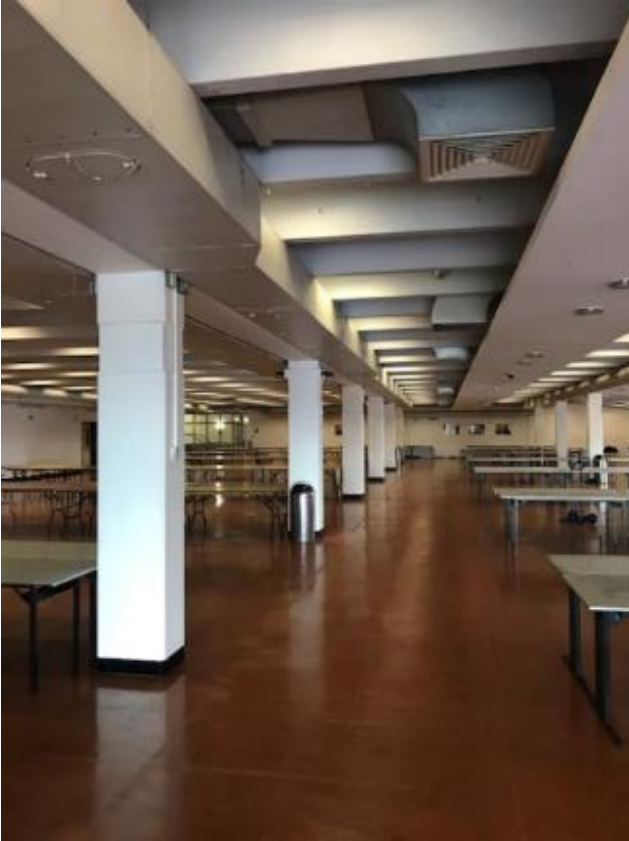
31. Esher Hall – general view.

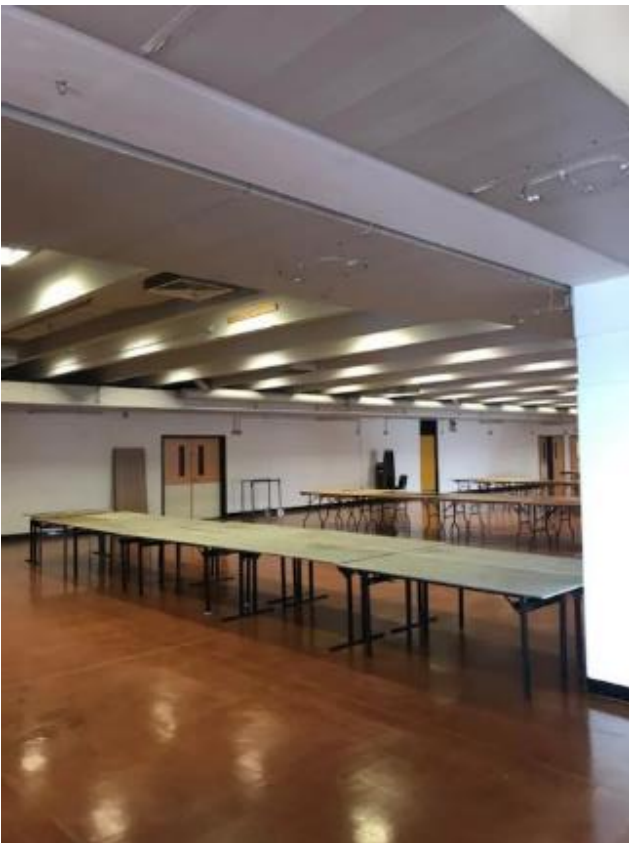
32. Esher Hall – general view.

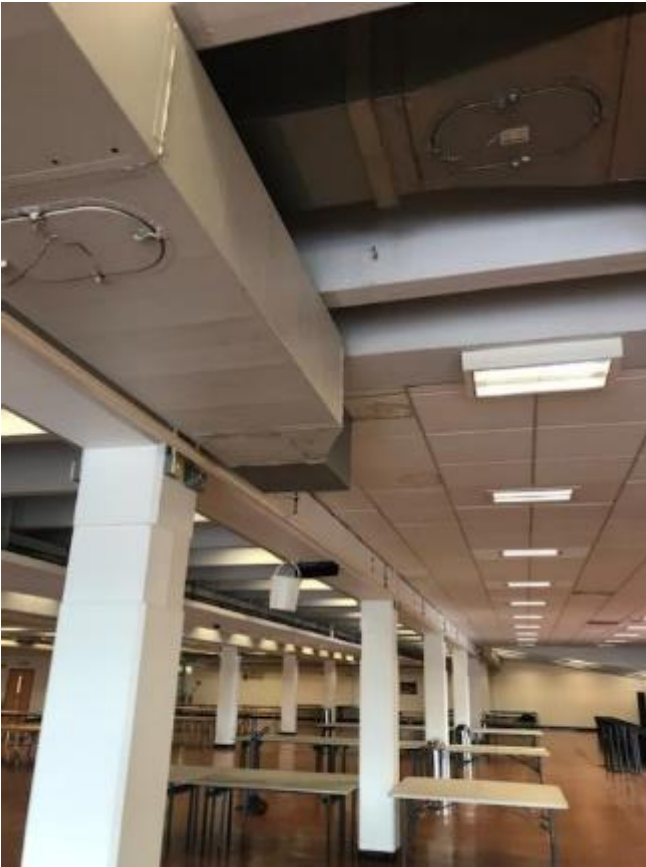
33. Esher Hall – general view and leaks and stains to ceiling tiles.

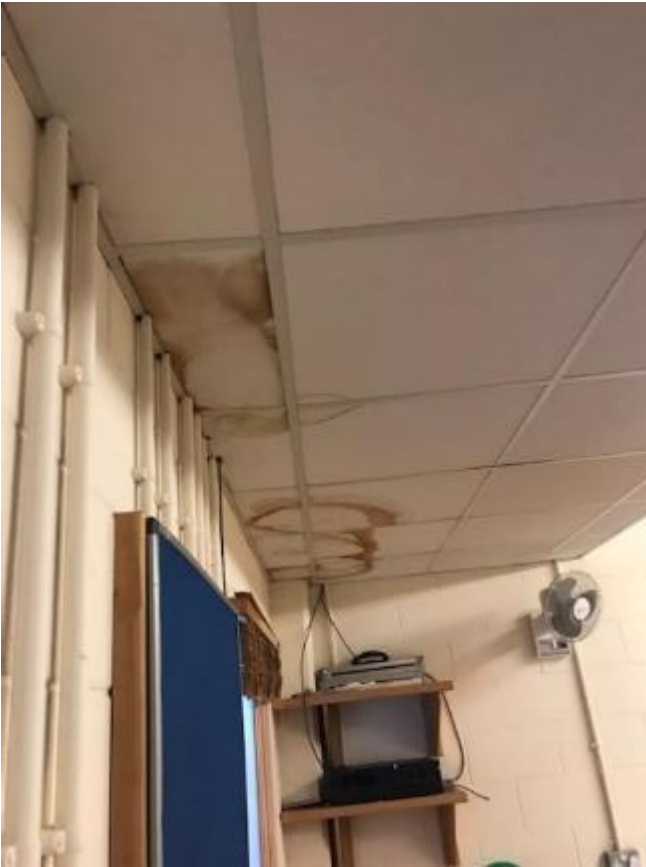
35. Leaks to ceiling tiles.

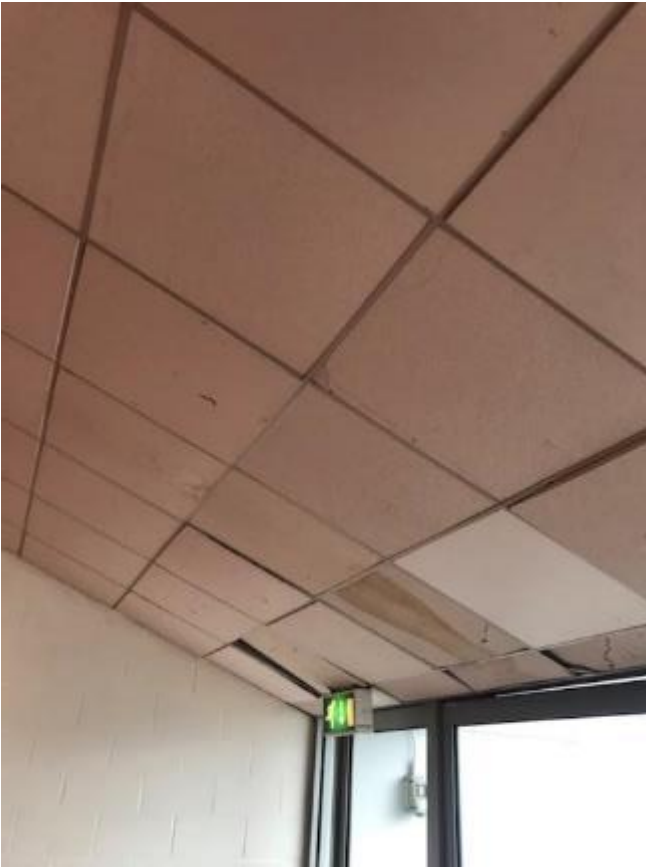
37. Leaks to ceiling tiles and ceiling tiles replaced where previously water damaged.

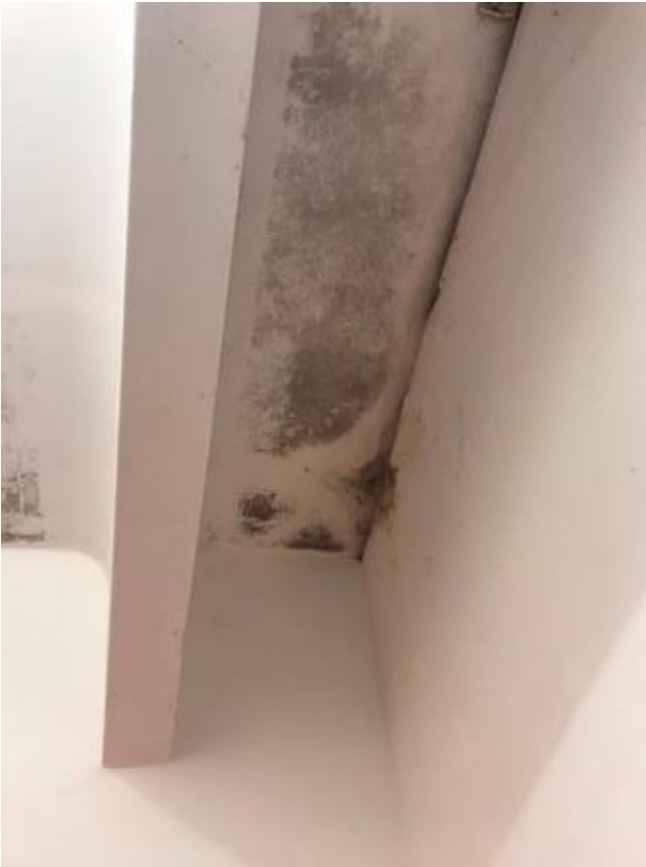
39. Damp staining to ceiling soffit.

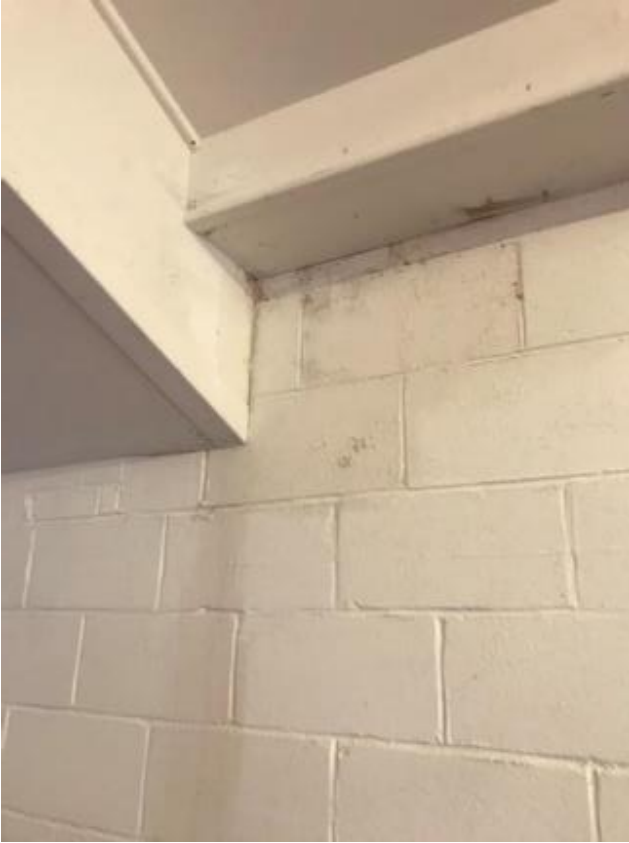
41. Damp staining to wall grinning through the painted finish.

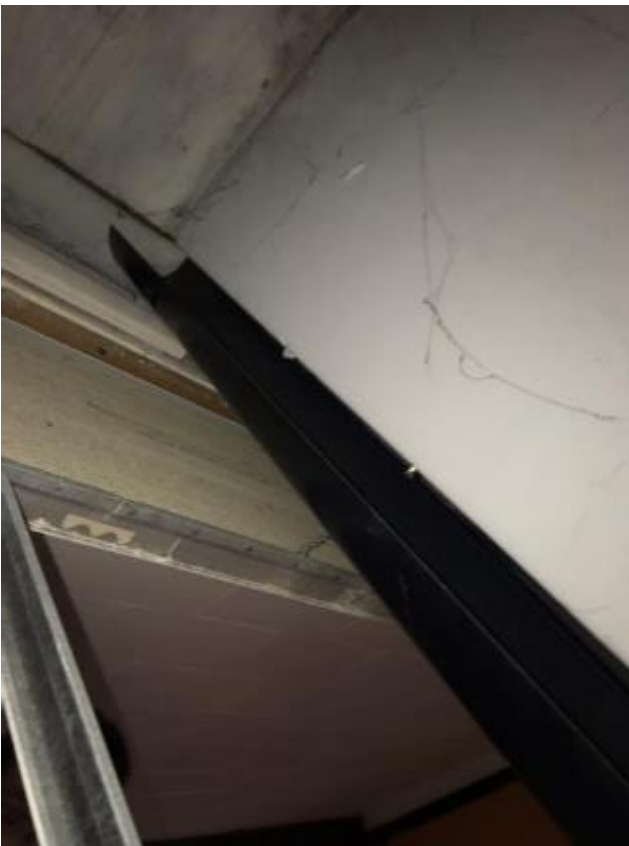
42. An example of the underlining and guttering installed above ceilings in an attempt to manage the extensive leaks through the steppings above.

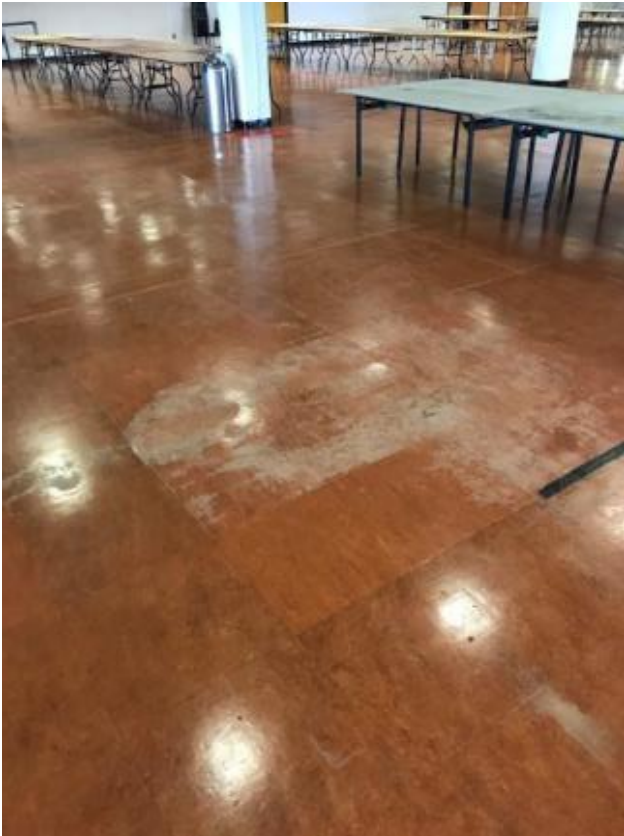
43. Heavy staining to the floor covering from persistent leaks. Note: a section of the floor vinyl has been replaced in non-matching finish (as original is no longer available). Joints to the new vinyl are lifting and have been taped down.

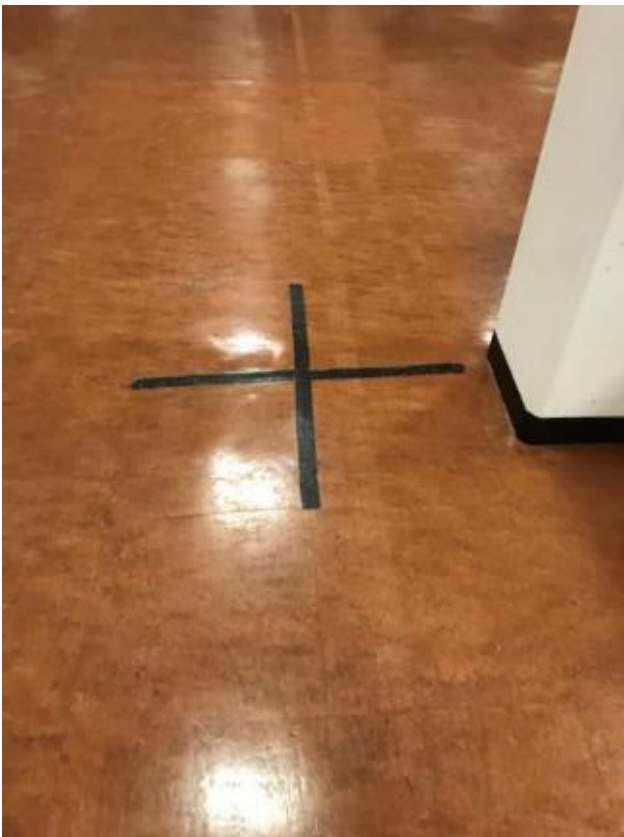
44. Further example of lifting joints to vinyl floor lining having been taped down.

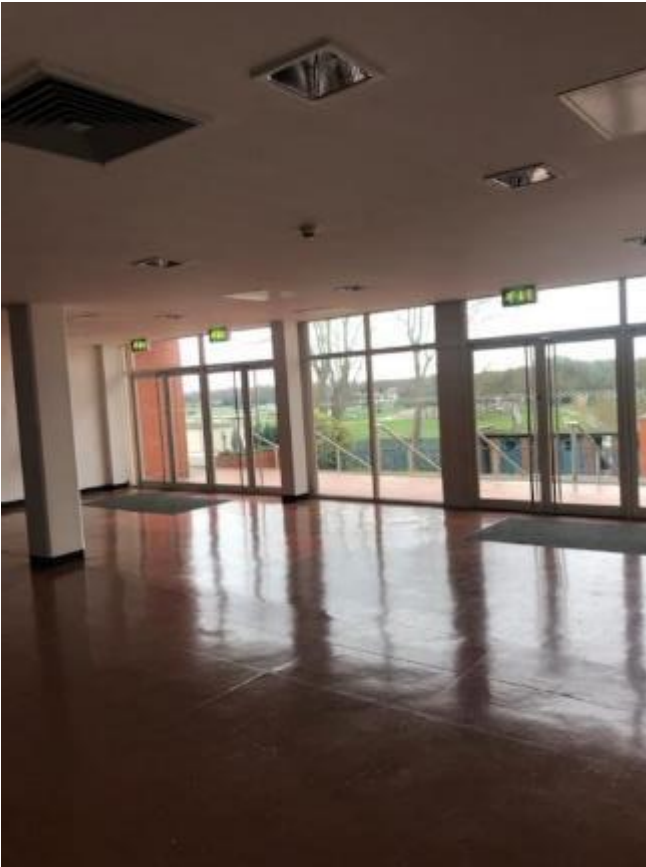
45. View of floor covering with joints lifting.

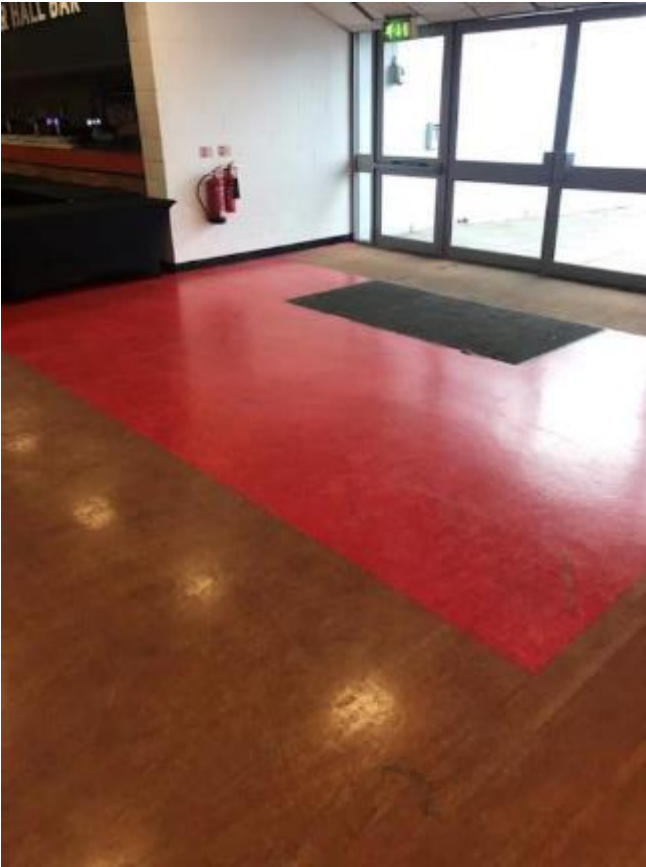
47. Floor covering patch repaired in non-matching colours, as original colour is no longer available.

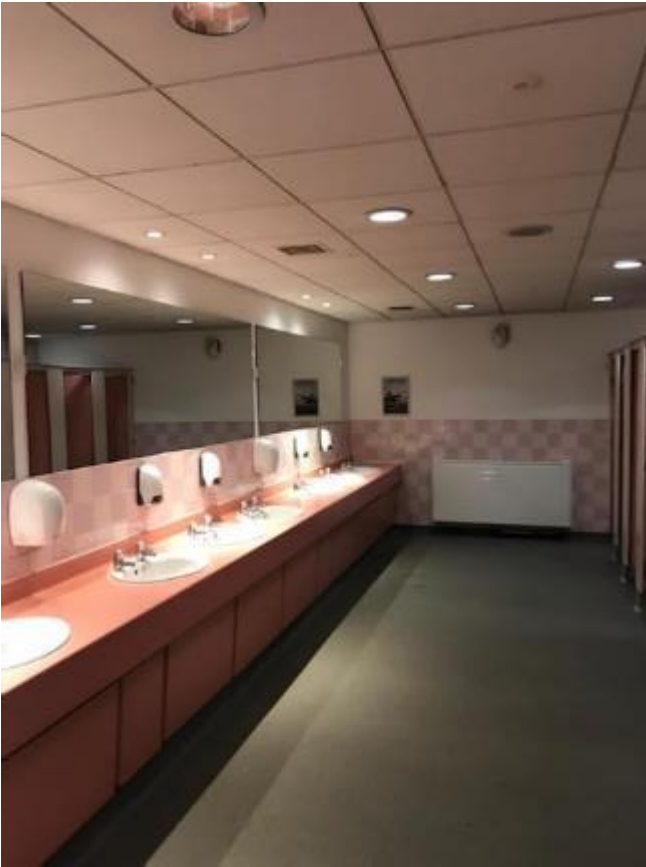
- 3.26 The main second floor Ladies and Gents toilets are a dated design with water stained and soiled ceilings and soiled and stained vinyl floor coverings, otherwise with general wear and tear. The toilets are in need of refurbishment and modernisation to meet Customer expectations.

49. Dated Ladies Toilets in need of upgrade/modernisation by Customer Standards.

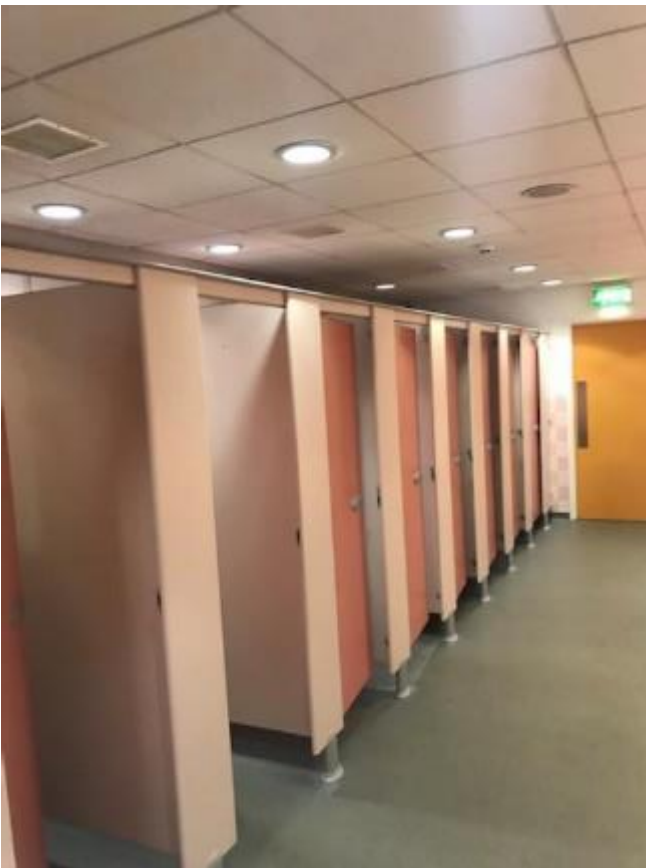
50. Dated Ladies Toilets in need of upgrade/modernisation by Customer Standards.

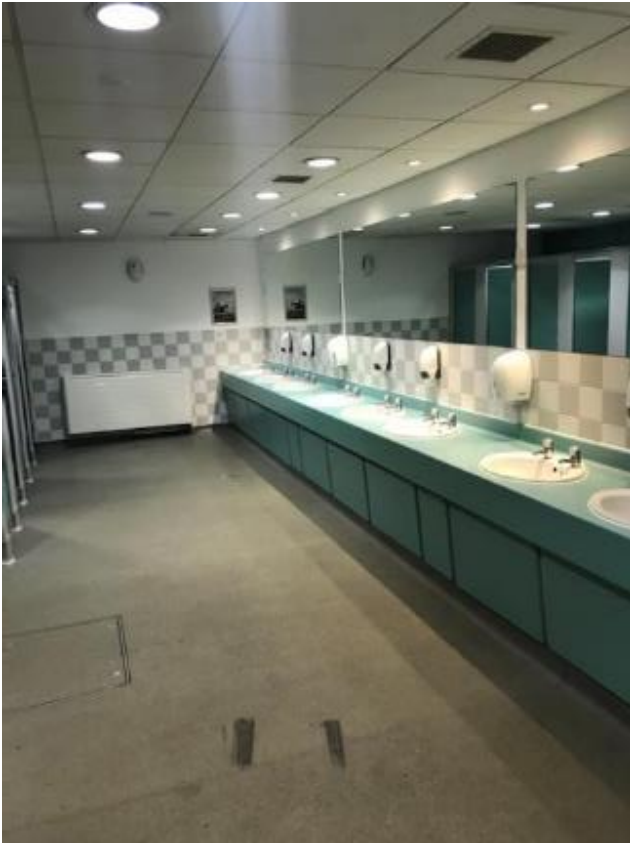
51. Dated Gents Toilets in need of upgrade/modernisation by Customer Standards.

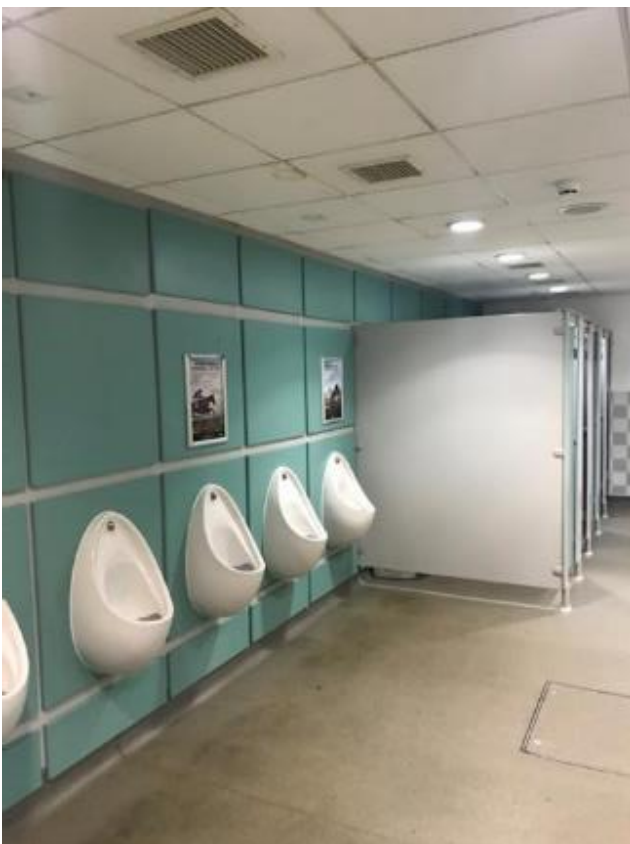
52. Dated Gents Toilets in need of upgrade/modernisation by Customer Standards. Note: heavy staining to sheet vinyl flooring around urinals, also stained and soiled ceiling tiles.

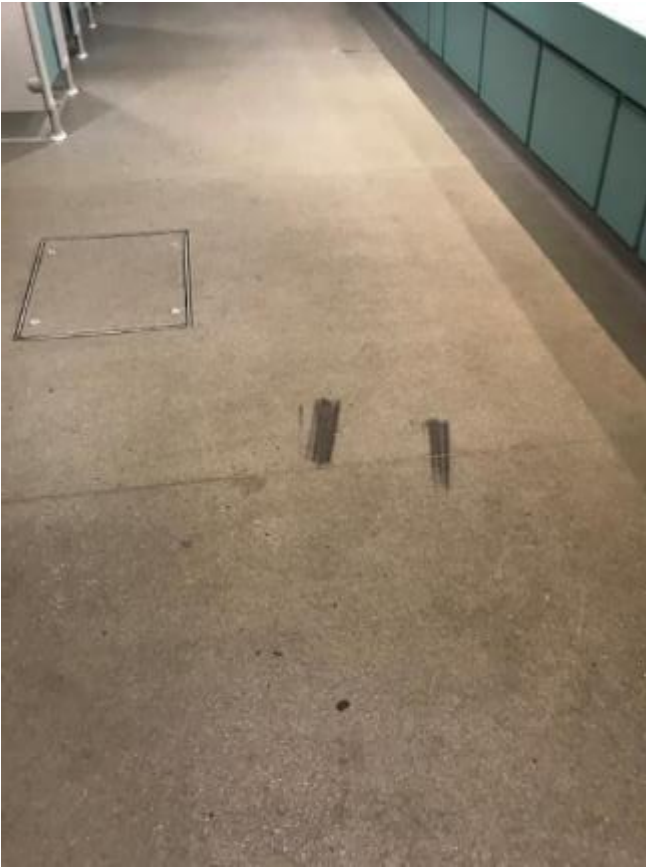
53. Heavy marking/staining to sheet vinyl floor in Gents Toilet.

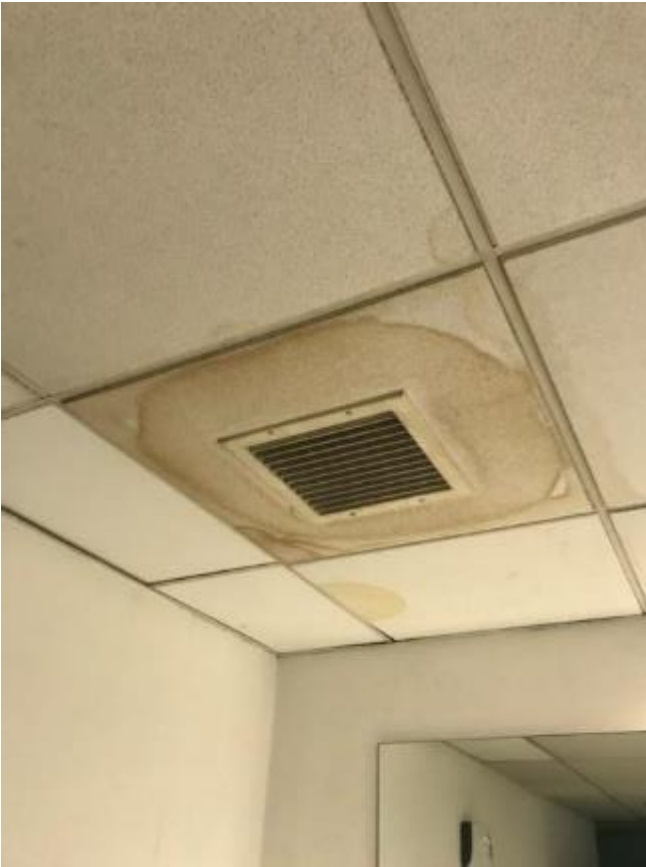
55. Example of stained ceiling tiles from leaks in Gents Toilets.

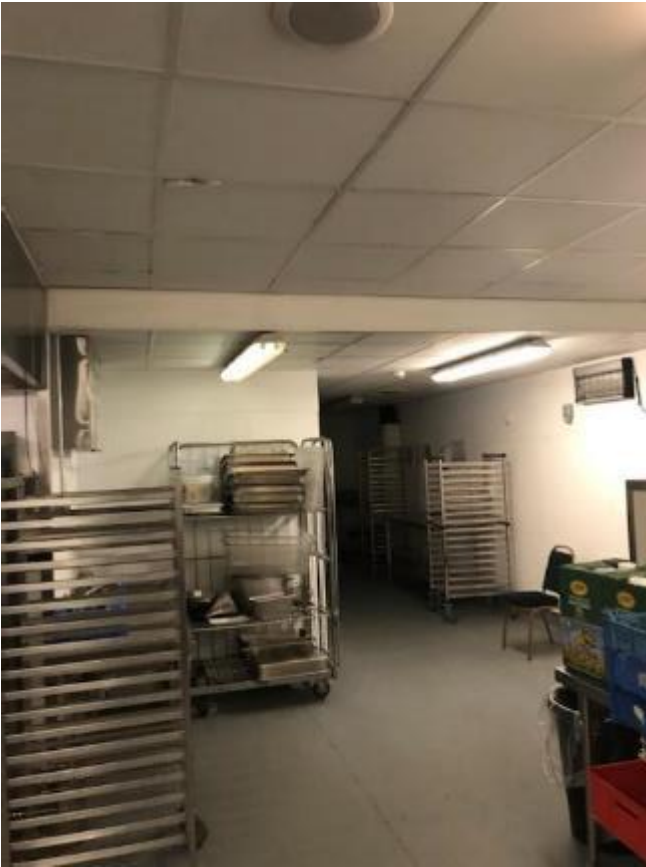
57. Esher Hall Kitchen – general view.

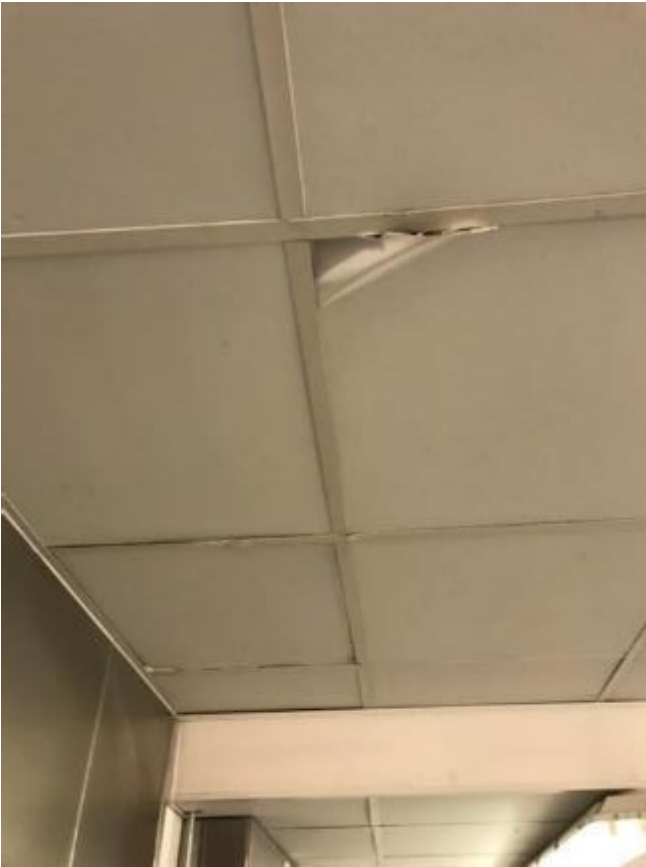
59. Example of damaged ceiling tiles.

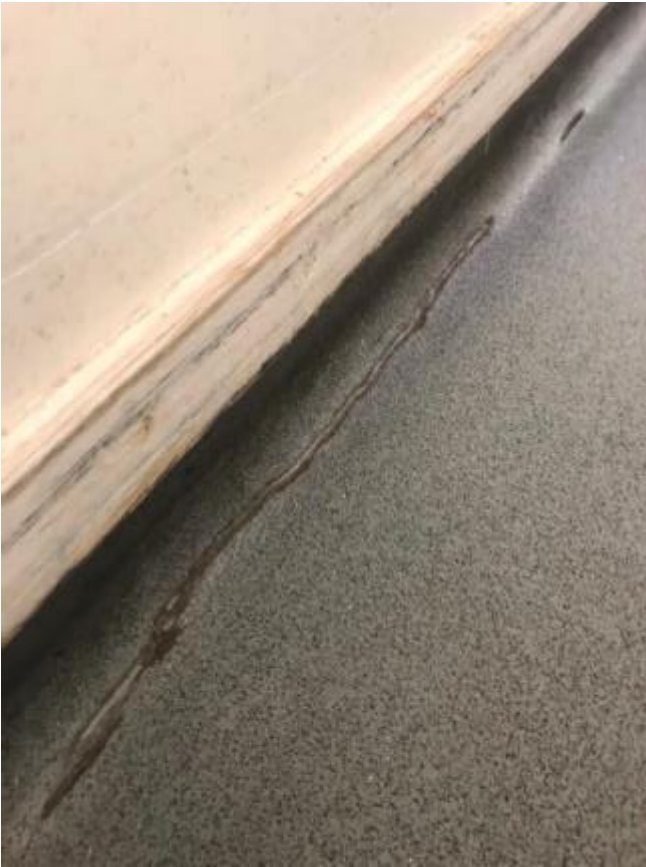
61. Example of damaged/scuffed vinyl floor coverings in the kitchen.

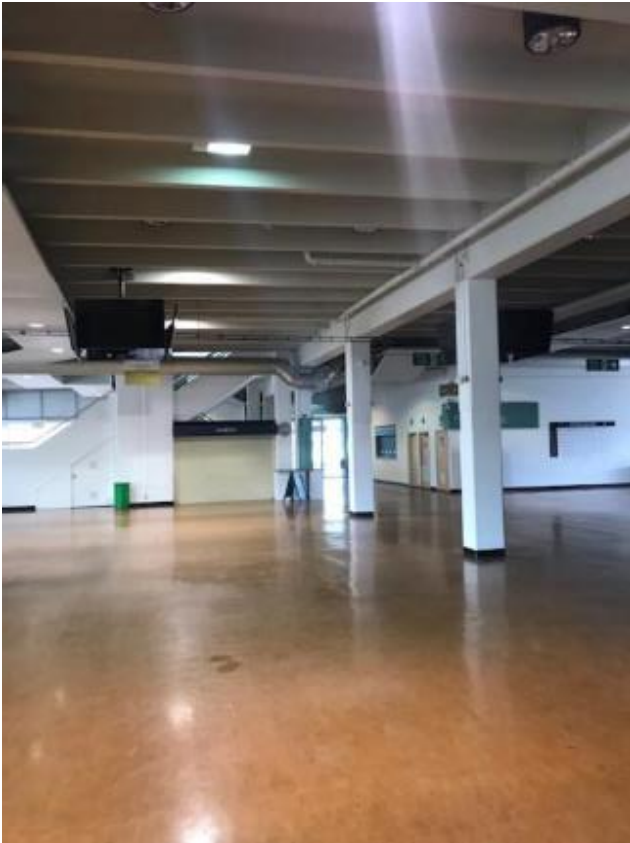
63. Surrey Hall – general view.
