BUILDING CONDITION REPORT 2020, INCLUDING M&E CONDITION SURVEY

Summary Building Condition Report for
Jockey Club Racecourses Limited

SANDOWN PARK RACECOURSE
PORTSMOUTH ROAD
ESHER
SURREY
KT10 9AJ

March 2020

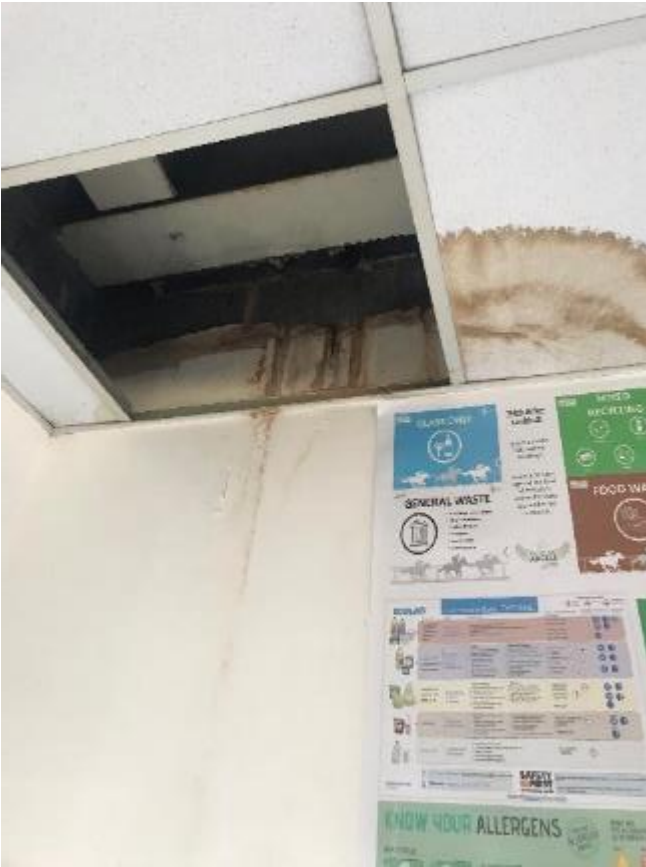
69. Missing ceiling tile and visible leaks.

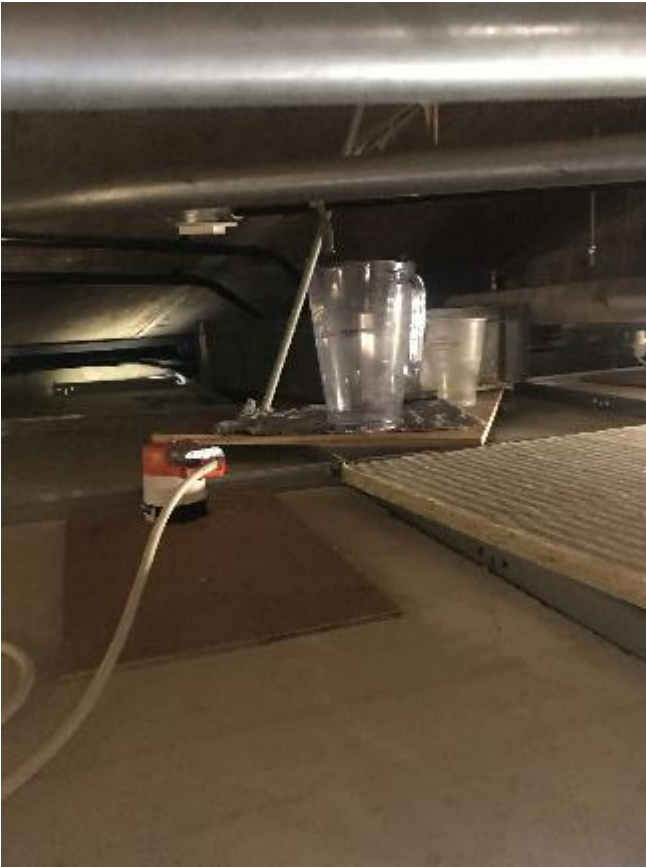
71. Example of buckets strategically placed above ceilings to Champagne Bar to catch leaks.

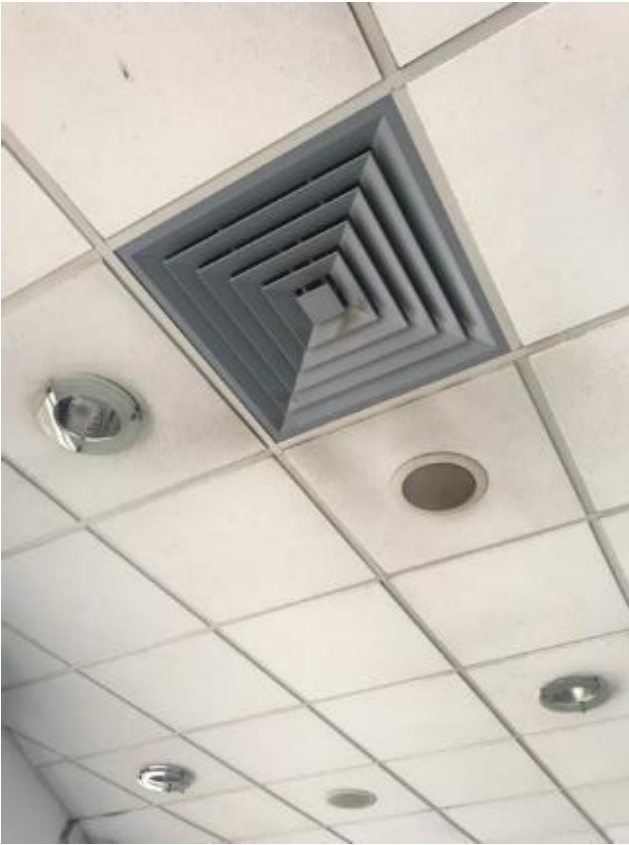
73. Example of heavily soiled ceiling tiles around vent grille.

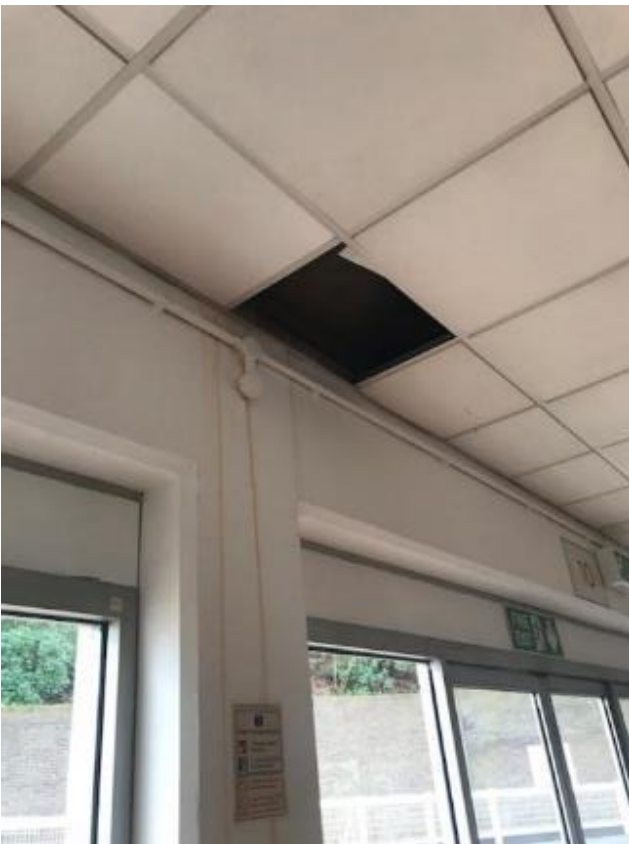
74. Water damaged ceiling tiles removed adjacent to doors below Parade Ring Terrace. Note: also run marks on wall from leaks.

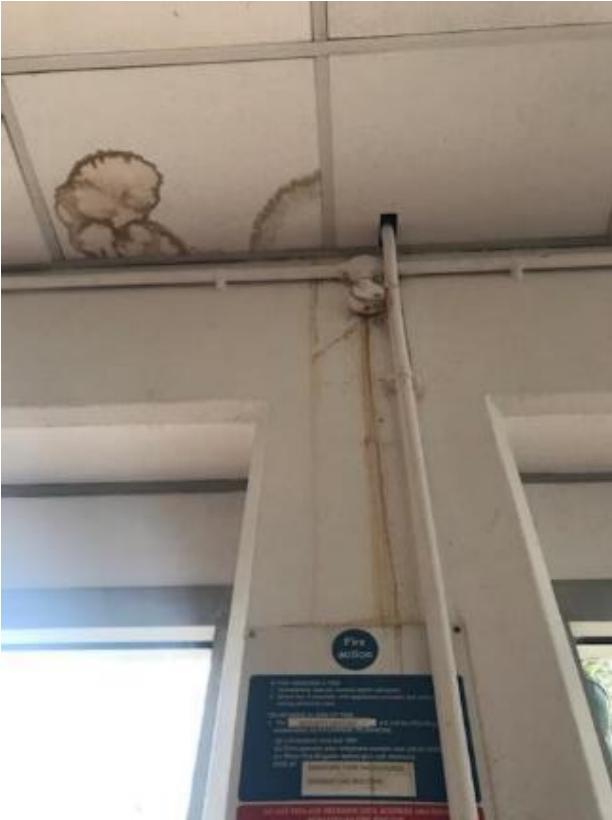
75. Further example of water stained ceiling tiles below Parade Ring Terrace and staining to wall below from water ingress.

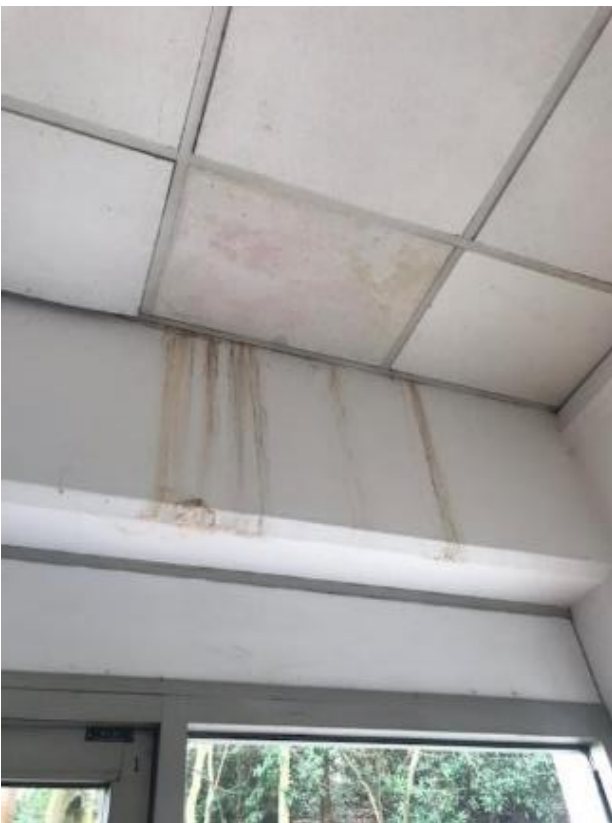
76. Further example of water stained ceiling tiles below Parade Ring Terrace and run marks to wall below from water ingress.

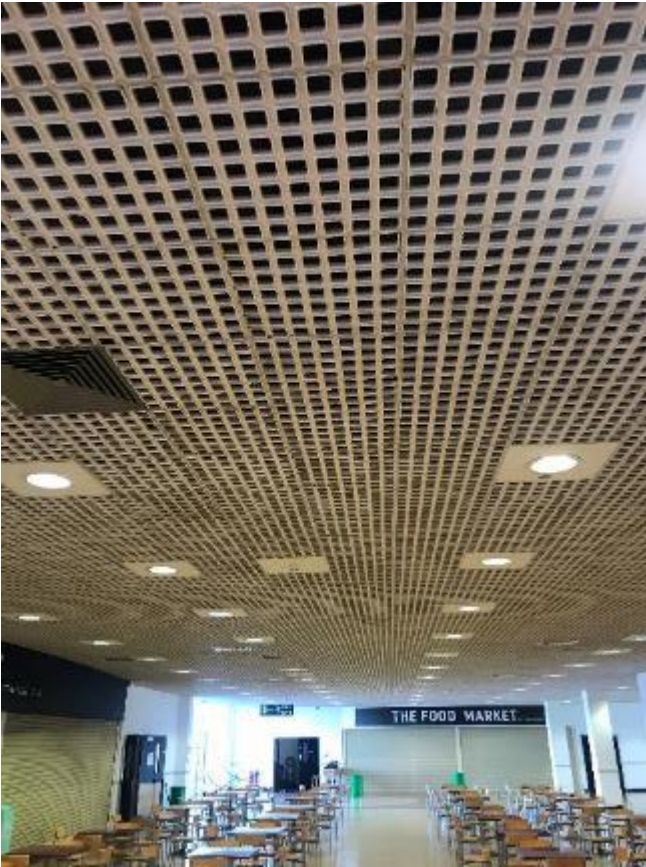
77. Dated stained and damaged ceiling to Food Court Area.

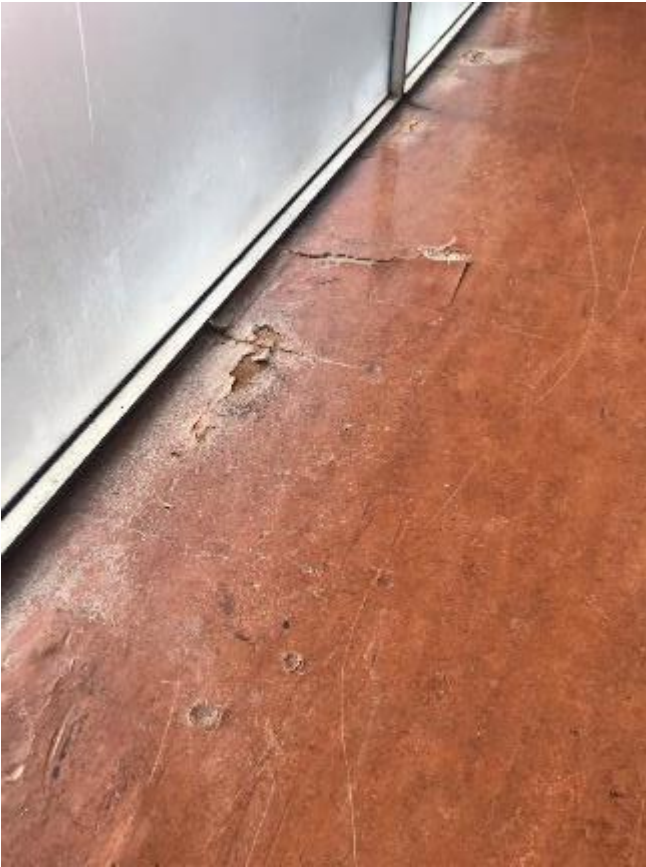
79. Example of damaged and lifting floor vinyl from persistent leaks.

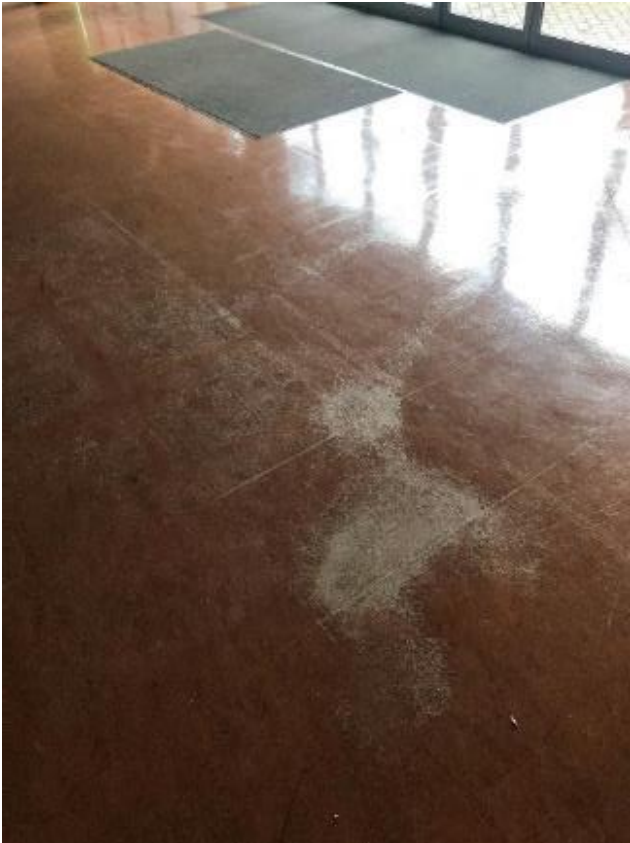
81. Example of heavily stained floor vinyl due to persistent leaks from Parade Ring Terrace.

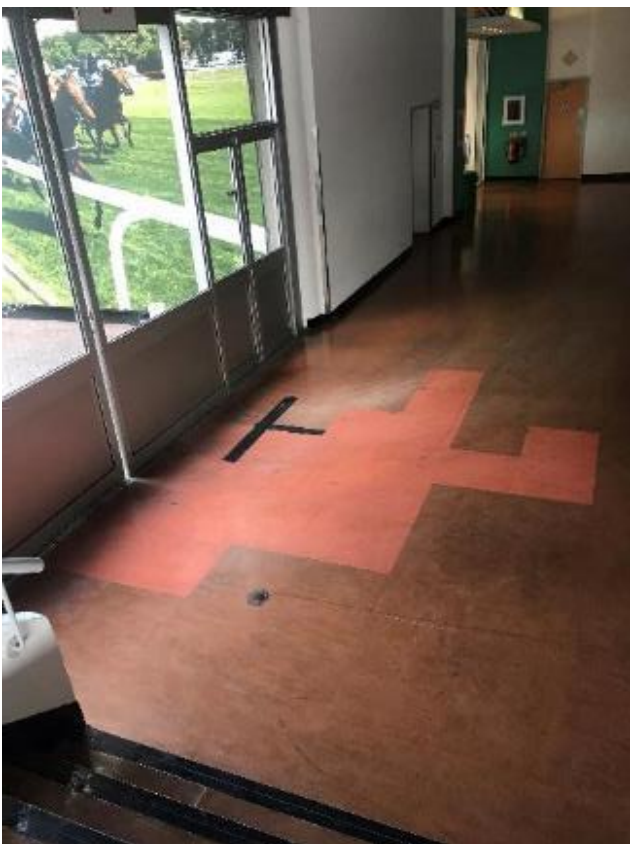
82. Water damaged vinyl floor replaced in non-matching section as original is no longer available. Ongoing water ingress has caused joints to lift which have been taped down to reduce risk of a trip hazard.

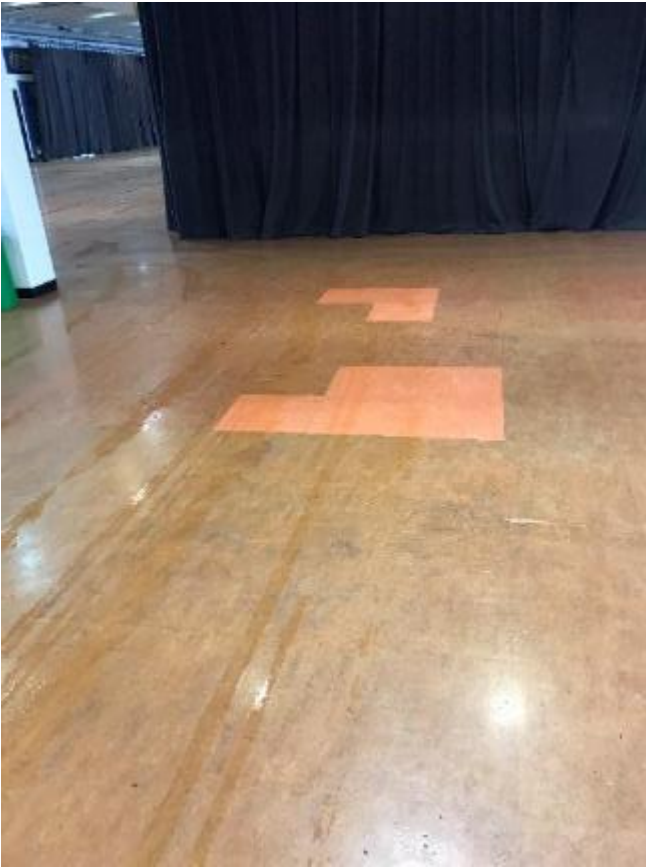
83. Further example of sections of vinyl floor having been replaced with non-matching sections.

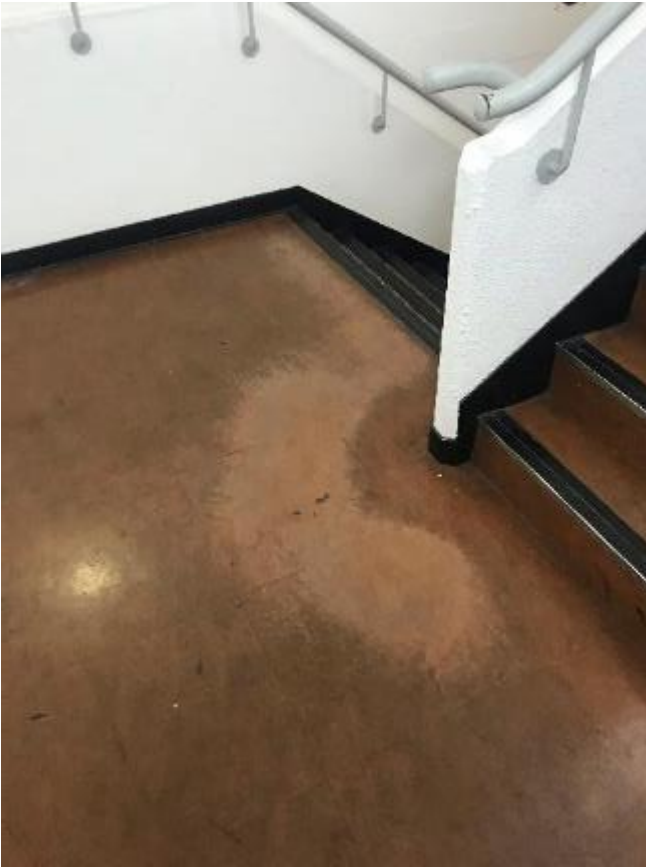
85. Heavily worn vinyl floor to stairwell leading to toilets.

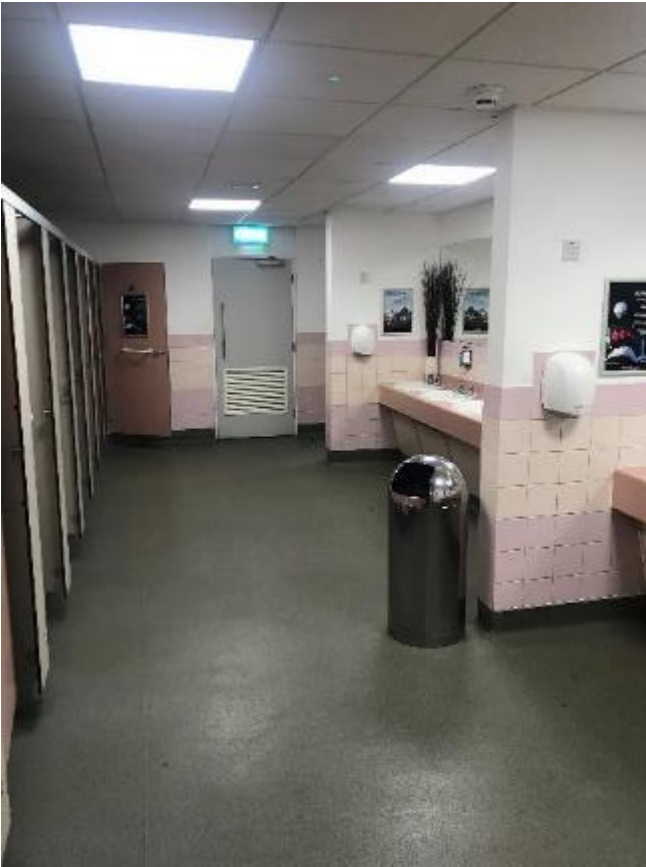
87. Dated Ladies Toilets in need of upgrade by Customer Standards.

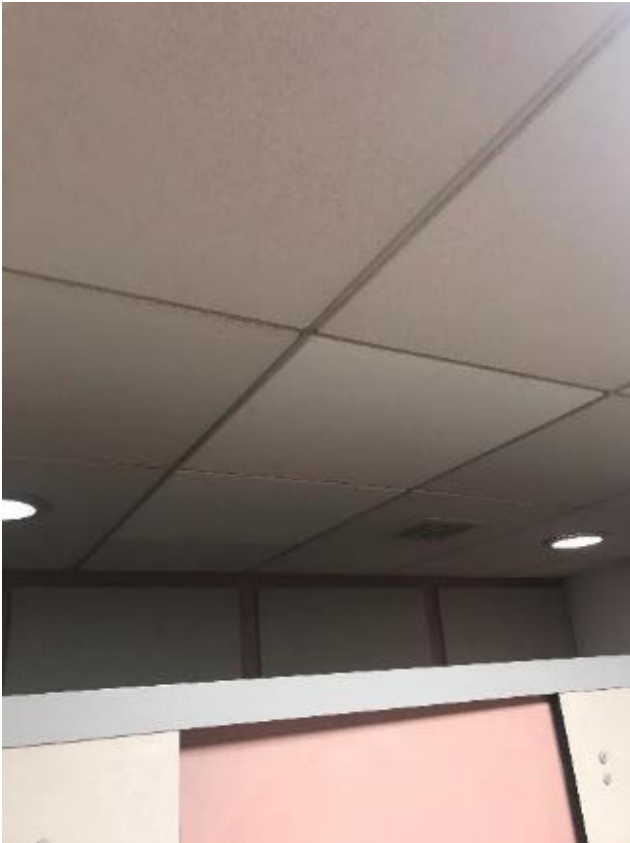
89. Example of replacement stained ceiling tiles which are non-matching due to age of surrounding tiles in Ladies Toilet.

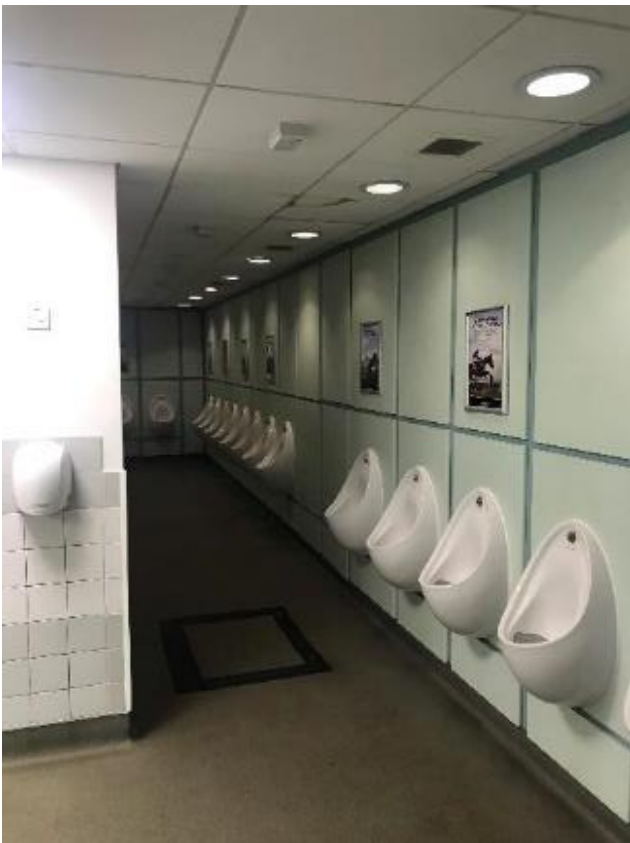
90. Dated Gents Toilets in need of upgrade by Customer Standards.

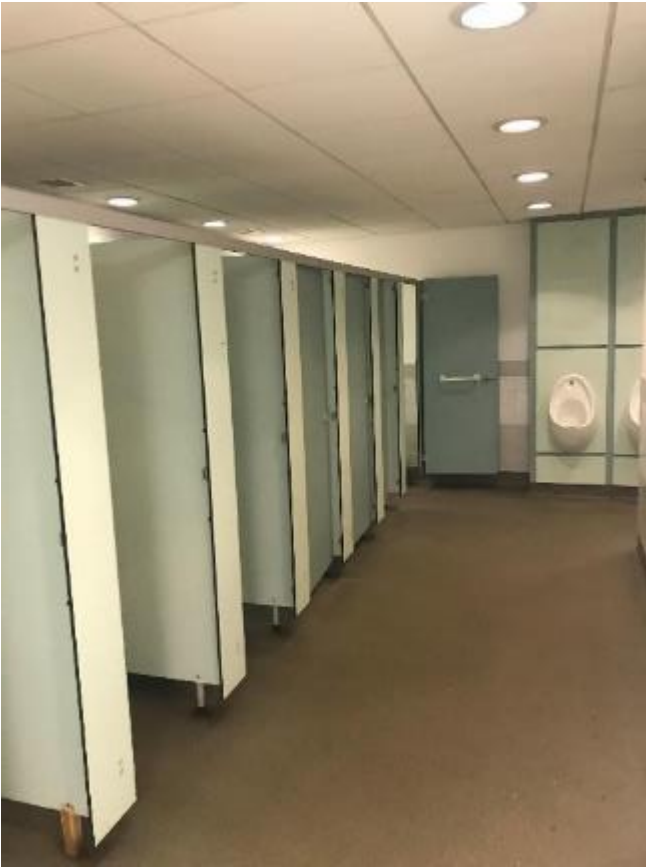
91. Dated Gents Toilets in need of upgrade by Customer Standards.

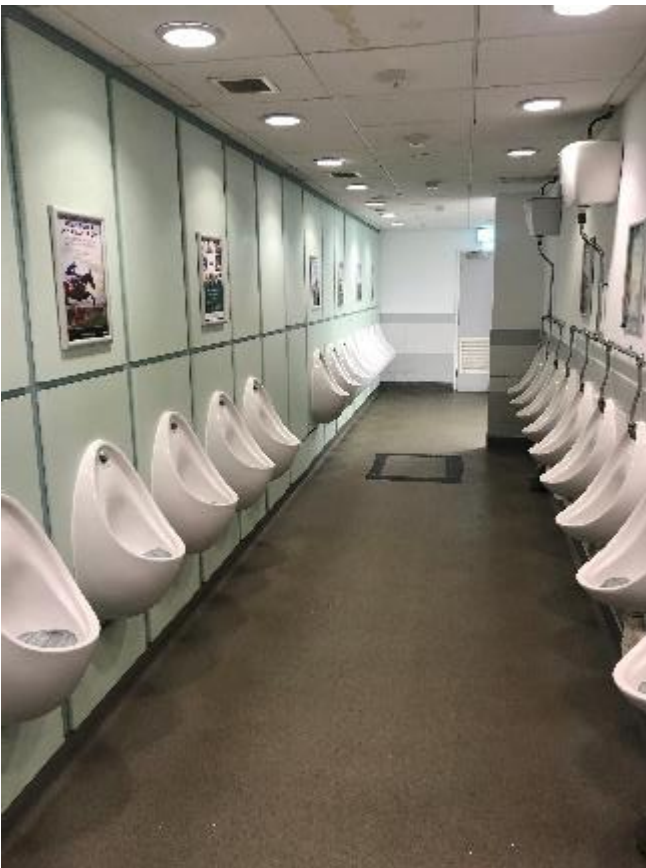
92. Dated Gents Toilets in need of upgrade by Customer Standards.

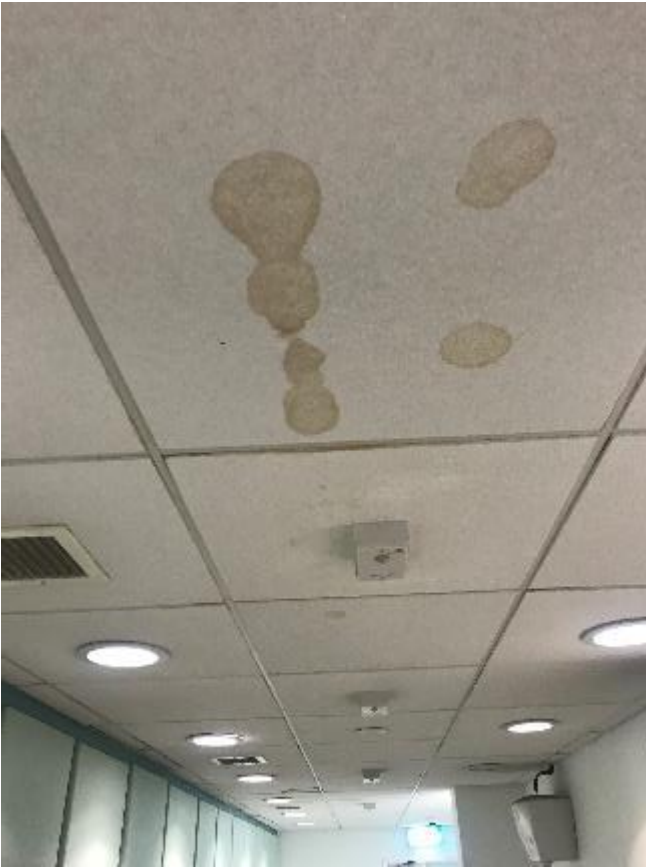
93. Example of water stained ceiling tiles in Gents Toilets.

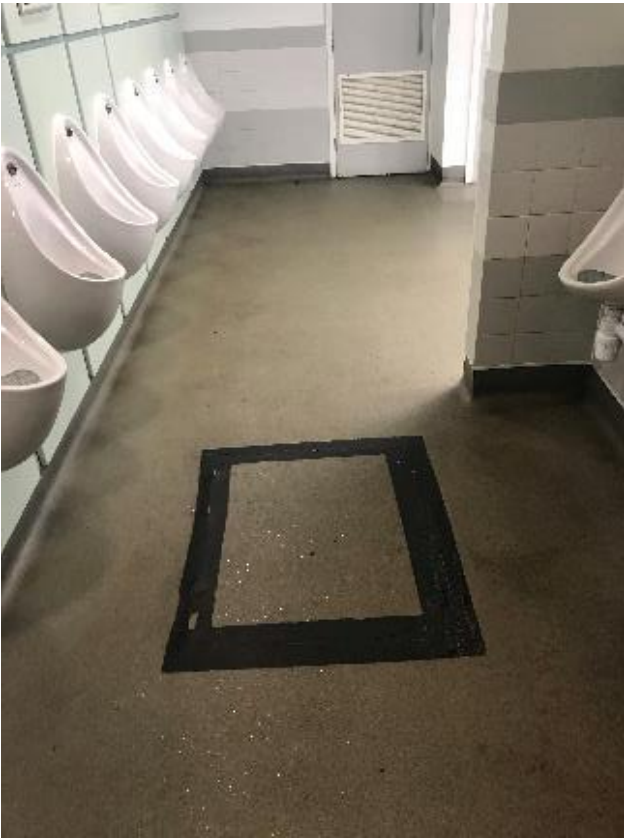
95. Heavy staining and patch repairs to vinyl floor around drainage access cover to Gents Toilets.

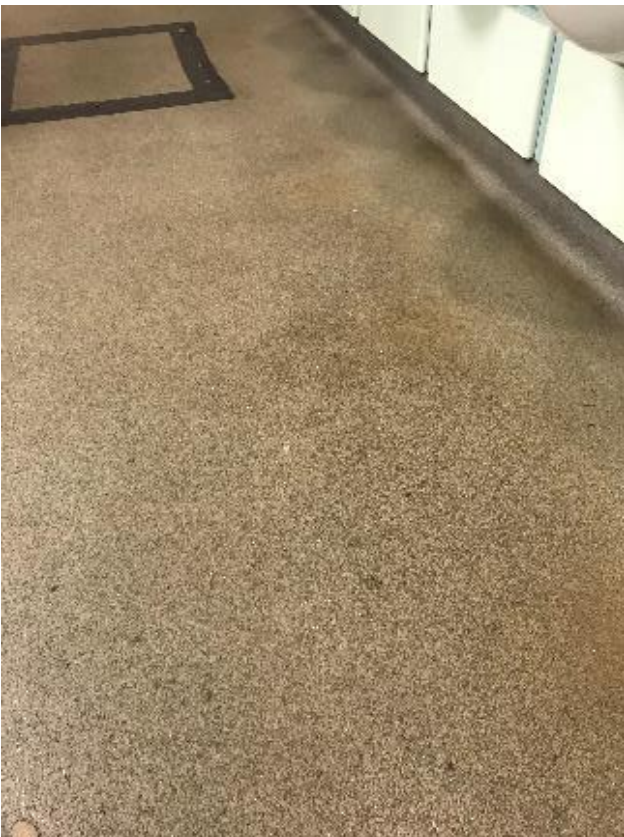
96. Heavy staining and patch repairs to vinyl floor around drainage access cover to Gents Toilets.

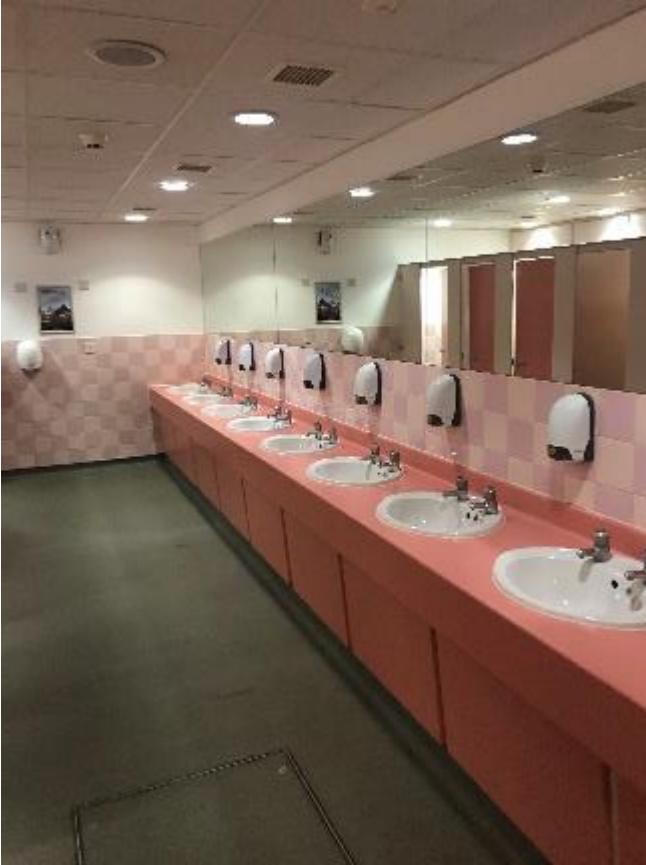
97. Lower floor Ladies Toilets are dated and in need of upgrade by Customer Standards.

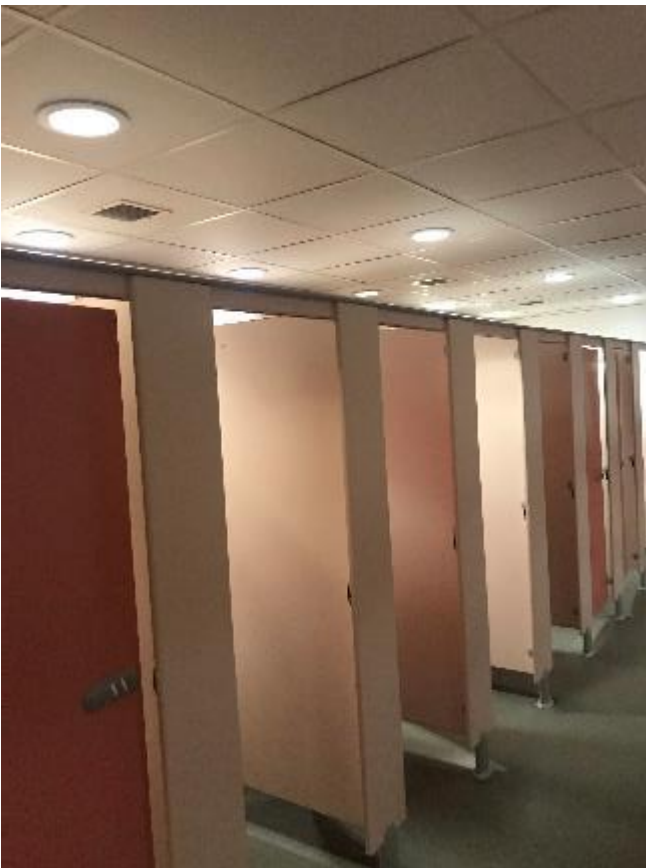
98. Lower floor Ladies Toilets are dated and in need of upgrade by Customer Standards.

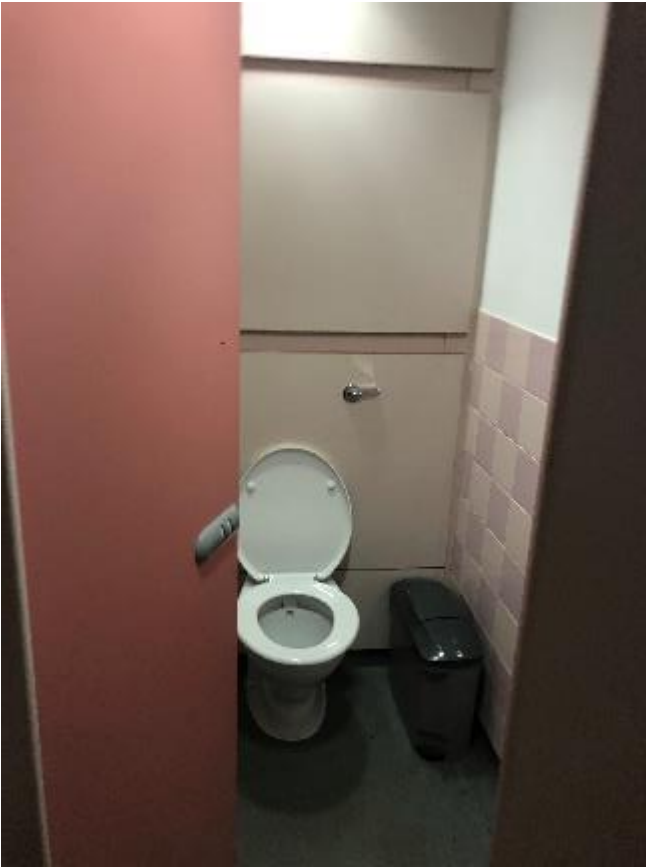
99. Lower floor Ladies Toilets are dated and in need of upgrade by Customer Standards.

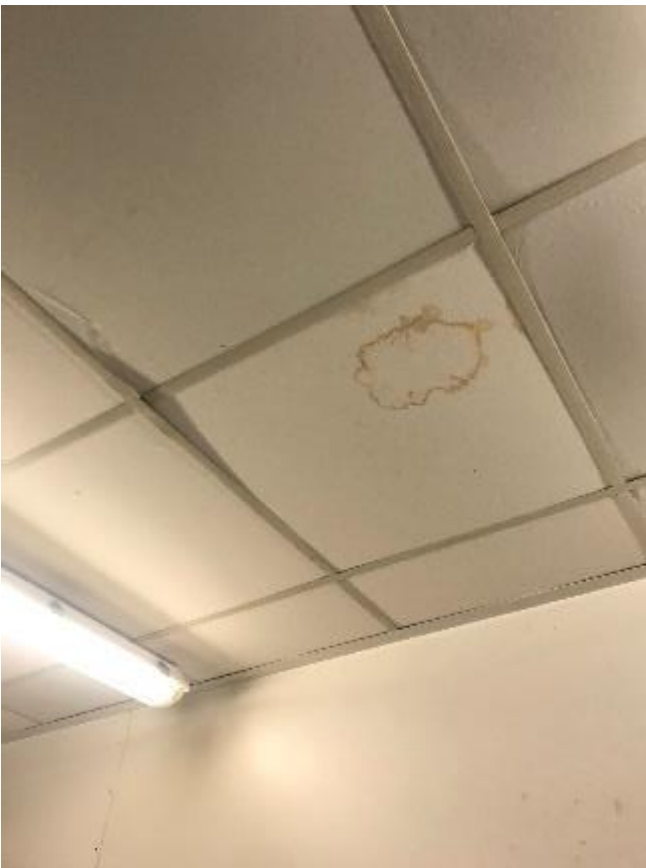
104. Example of water ingress to ceiling.

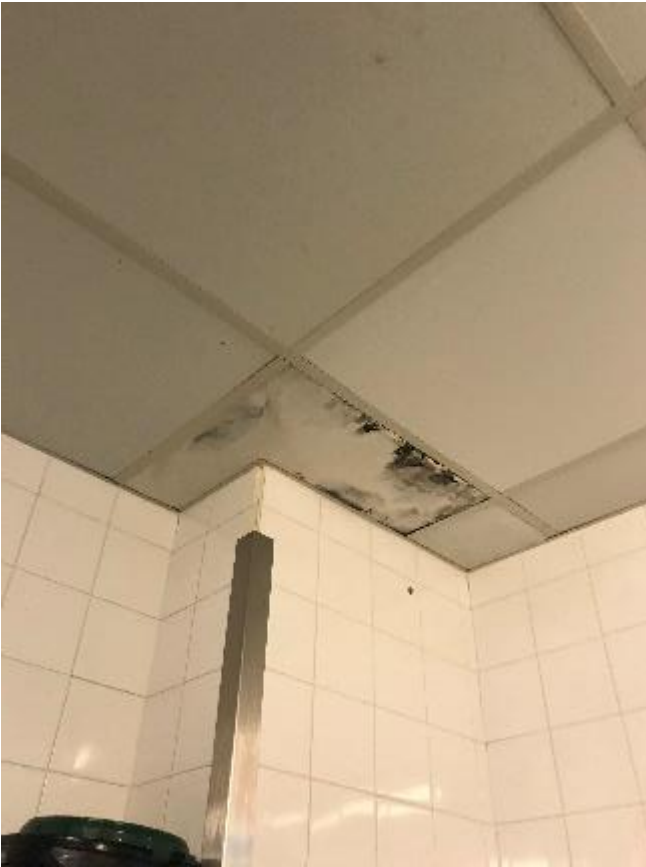
105. Example of water ingress to ceiling.

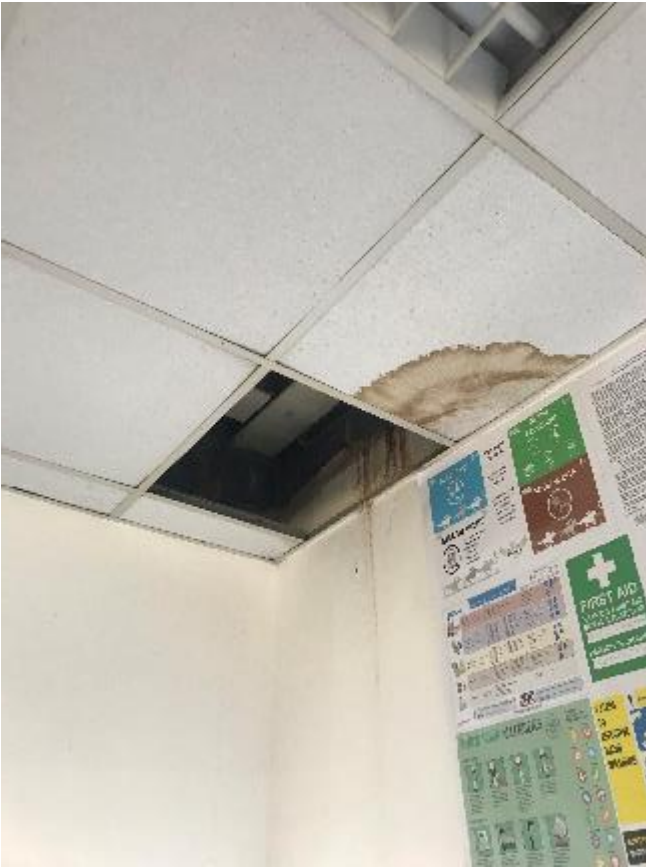
109. Example of missing and stained ceiling tiles with water stains running down the wall.

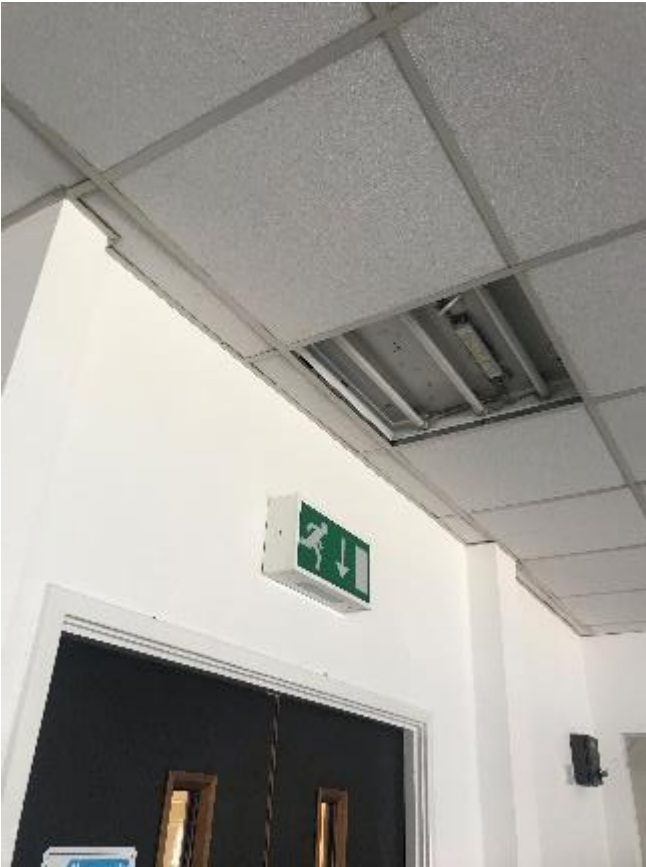
111. Example of faulty light fitting.

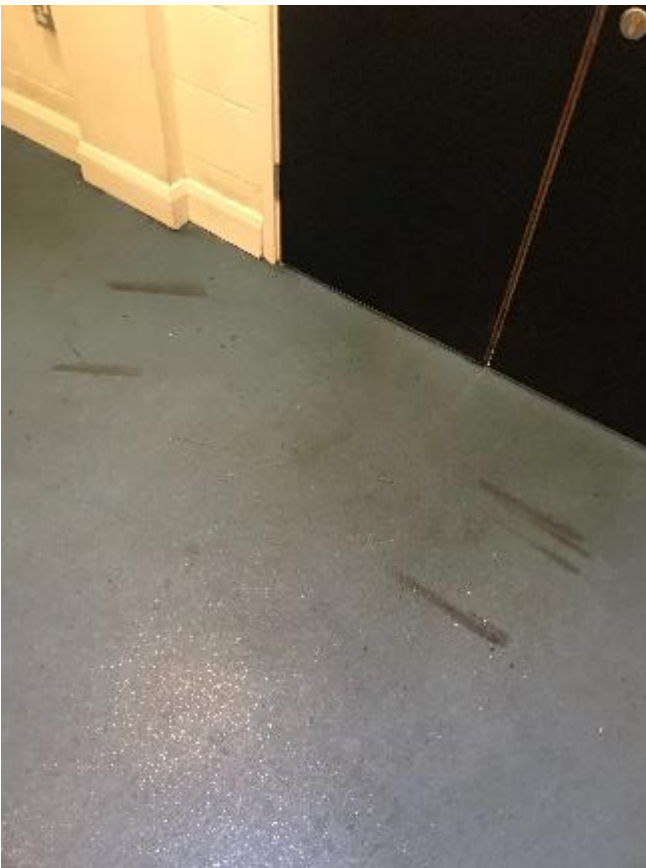
112. Close up example of scuffing/soiling to vinyl floor.

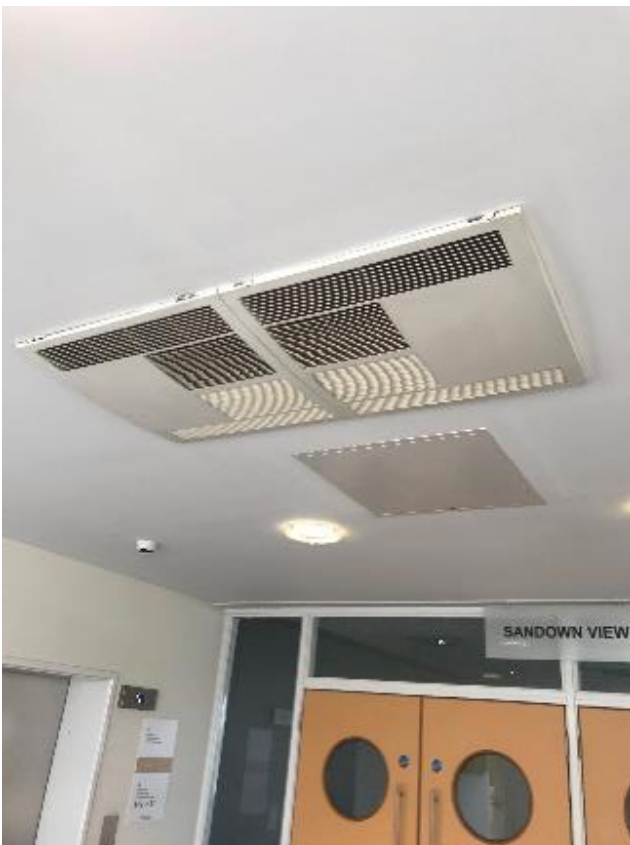
114. General view of entrance lobby.

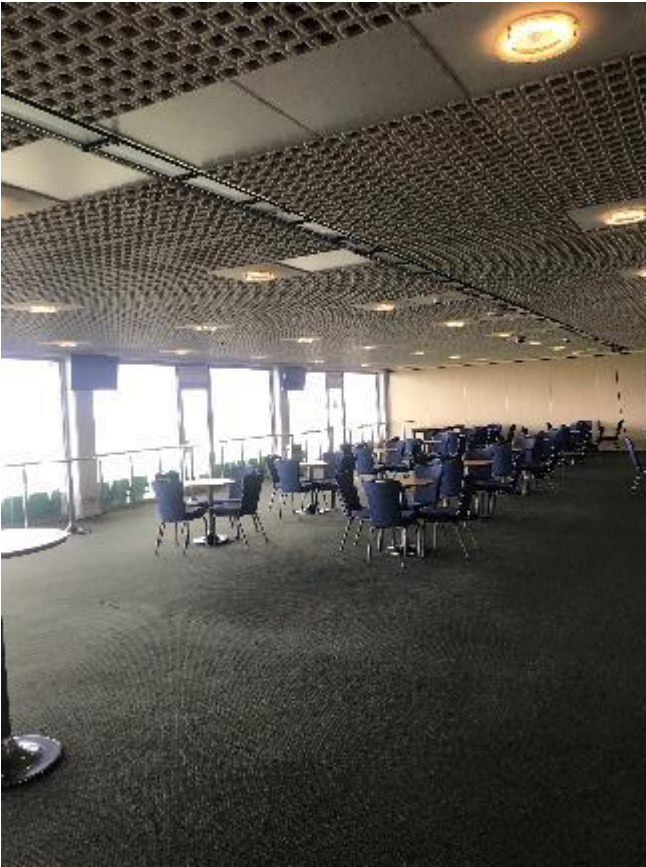
115. General view of the Sandown View Function Room.

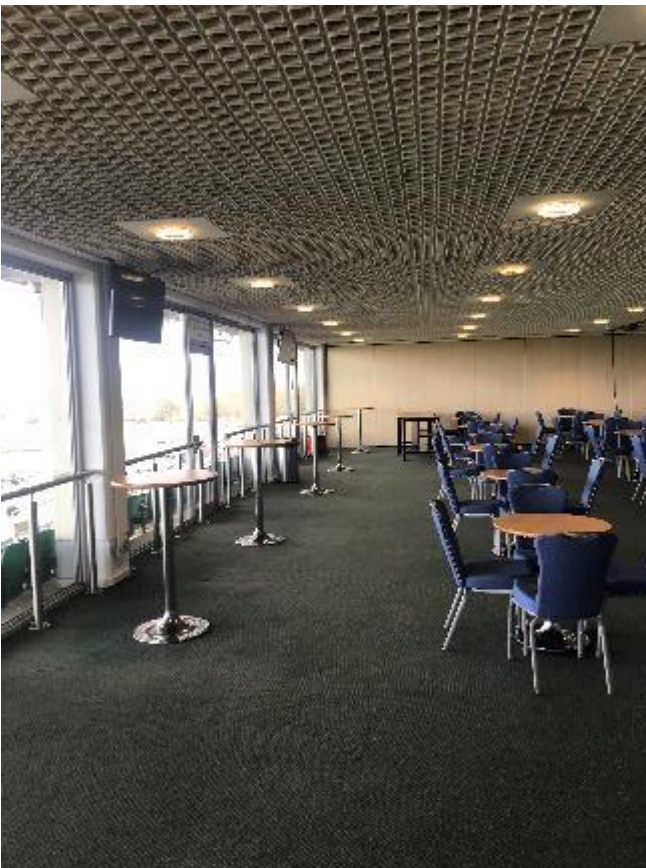
116. General view of the Sandown View Function Room.

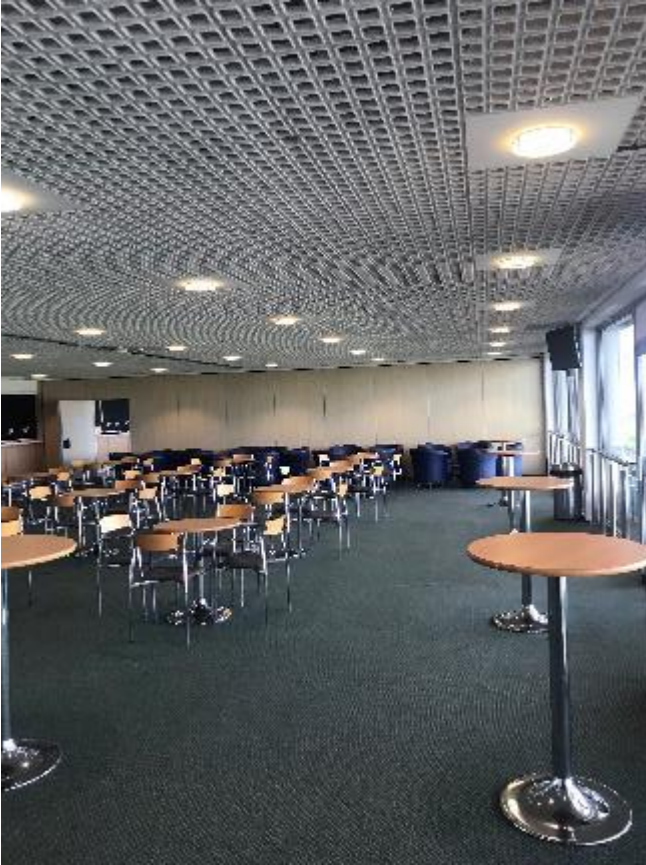
117. General view of the Sandown View Function Room.

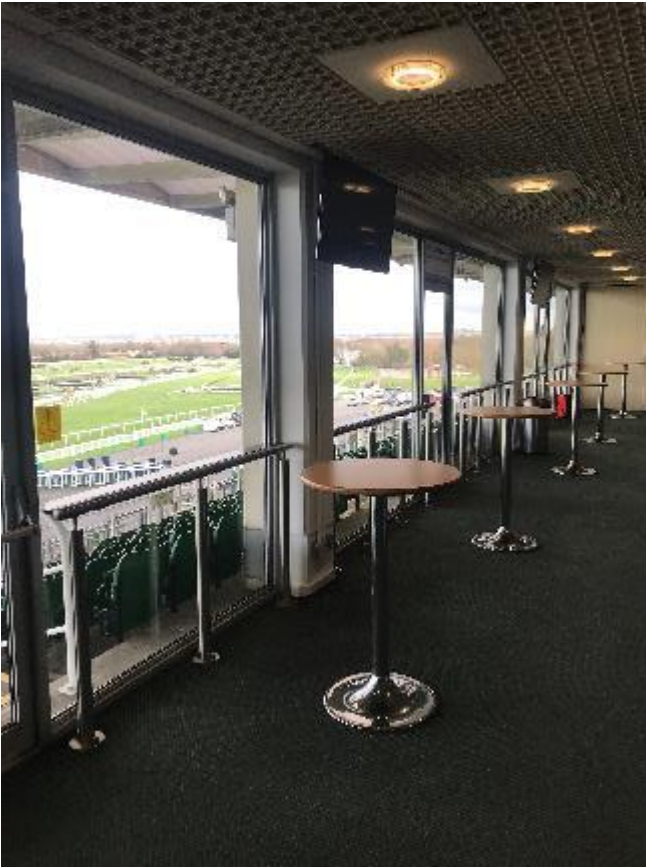
121. Large single glazed windows and doors are draughty with poor energy efficiency rating.

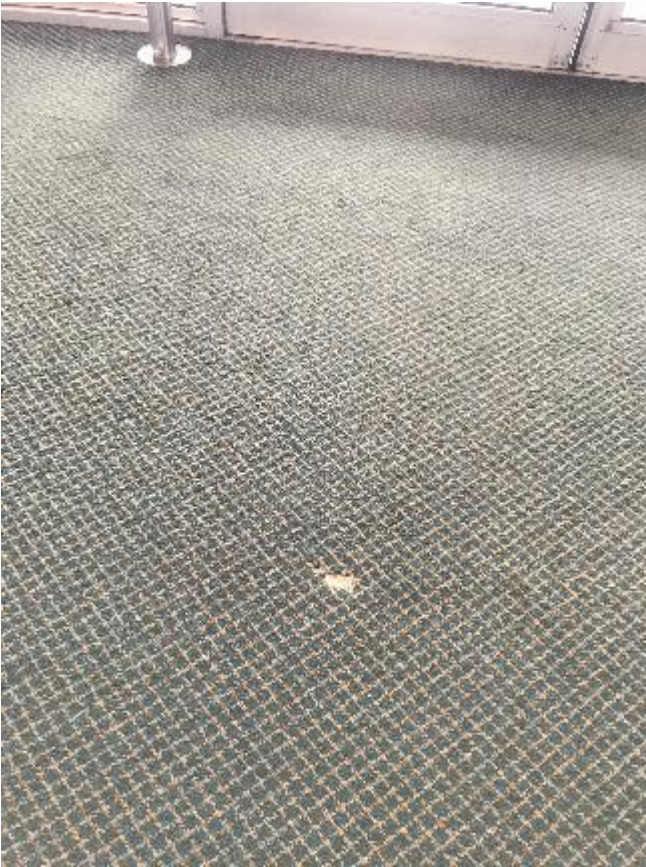
123. Close up of worn and tracked carpet.

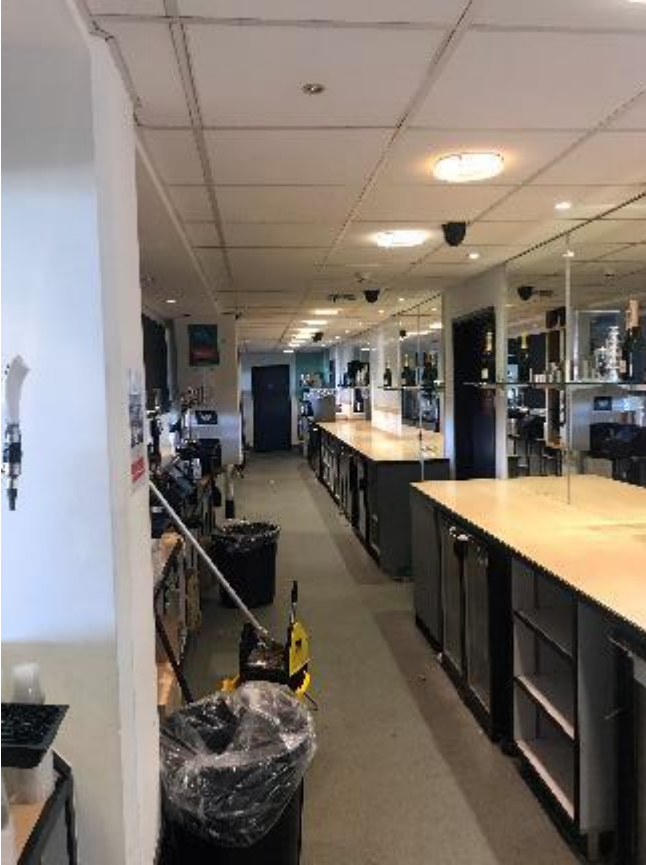
125. General view of servery/bar area.

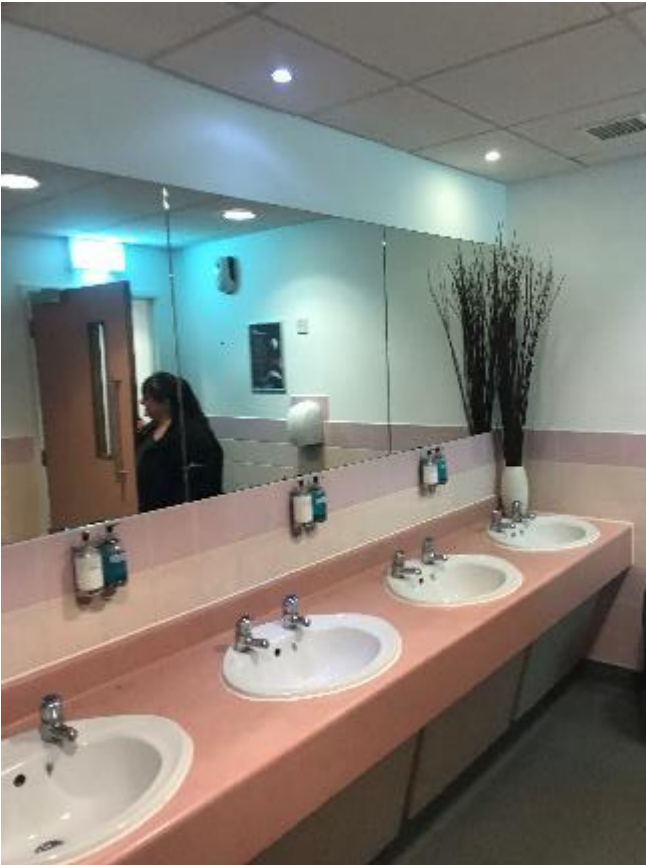
127. Ladies Toilets are dated for Customer Standards.

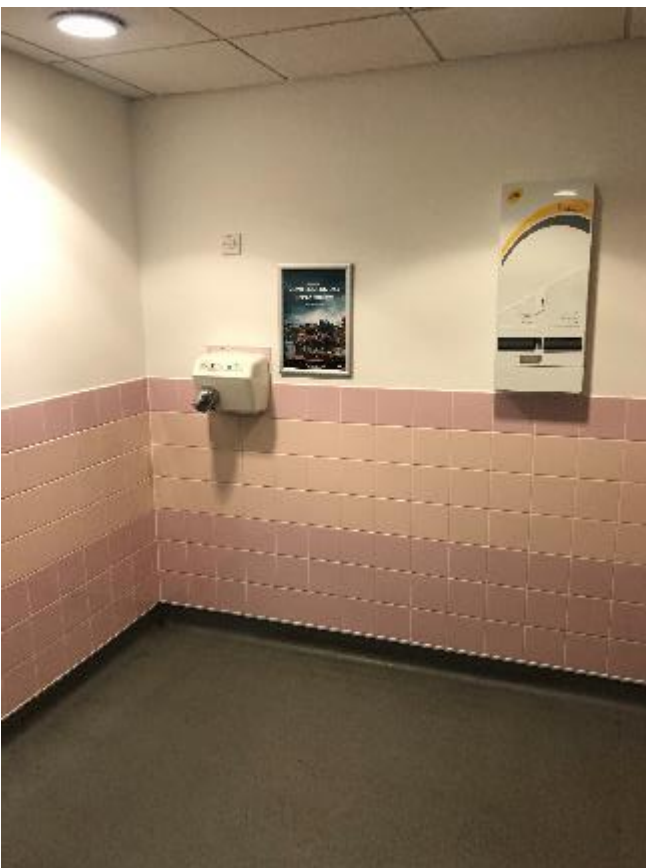
128. Ladies Toilets are dated for Customer Standards.

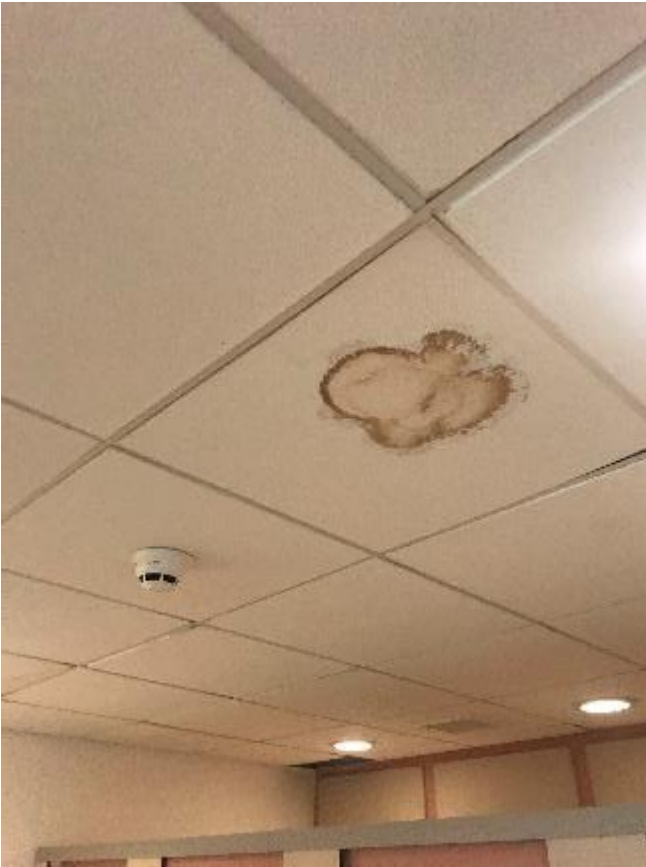
129. Example of water stained ceiling tiles in Ladies Toilets.

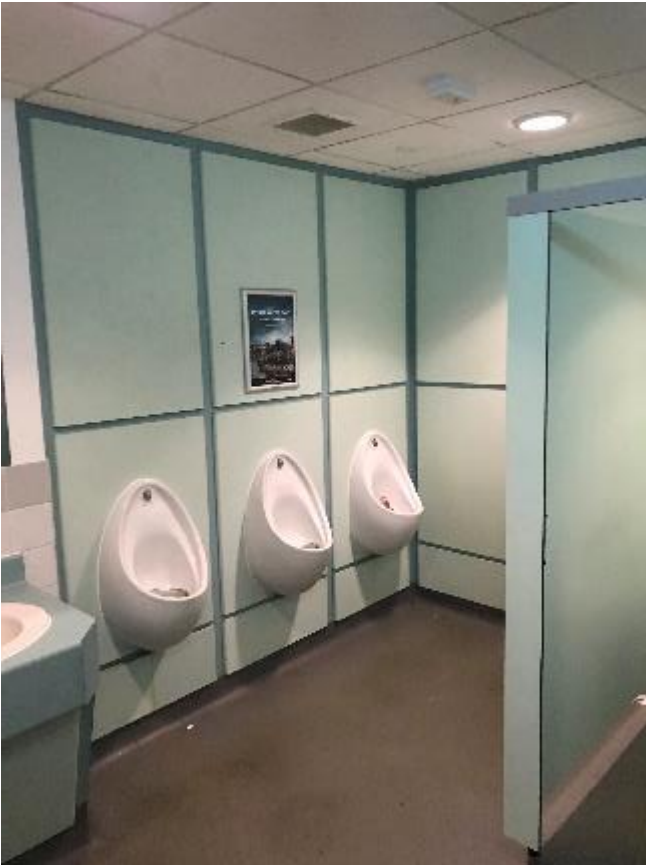
131. Gents Toilets are dated by Customer Standards.

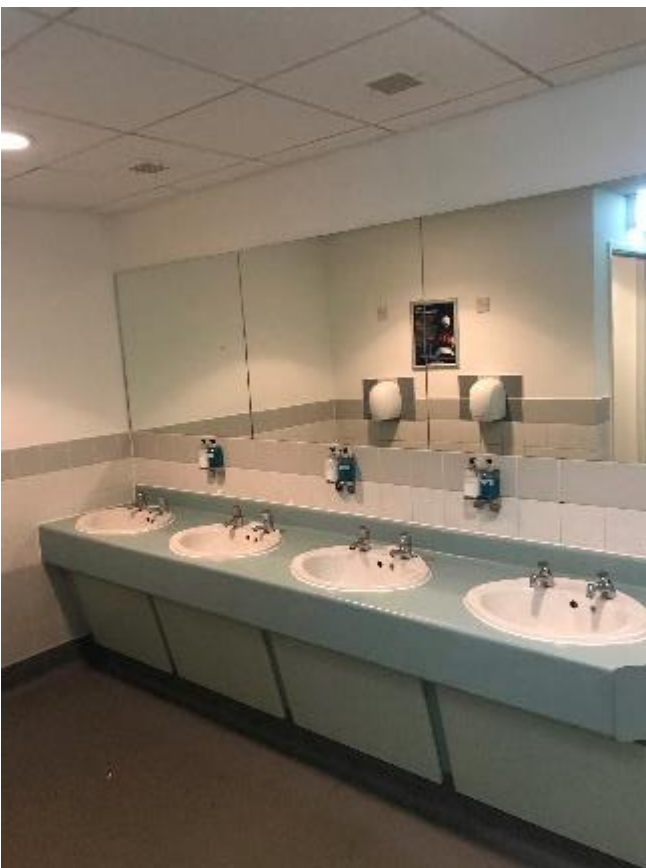
132. Gents Toilets are dated for Customer Standards.
