BUILDING CONDITION REPORT 2020, INCLUDING M&E CONDITION SURVEY

Summary Building Condition Report for
Jockey Club Racecourses Limited

SANDOWN PARK RACECOURSE
PORTSMOUTH ROAD
ESHER
SURREY
KT10 9AJ

March 2020

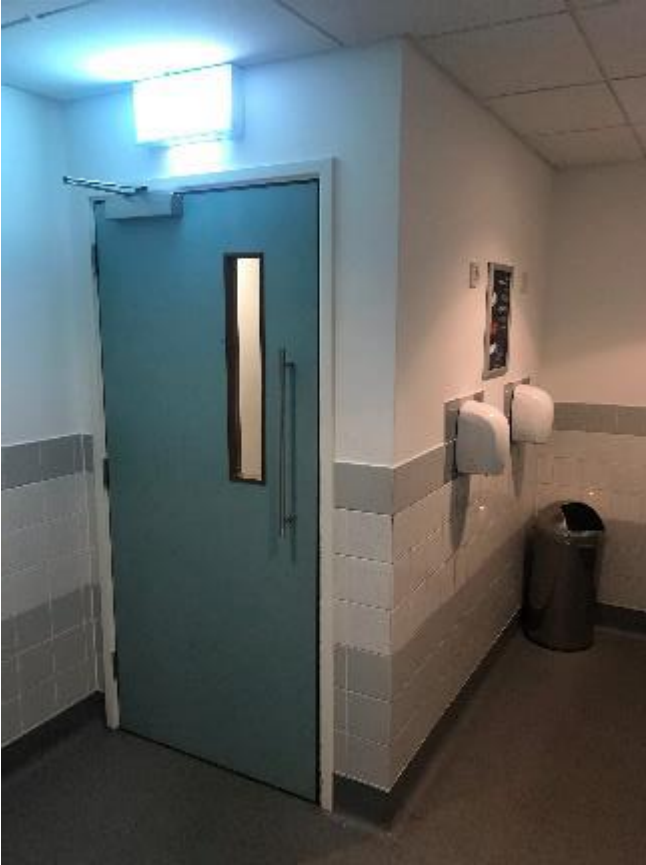
133. Gents Toilets are dated for Customer Standards.

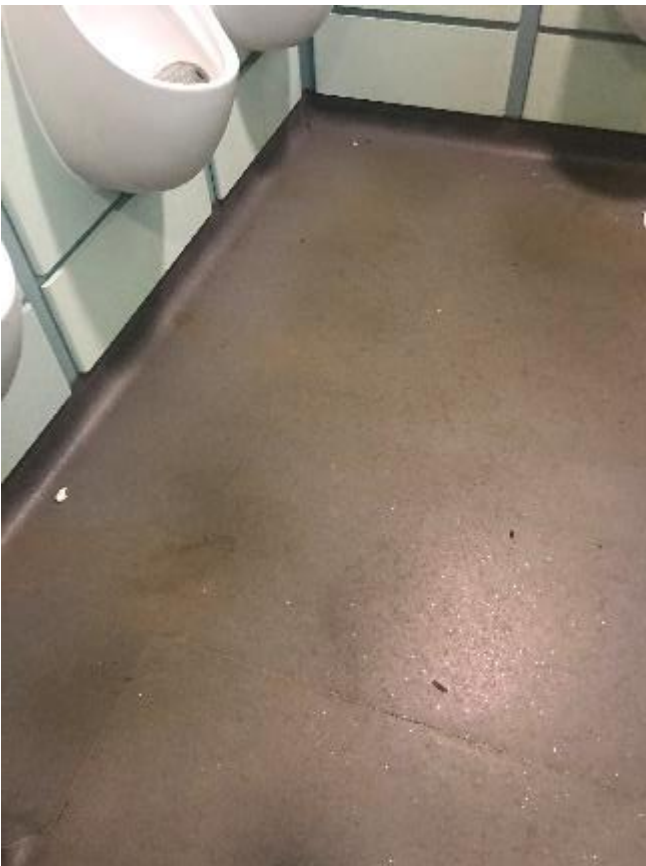
134. Soiled and worn vinyl floor covering in Gents Toilet.

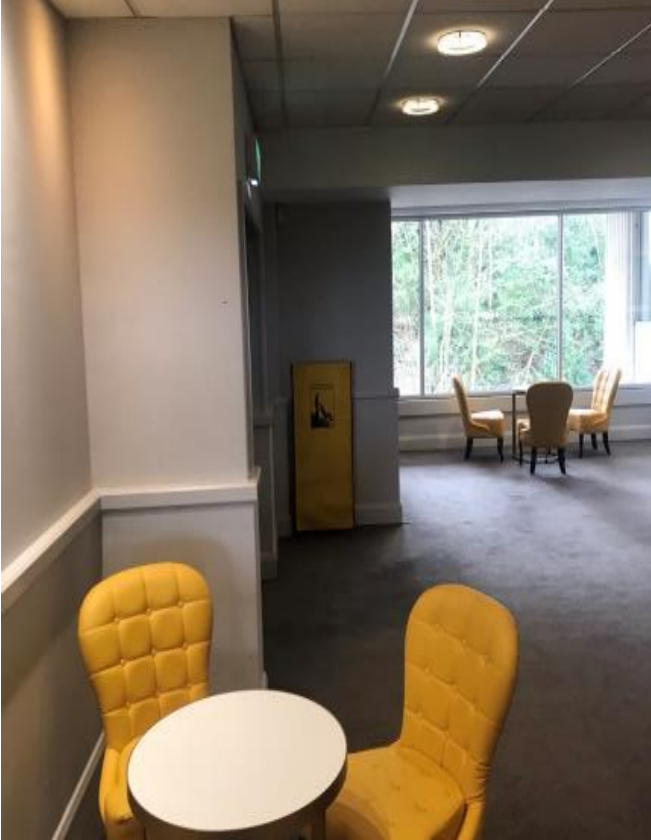
135. General view of lobby to Second Floor Boxes.

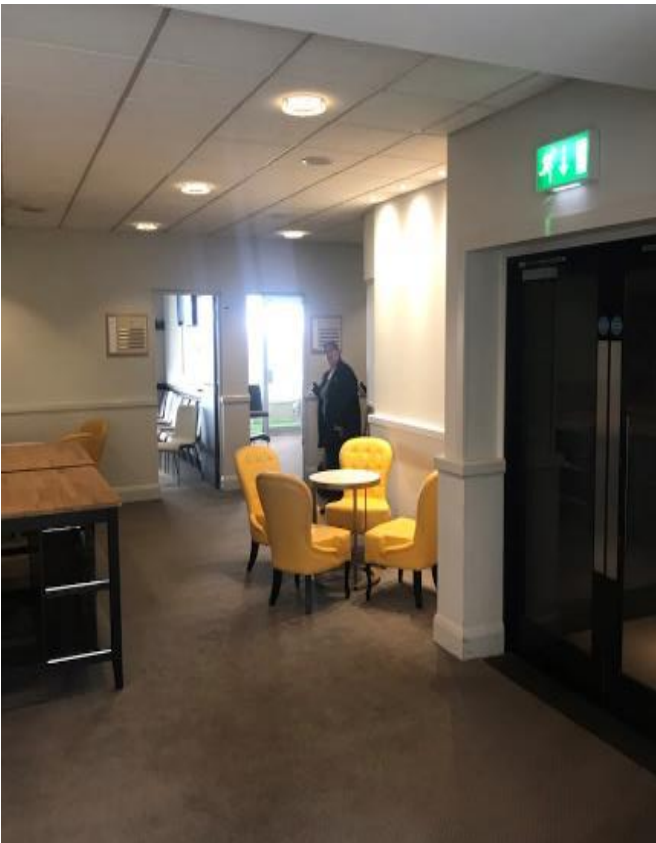
136. General view of lobby to Second Floor Boxes. Note: worn and tracking carpet.

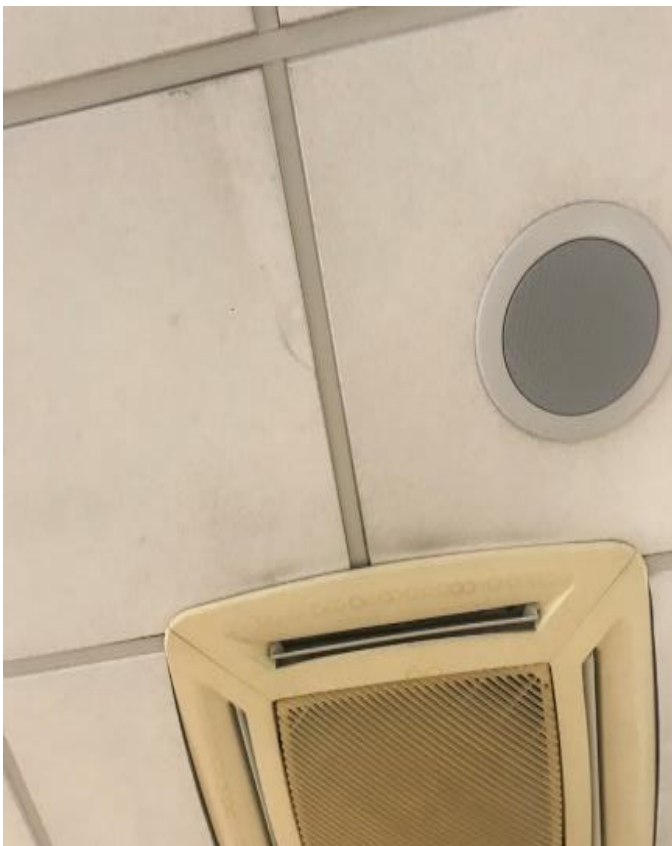
138. Close up of heavy soiling to ceiling in lobby area.

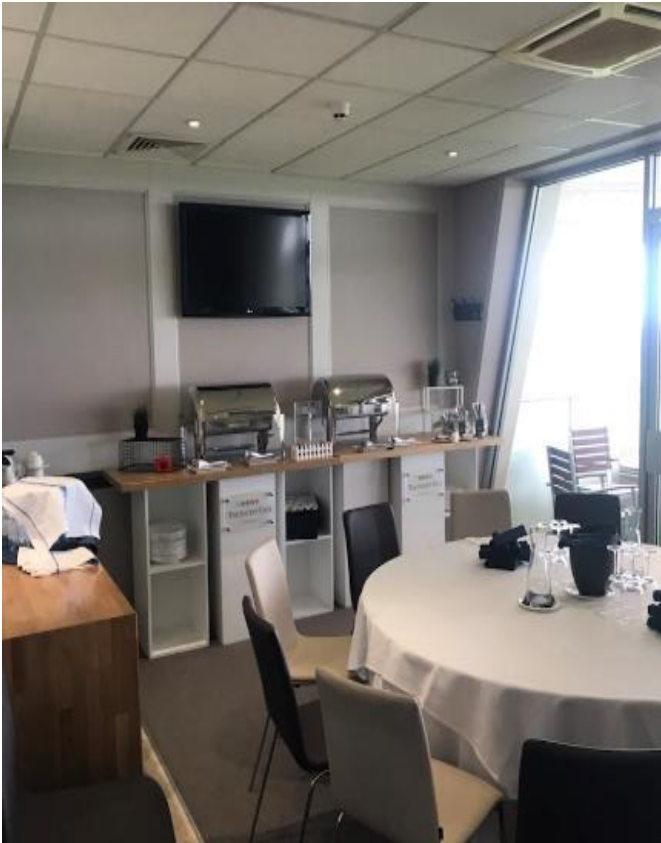
139. Typical view of Second Floor Box.

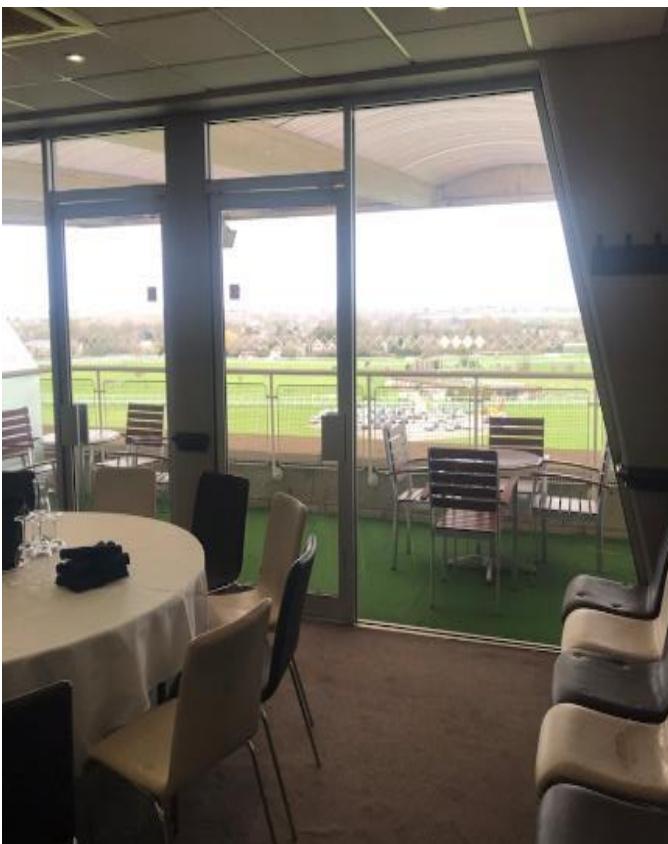
140. Typical view of Second Floor Box. Note: single glazed windows and doors are draughty and offer poor energy efficiency.

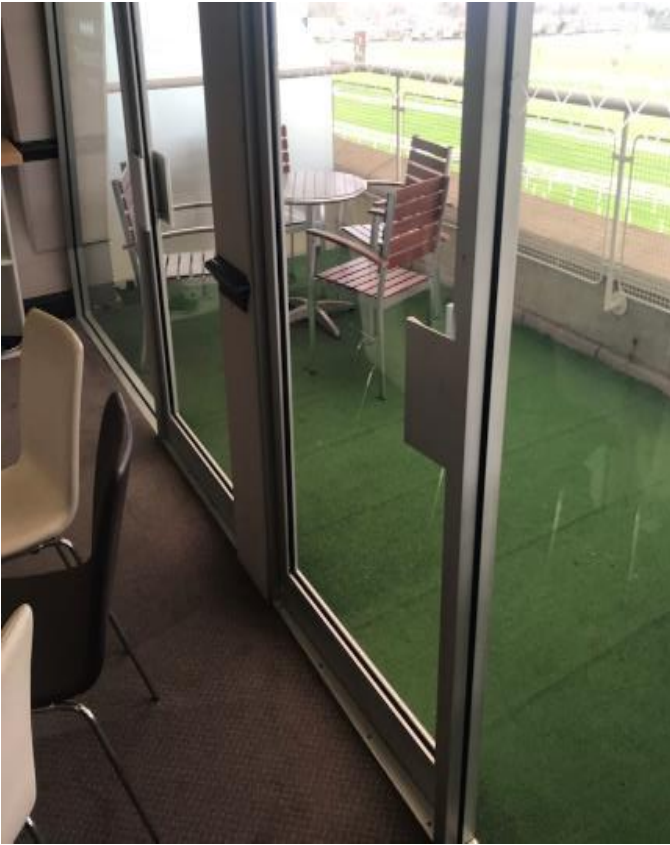
141. Close up of single glazed doors and windows to Second Floor Boxes.

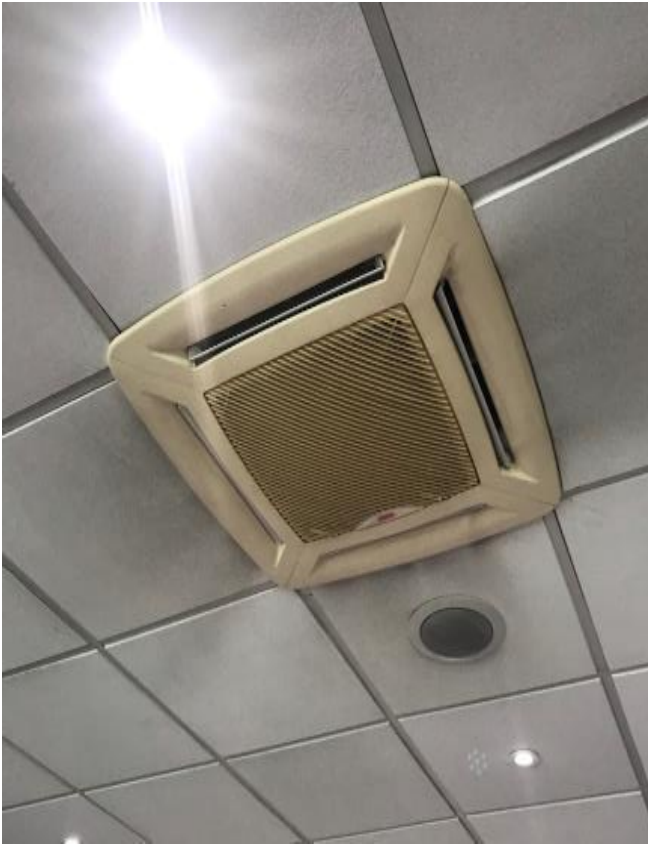
143. Typical staining to ceilings.

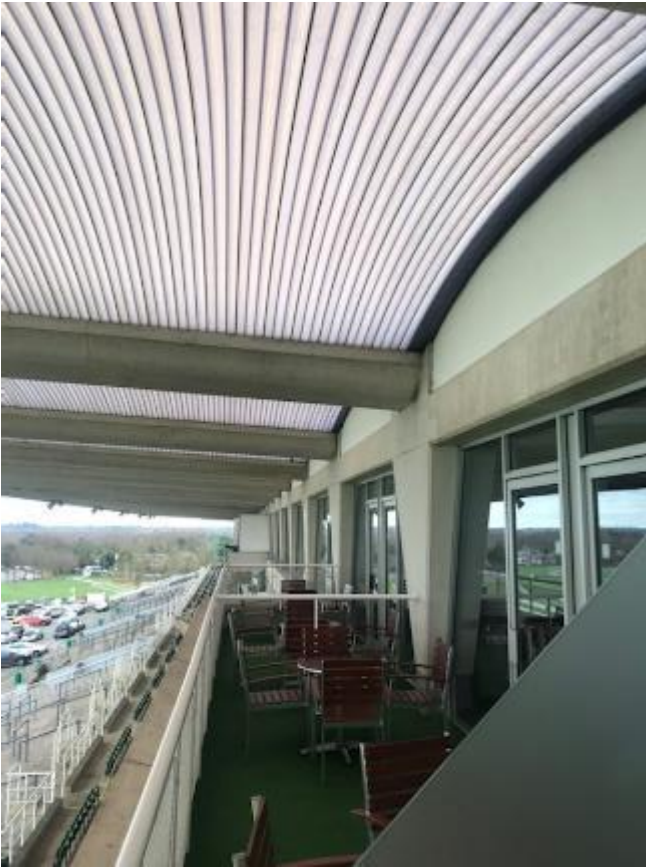
145. General view of private balconies to Second Floor Boxes.

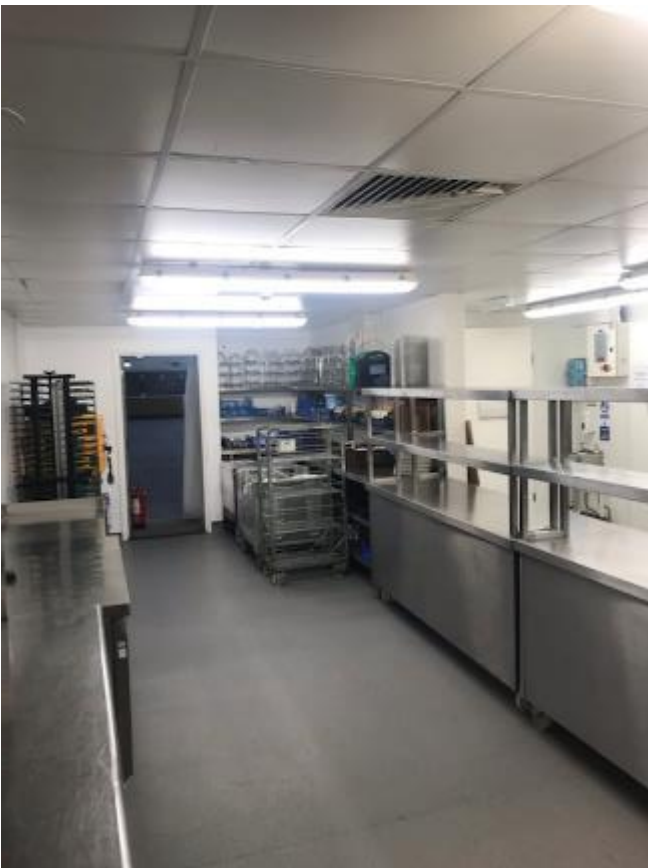
148. Second floor kitchen – general view.

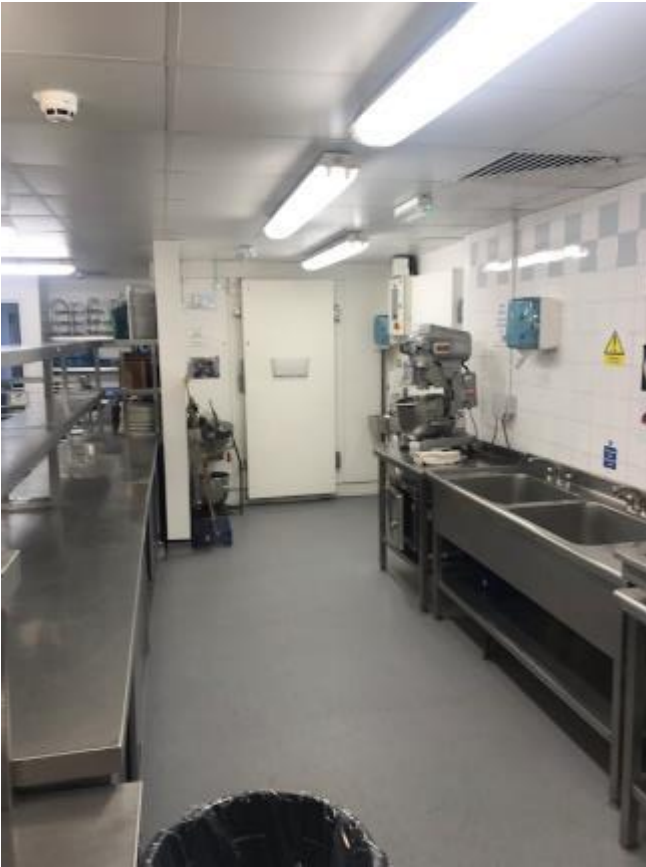
149. Second floor kitchen – general view.

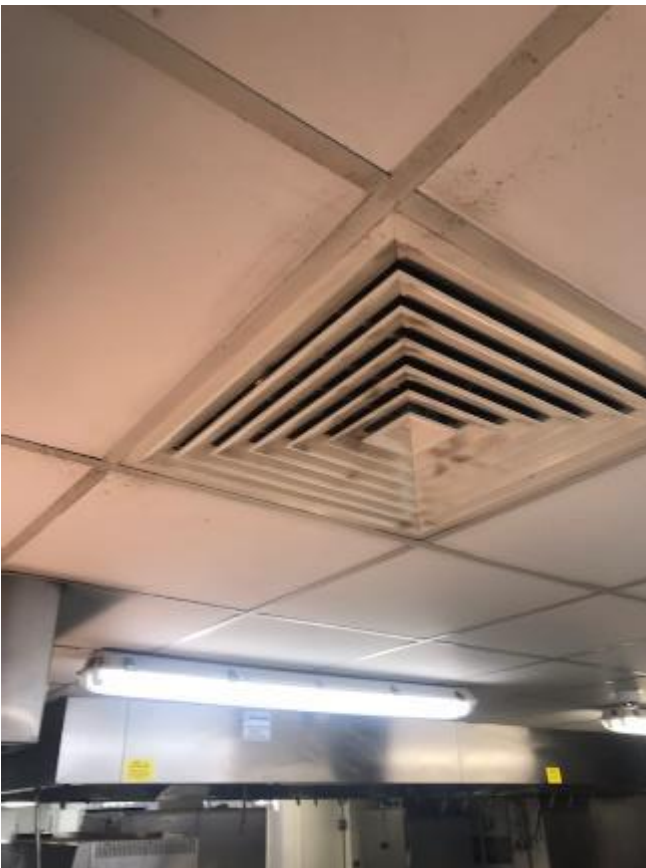
150. Close up of soiled ceiling and grille to second floor kitchen.

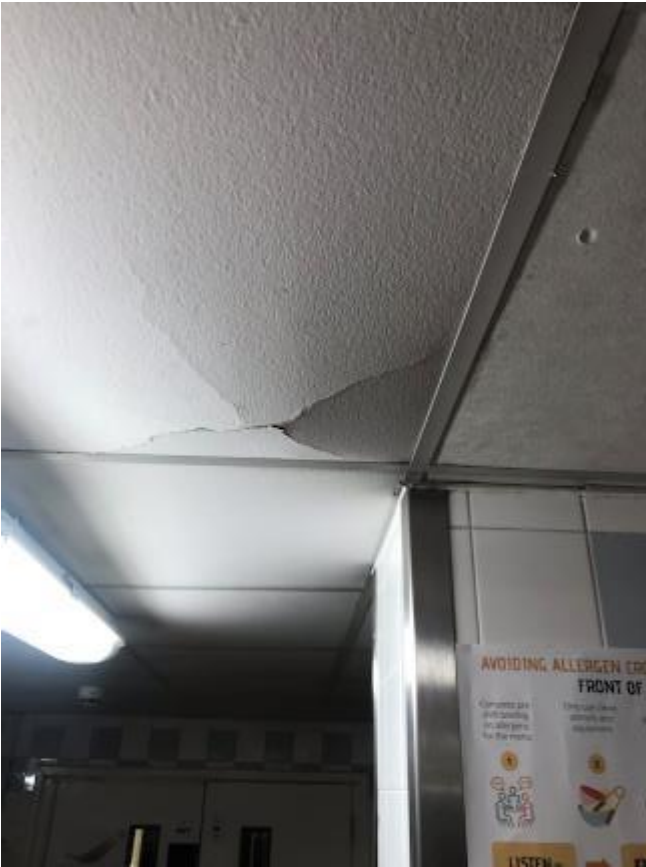
151. Close up of damage to kitchen ceiling.

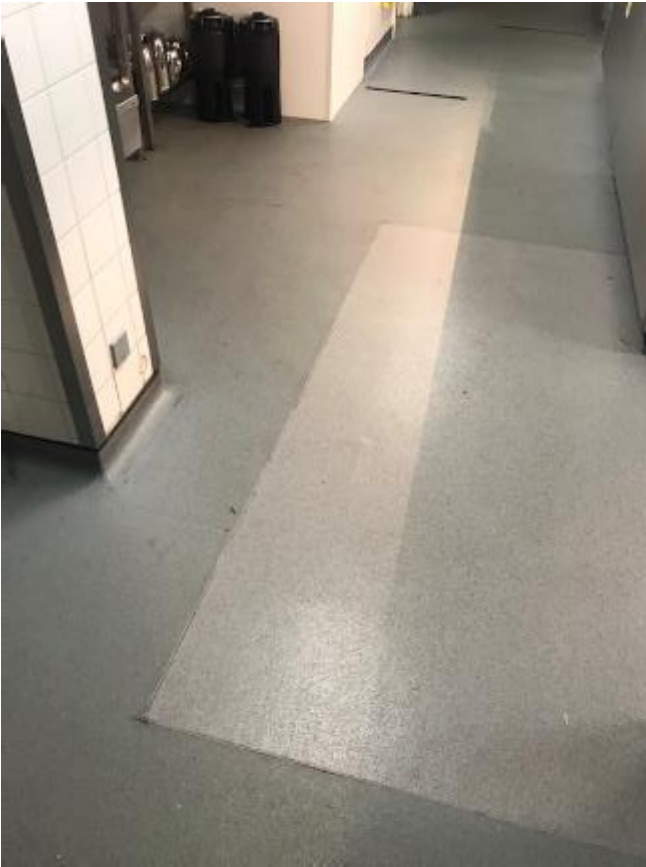
153. Example of soiled and patch repaired vinyl floor covering to second floor kitchen.

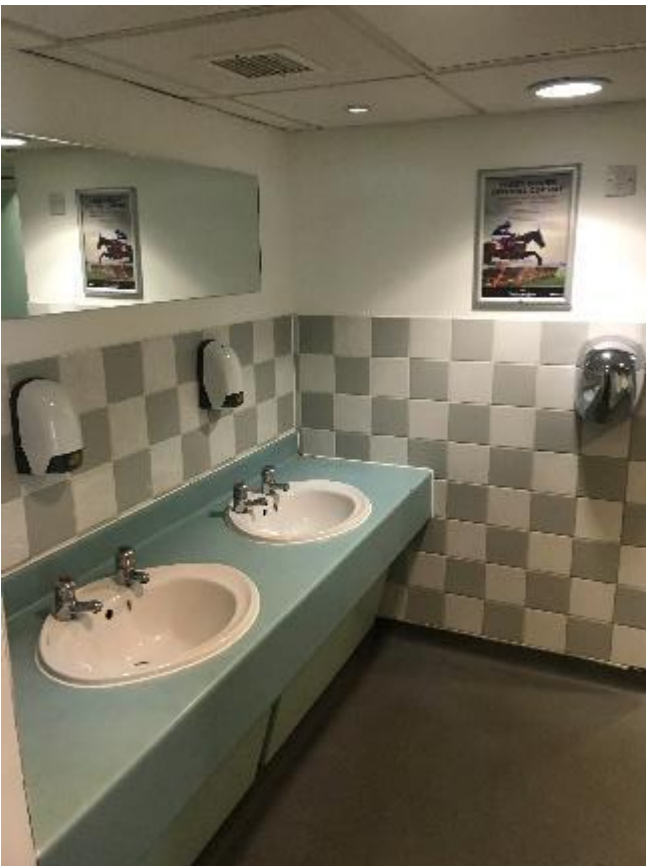
154. General view of second floor Gents Toilets dated by Customer Standards.

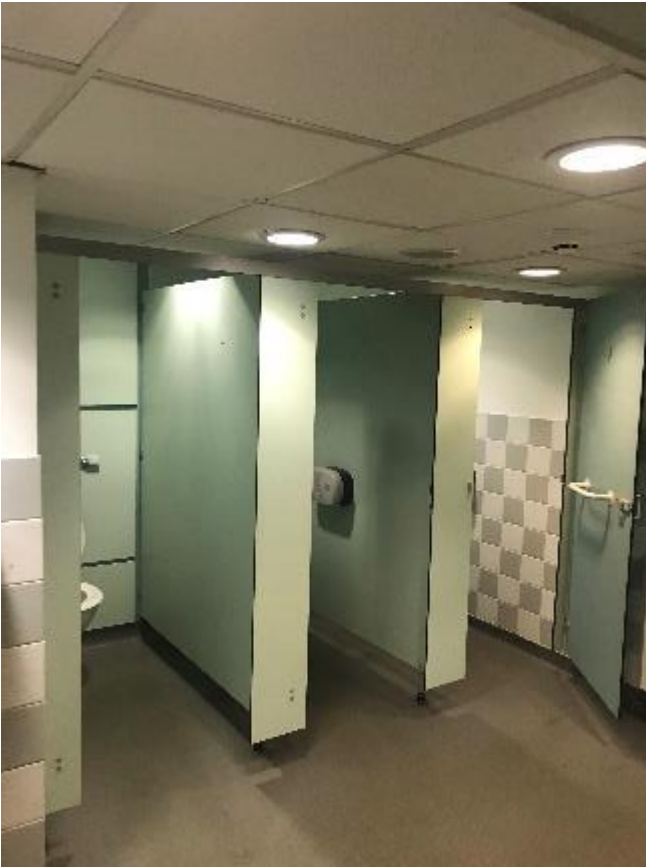
155. General view of second floor Gents Toilets dated by Customer Standards.

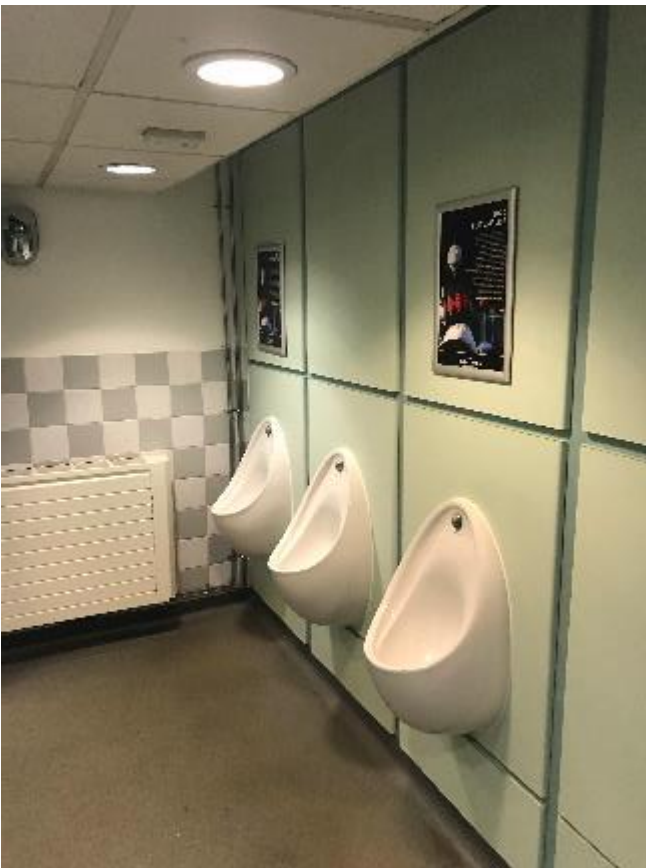
156. General view of second floor Gents Toilets dated by Customer Standards.

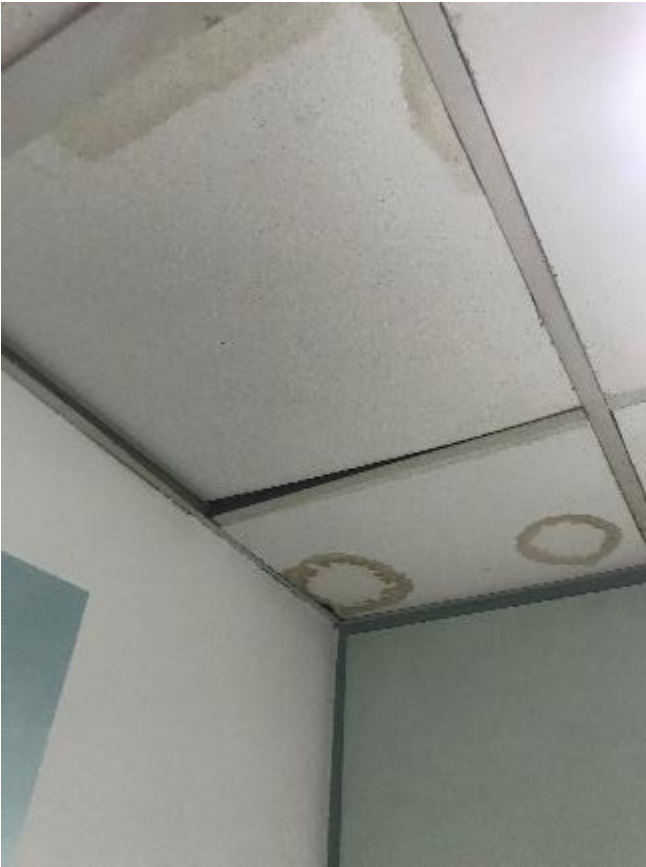
157. Example of stained ceiling tiles from roof leaks to Gents Toilets.

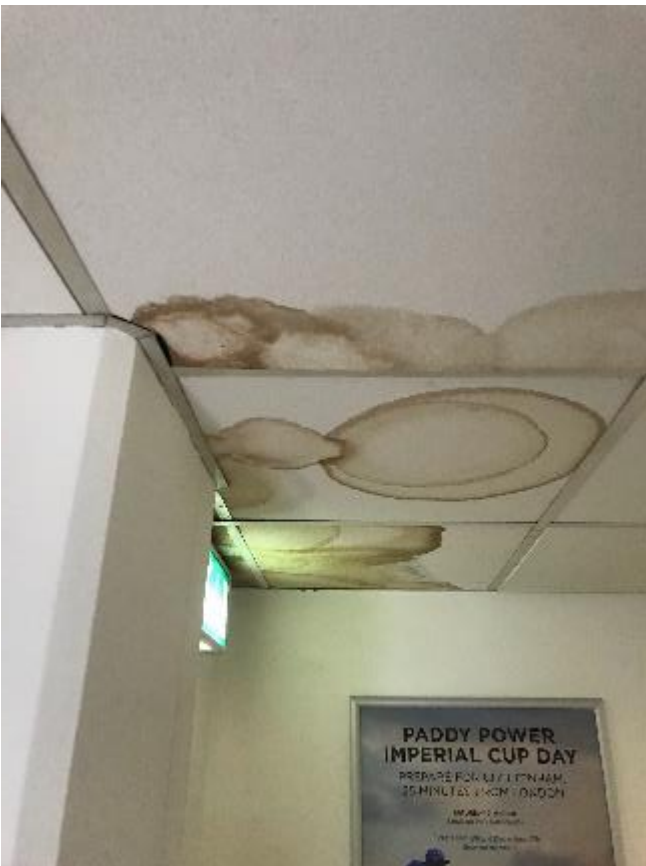
158. Example of stained ceiling tiles from roof leaks to Gents Toilets.

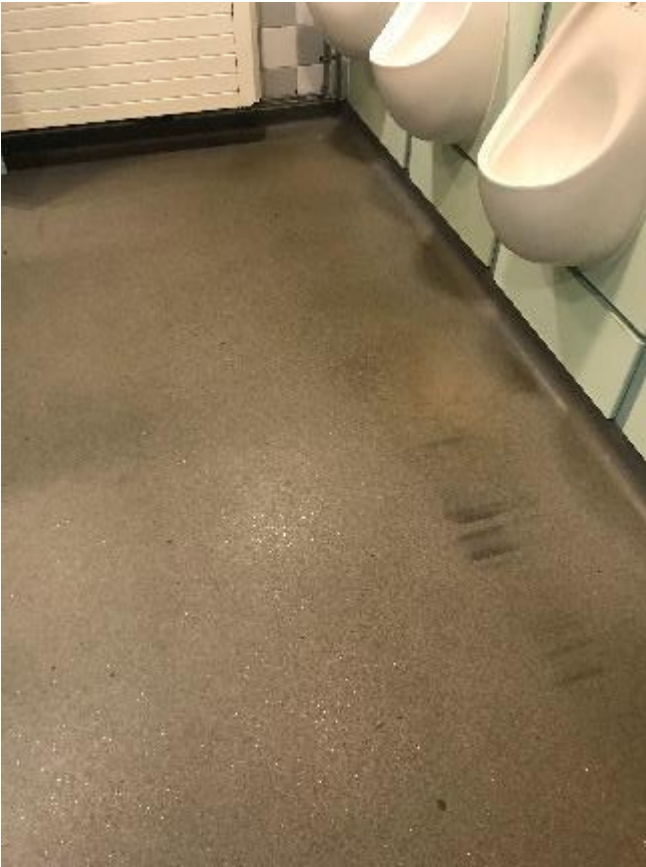
159. Close up of staining to vinyl floor covering in Gents Toilets.

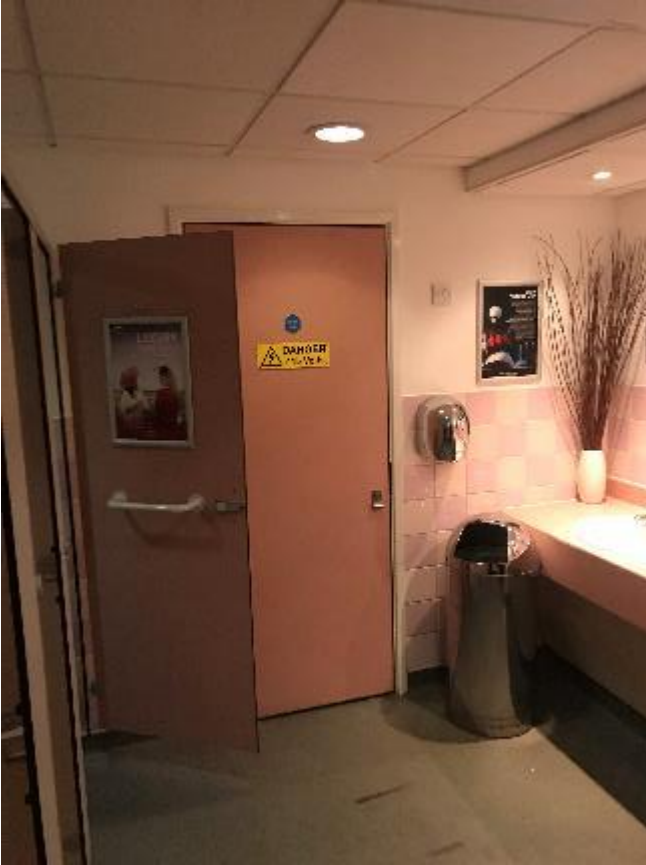
161. General view of second floor Ladies Toilets – dated by Customer Standards.

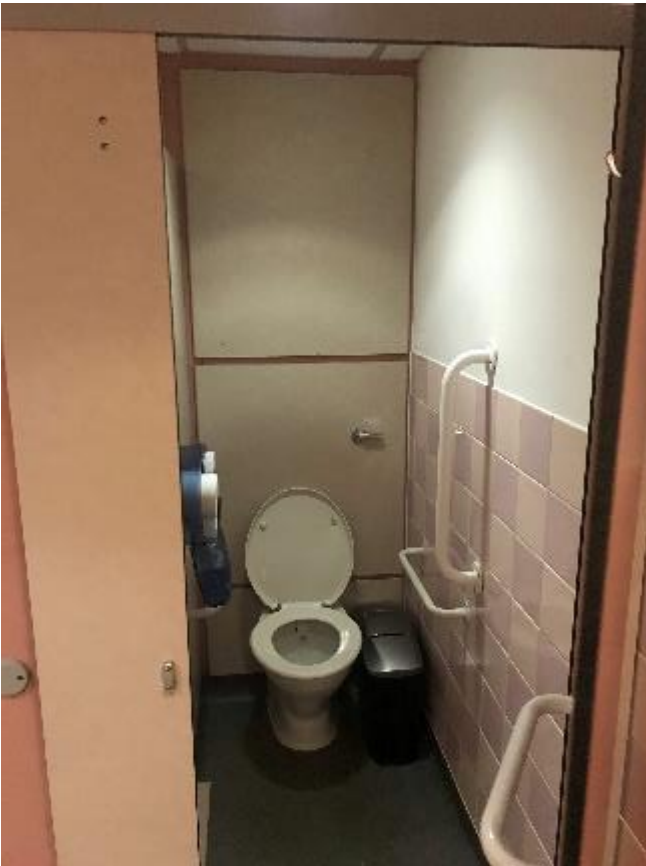
162. General view of second floor Ladies Toilets – dated by Customer Standards.

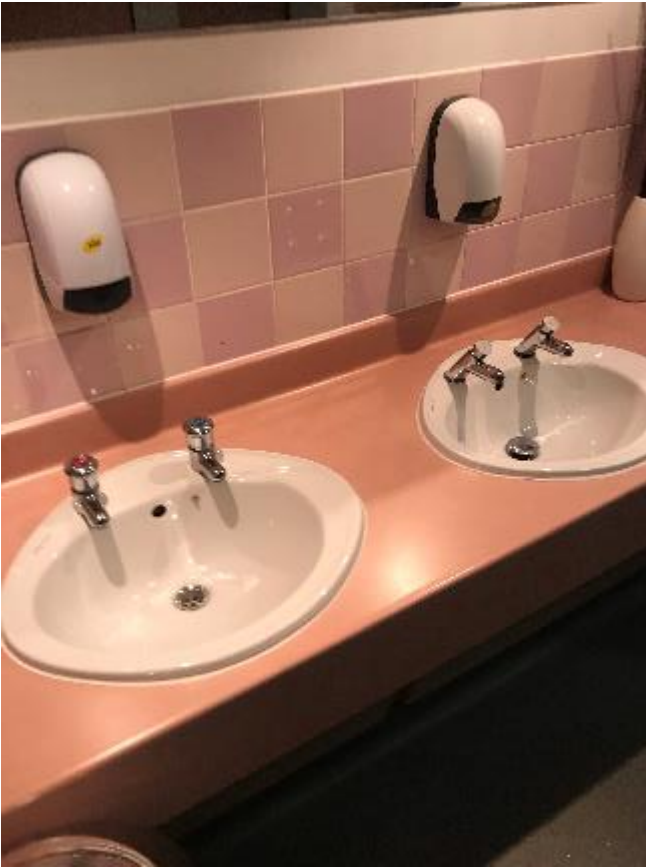
163. General view of second floor Ladies Toilets. Note: non-matching taps.

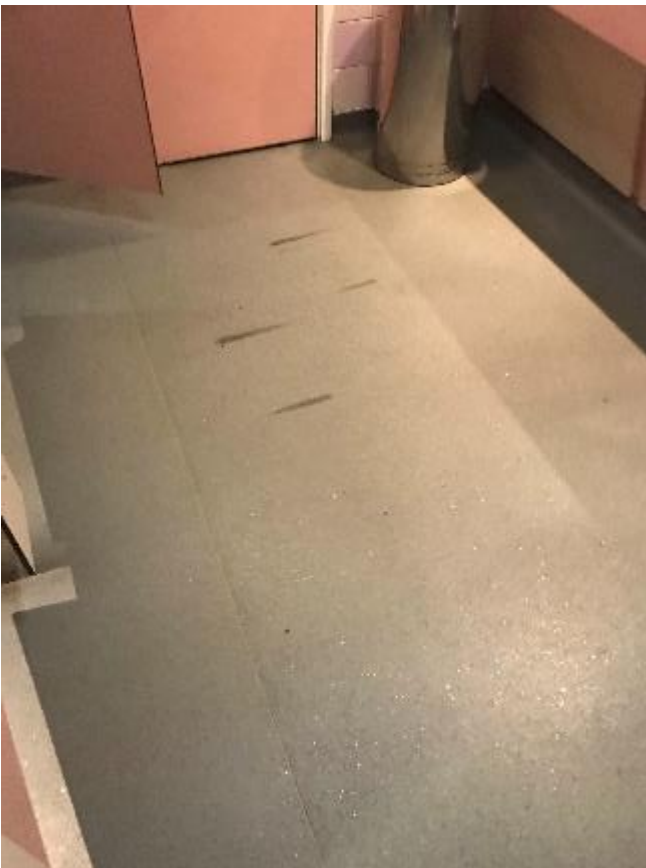
164. Soiled and marked vinyl floor covering to second floor Ladies Toilets.

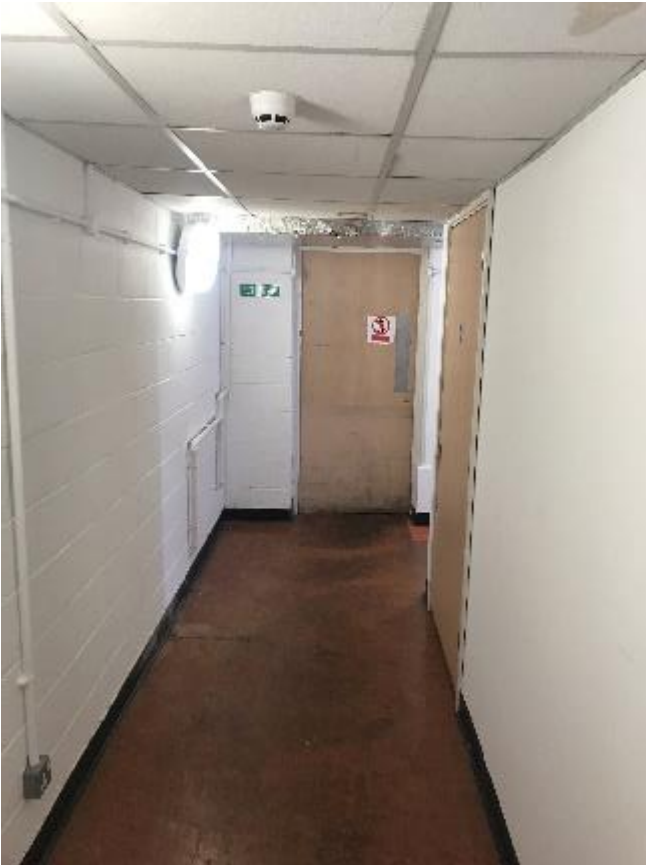
165. General view of second floor escape corridor.

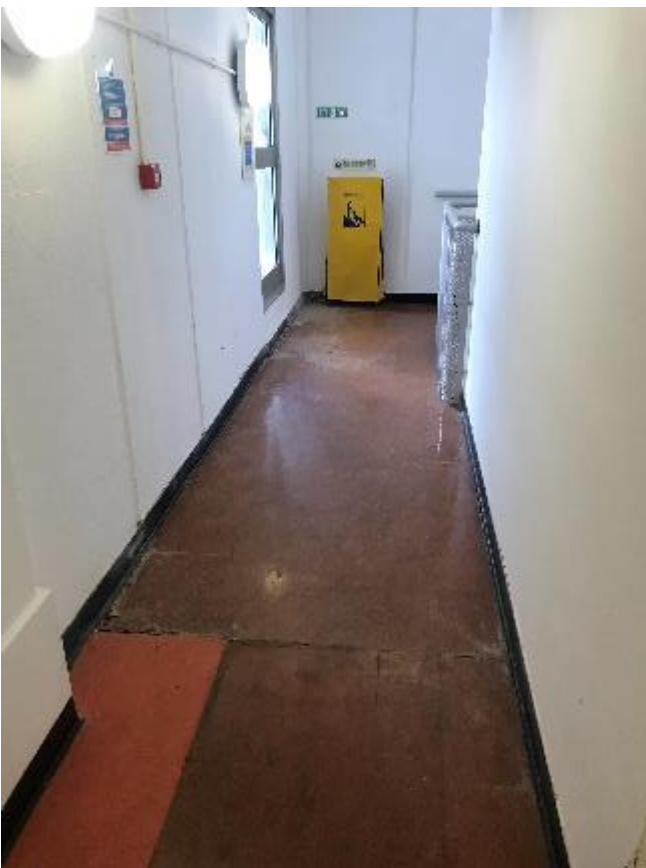
166. General view of second floor escape corridor.

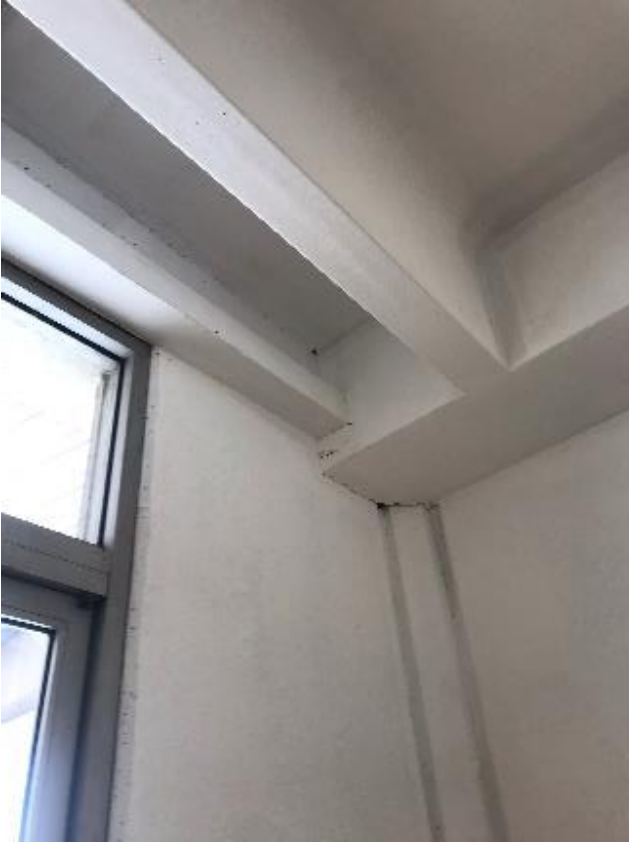
167. Staining from water ingress to corner of escape stairwell.

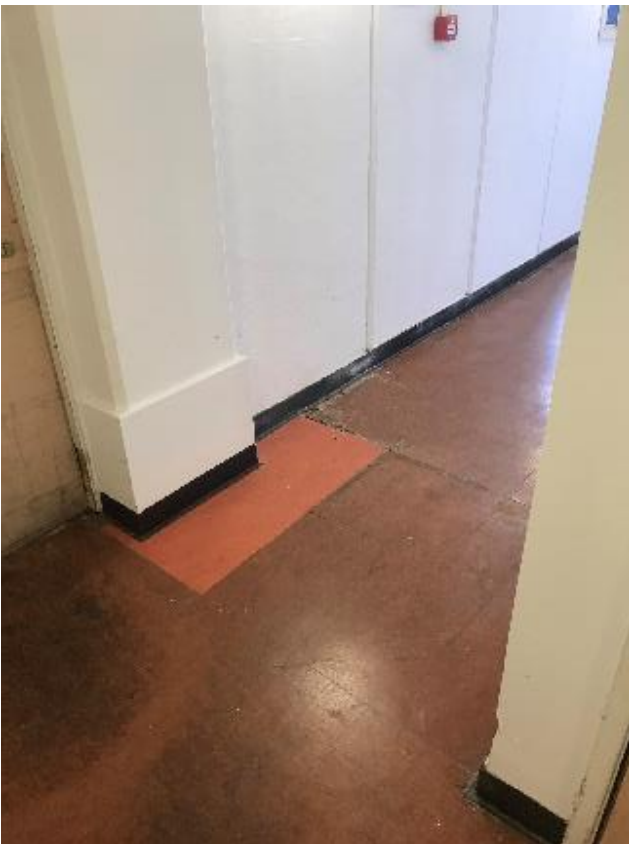
168. Close up of water damaged and patch repaired vinyl floor covering to second floor escape corridor (original colour of vinyl floor covering no longer available).

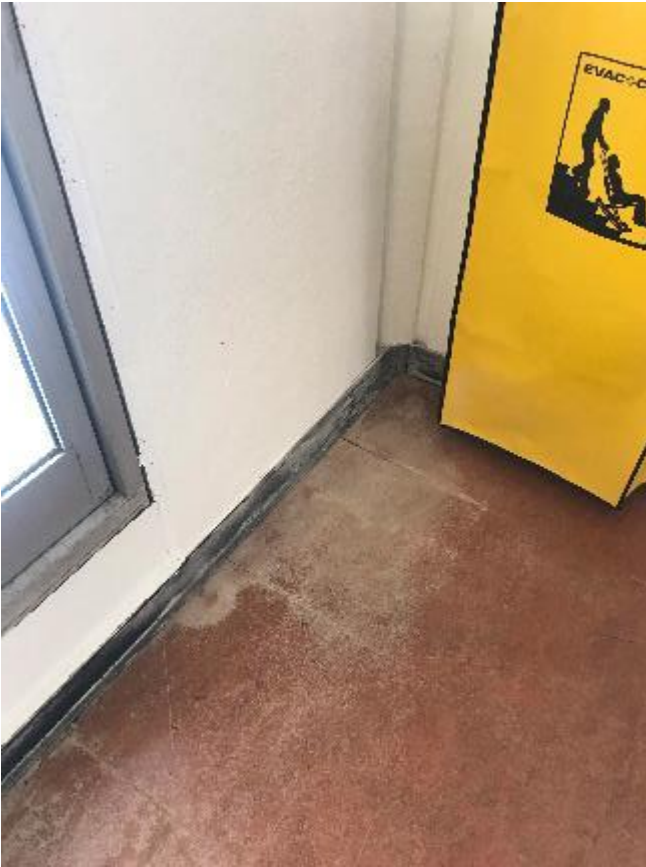
169. Staining/damage to vinyl floor covering due to roof leaks in second floor escape stairwell.

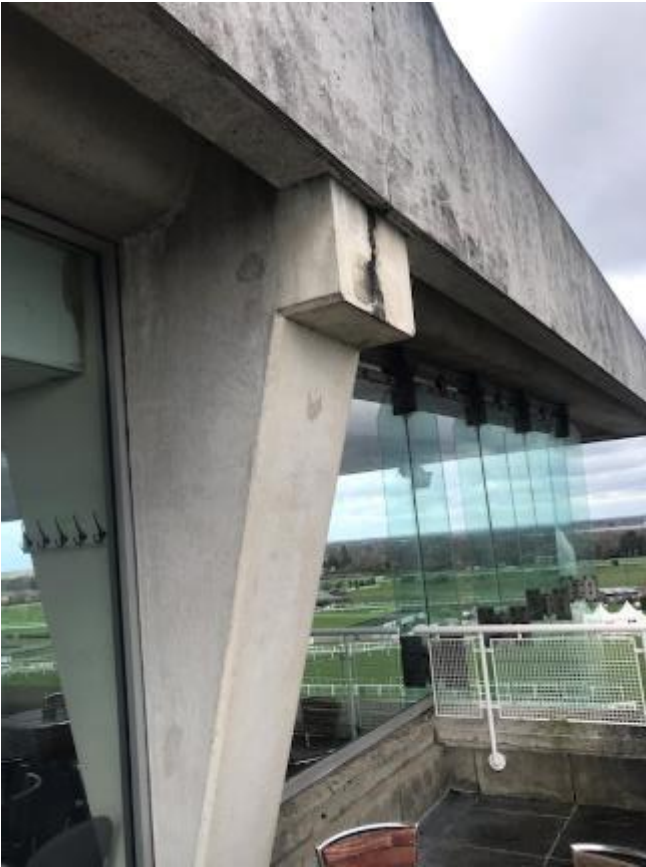
171. Leaks from roof/parapet onto second floor and terrace adjacent to second floor boxes.

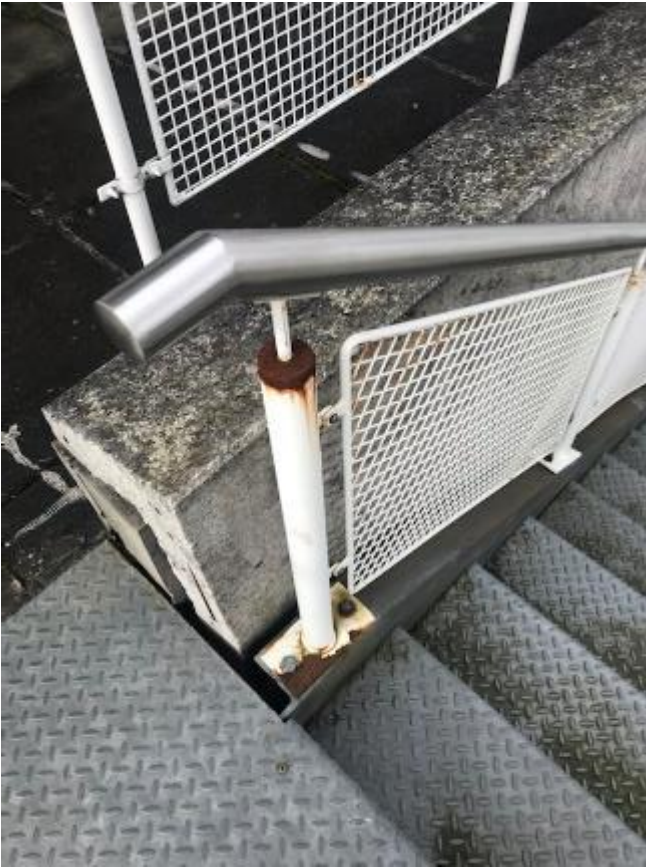
173. External escape stairwell from second floor terrace. Note: corrosion to balustrades.

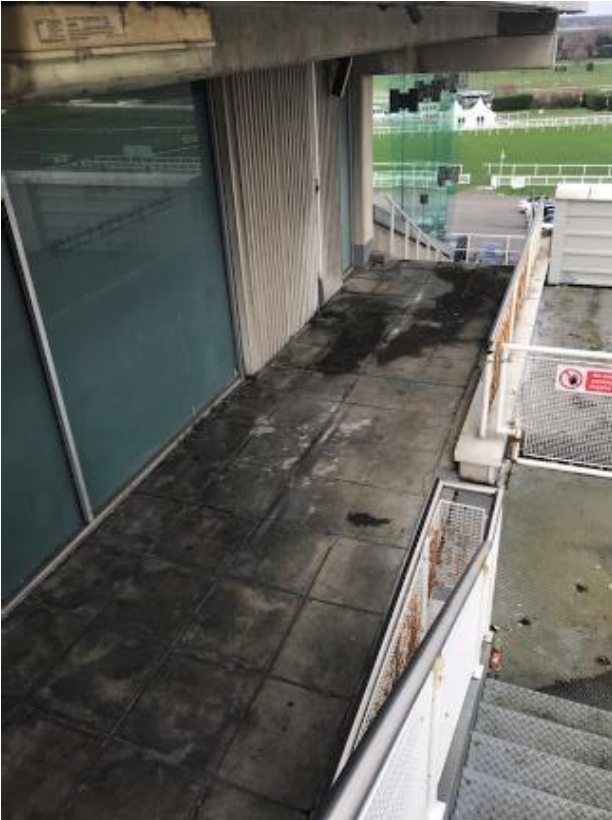
175. External escape stairwell from second floor terrace. Note: corrosion to balustrades and staining to pavings from roof/terrace leaks.

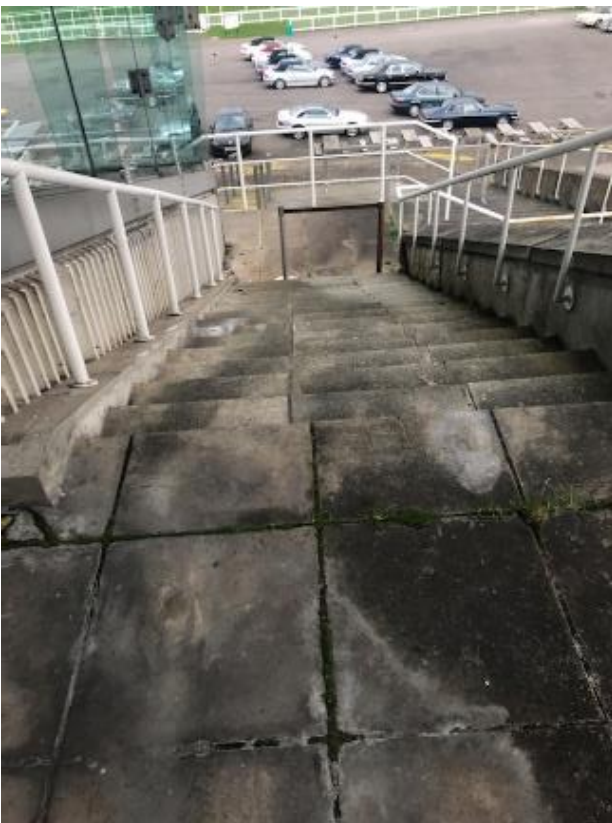
176. External escape stairwell from second floor terrace. Note: staining to pavings from roof/terrace leaks.

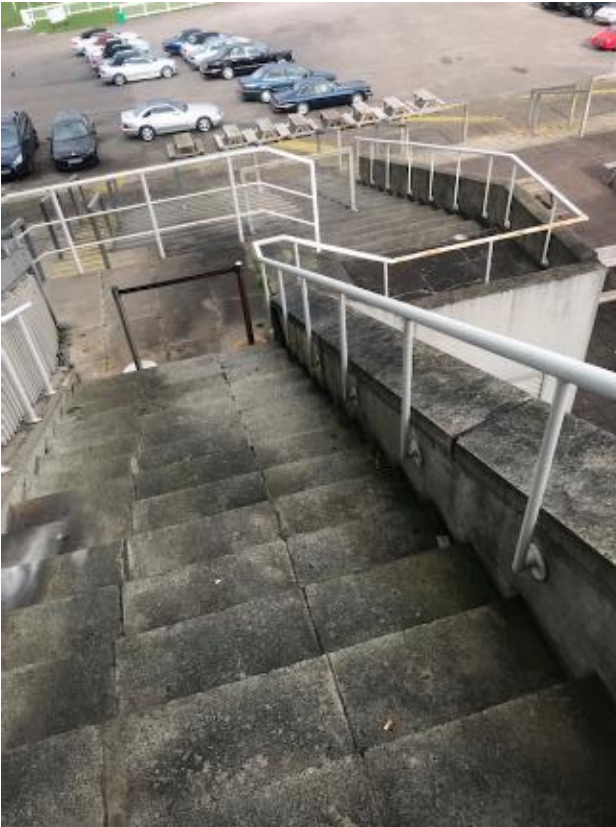
177. External escape stairwell from second floor terrace. Note: staining to pavings from roof/terrace leaks.

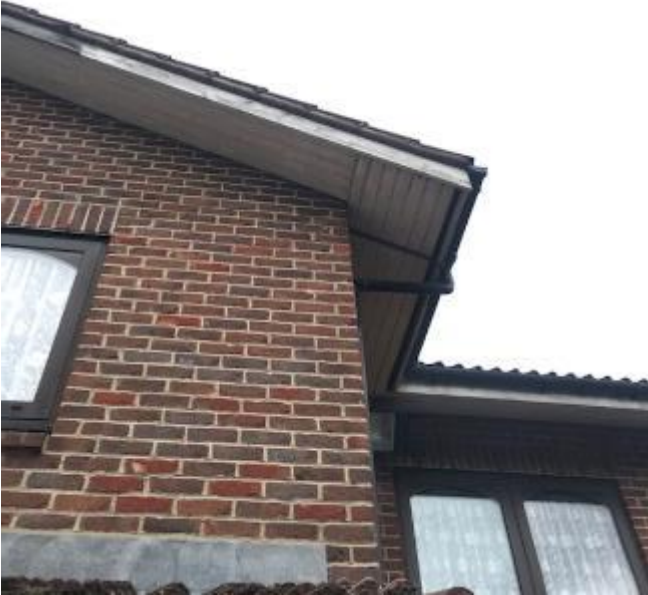
179. Fascias and soffits are in poor decorative order and partially rotten.

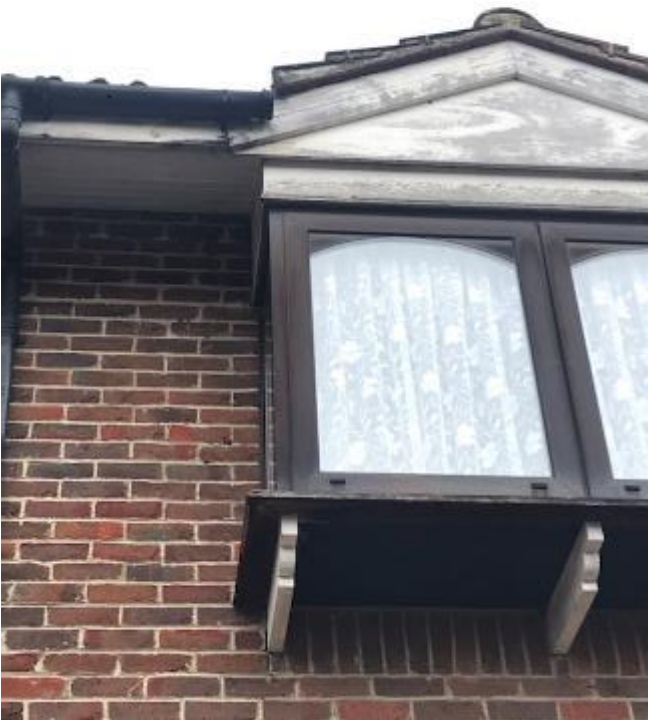
180. Fascias and soffits are in poor decorative order and partially rotten.

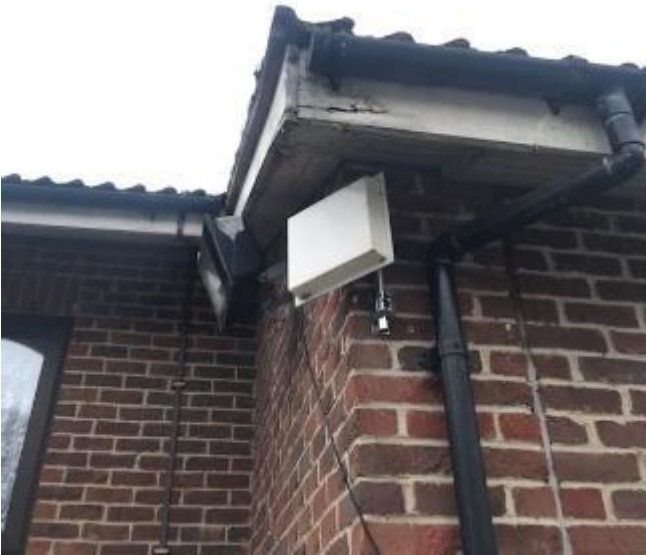
181. Fascias and soffits are in poor decorative order and partially rotten.

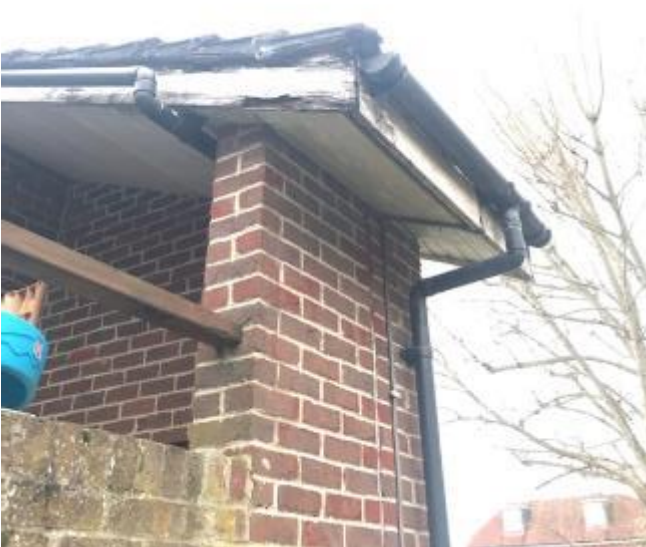
182. Fascias and soffits are in poor decorative order and partially rotten.

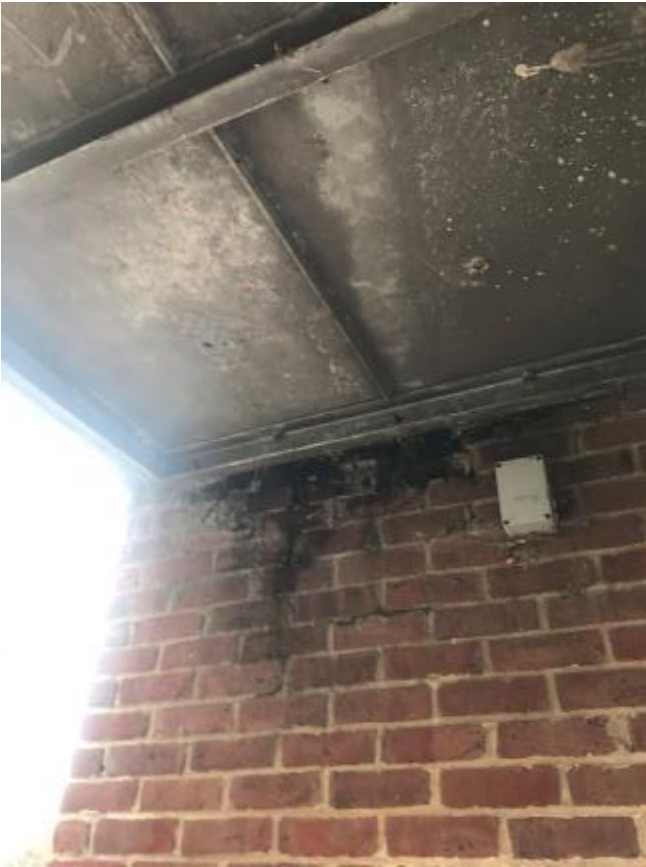
183. Leaks from metal fire escape onto brickwork and surface corrosion to metal staircase.

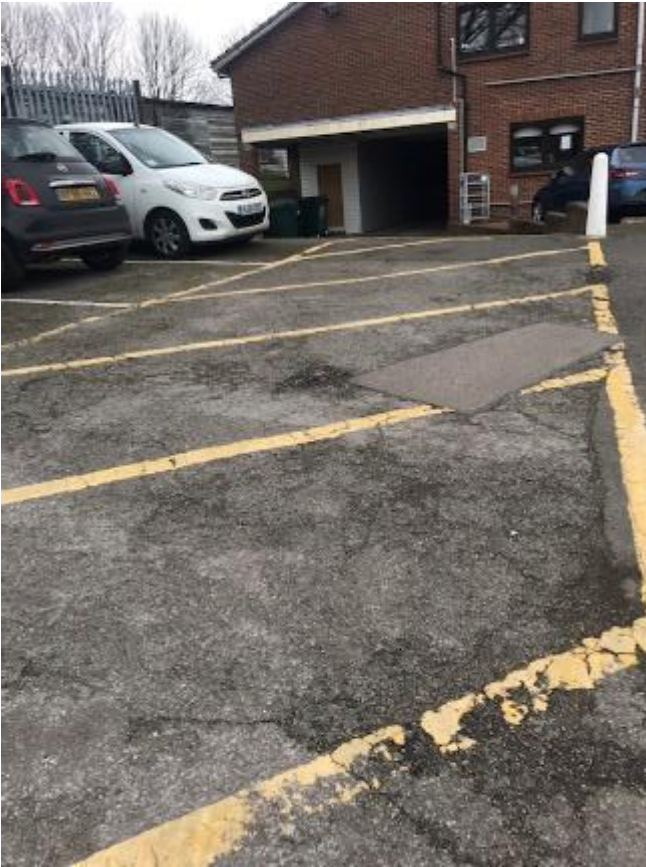
185. Car park surface in the vicinity of Sandown Lodge is breaking up.
