BUILDING CONDITION REPORT 2020, INCLUDING M&E CONDITION SURVEY

Summary Building Condition Report for
Jockey Club Racecourses Limited

SANDOWN PARK RACECOURSE
PORTSMOUTH ROAD
ESHER
SURREY
KT10 9AJ

March 2020

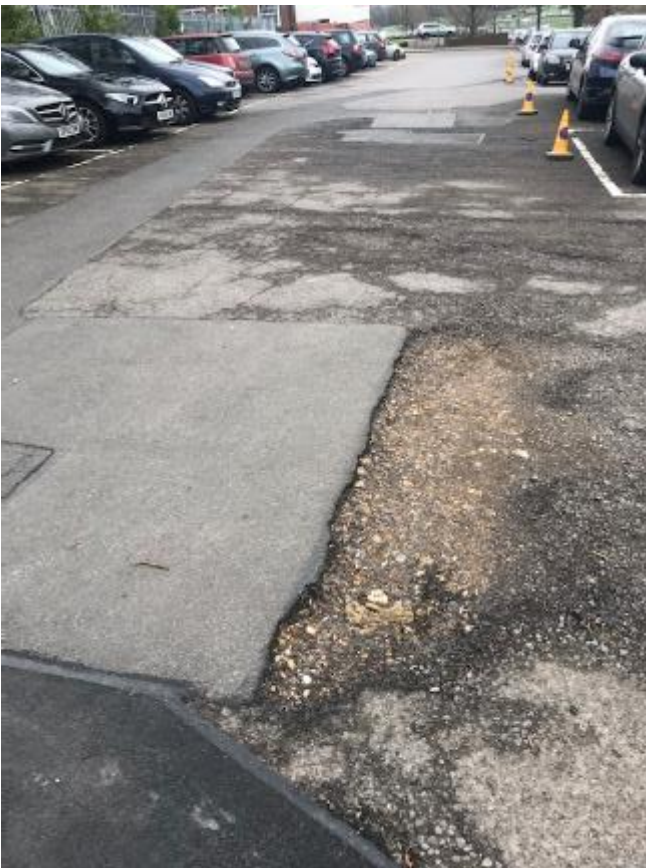
186. Car park surface in the vicinity of Sandown Lodge is breaking up.

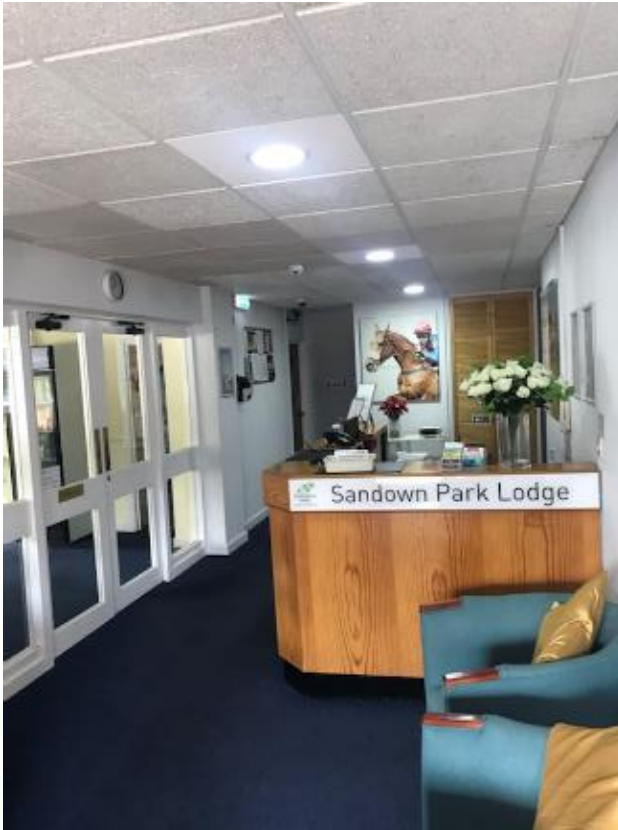
187. Sandown Lodge Entrance Lobby. Note: ceiling tiles have been patch repaired with non-matching replacements as original tiles are no longer available.

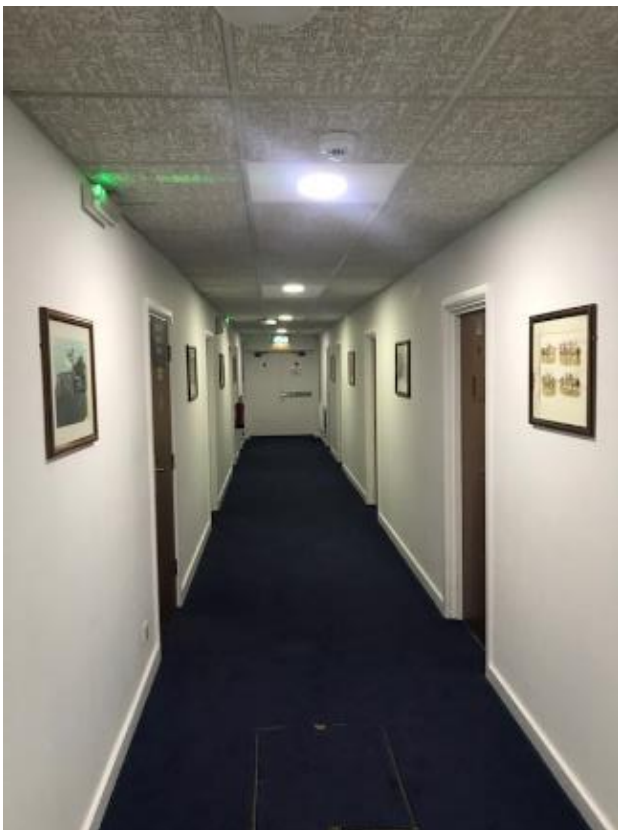
188. Bedroom corridor is dated in appearance with some non-matching ceiling tiles.

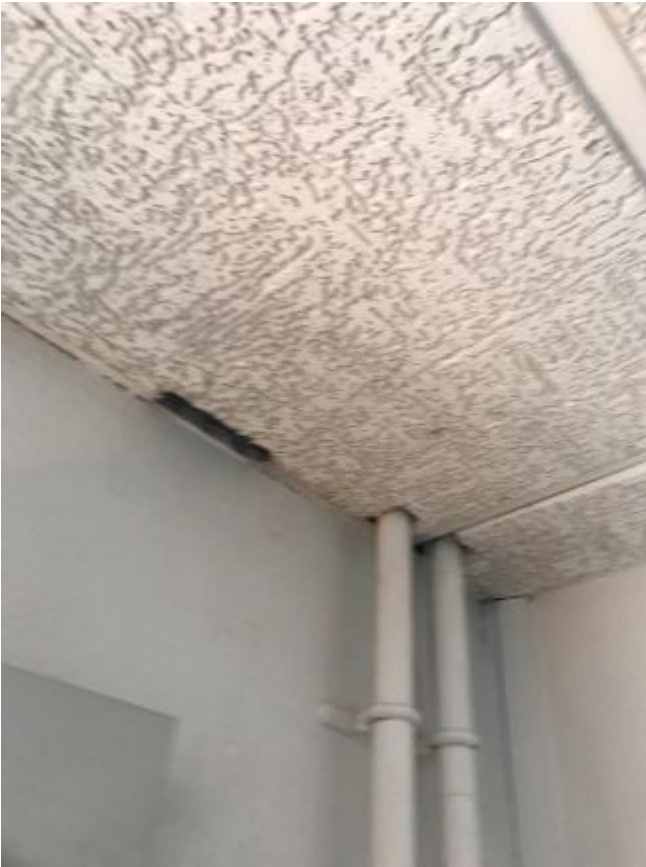
189. Close up example of damage to dated ceiling tiles.

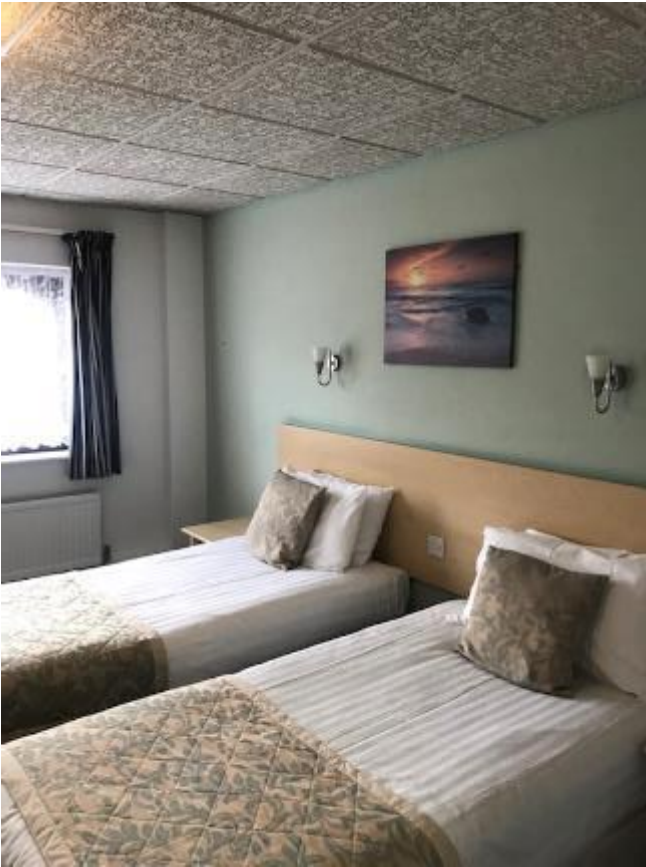
191. Typical bedroom in need of modernisation to meet customer standards.

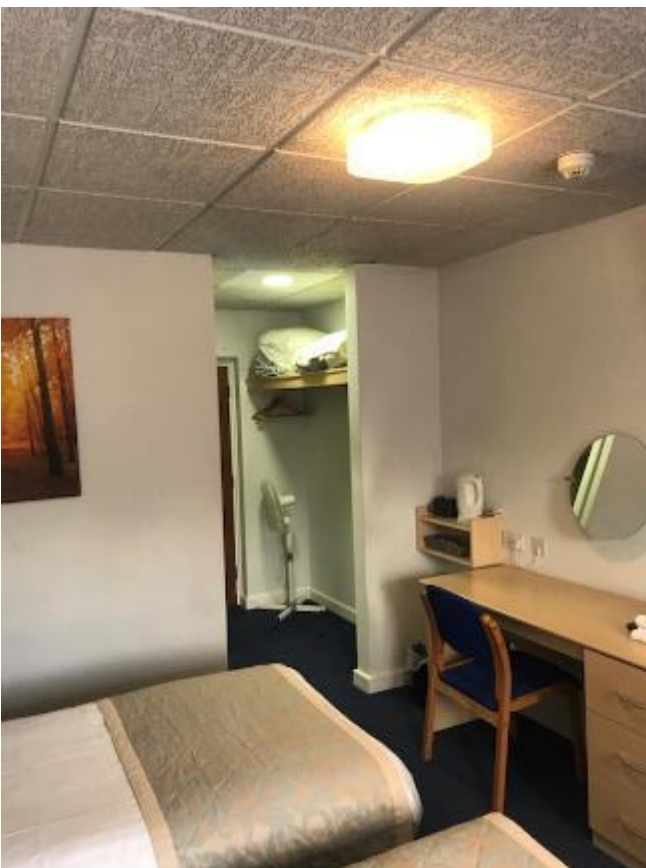
192. Typical bedroom in need of modernisation to meet customer standards.

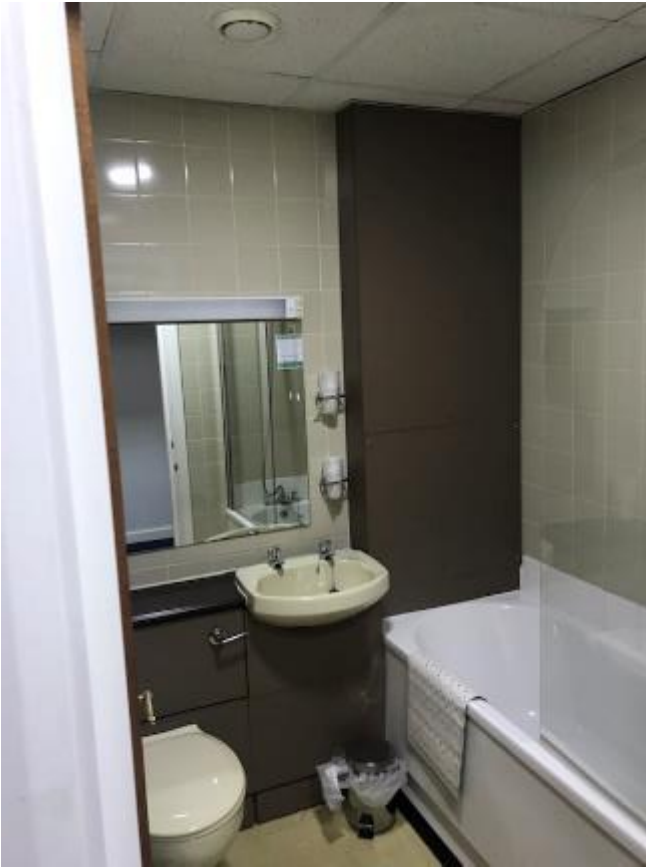
193. Typical en-suite bathroom in need of modernisation to meet Customer Standards.

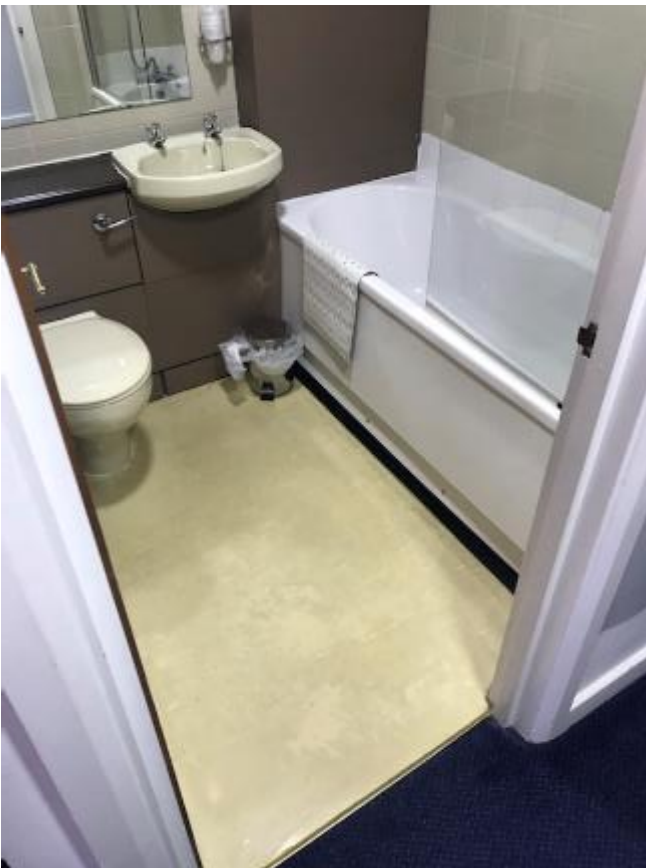
194. Typical en-suite bathroom in need of modernisation to meet Customer Standards.

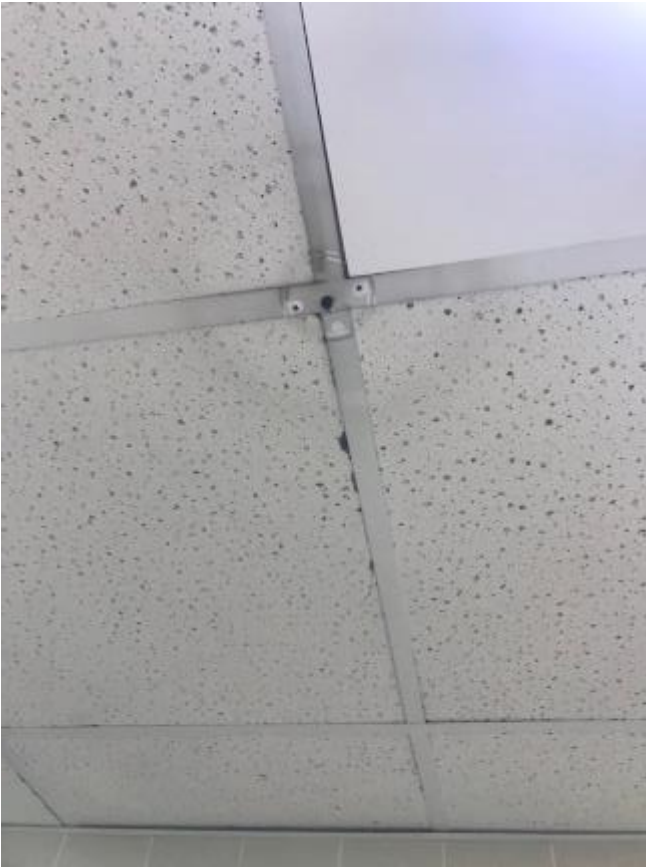
195. Soiled and non-matching ceiling tiles to bathroom.

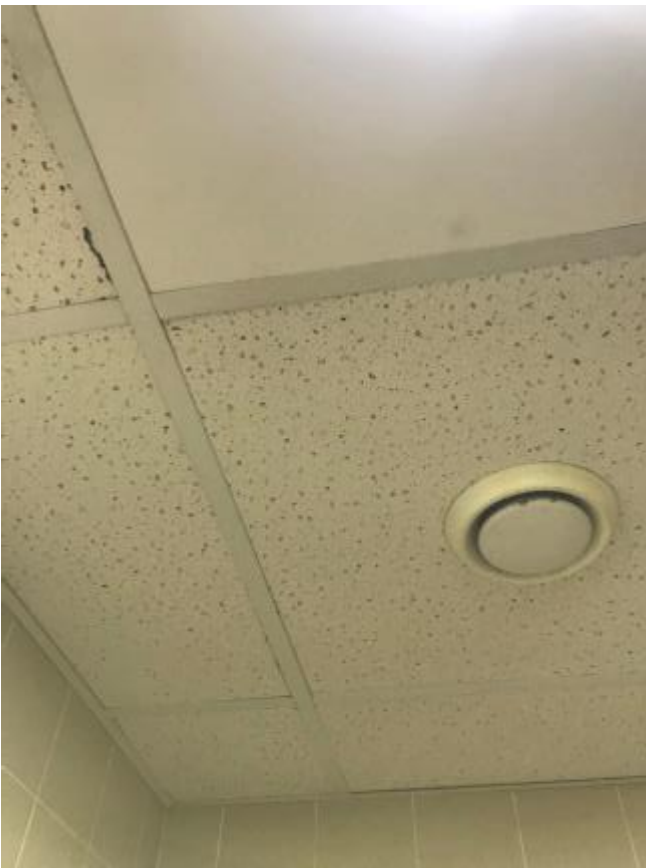
196. Soiled and non-matching ceiling tiles to bathroom.

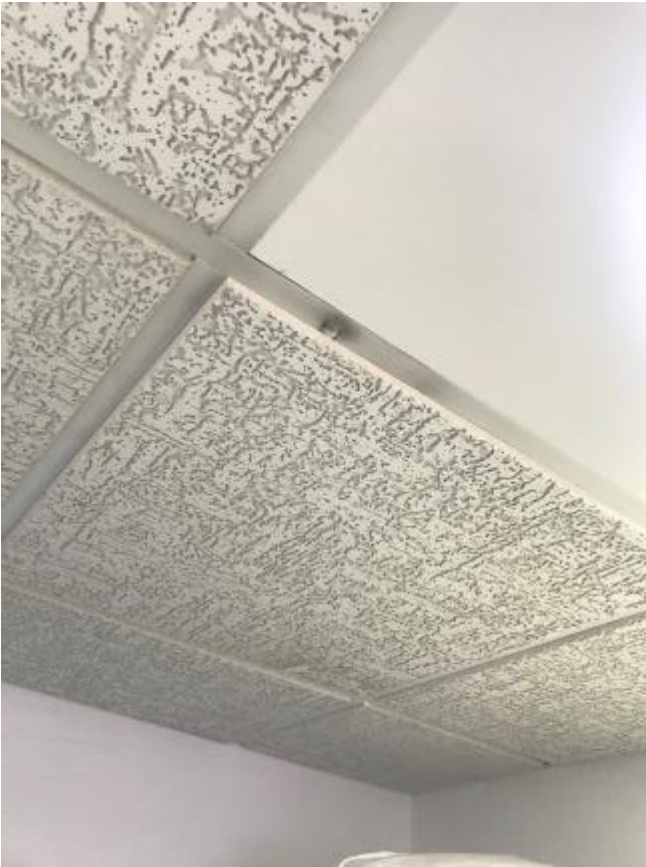
197. Example of dated and non-matching ceiling tiles in bedrooms (and common areas).

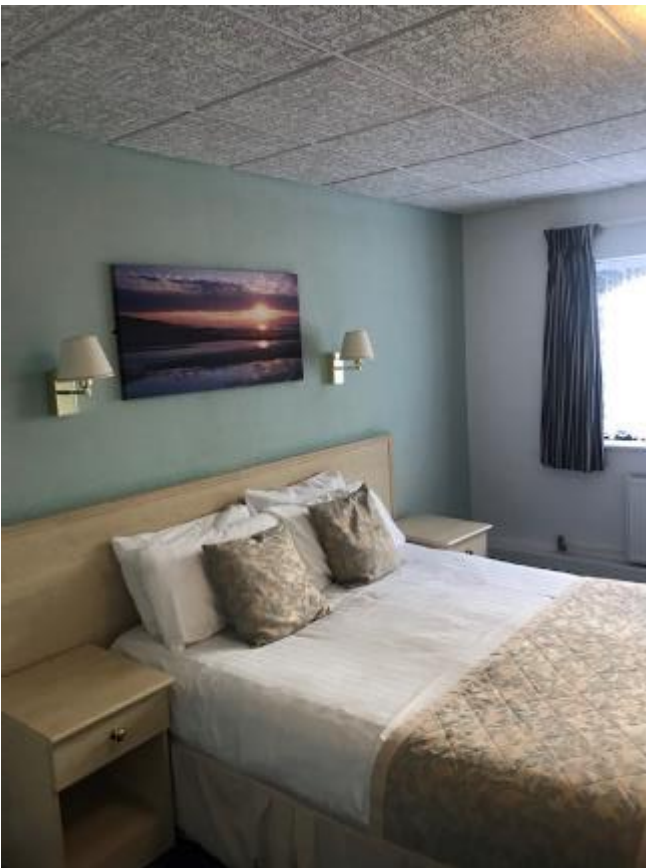
198. Second example of Bedroom in need of modernisation by Customer Standards.

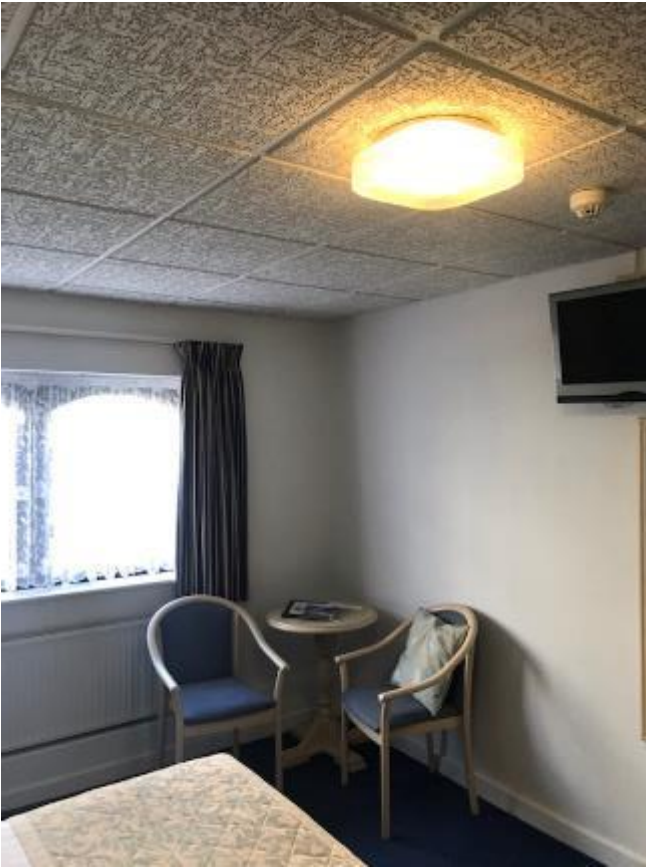
199. Second example of Bedroom in need of modernisation by Customer Standards.

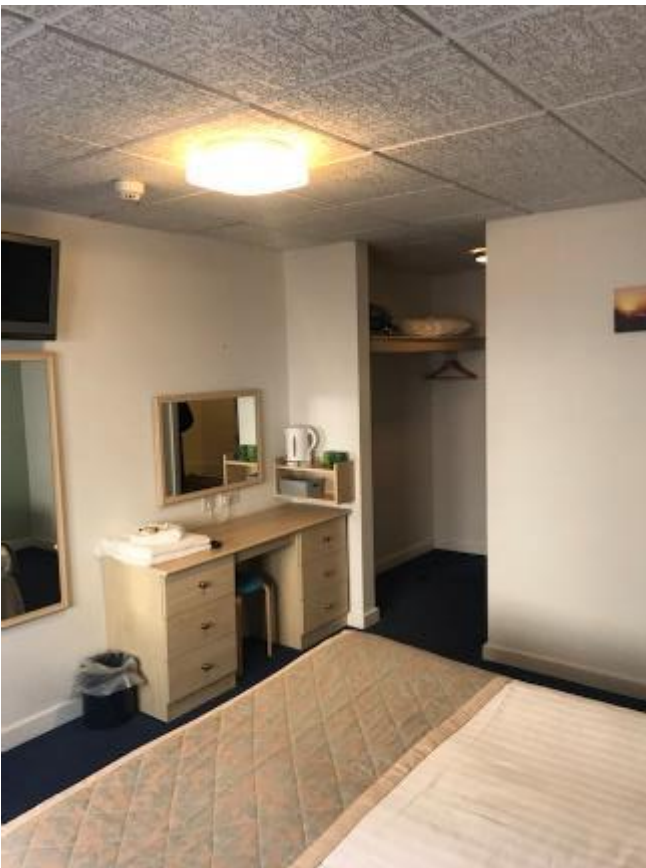
200. Second example of Bedroom in need of modernisation by Customer Standards.

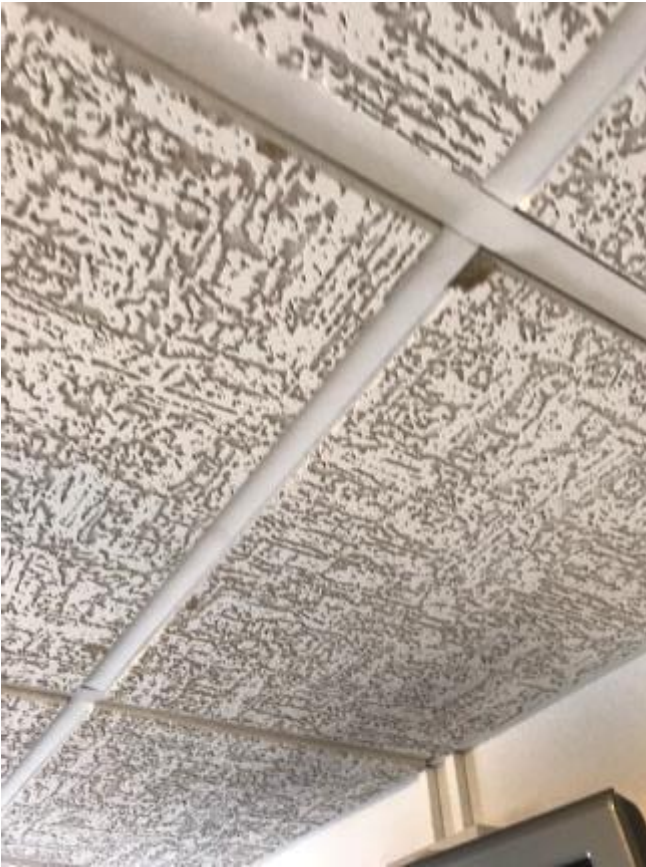
201. Close up of damaged and dated ceiling tiles.

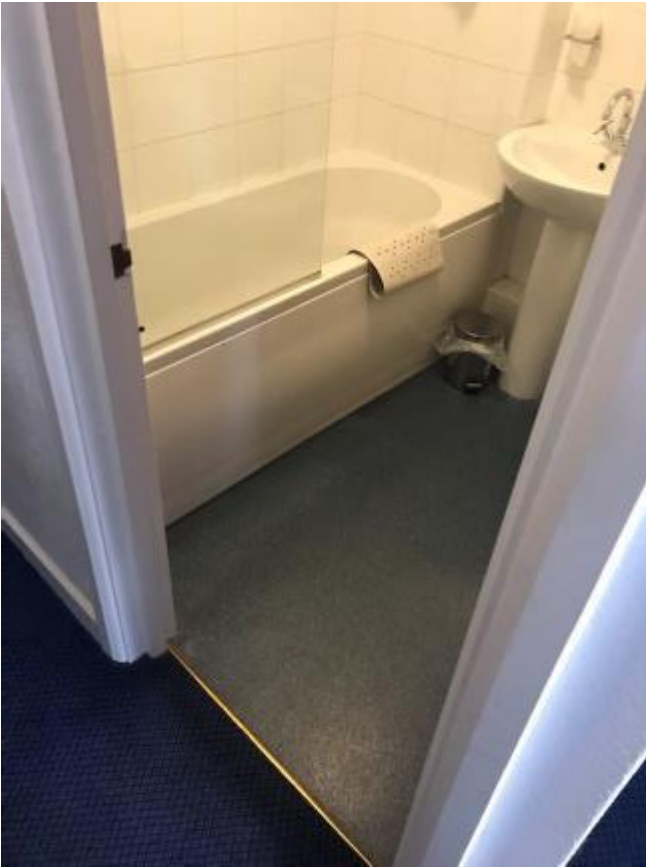
203. En-suite bathroom in need of modernisation by Customer Standards.

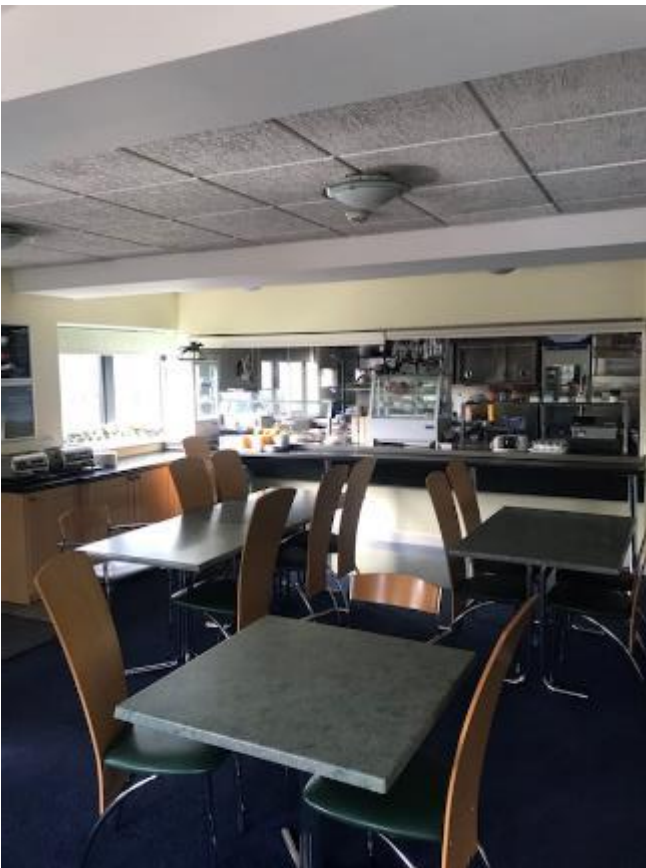
204. Sandown Lodge Dining Room/Stable Lads Canteen in need of modernisation.

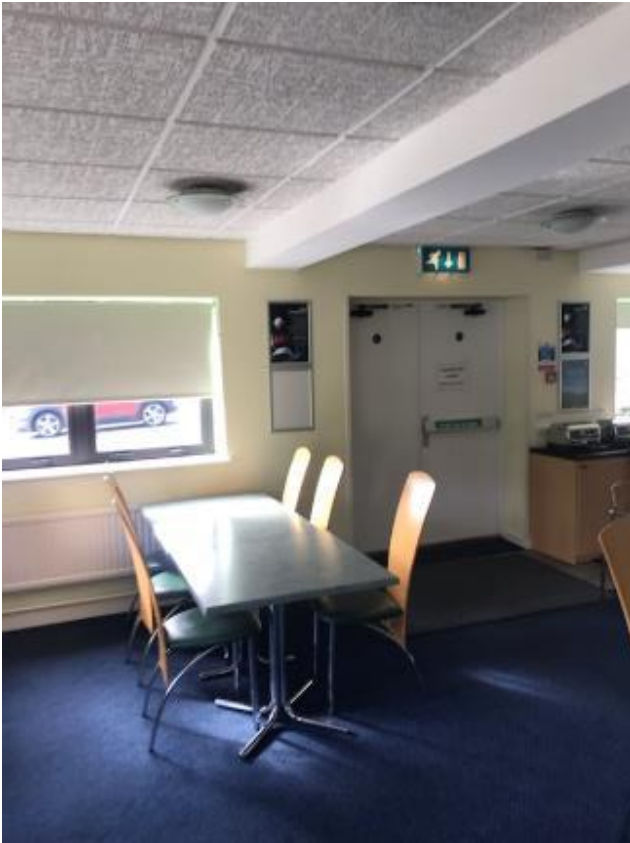
205. Sandown Lodge Dining Room/Stable Lads Canteen in need of modernisation.

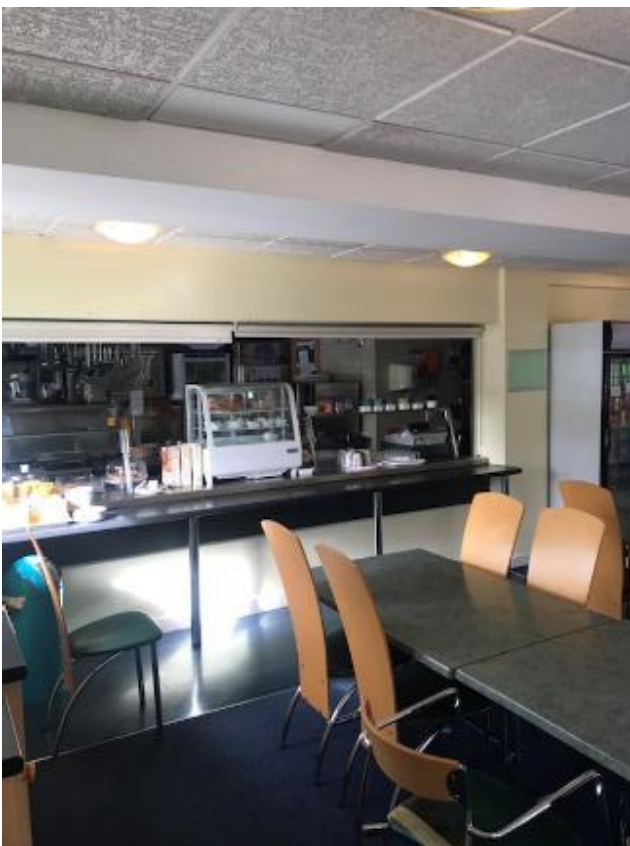
206. Sandown Lodge Dining Room/Stable Lads Canteen in need of modernisation. Note: dated and non-matching ceiling tiles.

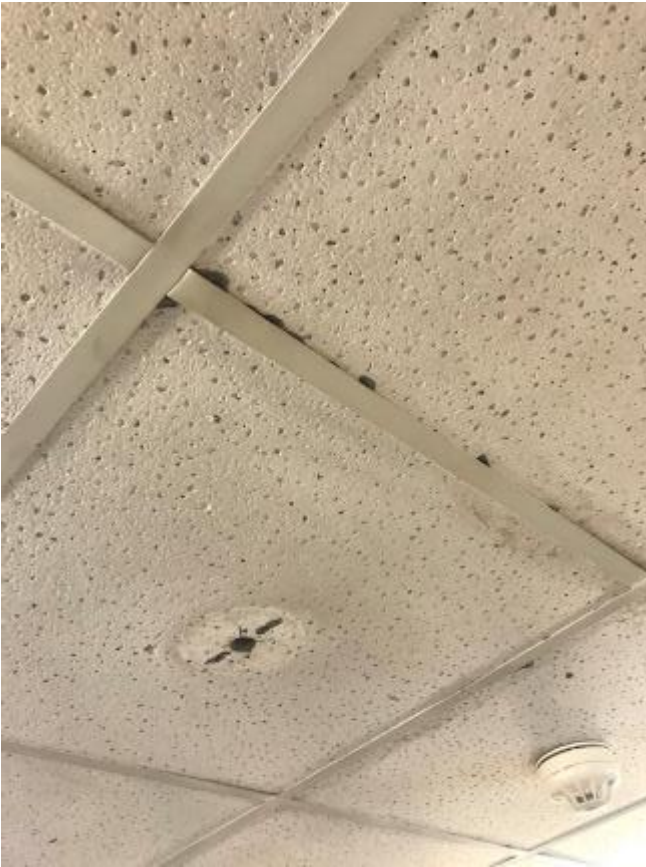
209. Close up of soiled and damaged ceiling tiles to kitchen.

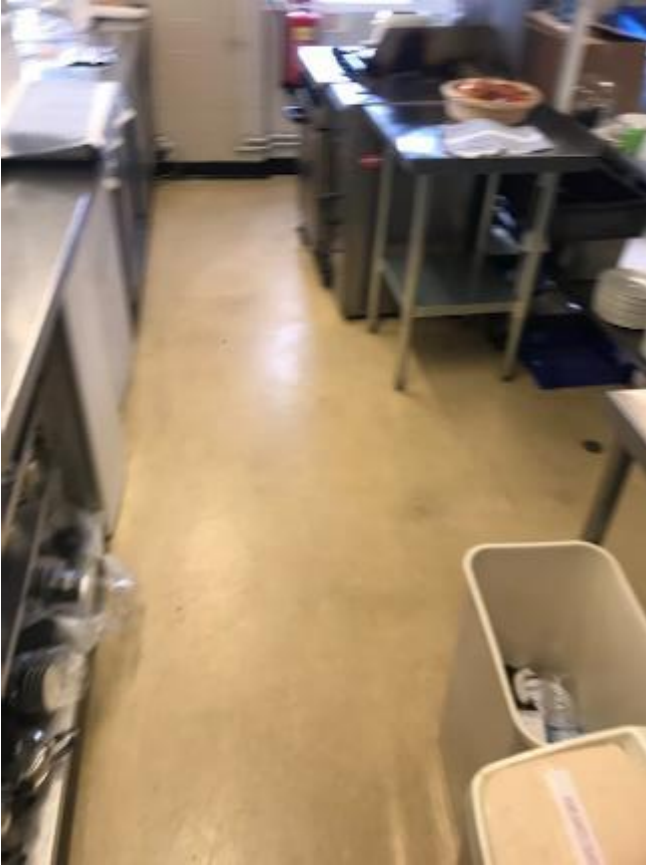
211. Vinyl floor covering in kitchen is marked and soiled.

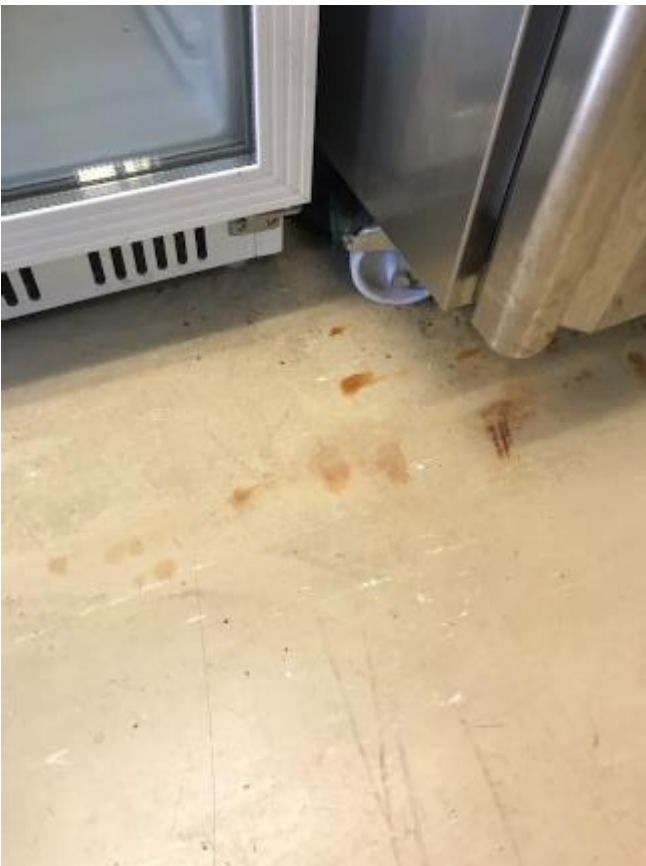
212. Vinyl floor covering in kitchen is marked and soiled.

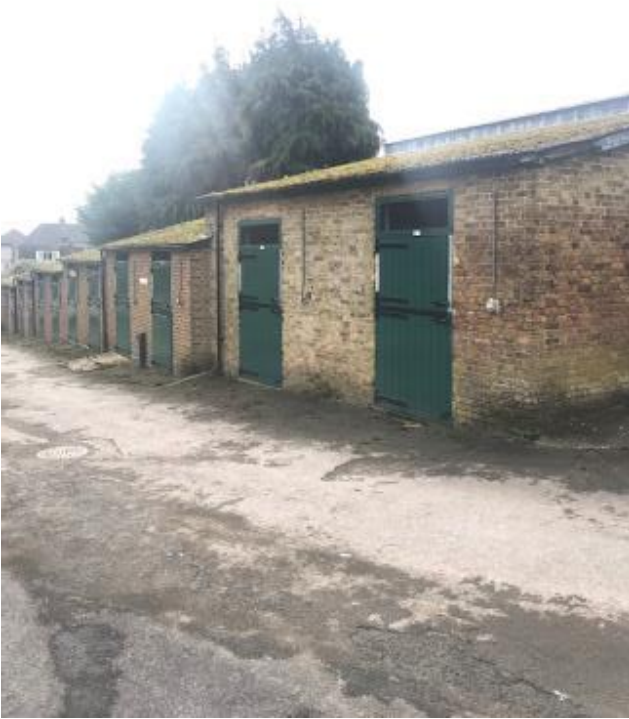
213. Stable Block 56-69. Note: substantial moss/vegetation cover to the brittle asbestos cement roofs.

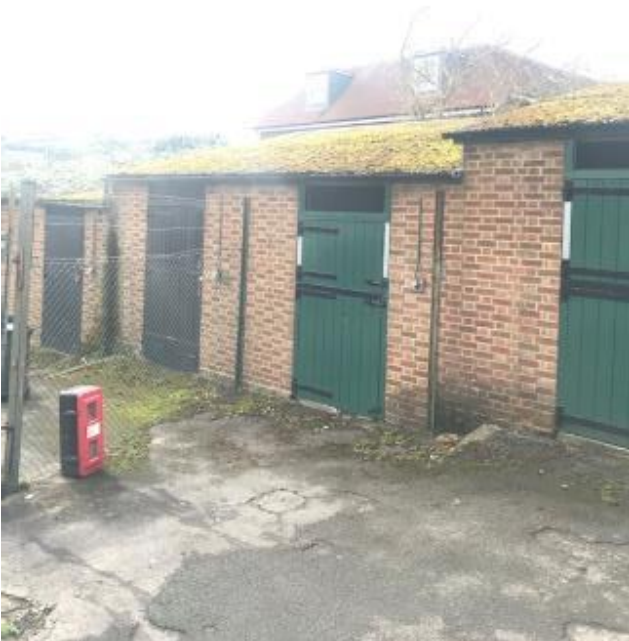
214. Stable Block 56-69. Note: substantial moss/vegetation cover to the brittle asbestos cement roofs.

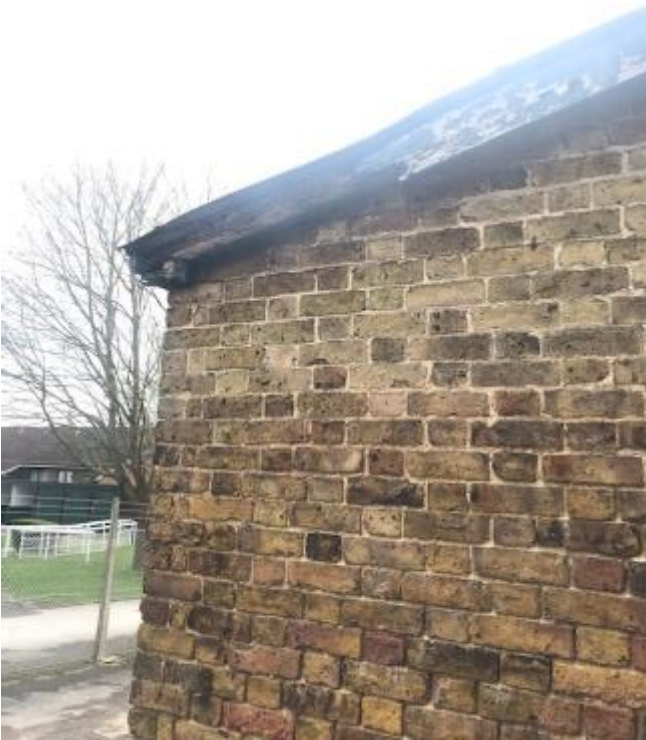
215. Barge boards and fascias are in poor decorative order with some wet rot/missing sections of timber.

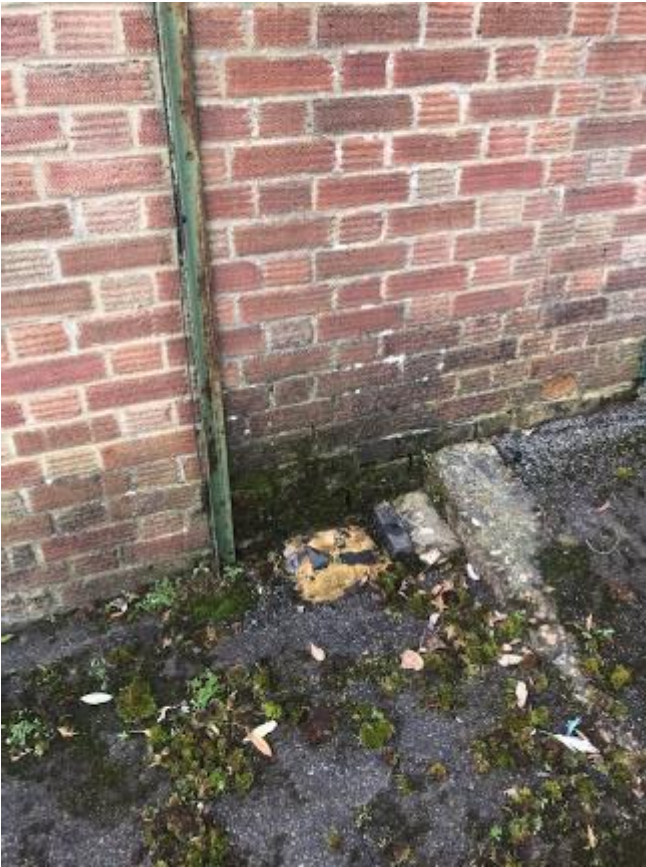
218. Defective rainwater goods are leaking and causing damp staining to the brickwork below.

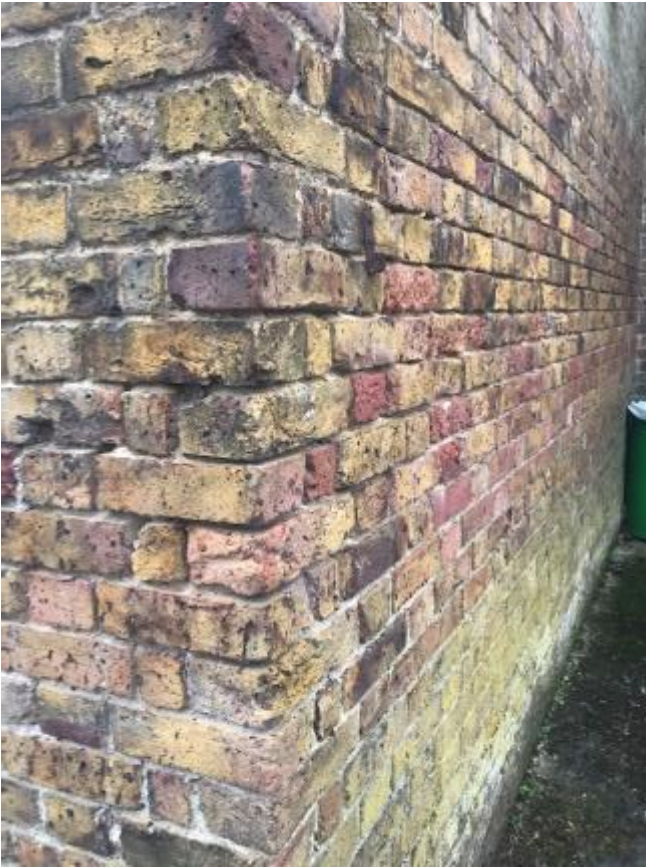
219. Mortar pointing to brickwork is perished in part, notably to the corner of stable 56.

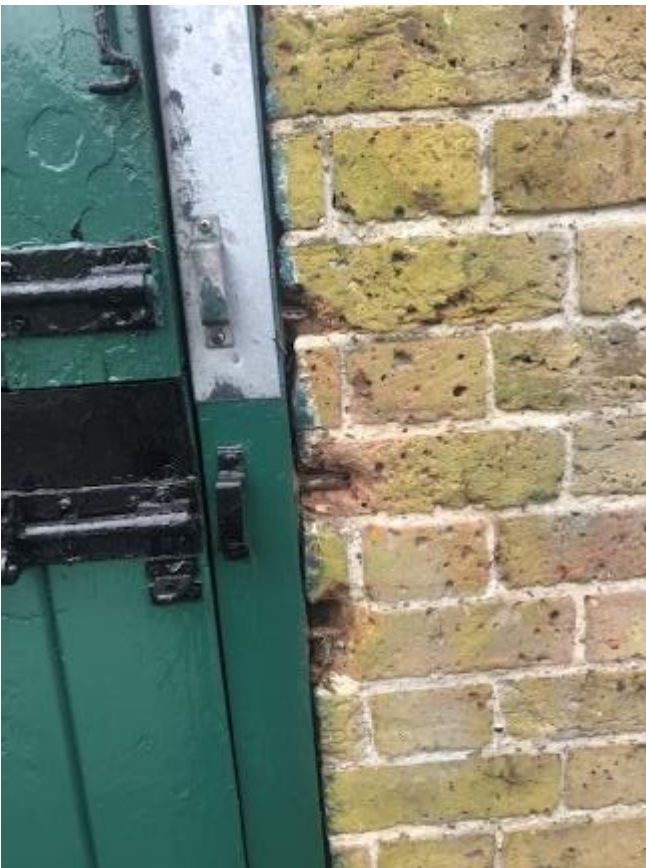
220. The brickwork is crumbling due to the weight of the doors and fixings for the door frames.

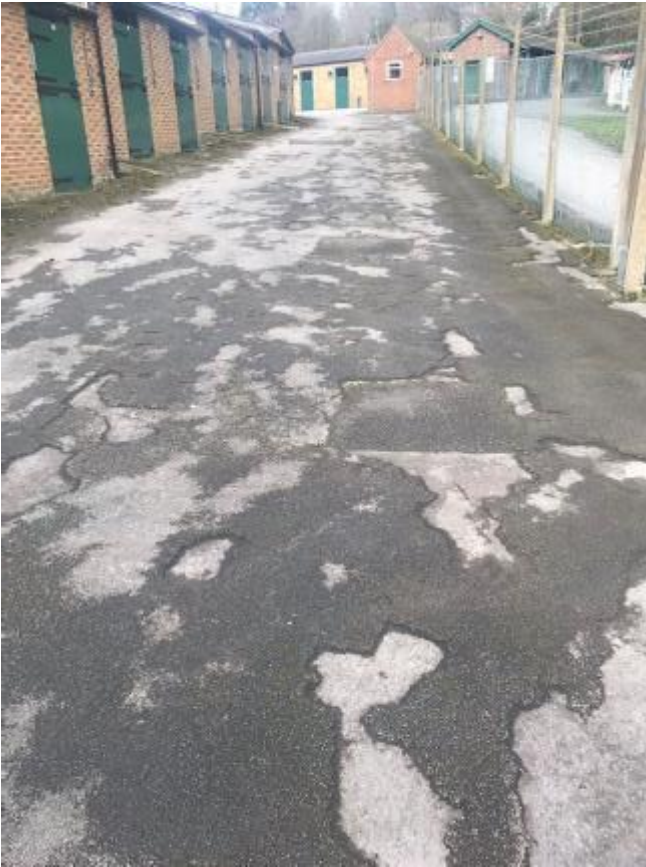
221. The yard surface is breaking up alongside stable block 56 – 69 and a trip hazard for horses and personnel alike.

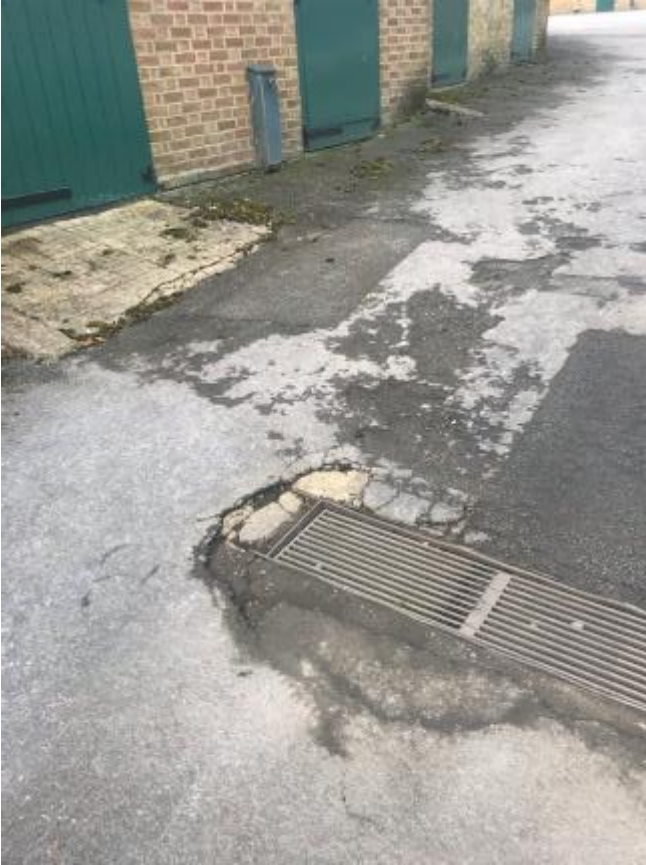
223. The yard surface is breaking up alongside stable block 56 – 69 and a trip hazard for horses and personnel alike.

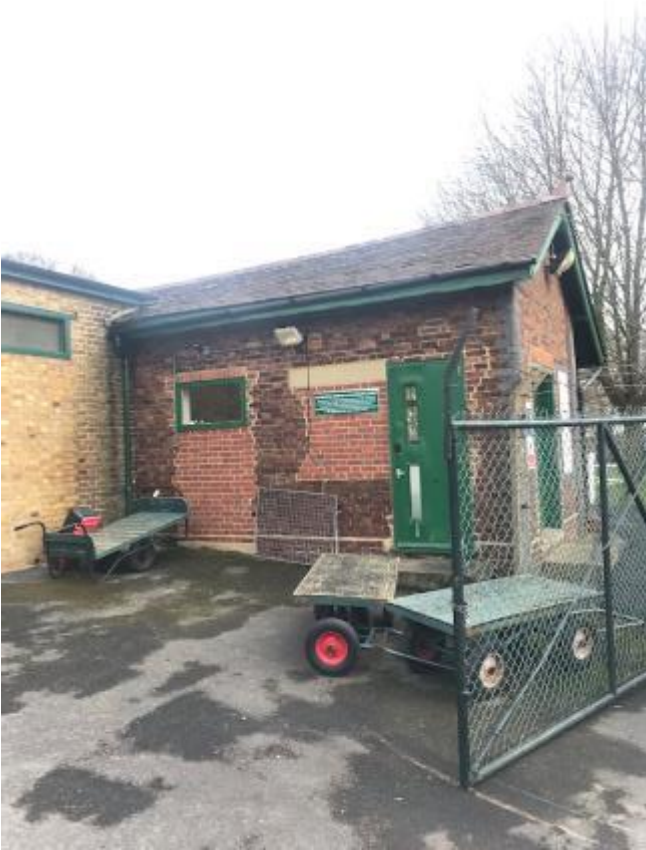
225. Patch repaired and cracked brickwork to Stable Managers Office.

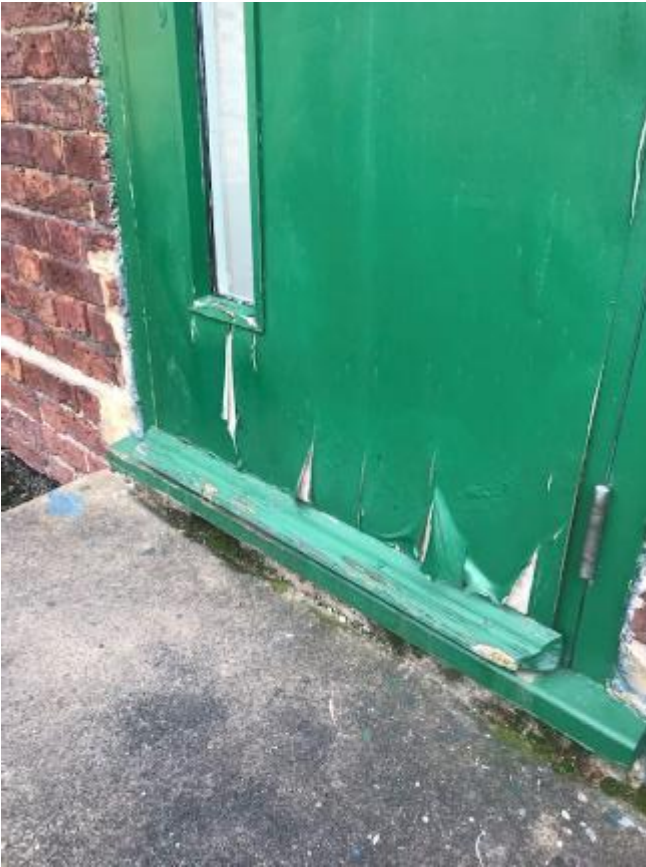
227. Decorations required to joinery.

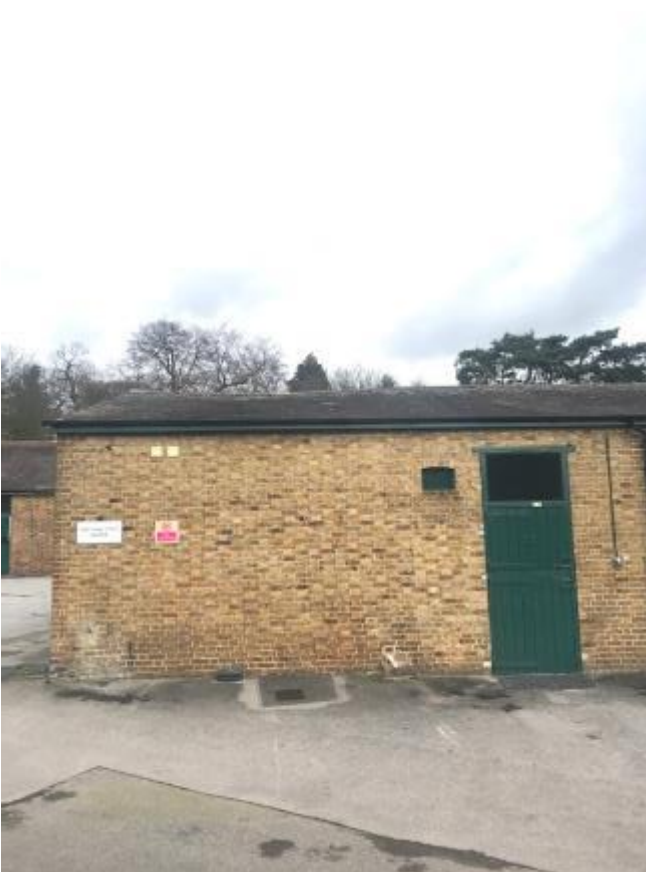
228. Slate roof over stable 72 is sagging.

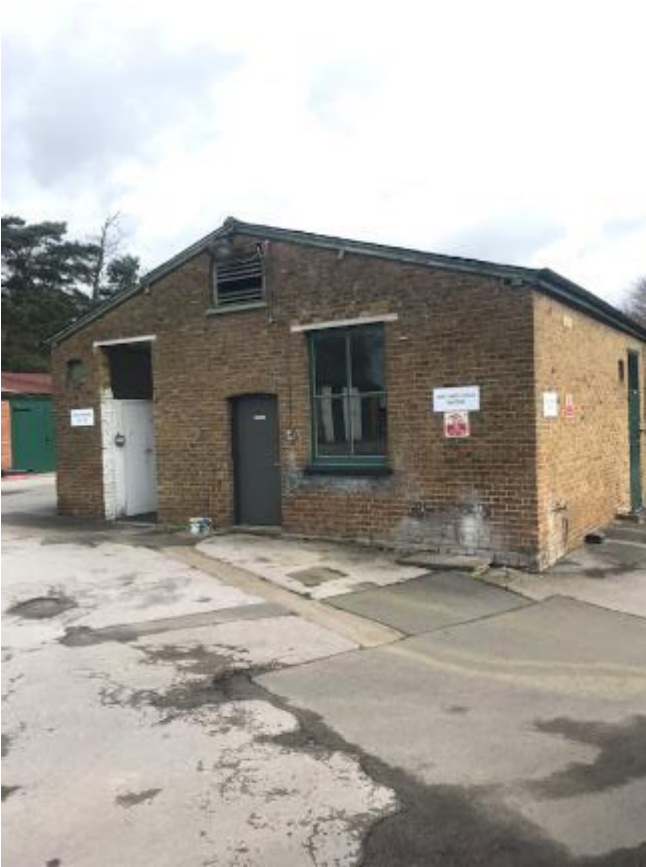
229. Decorations and brickwork to the gable elevation of stable 72 are in poor condition.

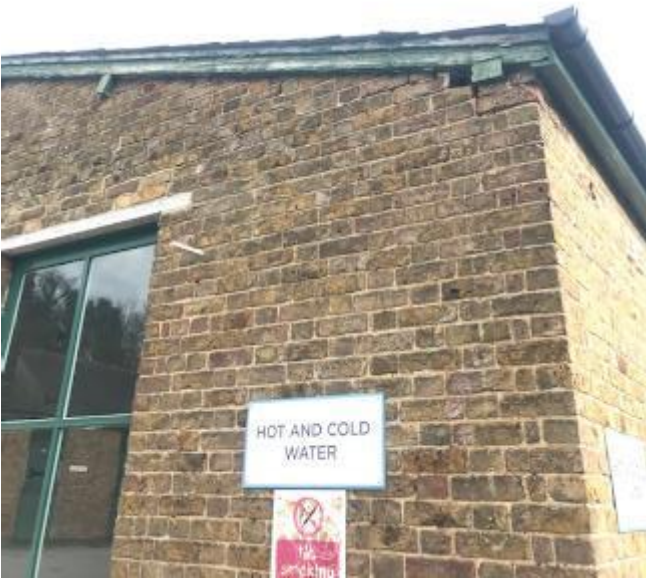
231. Decorations and brickwork to the gable elevation of stable 72 are in poor condition.

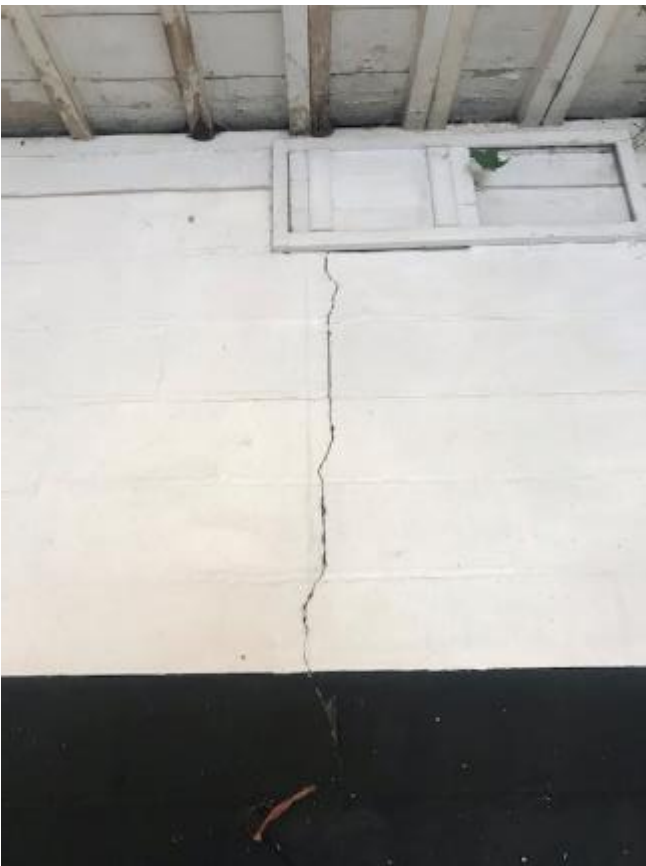
232. Cracking to rear wall of stable 50.

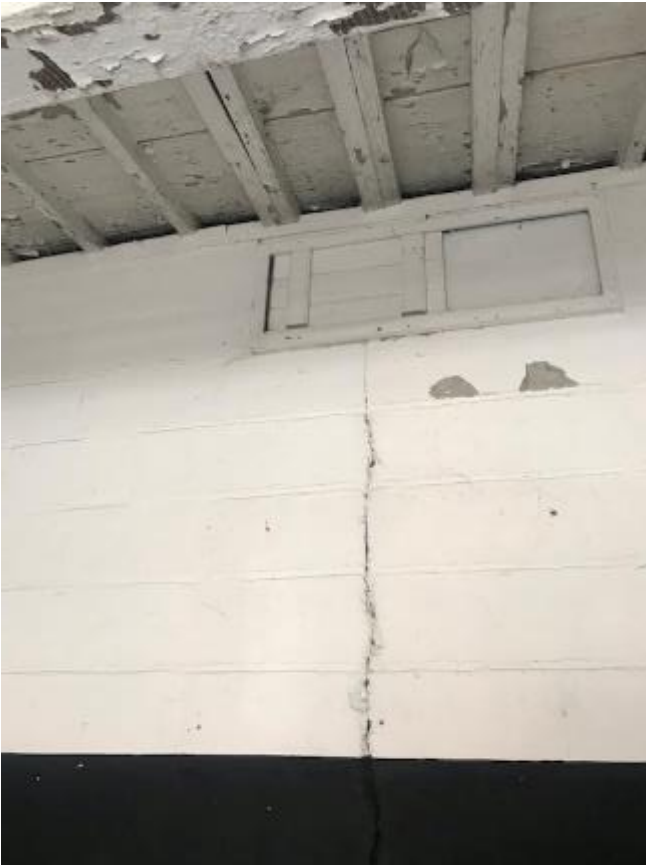
233. Cracking to rear wall of stable 46.

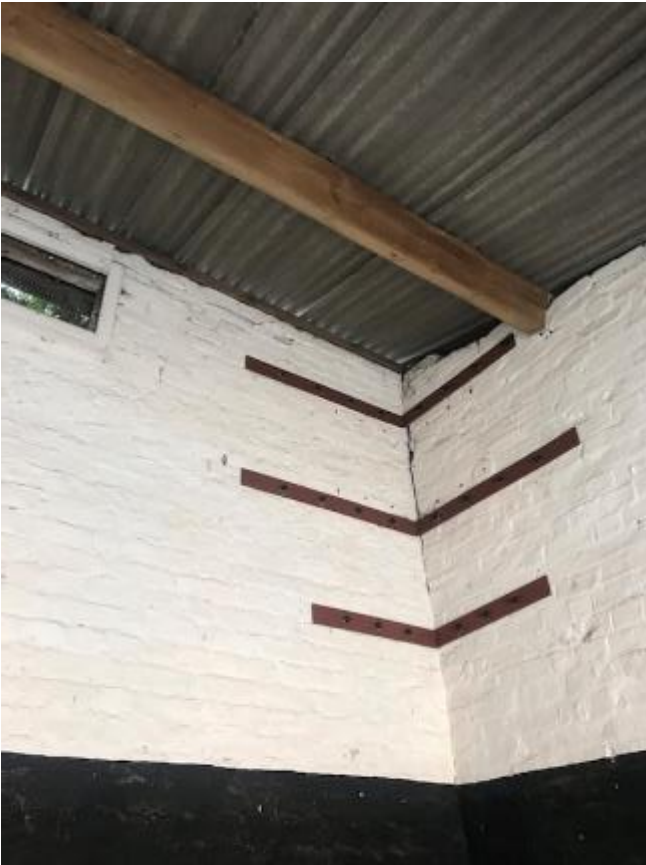
235. Metal strapping applied to restrain rear and side wall of stables 39-42.

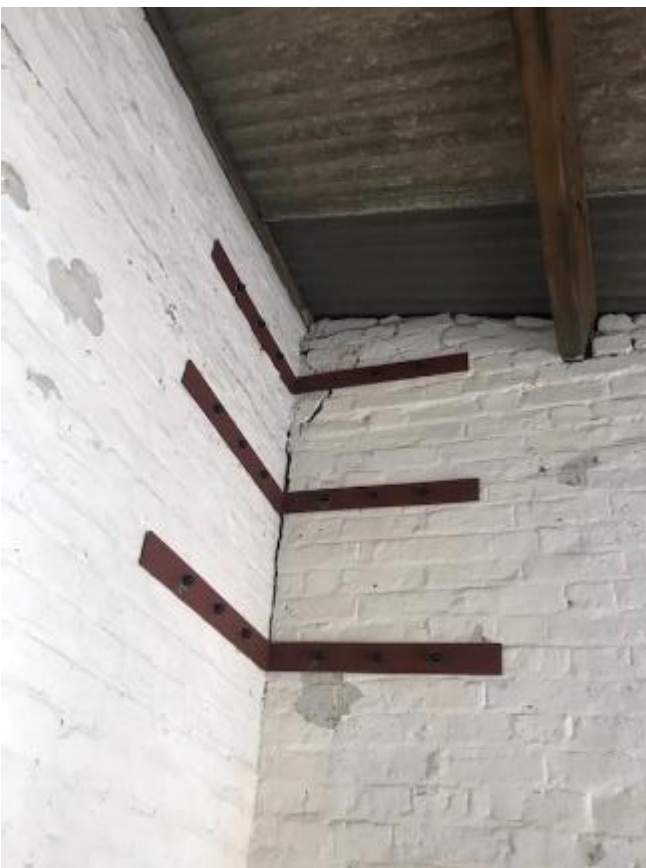
236. Metal strapping applied to restrain rear and side wall of stables 39-42.

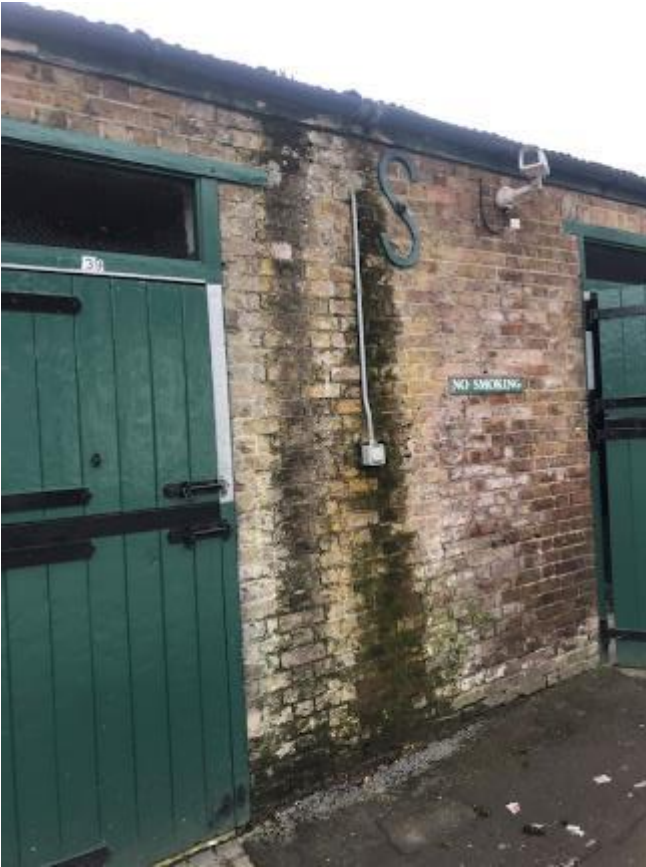
237. Leaking gutter, rotten fascia, damp and perished brickwork between stables 38 and 39.

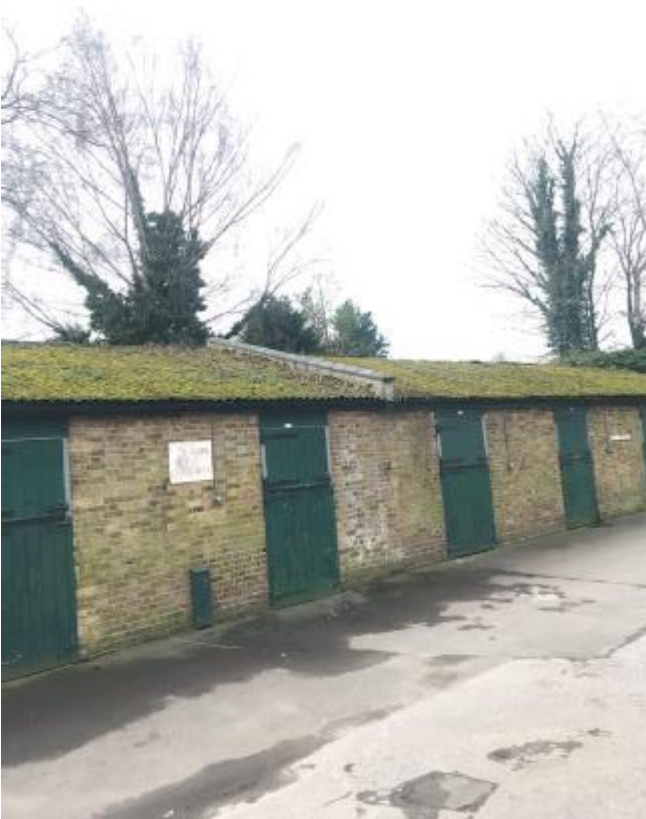
238. Substantial moss cover to brittle asbestos cement stable roofs.
