BUILDING CONDITION REPORT 2020, INCLUDING M&E CONDITION SURVEY

Summary Building Condition Report for
Jockey Club Racecourses Limited

SANDOWN PARK RACECOURSE
PORTSMOUTH ROAD
ESHER
SURREY
KT10 9AJ

March 2020

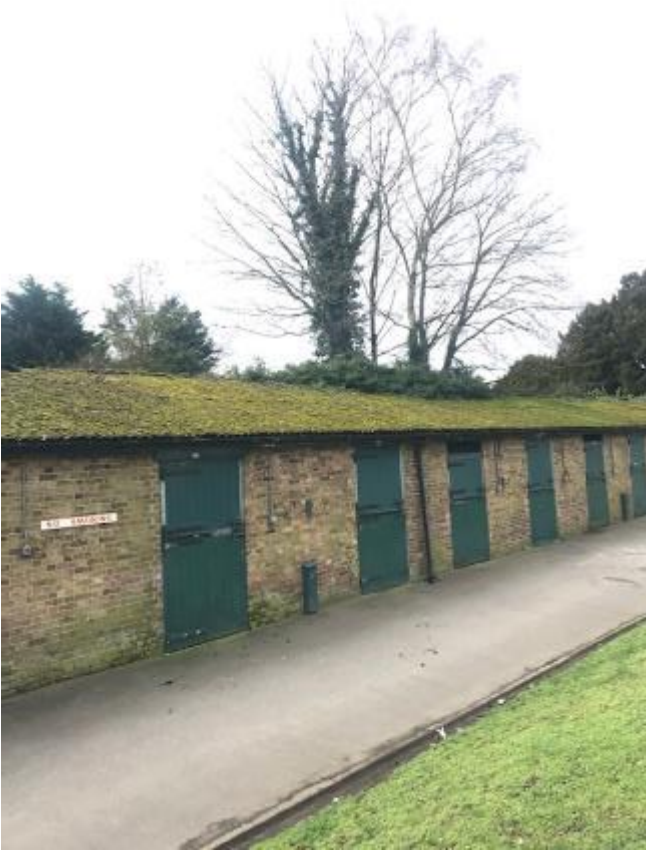
239. Substantial moss cover to brittle asbestos cement stable roofs.

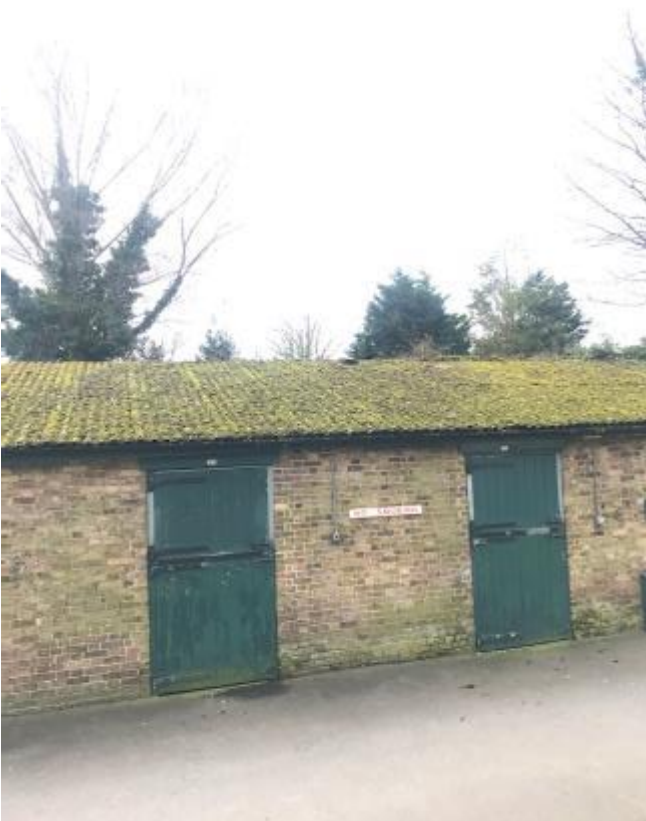
240. Substantial moss cover to brittle asbestos cement stable roofs.

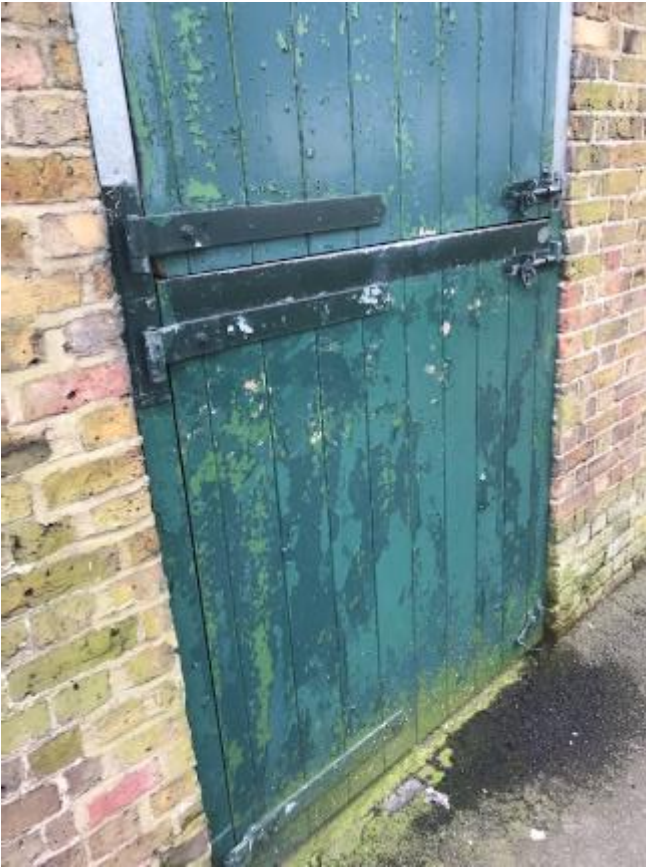
241. Close up of typical example of poor condition of decorations to the majority of the stable doors.

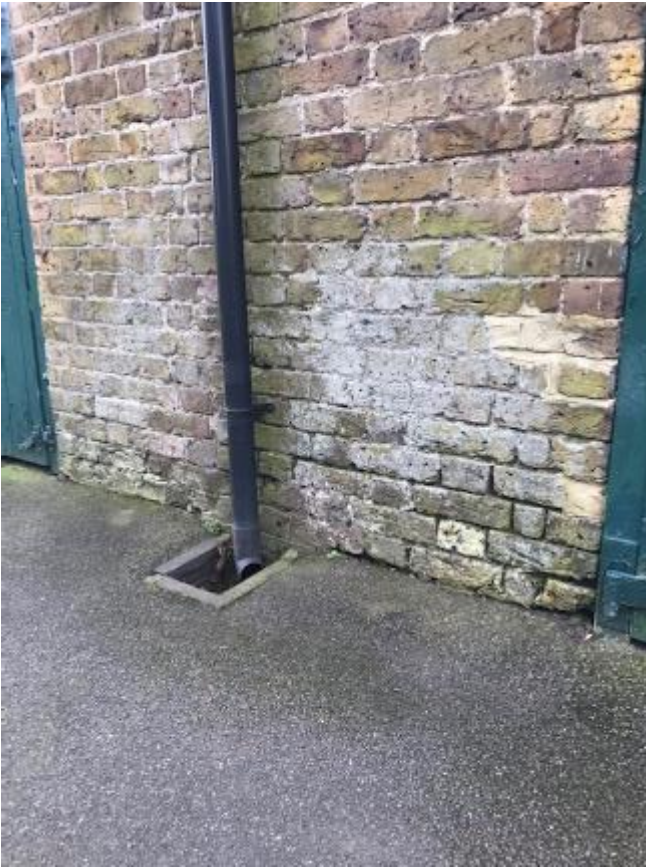
243. Close up of typical example of perished mortar to low level brickwork.

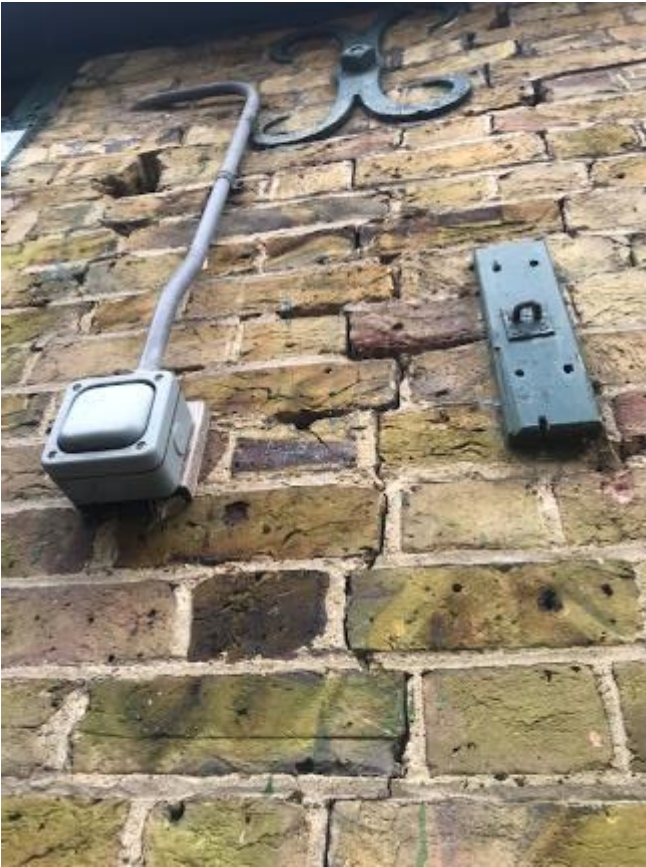
245. Cracked and damaged brickwork to front wall of stable 19.

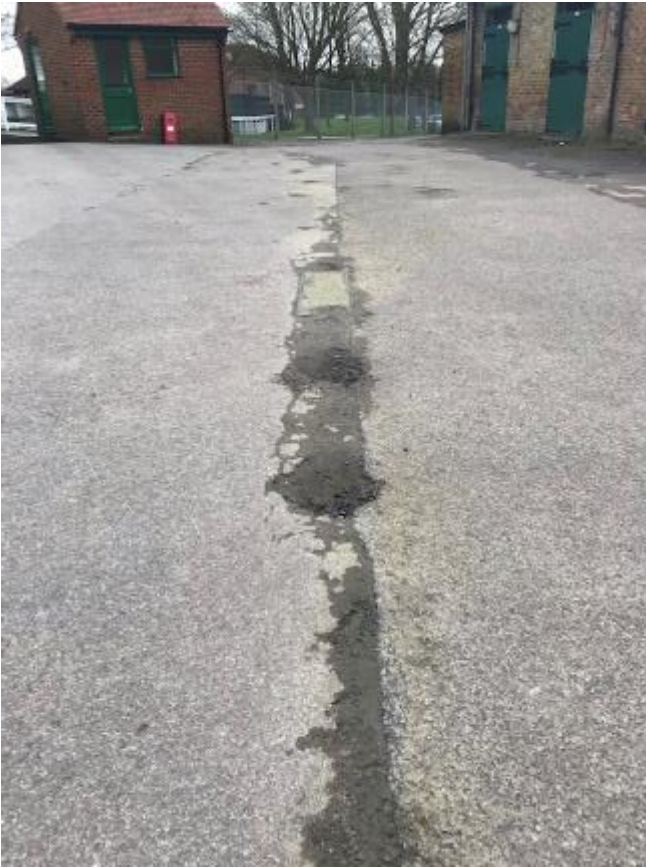
247. Pot holes in yard surface to area between stables 72 and 48.

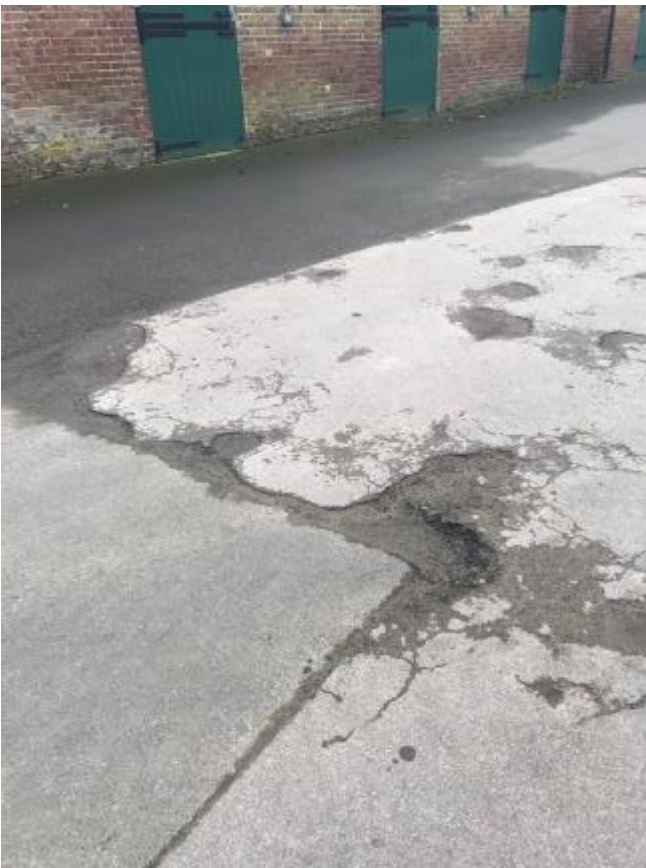
248. Pot holes in yard surface to area between stables 72 and 48.

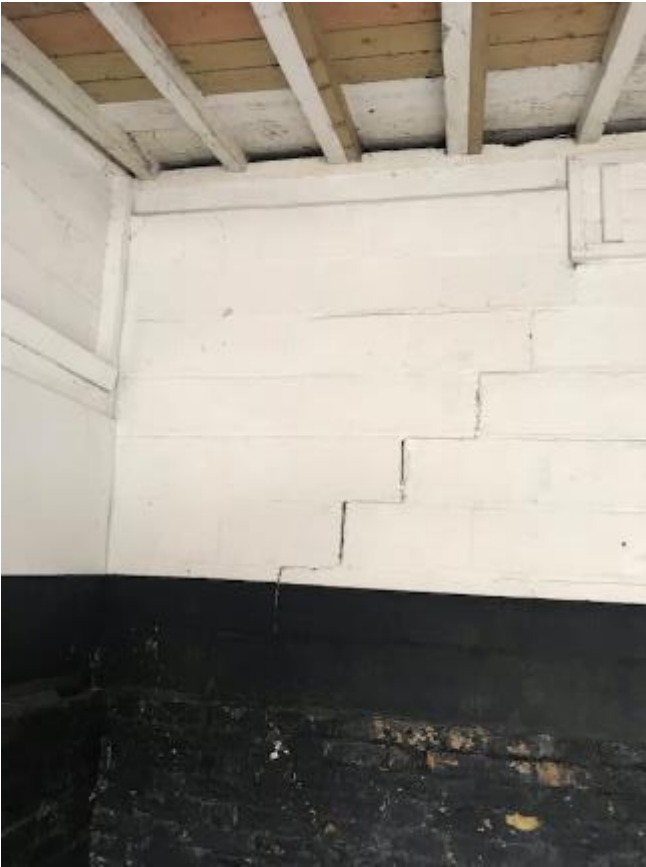
249. Stepped cracking to rear wall of stable 48.

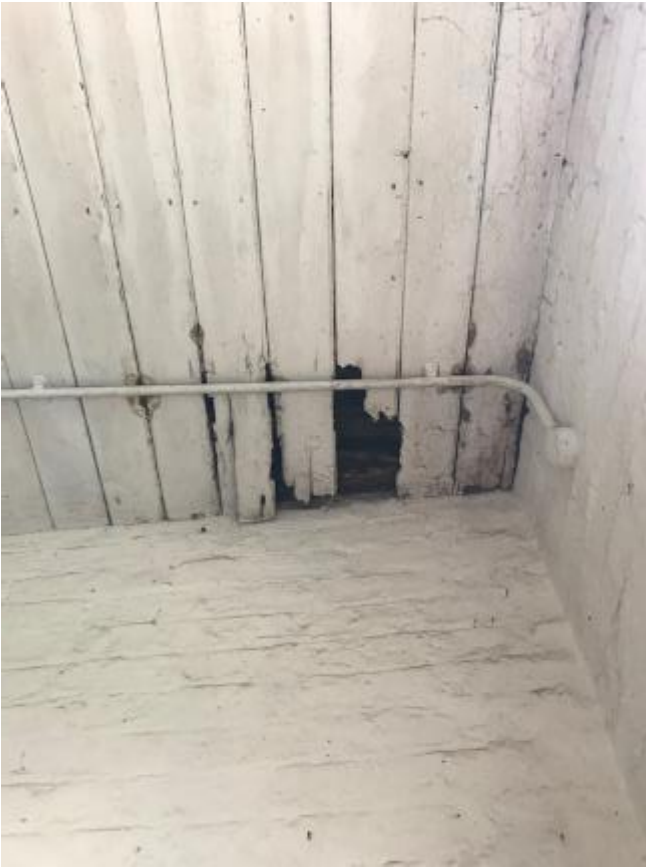
251. Lining soffit is rotten in part to stable 57.

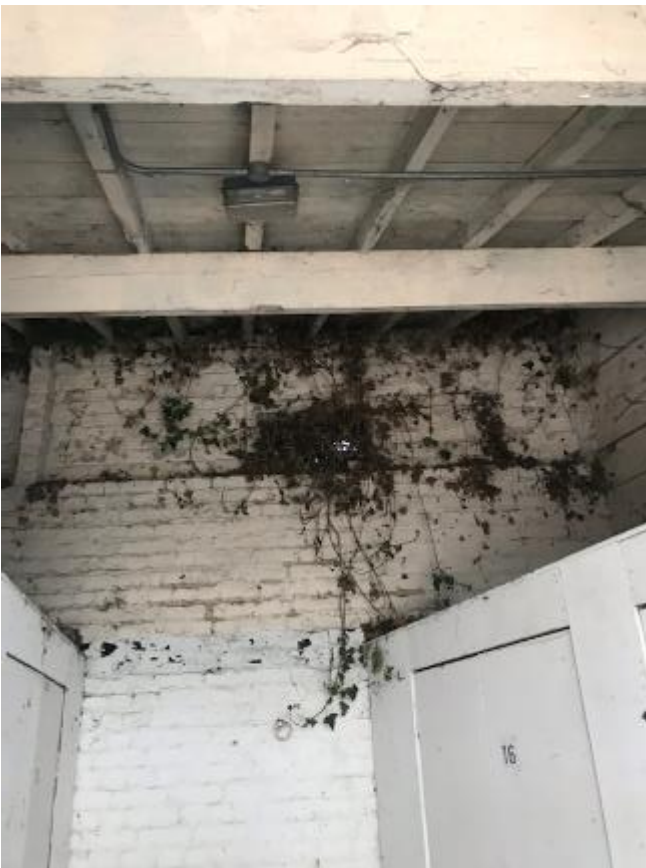
252. Vegetation growth through eaves and onto rear wall of Tack Boxes 13-18.

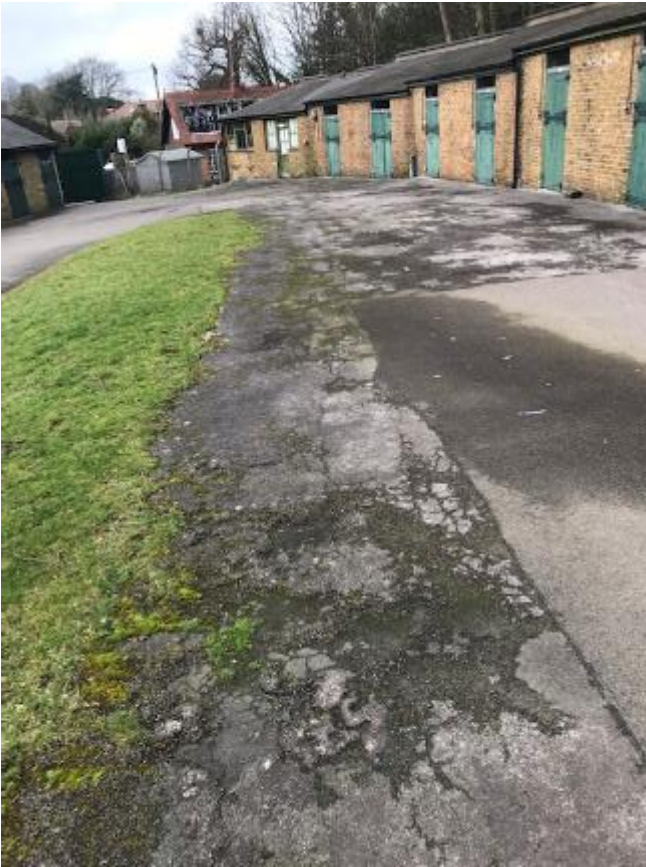
253. Yard surface is breaking up adjacent to stables 104-110.

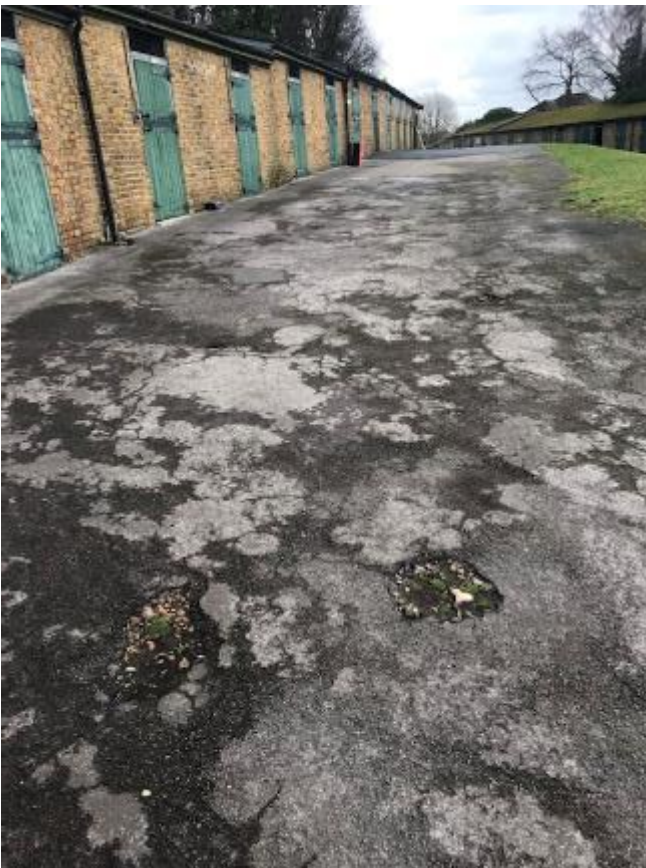
254. Yard surface is breaking up adjacent to stables 104-110.

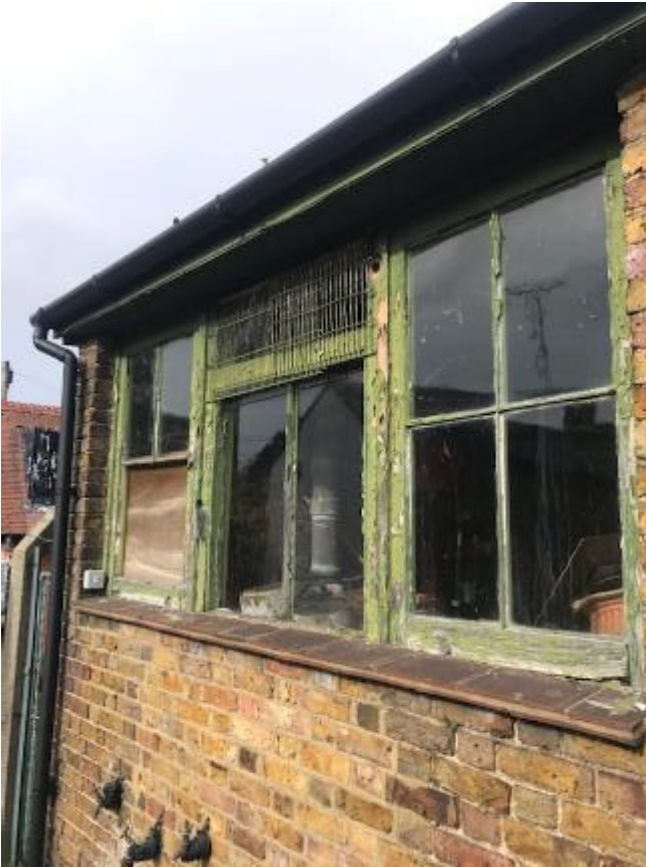
255. Rotten windows to Stable Stores.

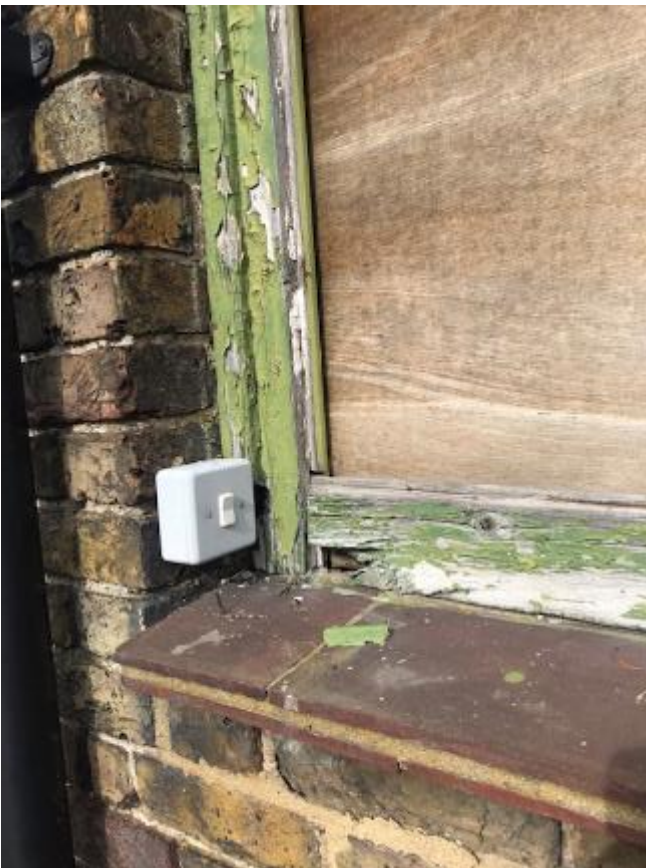
256. Rotten windows to Stable Stores.

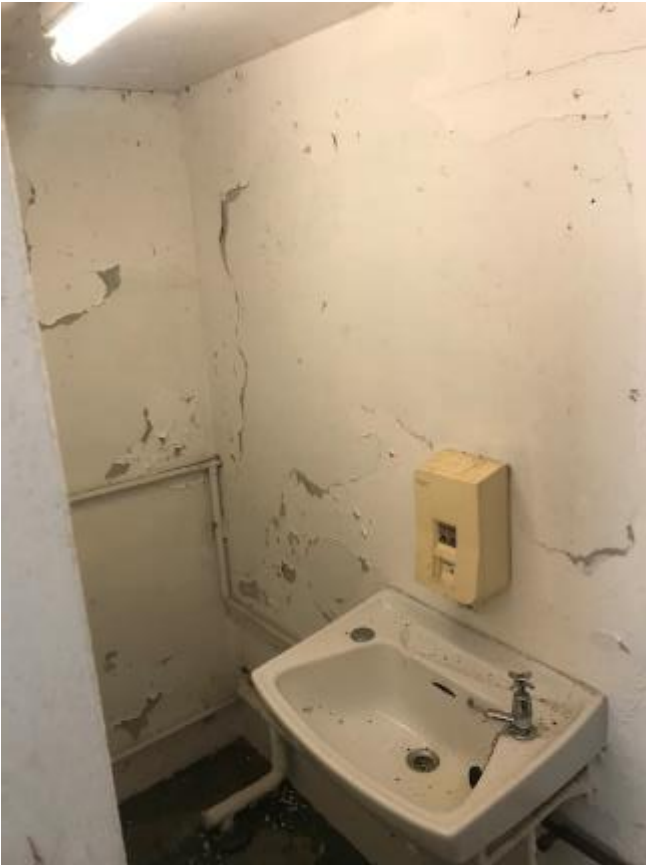
257. Damp walls and peeling paintwork to Stable Toilet.

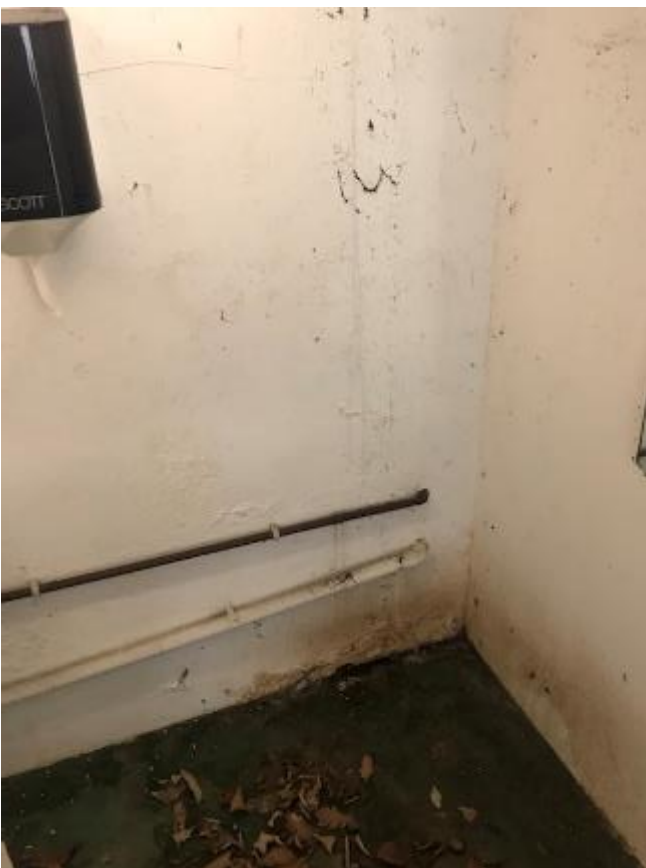
258. Damp walls and peeling paintwork to Stable Toilet.

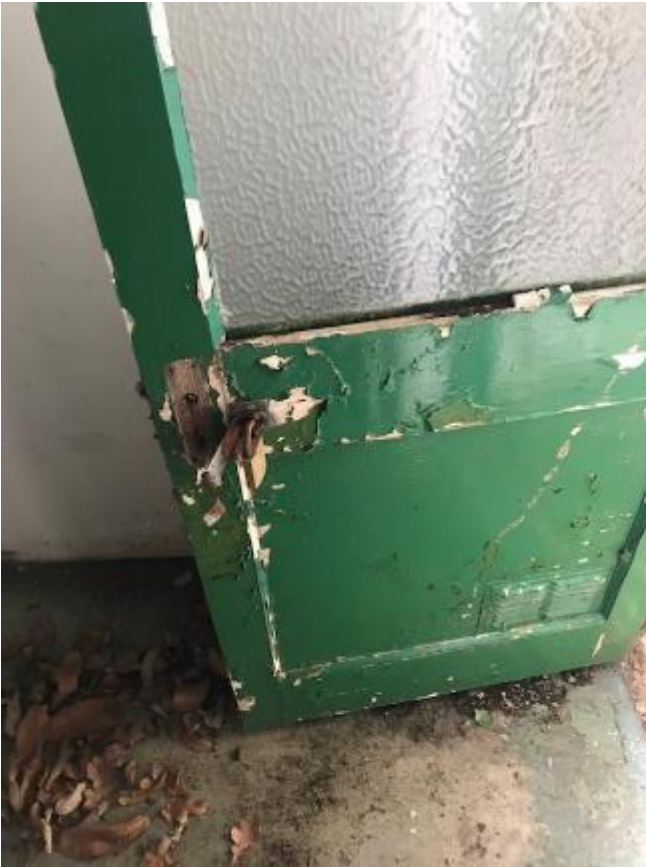
259. Rotten door to Stable Toilet.

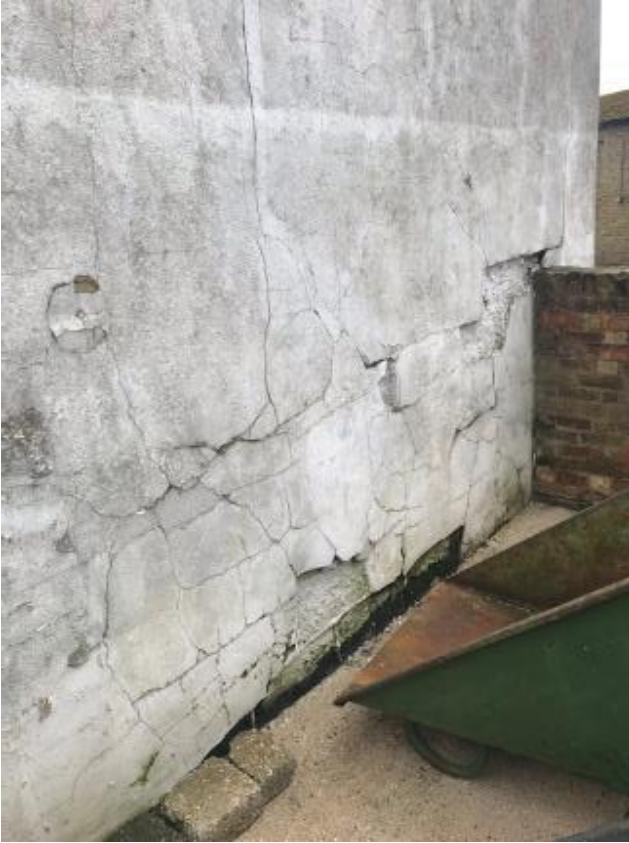
261. Cracked and blown render to gable elevation of Tack Boxes 7-12.

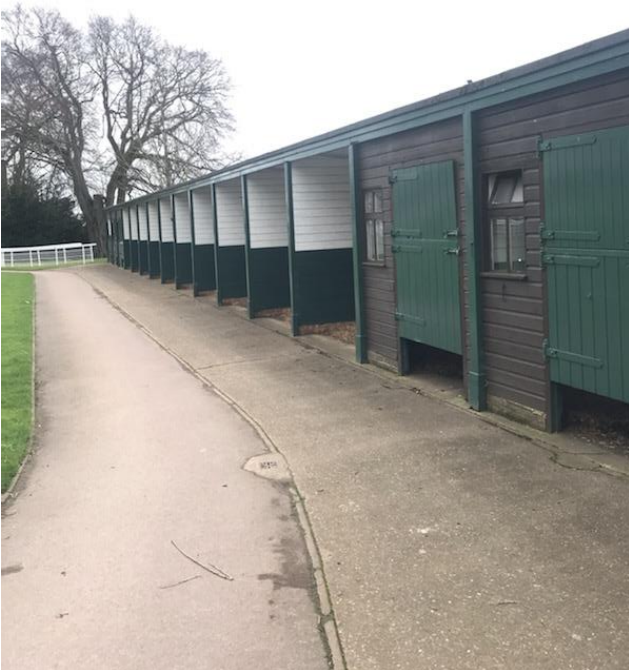
262. Front view of saddling boxes which appear in reasonable condition.

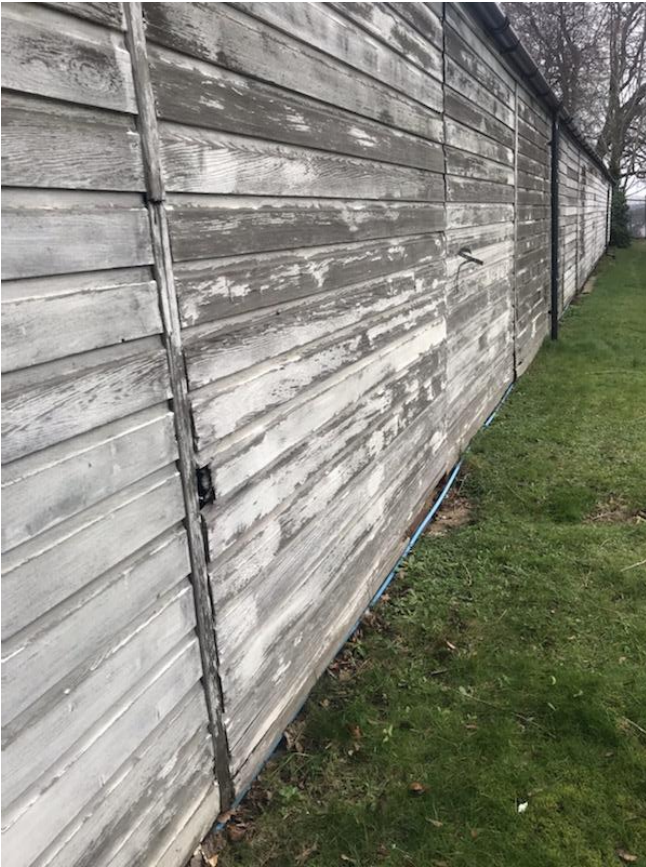
263. Rear elevation of saddling boxes in poor decorative order with some wet rot to the timber cladding.

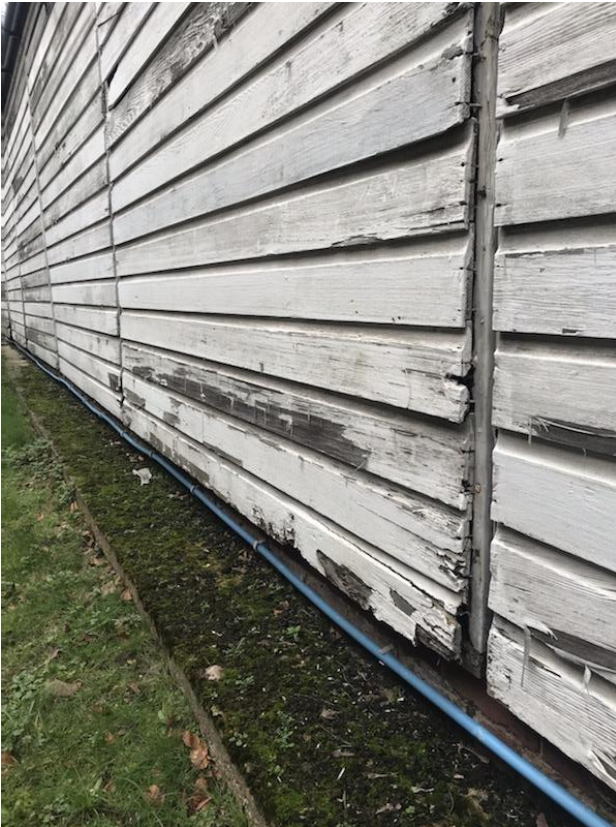
265. Rear elevation of saddling boxes in poor decorative order with some wet rot to the timber cladding.

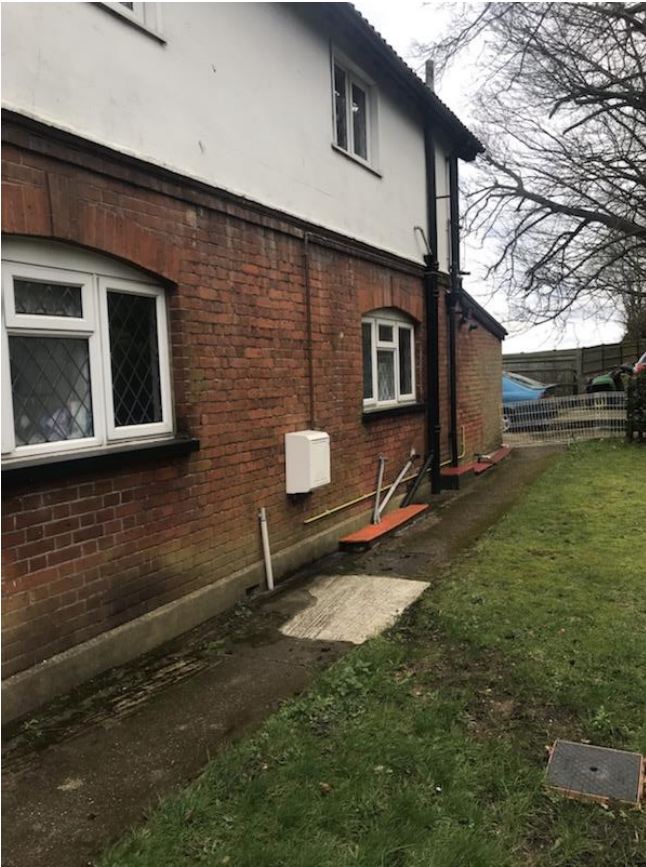
267. Damp stained and patch repointed external brickwork.

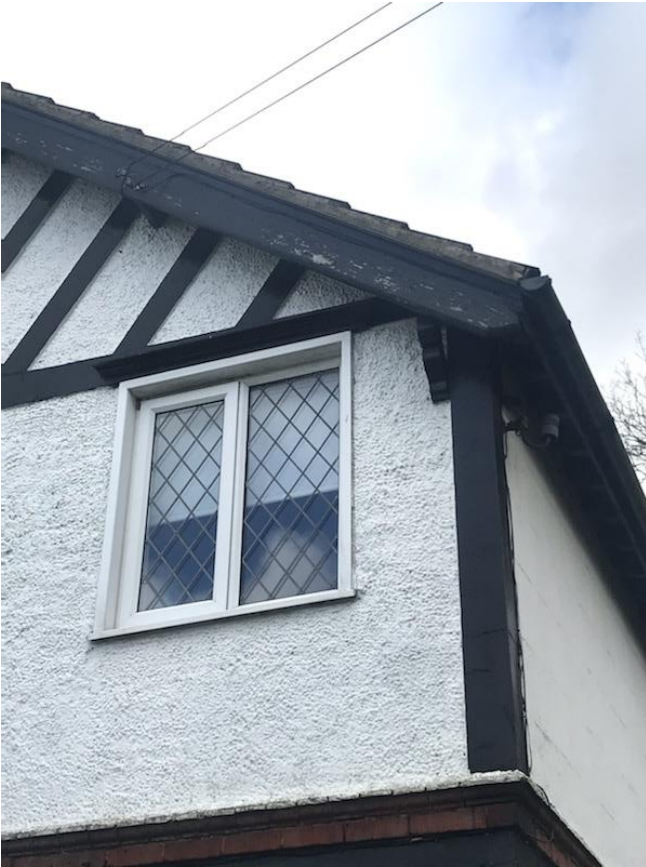
269. Peeling decorations to fascia/barge boards.

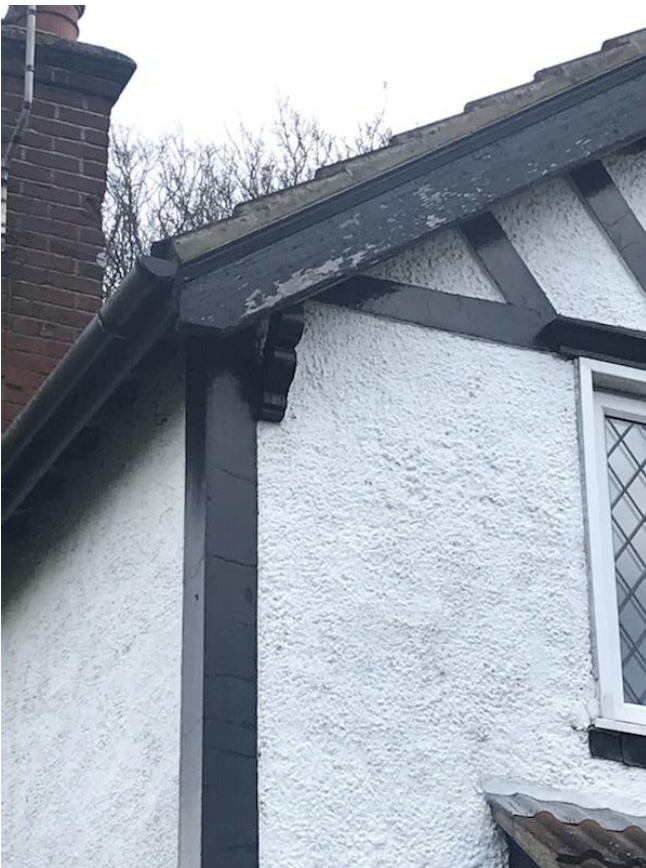
270. Peeling decorations to fascia/barge boards.

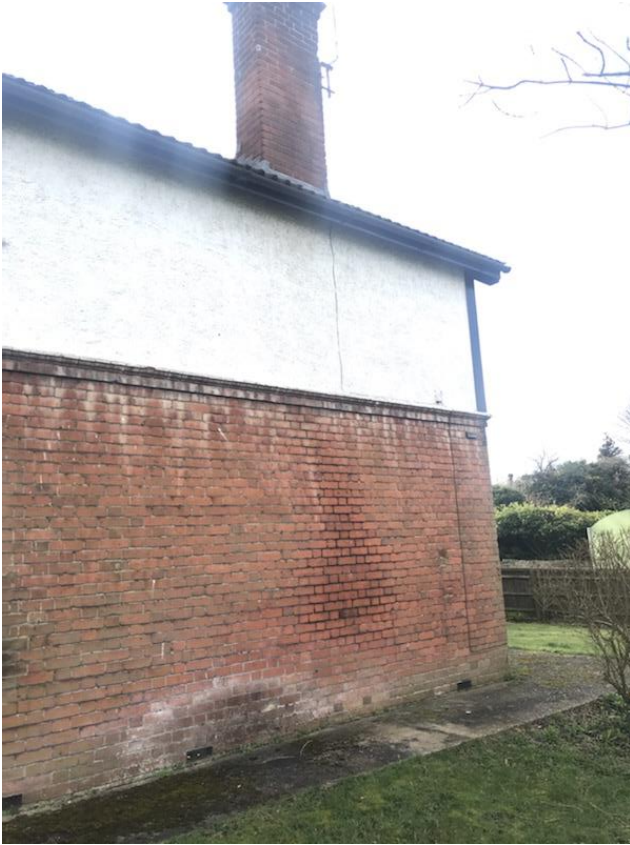
271. Damp and perished mortar pointing in the location of the chimney breast and at low level.

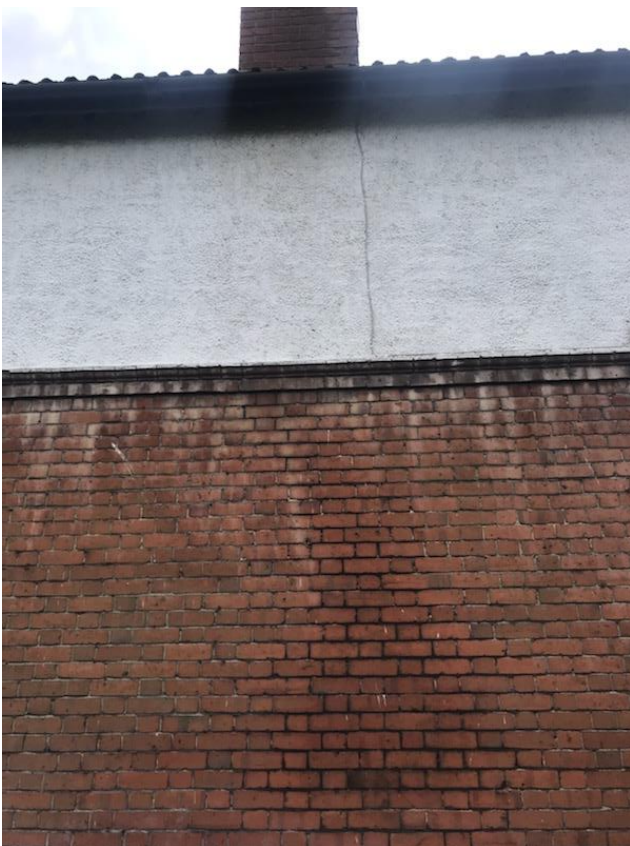
272. Damp and perished mortar pointing in the location of the chimney breast and at low level. Note: also cracked render.

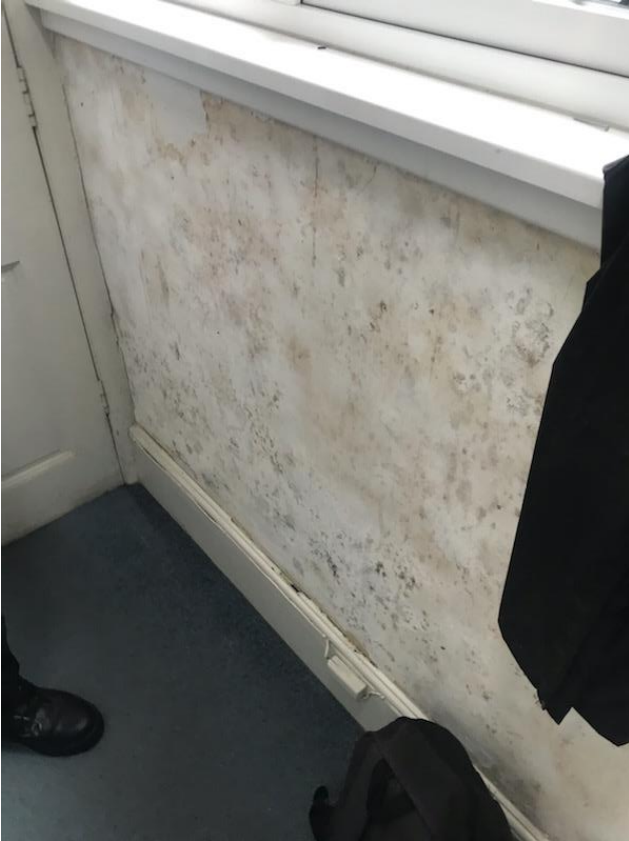
275. Damp plaster to entrance hall.

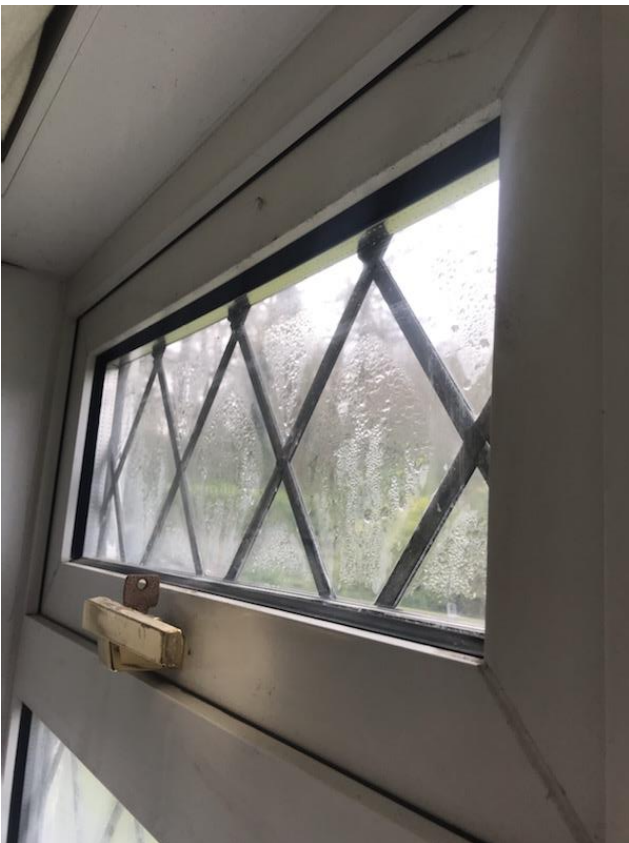
276. Condensation to double glazed windows.

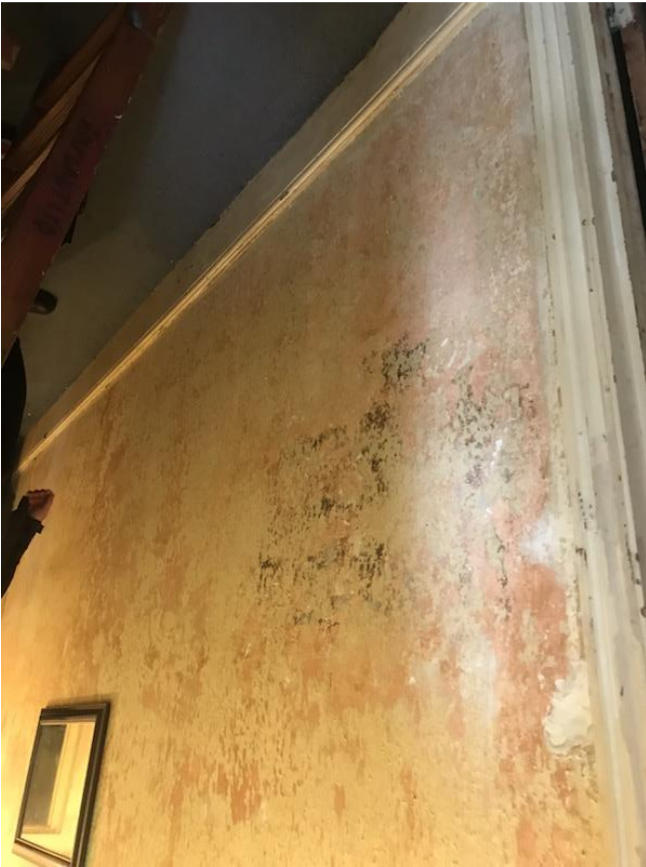
277. Damp to internal walls.

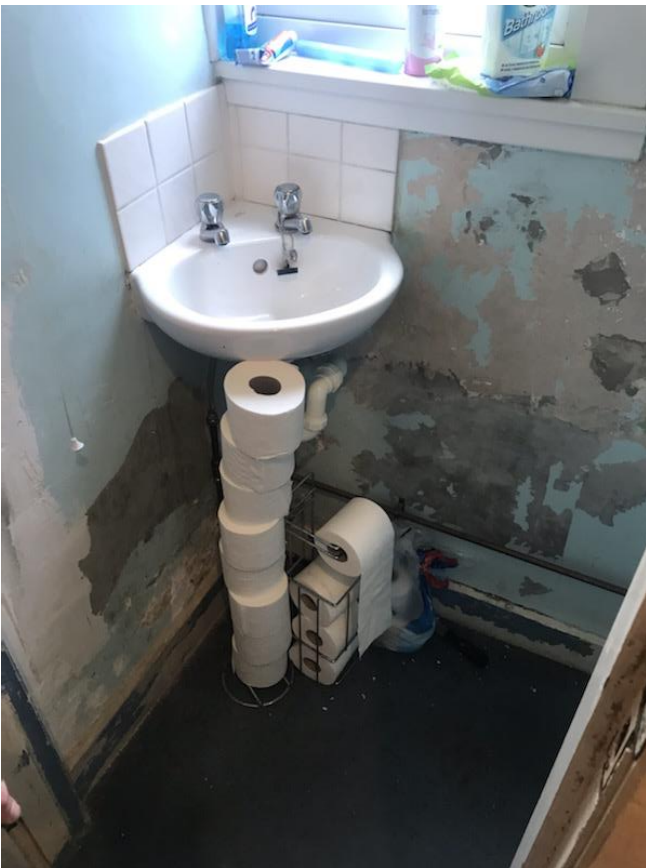
278. Damp plaster to bathroom.

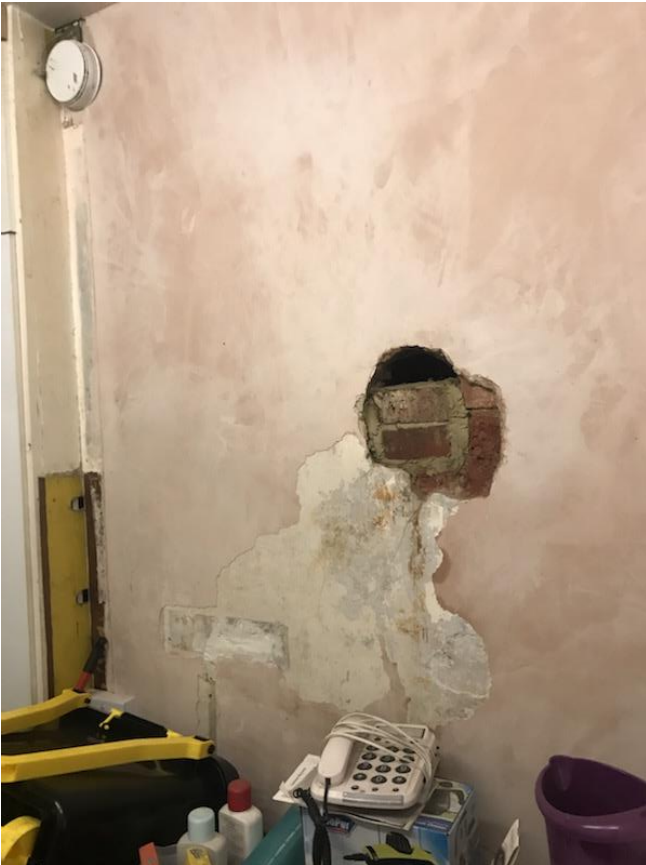
279. Damp plaster and brickwork to chimney breast.

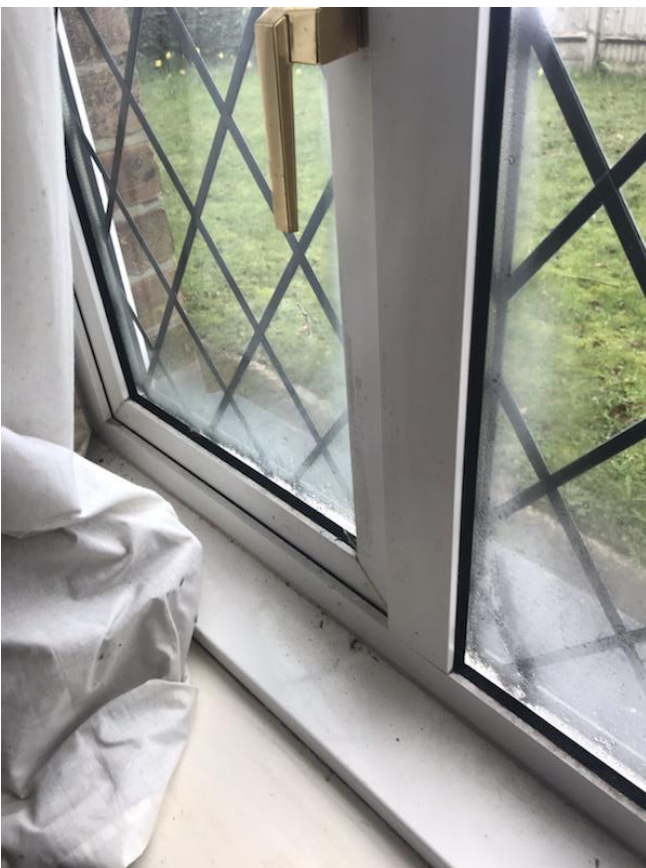
280. Condensation to double glazed window.

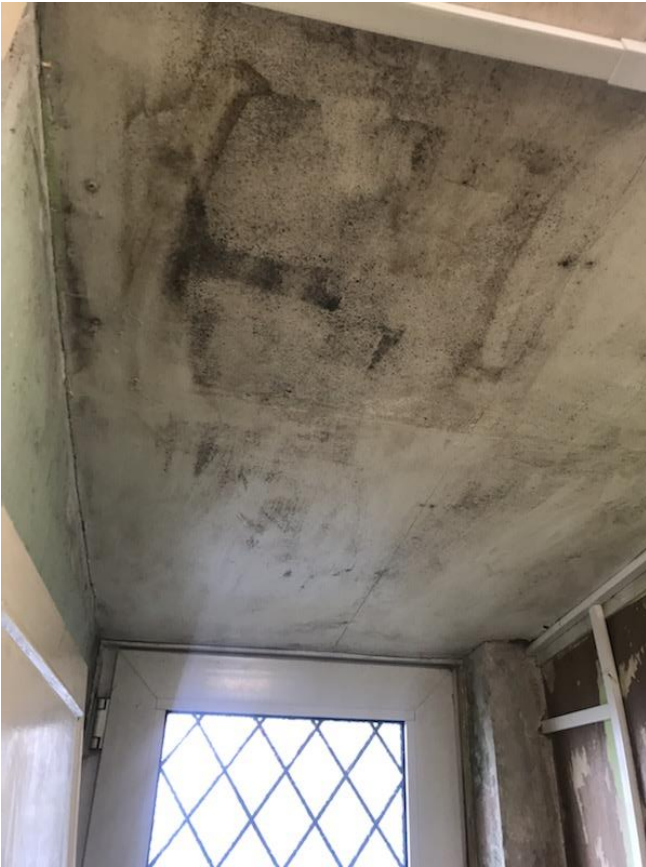
281. Damp ceiling to lean-to extension.

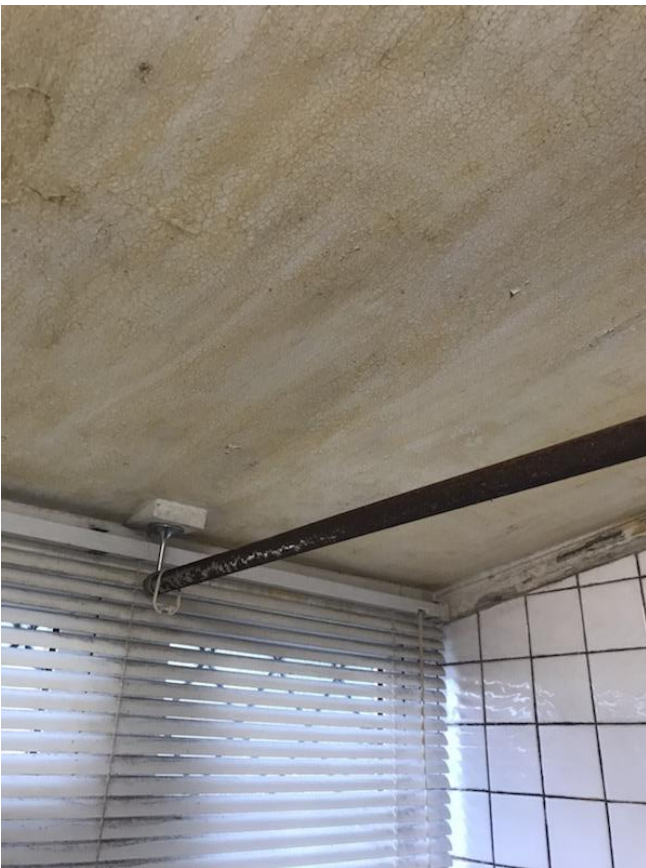
282. Damp ceiling in bathroom to lean to extension

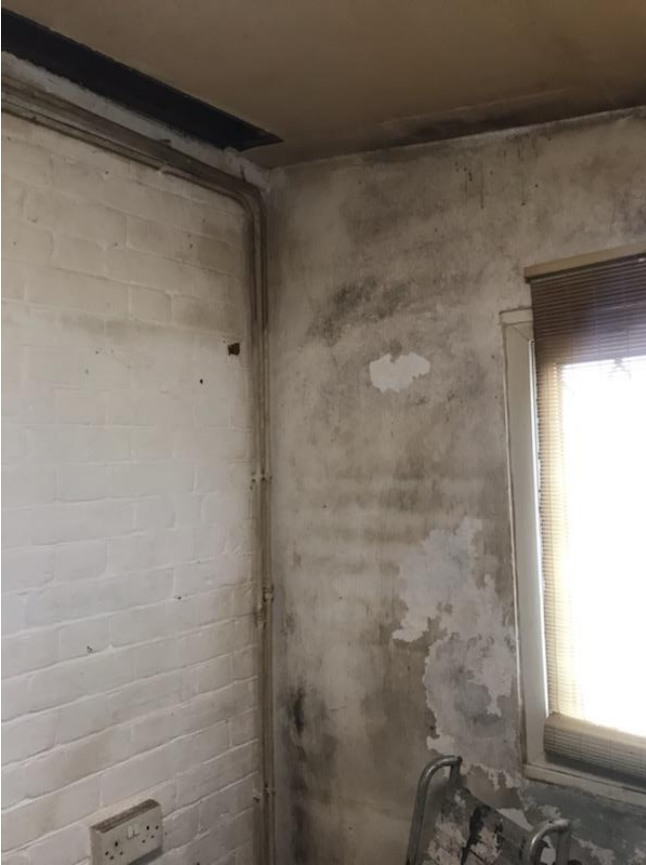
283. Damp walls to lean-to extension.

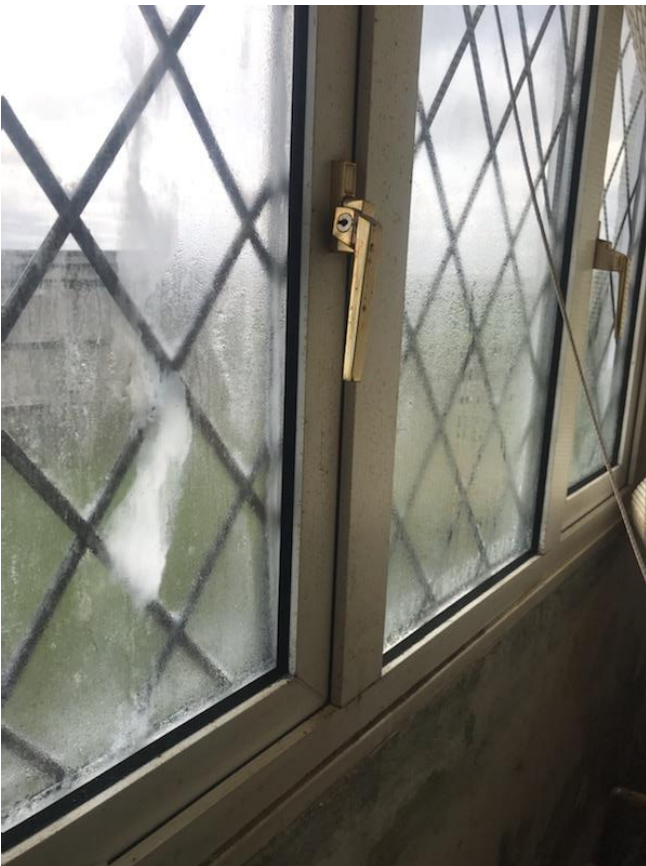
284. Condensation to double glazed windows.

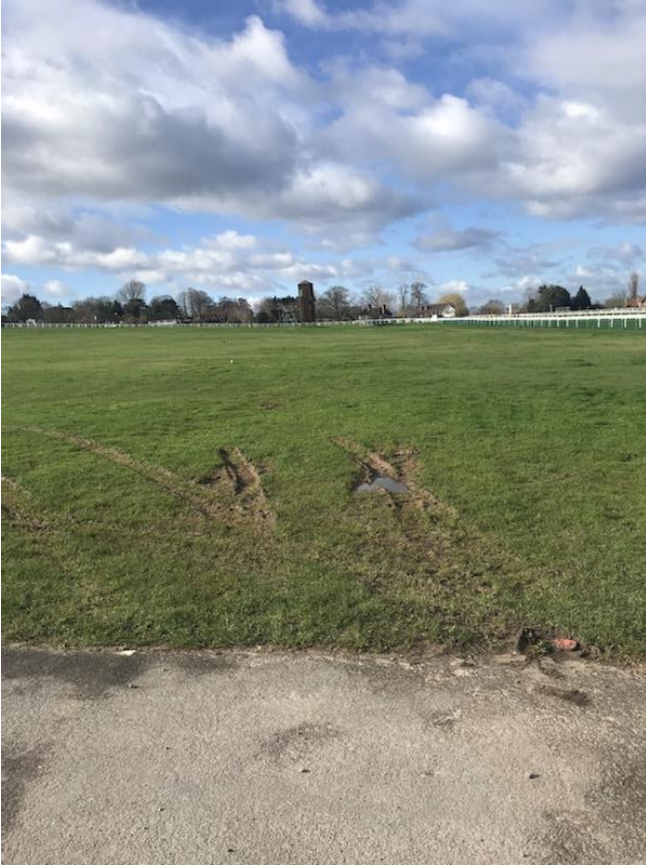
287. General view of grass parking area. Note: mud and surface water from tyre tracks.

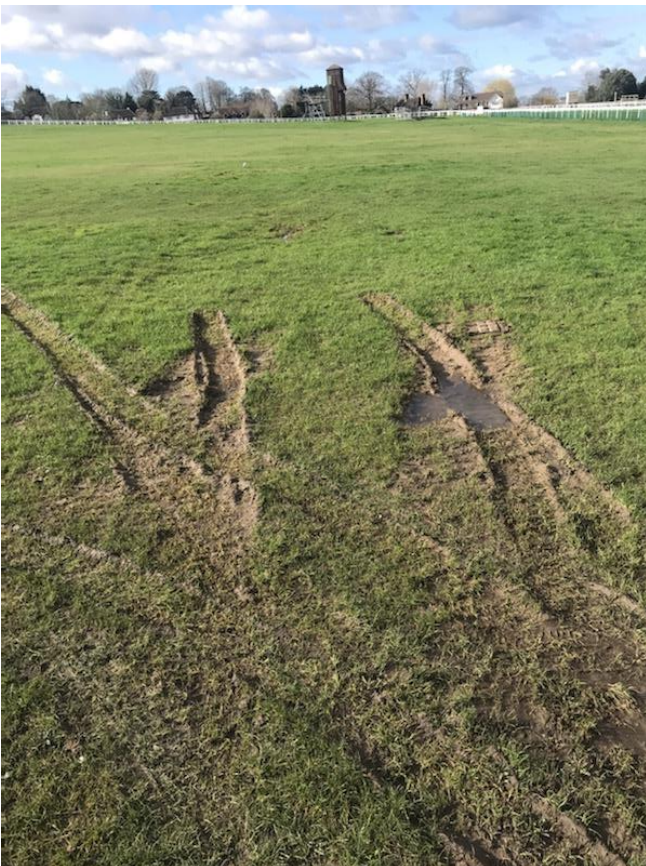
288. General view of grass parking area. Note: mud and surface water from tyre tracks.
